**ENVIRO-EXPERTS
ENVIRONMENTAL SITE ASSESSMENT PHASE II**

630, Montreal Road, Ottawa, On

Project 3260

Subject: Phase II Environmental Site Assessment for the property legally corresponding to **630, Montreal Road, Ottawa, ON.**

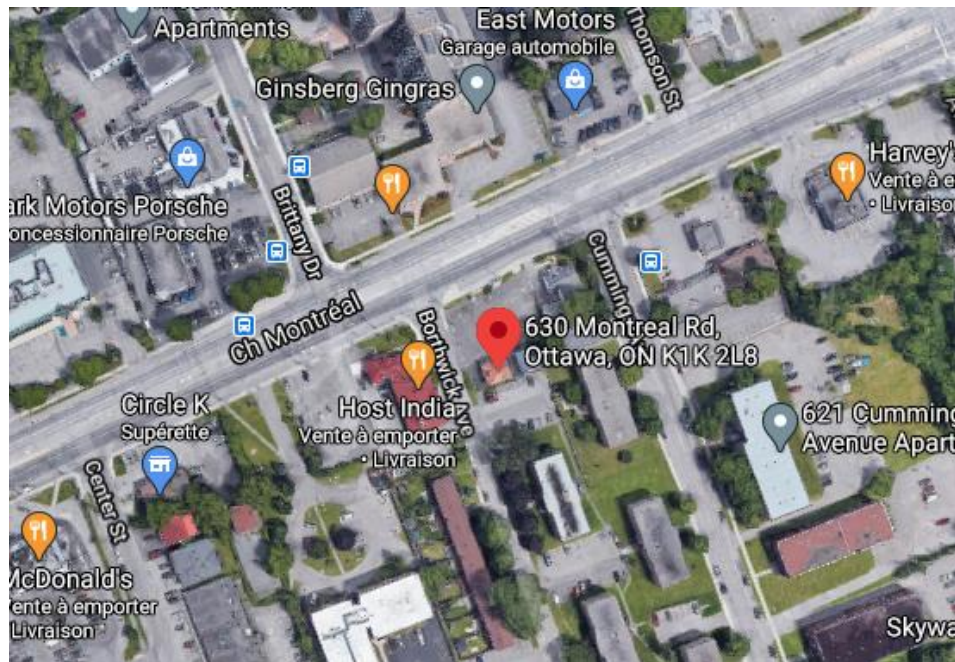
The property under study is located along Montreal Road and Borthwick Avenue, west of Cummings Avenue, in a mixed commercial and residential area of Ottawa.

Location of work site with respect to its neighbouring surroundings
(Google Earth)

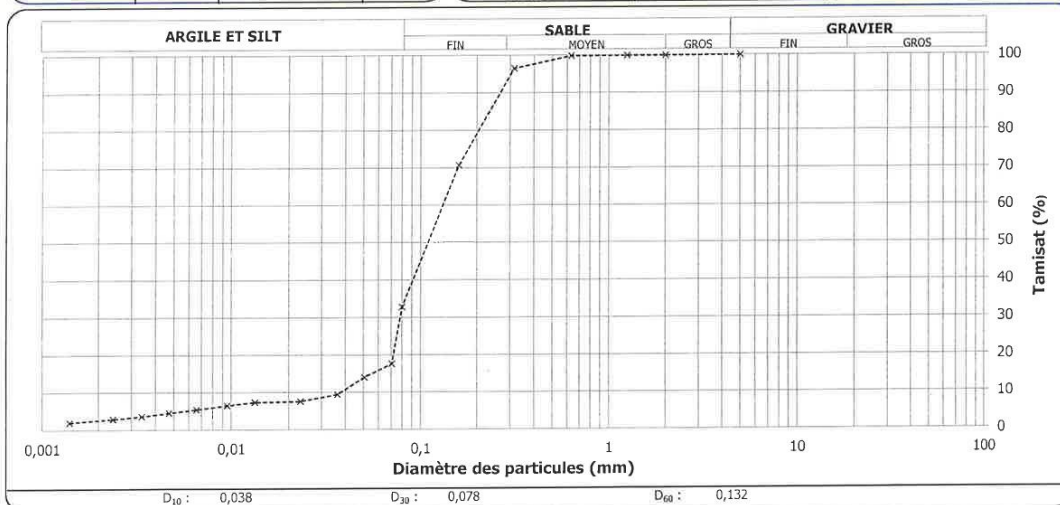
Sable :	67,2
Cailloux :	0,0
Gravier :	0,0
Silt :	30,3
Argile :	2,5

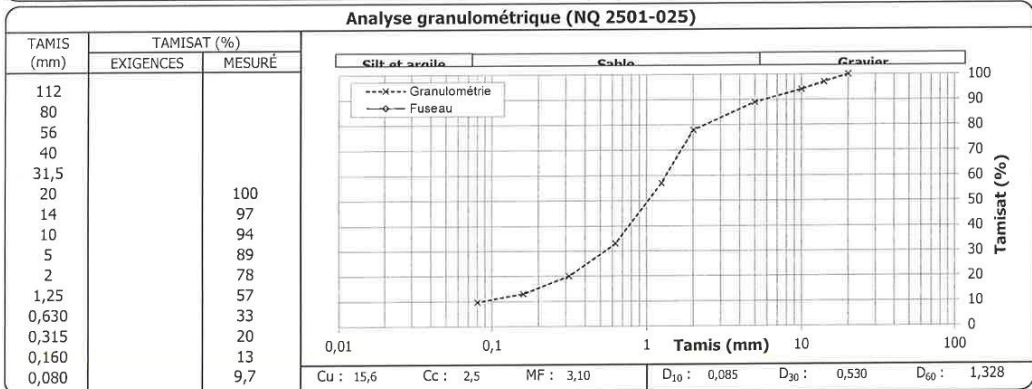
Client : Enviro-Experts	Dossier : P-0022322-0-01
Projet : Services techniques; Essais de laboratoire (Enviro-Experts)	Réf. client :
Endroit : .	Rapport n° : 84 Projet no. 3260
	Rév. 0
	Page 1 de 1

Masse vol. sèche maximale kg/m ³	Humidité optimale %	Retenu 5 mm %	Proportions selon analyse granulométrique (%)	
			Cailloux : 0,0	Sable : 79,3
			Gravier : 11,0	Silt et argile : 9,7

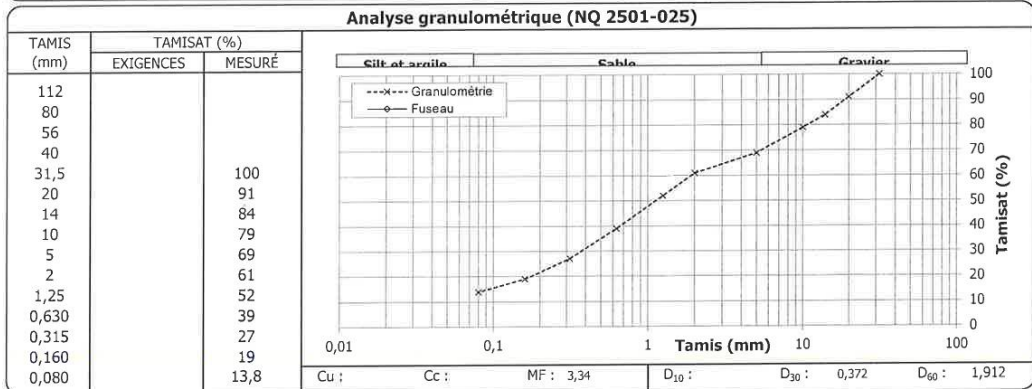
Client : Enviro-Experts	Dossier : P-0022322-0-01
Projet : Services techniques; Essais de laboratoire (Enviro-Experts)	Réf. client :
Endroit :	Projet no. 3260
	Rapport n° : 85 Rév. 0
	Page 1 de 1

Masse vol. sèche maximale kg/m ³	Humidité optimale %	Retenu 5 mm %	Proportions selon analyse granulométrique (%)	
			Cailloux : 0,0	Sable : 55,5
			Gravier : 30,7	Silt et argile : 13,8

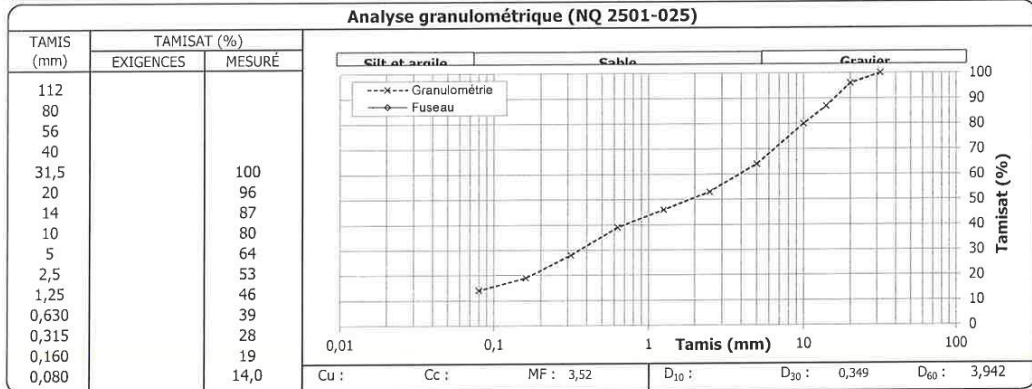
Client : Enviro-Experts	Dossier : P-0022322-0-01
Projet : Services techniques; Essais de laboratoire (Enviro-Experts)	Réf. client :
Endroit :	Projet no. 3260
	Rapport n° : 87 Rév. 0
	Page 1 de 1

Masse vol. sèche maximale kg/m ³	Humidité optimale %	Retenu 5 mm %	Proportions selon analyse granulométrique (%)	
			Cailloux : 0,0	Sablé : 49,5
			Gravier : 36,5	Silt et argile : 14,0

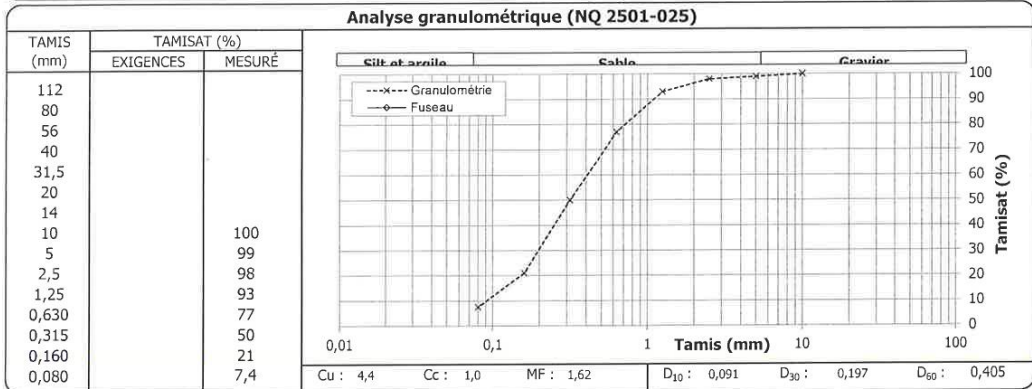
Client : Enviro-Experts	Dossier : P-0022322-0-01
Projet : Services techniques; Essais de laboratoire (Enviro-Experts)	Réf. client :
Endroit :	Projet no. 3260
	Rapport n° : 88 Rév. 0
	Page 1 de 1

Masse vol. sèche maximale kg/m ³	Humidité optimale %	Retenu 5 mm %	Proportions selon analyse granulométrique (%)	
			Cailloux : 0,0	Sable : 91,3
			Gravier : 1,3	Silt et argile : 7,4

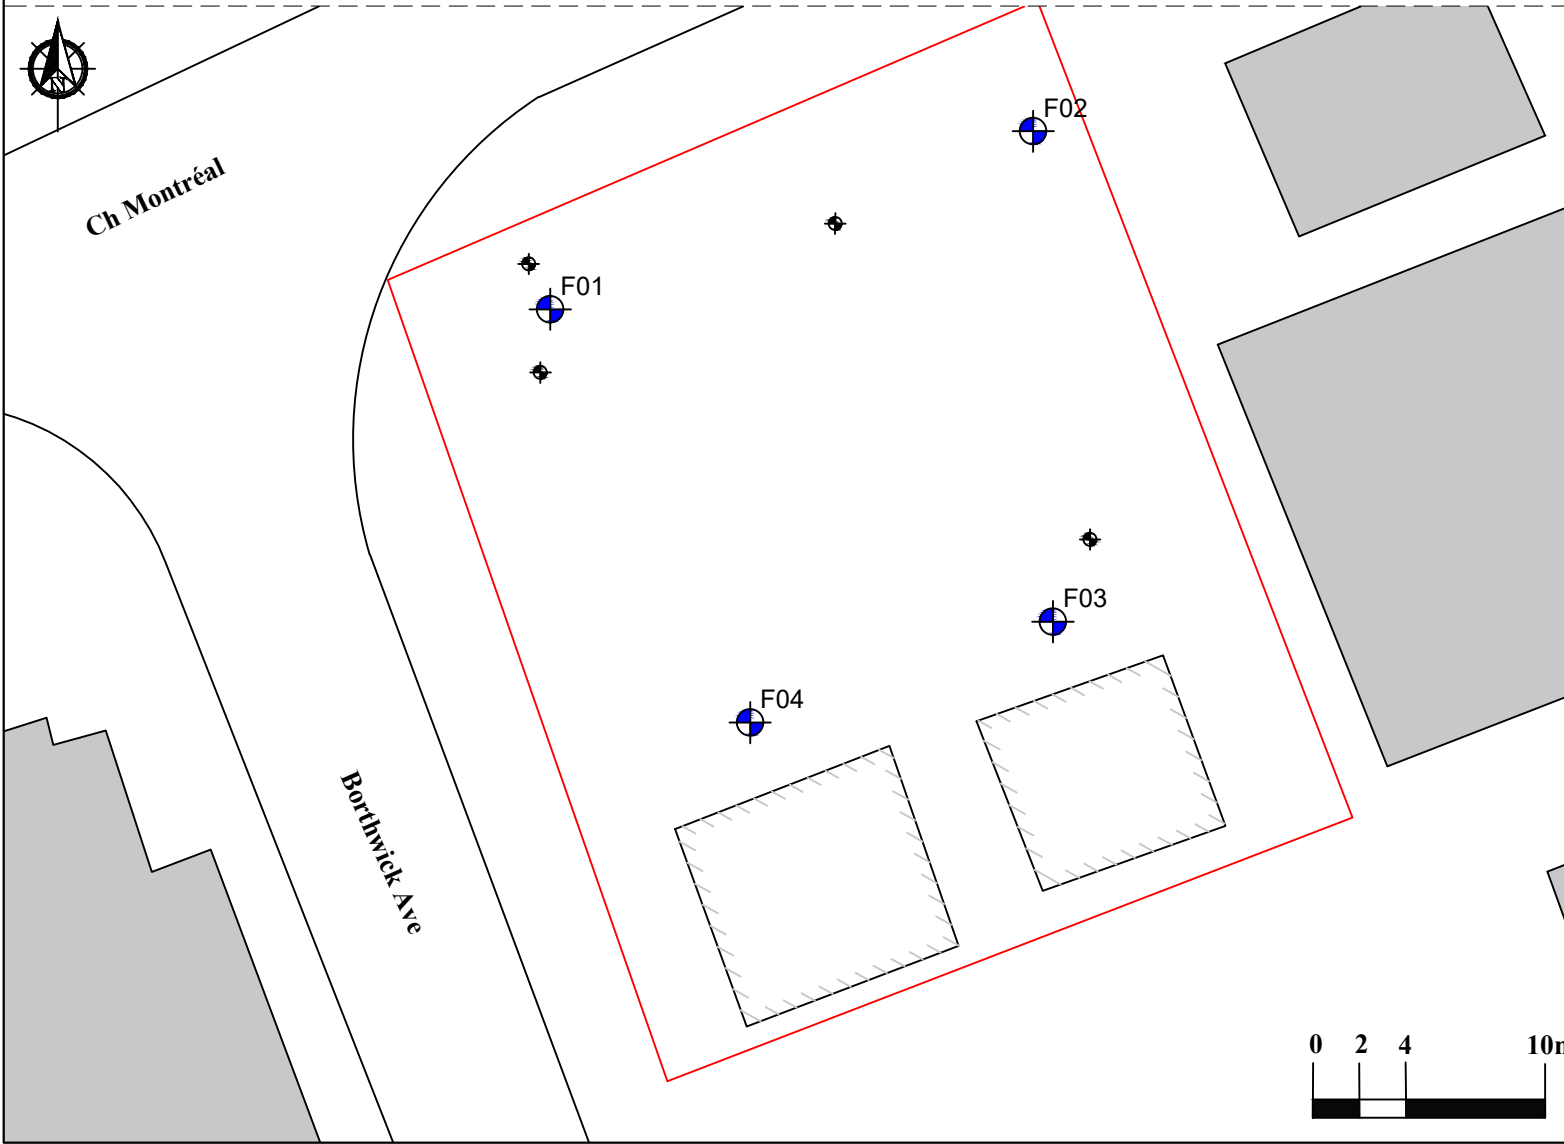
ENVIRONMENTAL SITE ASSESSMENT - PHASE II
 ADDRESS:
 360 Montreal Road, Ottawa,
 Ontario

A soil sampling and characterization plan was discussed and accepted by the client. This plan included the execution of four (4) boreholes, outside the building, identified as (F1 – F4). See appendix C (plan of borehole locations).

- Main building
- Existing Borehole
- Borehole
- Soil
 - < RPI
 - > RPI
 - > ICC
- Study Area

Appendix C shows a plan of borehole locations.
