**ENVIRO-EXPERTS
ENVIRONMENTAL SITE ASSESSMENT PHASE II**

630, Montreal Road, Ottawa, On

Project 3260

Subject: Phase II Environmental Site Assessment for the property legally
corresponding to **630, Montreal Road, Ottawa, ON.**

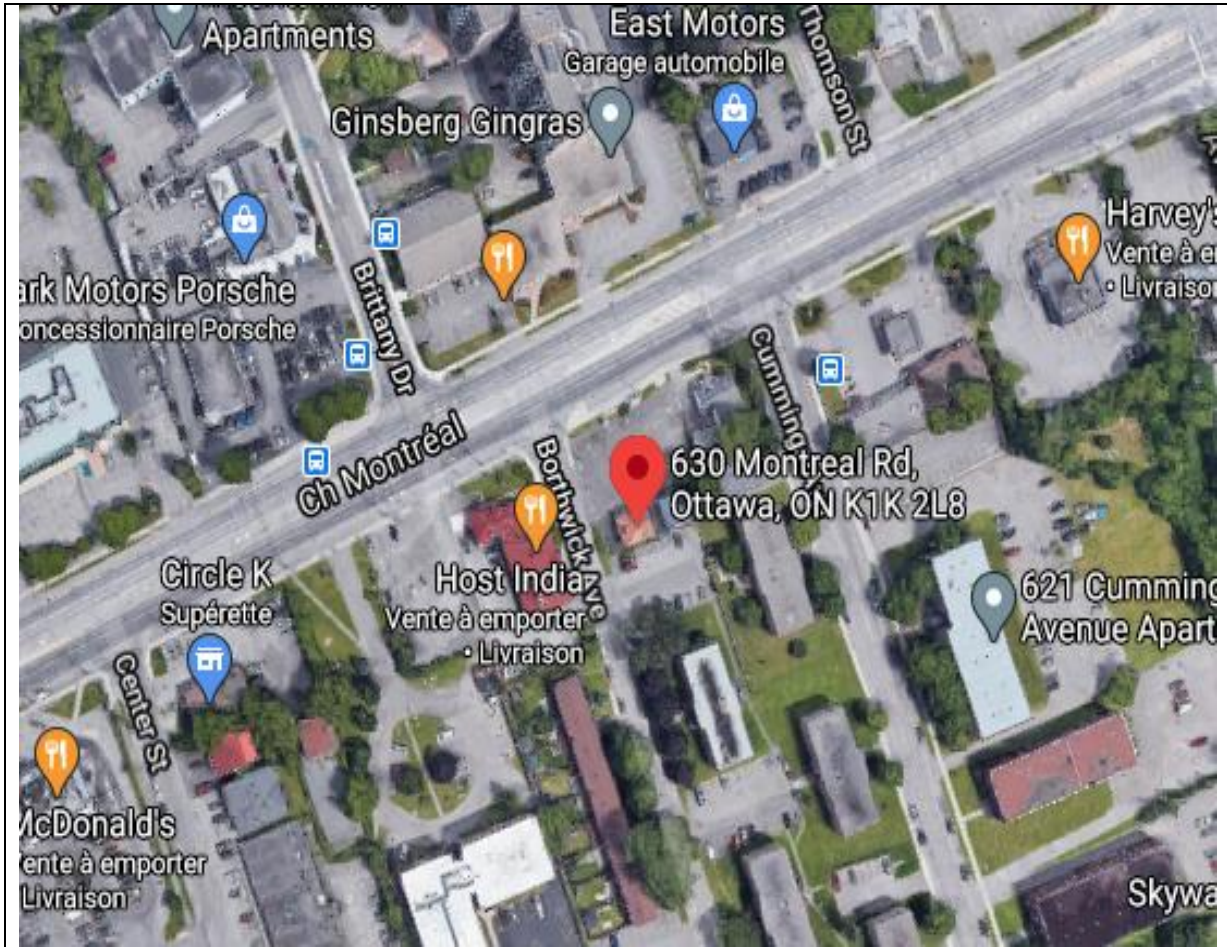
APPENDIX A: Location plan

Date : 11-12-2020	Title : Site Plan
Client M. Max Mahi	Page 1/1
