Phase I Environmental Site Assessment
135 Lusk Street
Ottawa, Ontario

KS1076

August 31, 2021

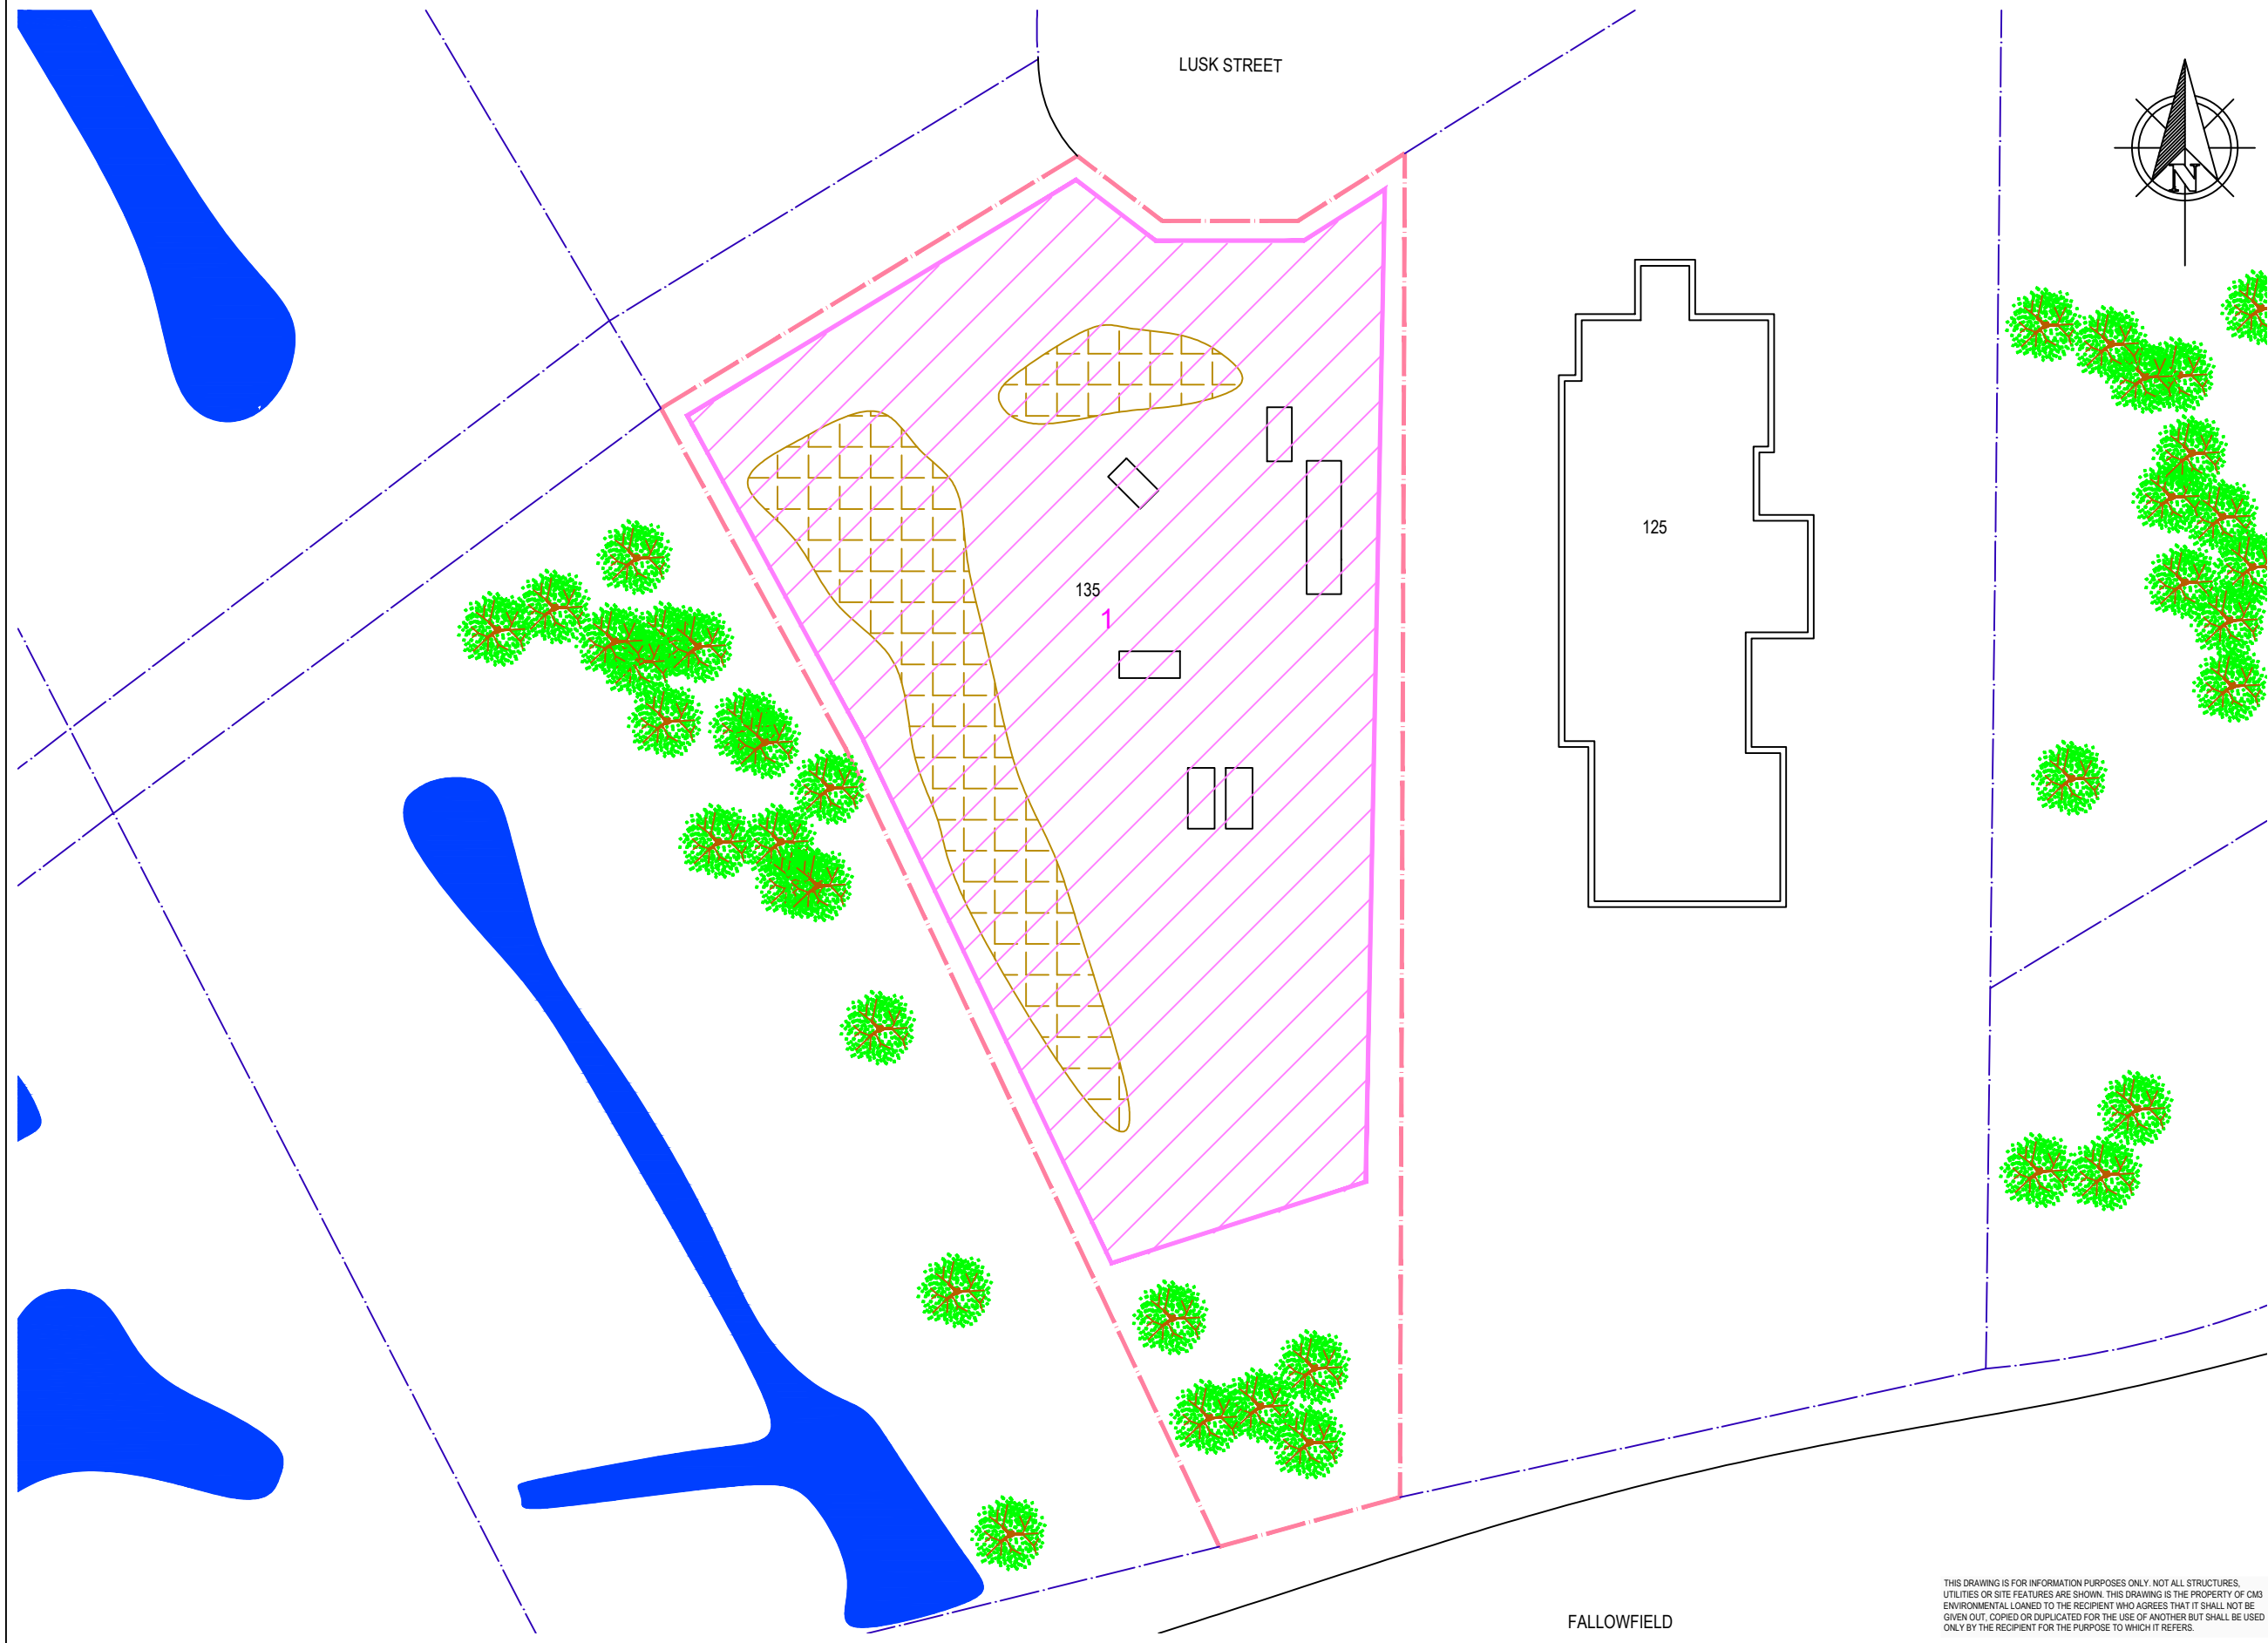
Table 7: Areas of Potential Environmental Concern			
APEC	Location	Cause of Concern	COC
1	Subject Site	Unknown Fill Quality	VOCs, PHCs F1 - F4, PAHs and metals

- PROPERTY BOUNDARY
- SITE
- BUILDING
- ON-SITE MOBILE CONSTRUCTION TRAILER AND/OR STEEL SHIPPING CONTAINERS
- ESTIMATED AREA OF STOCKPILE FILL MATERIAL
- APECs**
- (PCA 1 & 2 UNKNOWN FILL QUALITY)

Based on the above, CM3 is recommending a Phase II ESA for 135 Lusk Street to address the concerns of potential soil and groundwater contamination related to the unknown fill quality used and or stockpiled on-site.

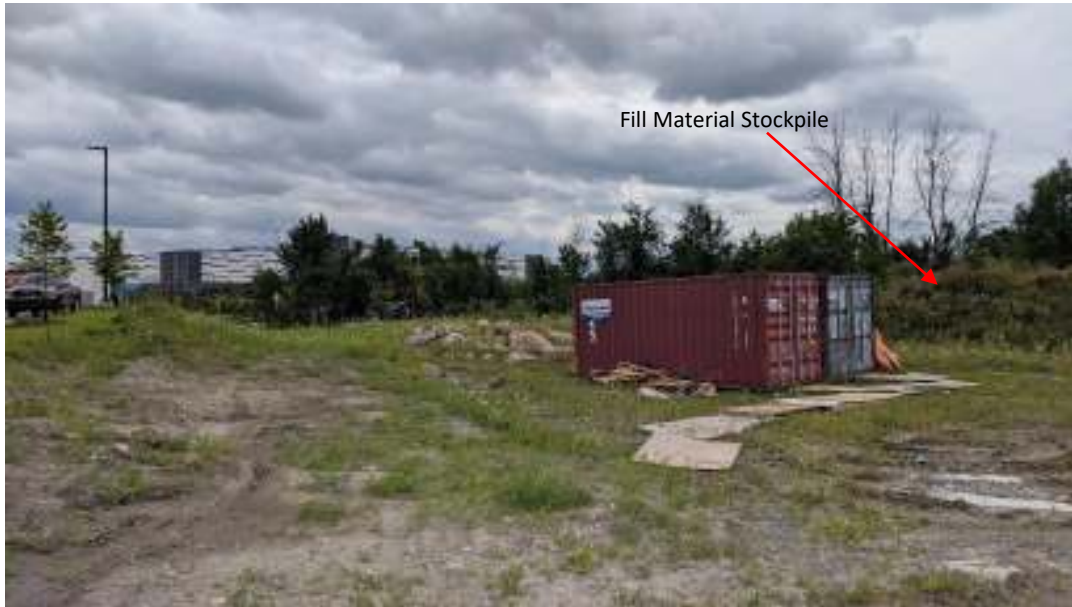
There were five steel shipping containers and one mobile construction office trailer on-site during the Phase I ESA site investigation. No permanent structures were located on the subject property. Photographs of the property and surrounding land uses are included in Appendix A. CM3 did not observe any obvious areas of obvious staining and/or unidentified substances surrounding the structures.

Photograph 3: Subject property view of two on-site steel shipping containers. (Photo facing south)

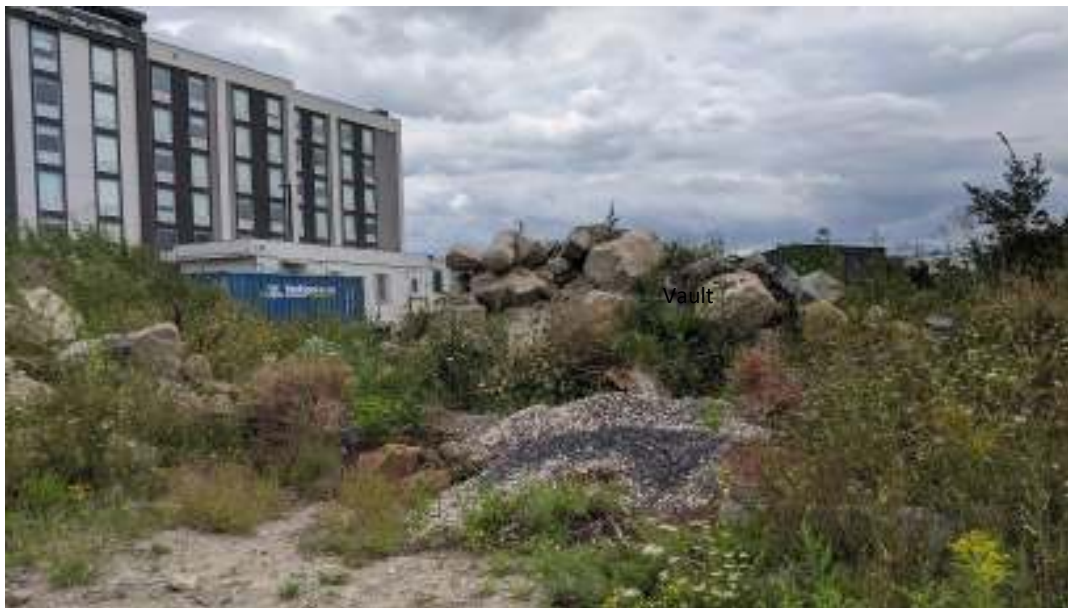
Photograph 5: Subject property fill material stockpile on north end of property. (Photo facing southeast)

Potentially contaminating activities (PCAs) are listed and numbered in O. Reg. 153/04, Schedule D; Table 2. Several areas of stockpiled soils were observed at the subject site. O. Reg. 153/04, Schedule D; Table 2 Item #30 identifies that importation of fill material of unknown quality is considered a PCA. CM3 is unaware of any documentation showing the quality of on-site stockpiled fill material and therefore the stockpiles are considered a PCA.

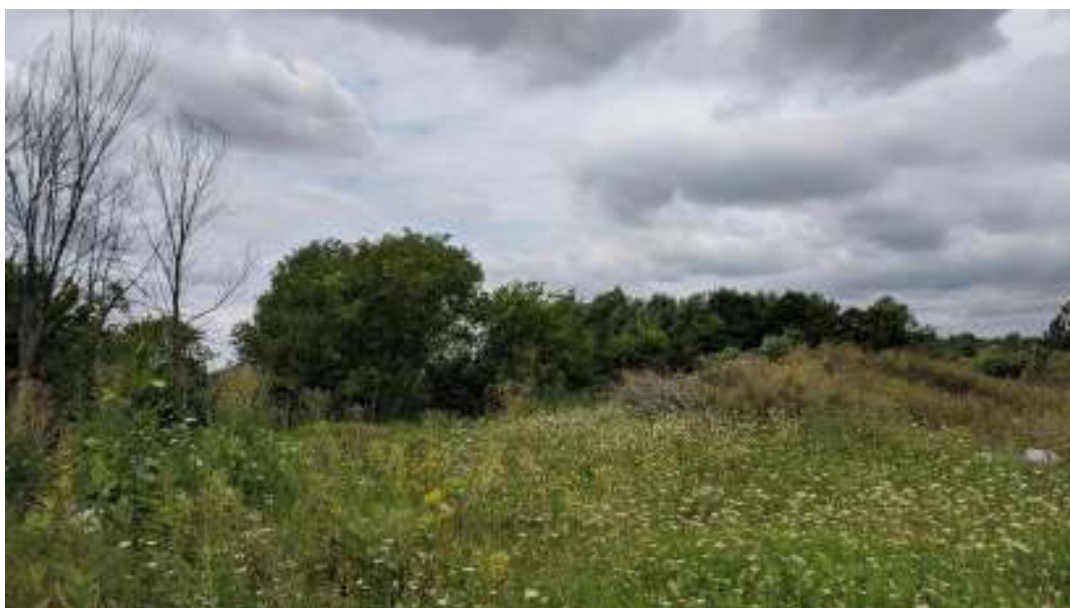
Photograph 6: Subject property fill material stockpile west side of property. (Photo facing north)

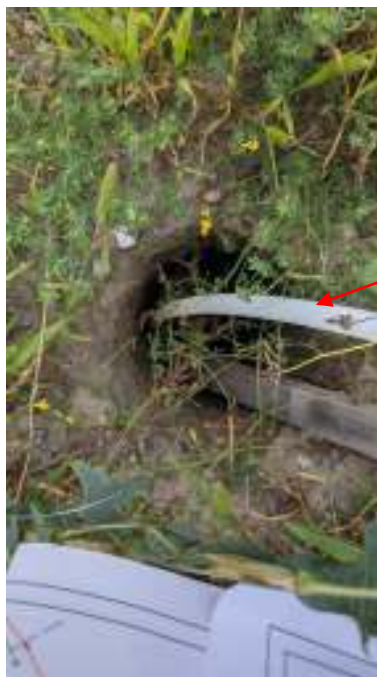
Polyethylene tubing

CM3 noted three borehole locations where a high density polyethylene tube was installed. The boreholes and tubing were likely completed during a previous geotechnical survey of the property. CM3 is unaware of the results from any site assessment completed at the site. No other wells were observed on the subject property during the Phase I ESA site investigation.

Photograph 9: One of several on-site former boreholes with high density polyethylene tubing .

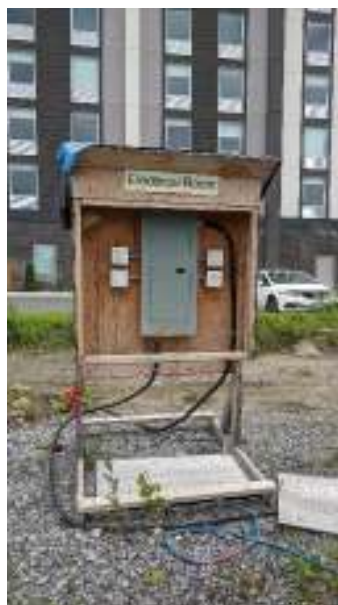
Photograph 10: On-site electrical service located on northeast corner of property adjacent to mobile office trailer.
