Phase I Environmental Site Assessment 135 Lusk Street Ottawa, Ontario

KS1076

August 31, 2021

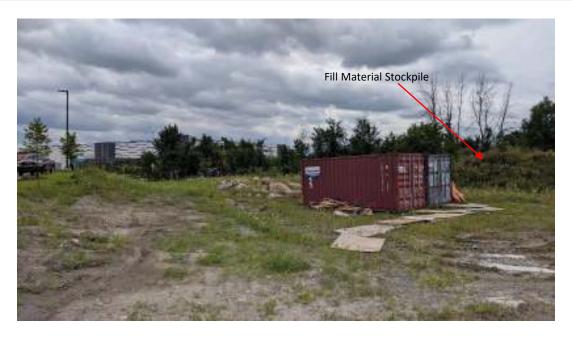
Photograph 3: Subject property view of two on-site steel shipping containers. (Photo facing south)

There were five steel shipping containers and one mobile construction office trailer on-site during the Phase IESA site investigation. No permanent structures were located on the subject property. Photographs of the property and surrounding land uses are included in Appendix A. CM3 did not observe any obvious areas of obvious staining and/or unidentified substances surrounding the structures.

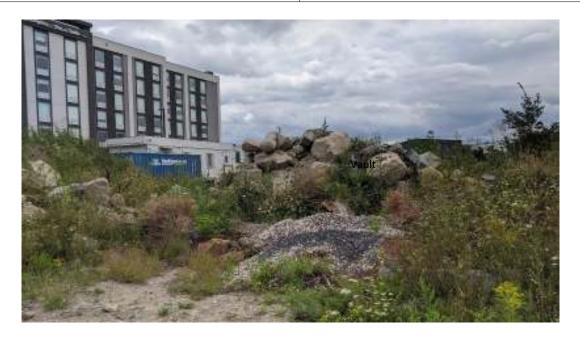
Photograph 5: Subject property fill material stockpile on north end of property. (Photo facing southeast)

Potentially contaminating activities (PCAs) are listed and numbered in O. Reg. 153/04, Schedule D; Table 2. Several areas of stockpiled soils were observed at the subject site. O. Reg. 153/04, Schedule D; Table 2 Item #30 identifies that importation of fill material of unknown quality is considered a PCA. CM3 is unaware of any documentation showing the quality of on-site stockpiled fill material and therefore the stockpiles are considered a PCA.

Based on the above, CM3 is recommending a Phase II ESA for 135 Lusk Street to address the concerns of potential soil and groundwater contamination related to the unknown fill quality used and or stockpiled on-site.

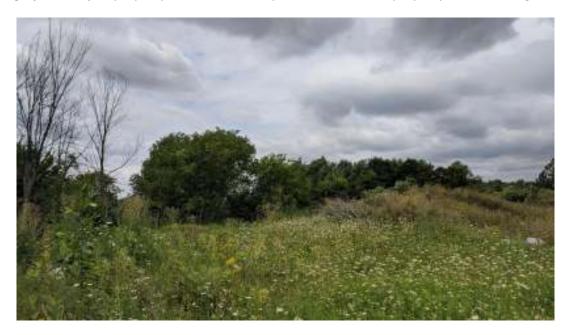
Photograph 6: Subject property fill material stockpile west side of property. (Photo facing north)

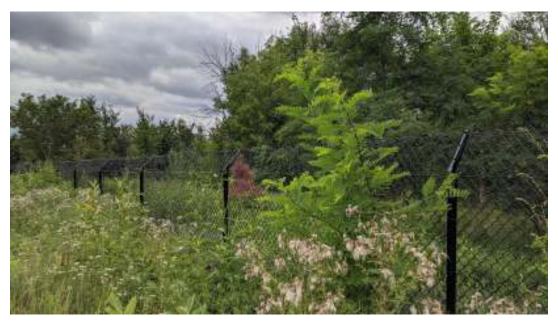
**Photograph 7:** Subject property west property line, chain-link fence separating site from storm water management area. (Photo facing southwest)

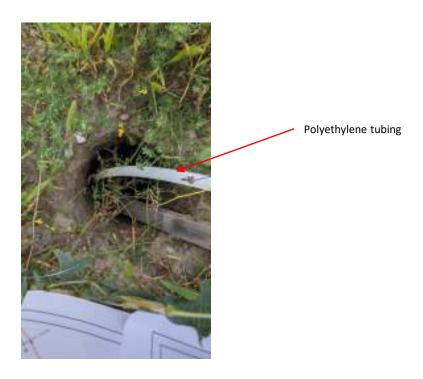
**Photograph 9:** One of several on-site former boreholes with high density polyethylene tubing .

CM3 noted three borehole locations where a hight density polyethylene tube was installed. The boreholes and tubing were likely completed during a previous geotechnical survey of the property. CM3 is unaware of the results from any site assessment completed at the site. No other wells were observed on the subject property during the Phase IESA site investigation.

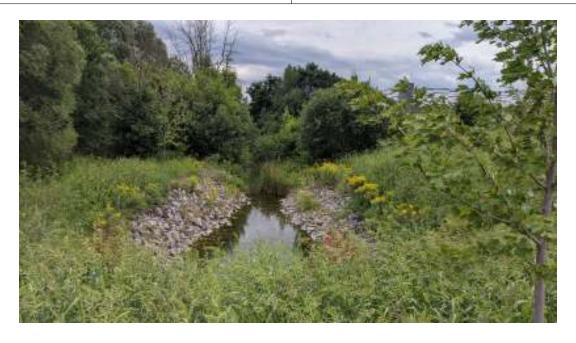
Photograph 15: Stormwater management pond adjacent to the west side of the subject site. (Photo facing south)

Surface water and wetlands were identified within the Phase I study area. Several small puddles of water were observed on site, but no swamps, pond or wetlands were present on the subject property. Hydrologic information is provided in in the ERIS PSR, Appendix F.

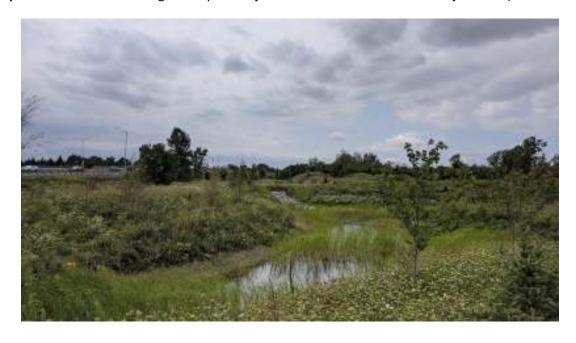
Photograph 16: Stormwater management pond adjacent to the west side of the subject site. (Photo facing west).

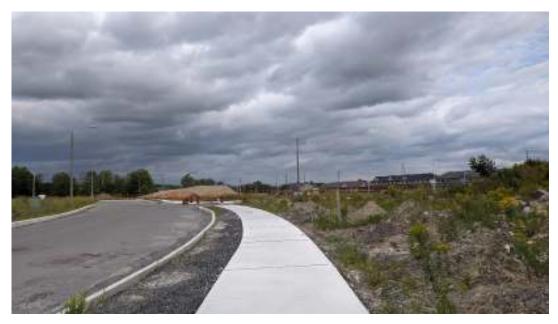
**Photograph 21:** Beyond east side Hampton Inn & Suites along Lusk St. Undeveloped land with stockpiles of fill. (Photo facing northeast on Lusk St.)

The findings of the Phase IESA identified two Potentially Contaminating Activities (PCAs) on-site and one PCA off-site within the subject study area. All three PCAs were related to the unknown quality of fill materials. The PCAs were evaluated with respect to the condition, location (source) of the PCA and the potential pathways/migration relative to the subject property. Consideration was also given to higher risk PCAs with respect to potential environmental liability. Areas of potential environmental concern (APEC) and contaminants of concern (COCs) were established based on the available information. The two on-site PCAs were considered APECs due to the unknown quality of fill material that may have been used and or stockpiled on-site.
