**Phase I Environmental Site Assessment**

2 Robinson Avenue  
Ottawa, Ontario

September 4, 2020

Report: PE4528-1

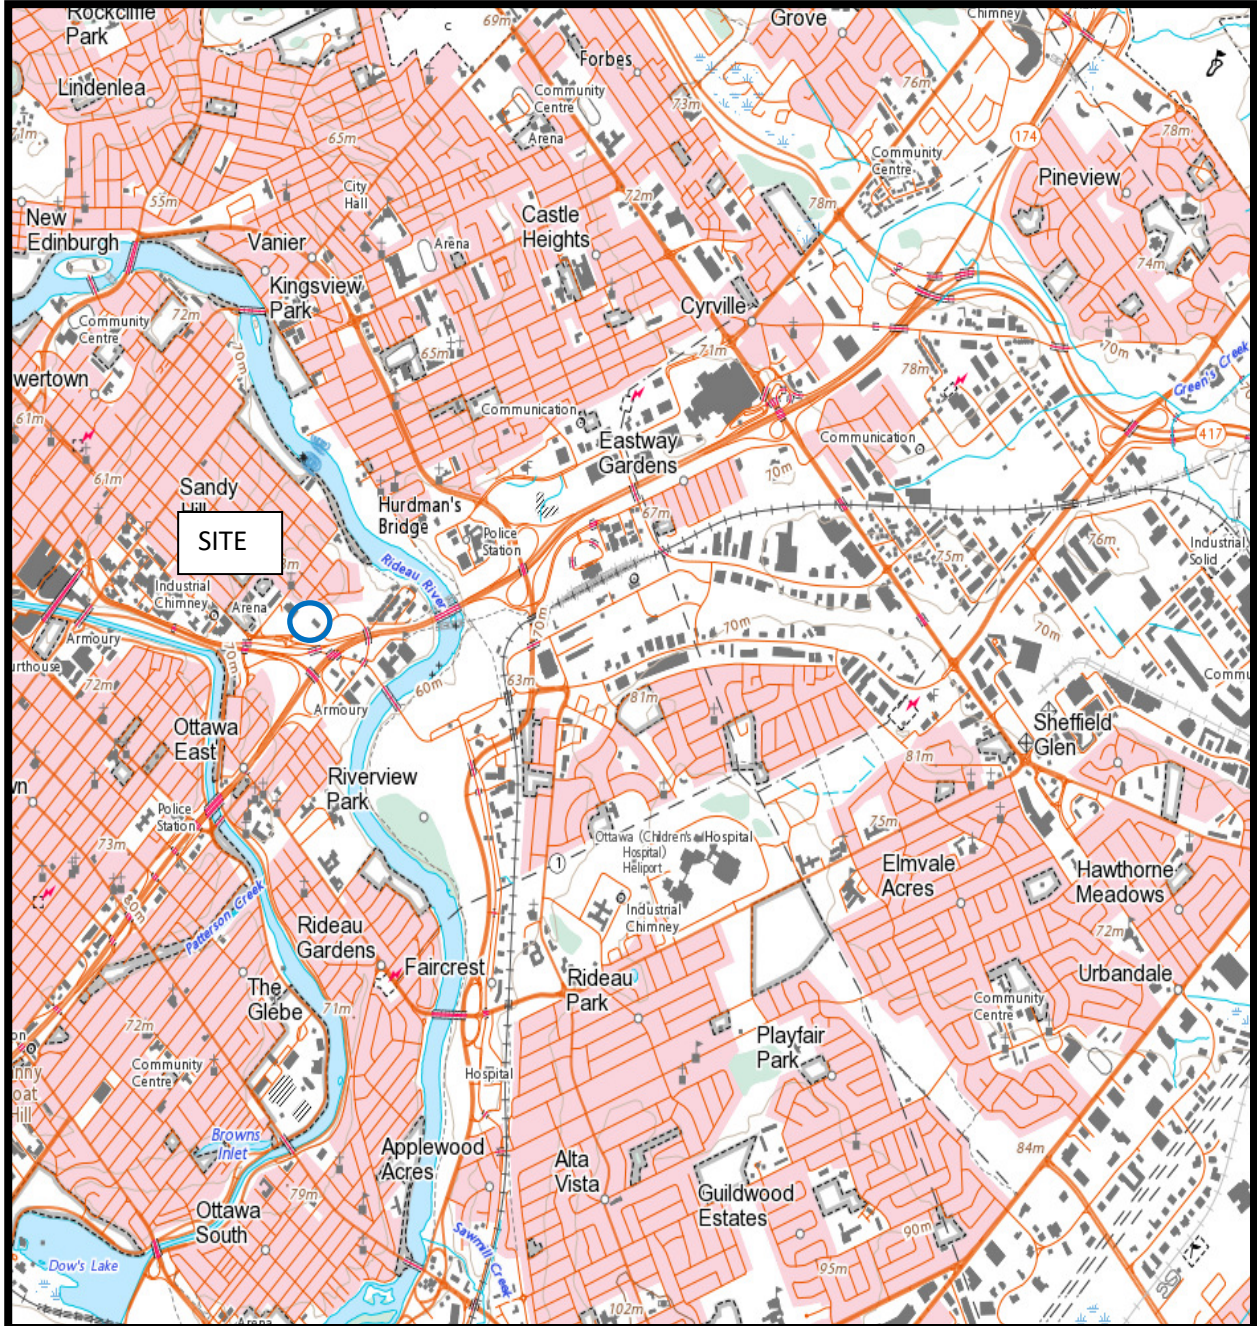
## TOPOGRAPHIC MAP

Topographic maps were obtained from Natural Resources Canada – The Atlas of Canada website and from the City of Ottawa website. The topographic maps indicate that the regional topography in the general area of the Phase I Property slopes gradually downward in a south-easterly direction. According to the maps, the nearest water body is the Rideau River, located approximately 375 m to the east of the Phase I Property. An illustration of the referenced topographic map is presented on Figure 2 – Topographic Map, appended to this report.

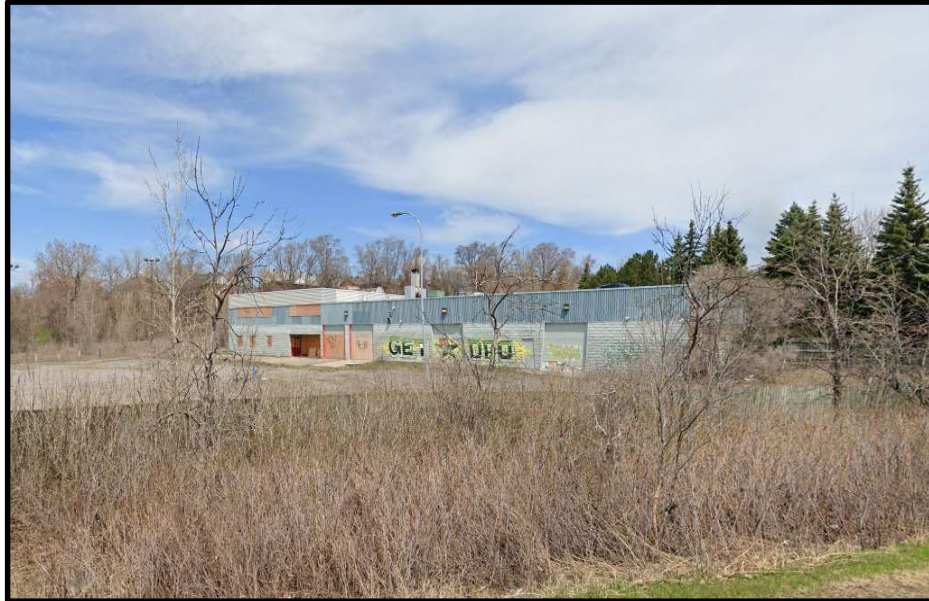
Photograph 1: Front view of the subject property, looking north.

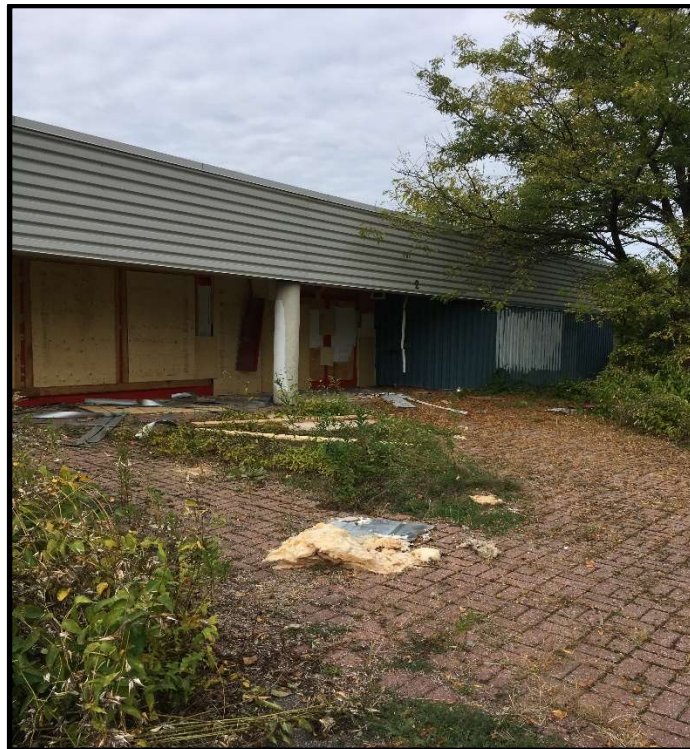
Photograph 2: Rear view of subject property, looking west.
