**Environmental Impact Statement  
6150 Thunder Road, Ottawa**

**Updated Report**

**July 15, 2021**

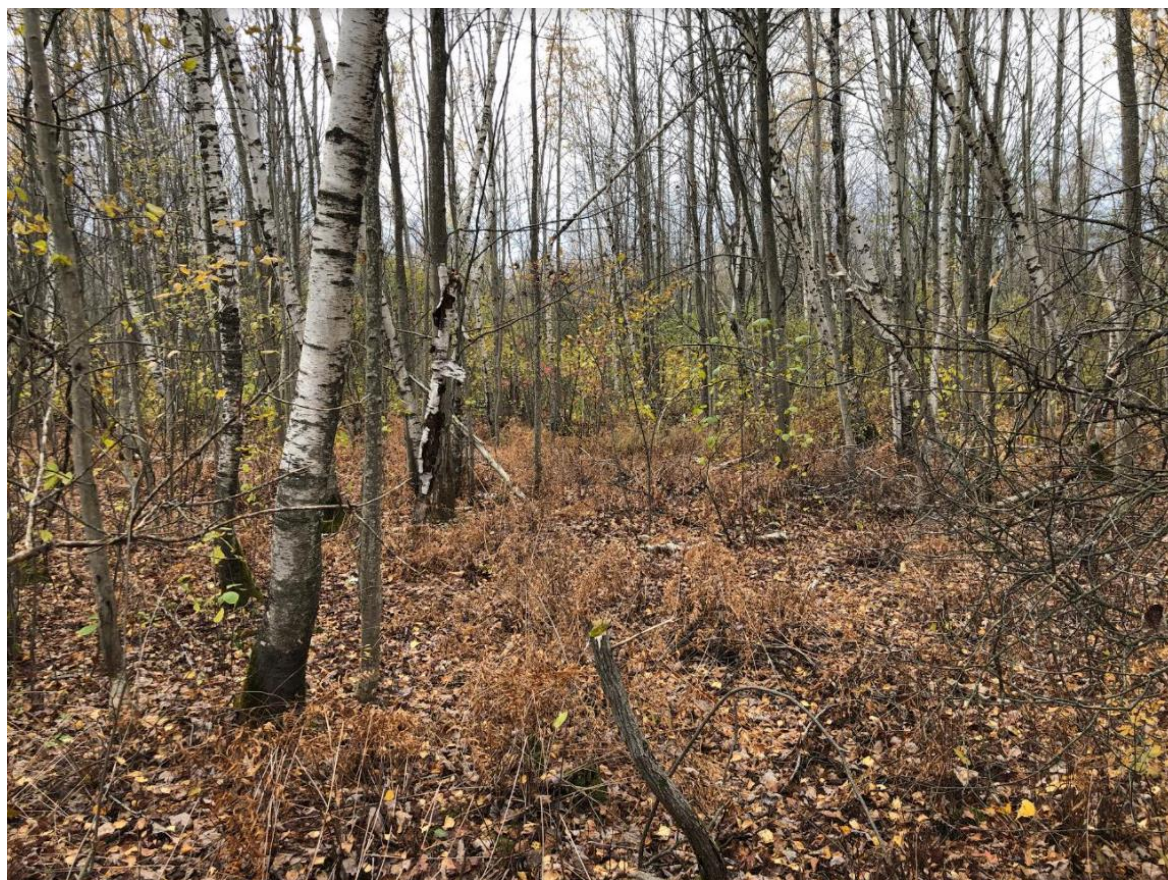
The northern end of the site – north of R7 – is a Fresh-Moist Poplar Deciduous Forest (FOD8-2). The ecosite is co-dominated by Balsam Poplar (*Populus balsamifera*) and Trembling Aspen (*Populus tremuloides*). These trees have a diameter at breast height (DBH) that ranges from 10 to 35 cm. Other tree species present in small numbers include Red Maple (*Acer rubrum*), European Birch (*Betula pendula*), Eastern Cottonwood (*Populus deltoids*) and Green Ash (*Fraxinus pennsylvanica*). This is the oldest contiguously wooded area on the Site, though it is still no more than 45 years old (City of Ottawa, 2020a).

**FOD8-2 Ecosite**

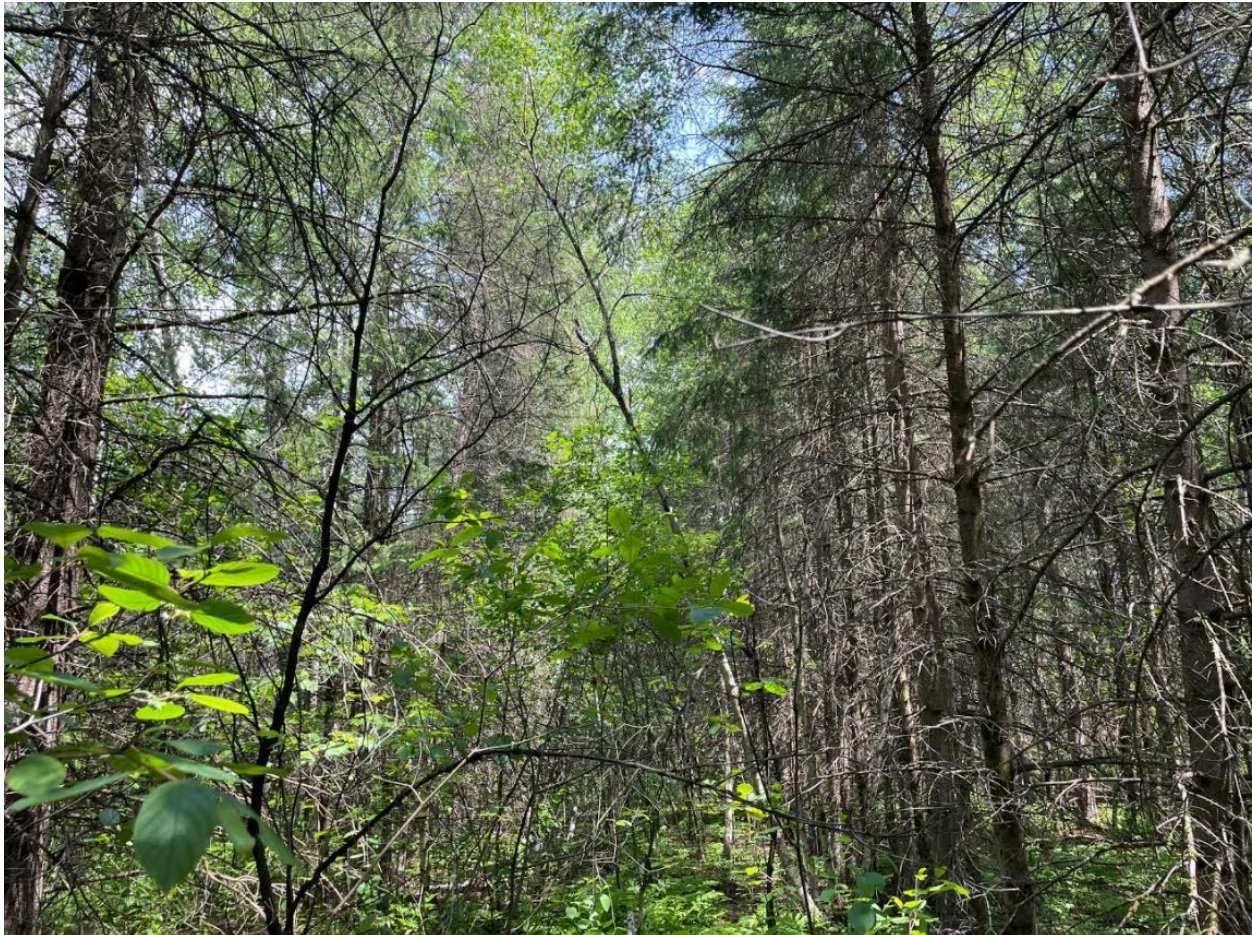
Immediately south of R7, the Site is spanned by a Coniferous Plantation (TAGM1) composed primarily of White Spruce (*Picea glauca*), with subordinate species of Jack Pine (*Pinus banksiana*) and Red Pine (*Pinus resinosa*). These conifers, growing in a linear orientation, are generally similar in size ranging from 30-35 cm DBH. Air photos from 1991 suggest that most of the area between R7 and R4 (which corresponds approximately with the northern limit of the Site clearing conducted in 2019) were planted with this type of plantation. The bulk of the TAGM1 plantation, however, is currently limited to a ~75 m band south of R7 with two other narrow bands remaining near R4.

#### **TAGM1 Ecosite**

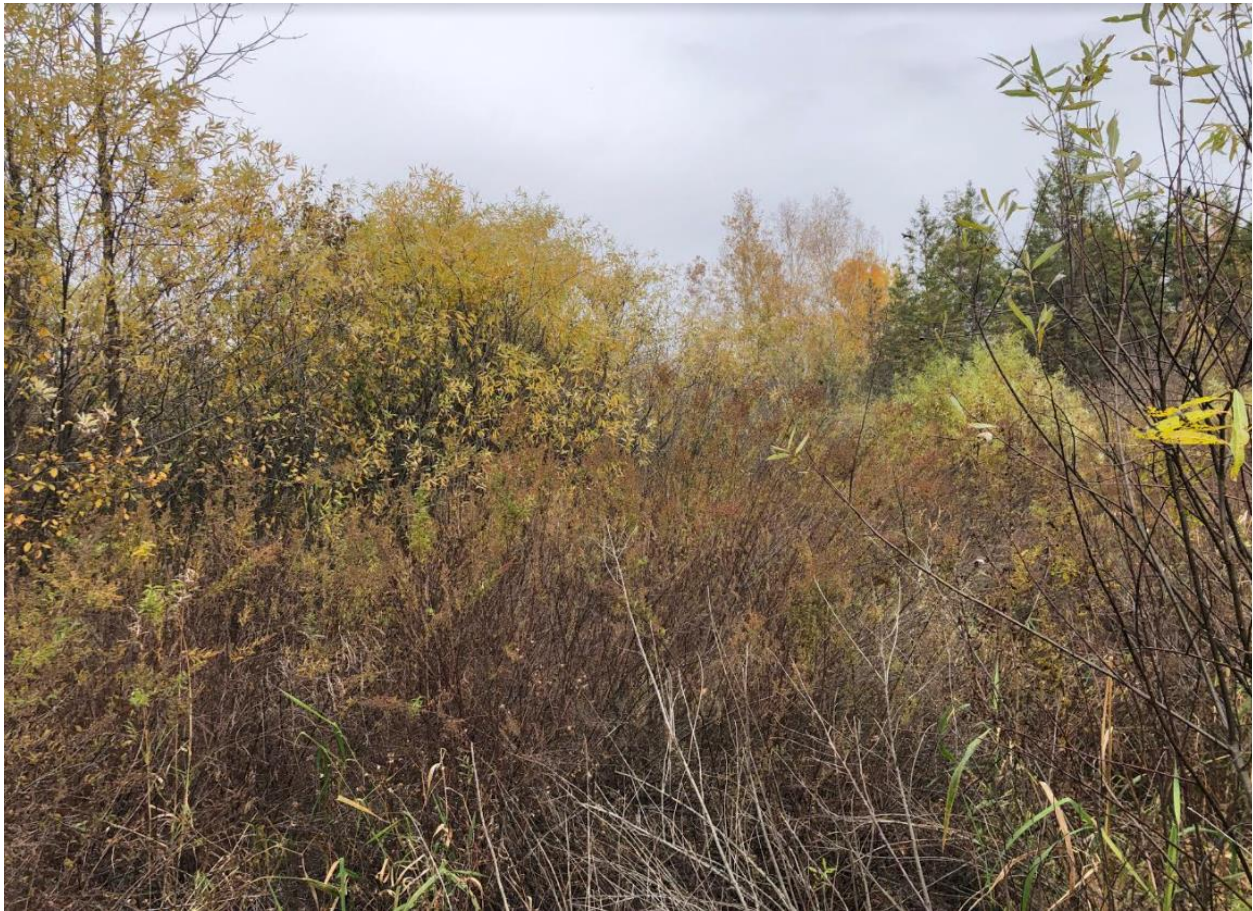
In the centre of the Site, immediately adjacent to the cleared area, a small (0.7 ha) depression forms a Willow Mineral Deciduous Thicket Swamp (SWT2) ecosystem, dominated by a mix of Bebb's Willow (*Salix bebbiana*) and Speckled Alder (*Alnus incana*) with some buckthorn. Groundcover here includes sedge (*Carex* sp.) and rush (*Juncus* sp.) species.

**Central SWT2 Ecosite**

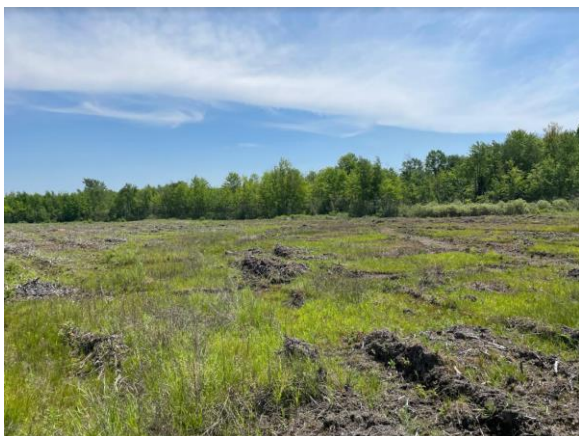
The southern portion of the Site was fully cleared of all vegetation in 2019. Vegetation cover here had previously consisted mostly of young, early-successional forest with the same FOD7 species mix apparent beyond the south and west site boundaries and present in the central portion of the Site. Trees here though had been the youngest on Site, with the forest cover only starting to develop in the late 1990s. A small pocket of SWT2 thicket swamp is located just off the southwest edge of the Site with the same species mix present the SWT2 pocket in the center of the site.

**Cleared area**

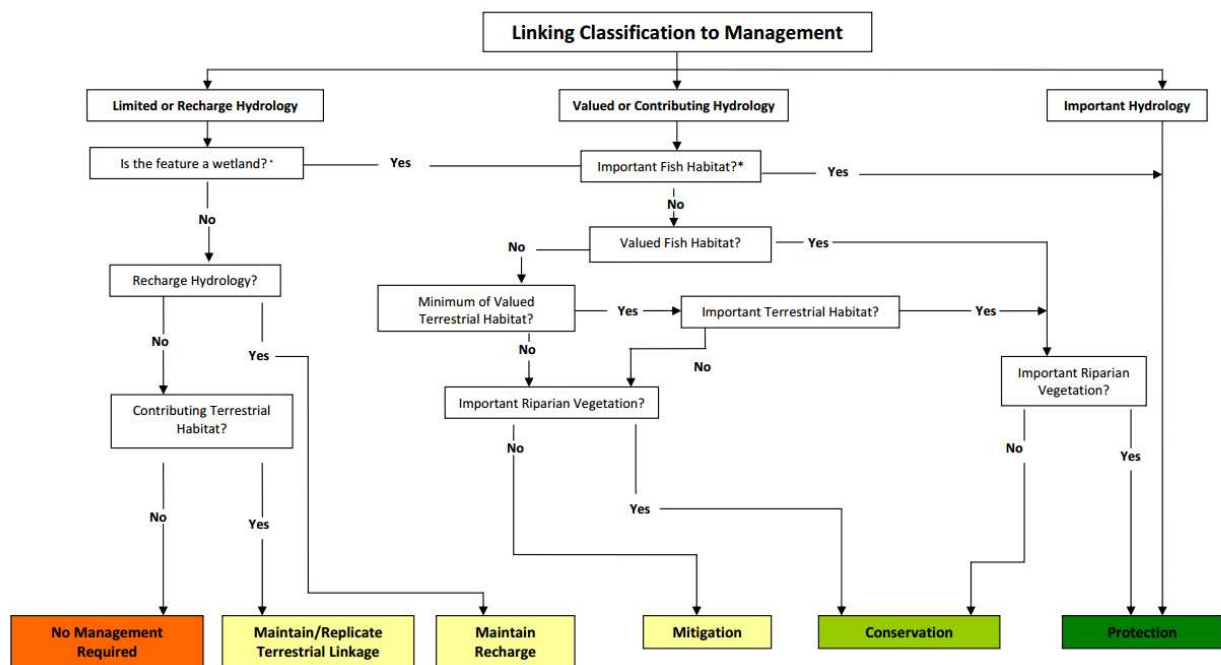
Figure 2. Headwater Drainage Feature Assessment (HDFFA) flow chart providing direction on management options

The classification categories identified in Section 2 provide the basis of the management recommendations provided here. The following flow chart (Figure 2) combines and translates the classification results to management recommendations.
