**Environmental Impact Statement
6150 Thunder Road, Ottawa**

Updated Report

July 15, 2021

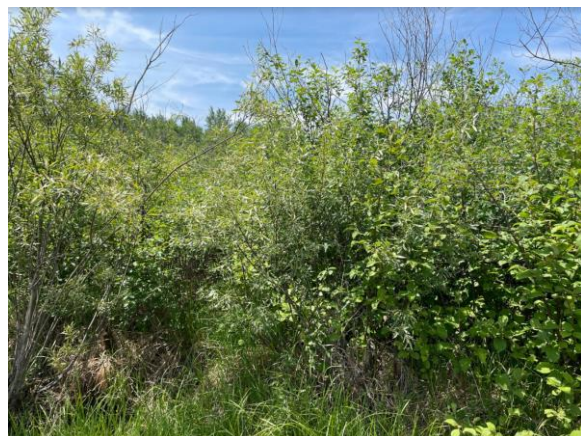
Adjacent SWT2 ecosit off the SW corner of the Site

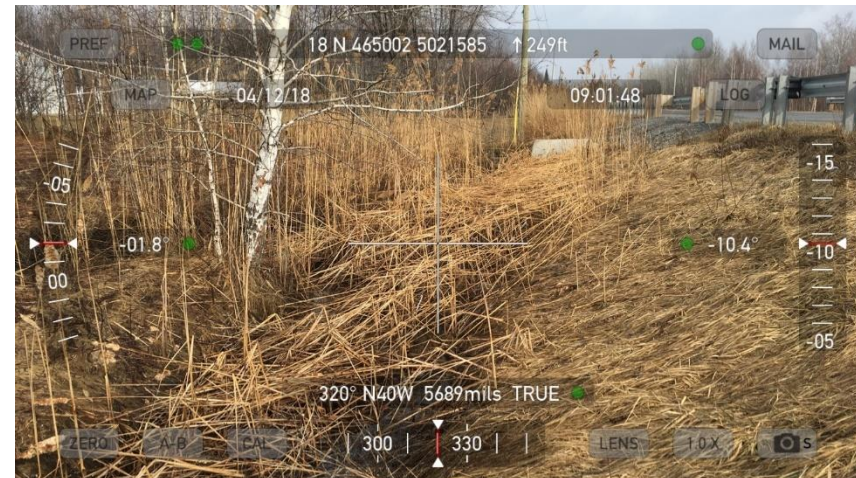
Reach 1

Upstream view

Downstream view

Channel R1 is the roadside ditch along Thunder Road. This feature is unlikely to be altered (realigned) in any meaningful way under future development plans. All other channels on site had been (i.e. in 2018) located within young, early successional wooded areas and coniferous plantation covering former agricultural fields. A single small wetland pocket was observed at the upstream end of Channel R4. Natural landcover along Channels R6, R5 and most of R2 was completely removed in 2019.

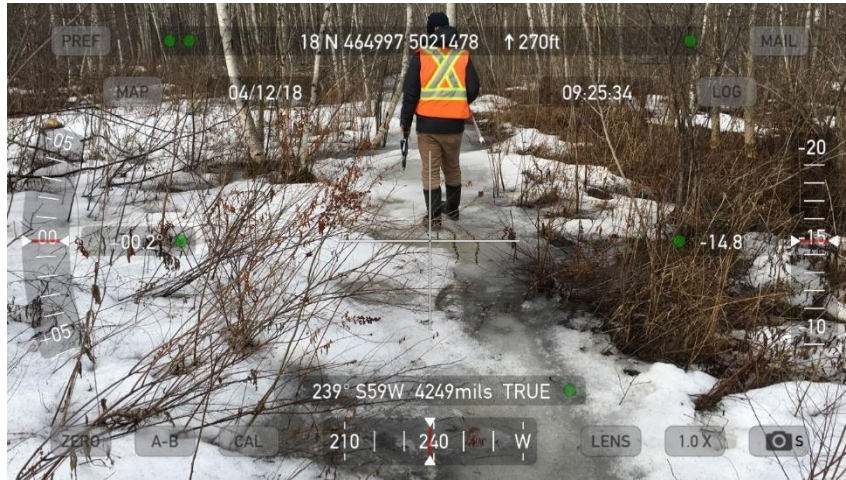
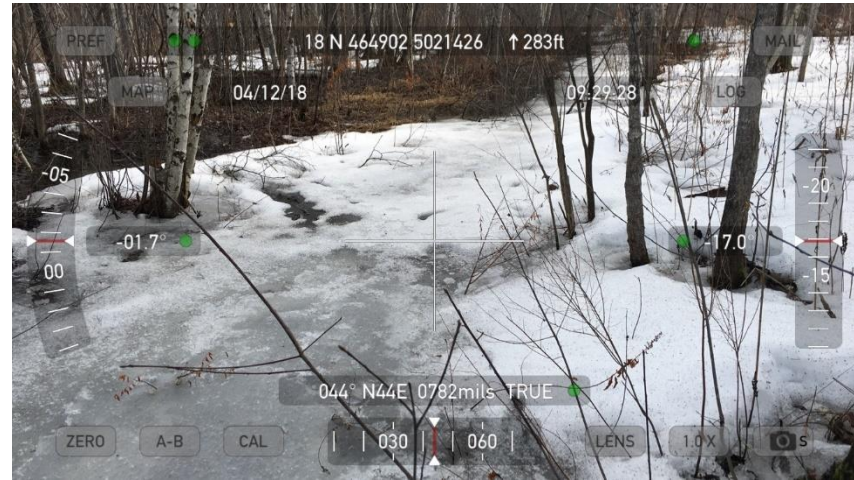
Reach 3

Upstream view

Downstream view

Channels R3 and R4, and the north half of Channel R2 were all wet until mid-summer in 2017, but only so because of the presence of beaver dams along Channel R7, which prevented the site from draining normally. With the dams having been removed, Channels other than R7, can be expected to run dry shortly after the spring freshet. Channels R5, R6 and the upper half of Channel R2 are ephemeral and ran dry very quickly after the freshet, even when beaver dams were present. Small numbers of fish were observed in all areas below Channel R 7 is considered as a potential fish habitat.

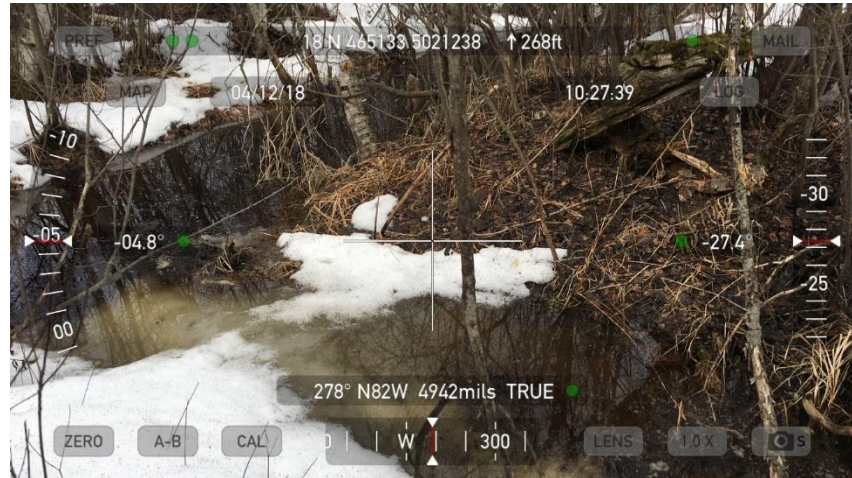
Reach 6

Upstream view

Downstream view
