**Headwater Drainage Feature Assessment
6150 Thunder Road, Ottawa**

Updated Report

July 15, 2021

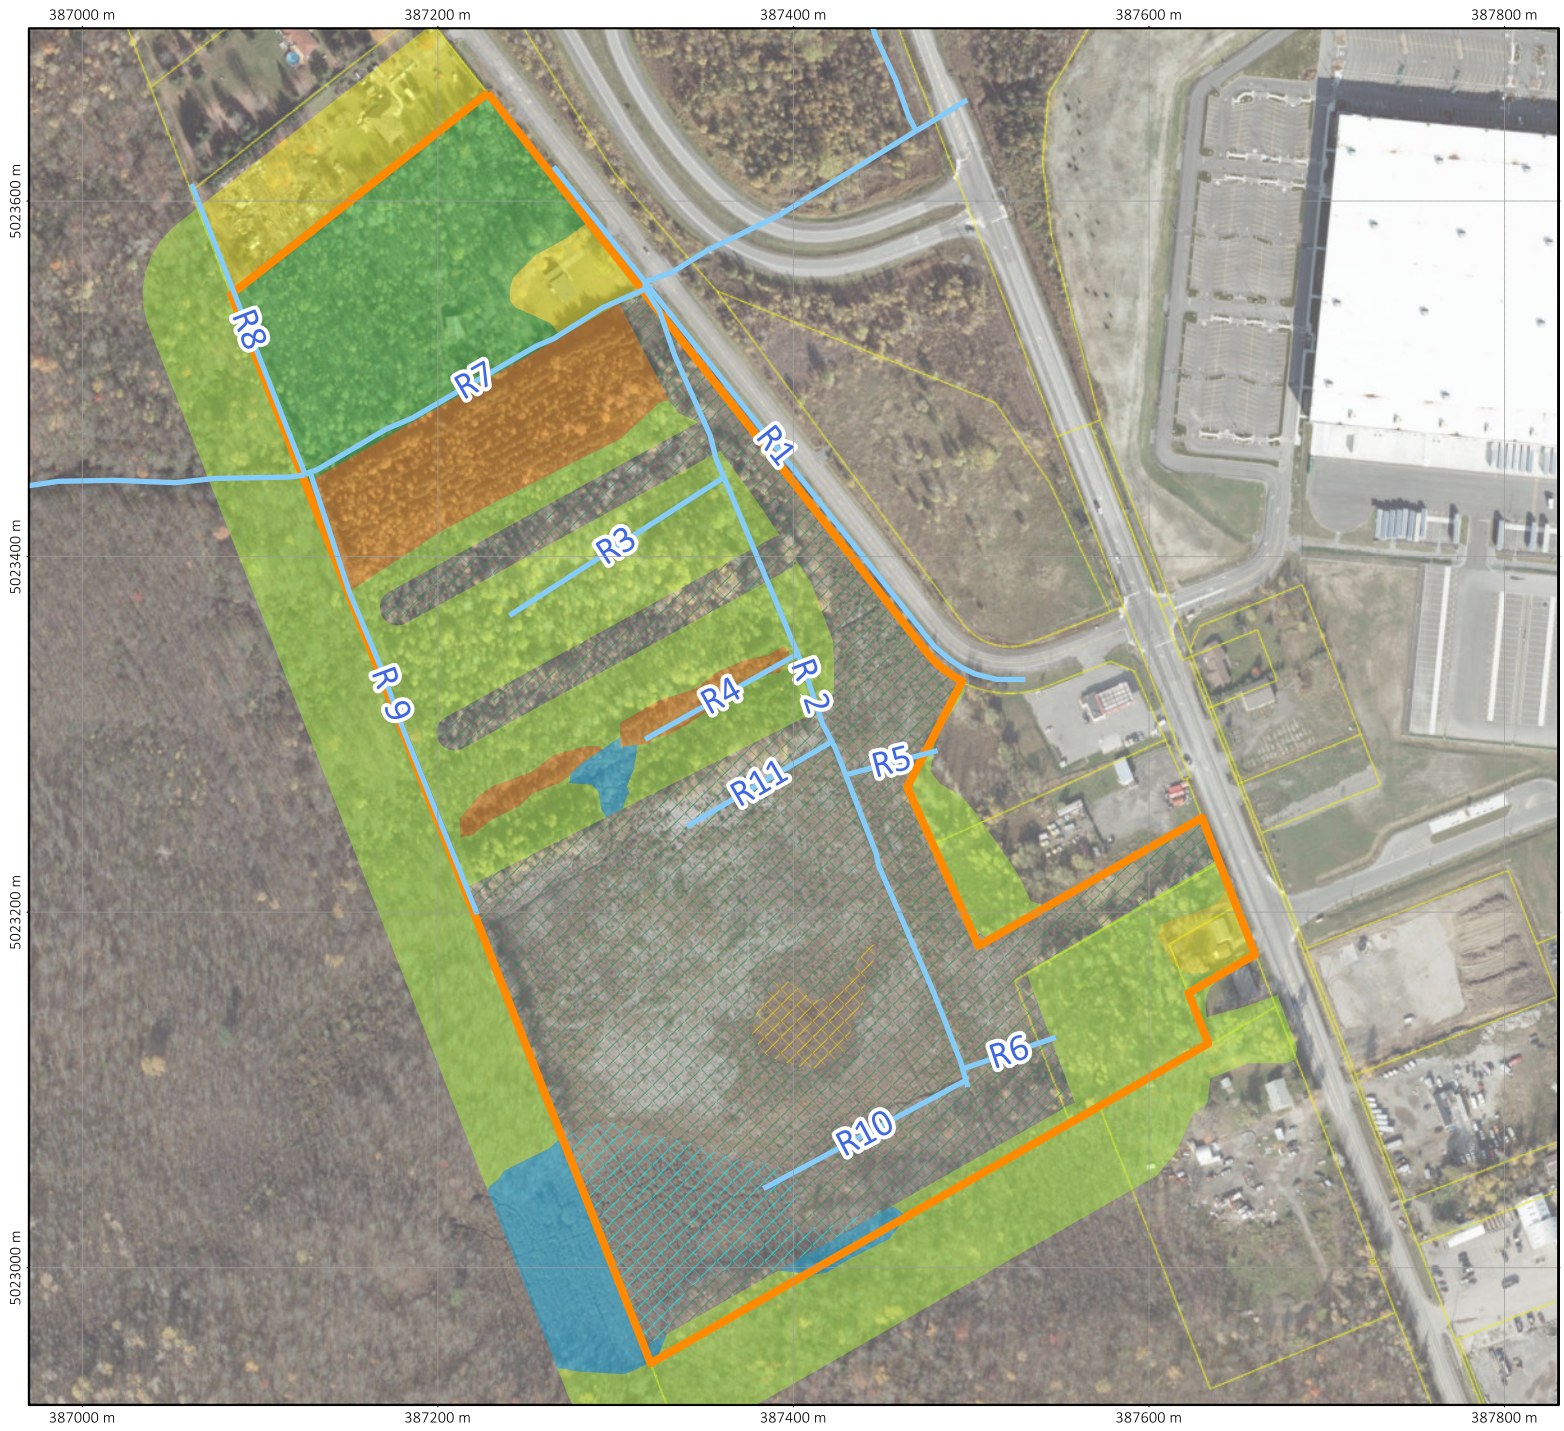
Figure 1 HDF Reaches

Two additional existing channels have been noted since that time along the western boundary of the Site (R8 and R9), which was not part of the initial review in 2018. Two further temporary drainage channels (R10 and R11) were added to the Site in 2021.

Channel R1 is the roadside ditch along Thunder Road. This feature is unlikely to be altered (realigned) in any meaningful way under future development plans. All other channels on site had been (i.e. in 2018) located within young, early successional wooded areas and coniferous plantation covering former agricultural fields. A single small wetland pocket was observed at the upstream end of Channel R4. Natural landcover along Channels R6, R5 and most of R2 was completely removed in 2019.

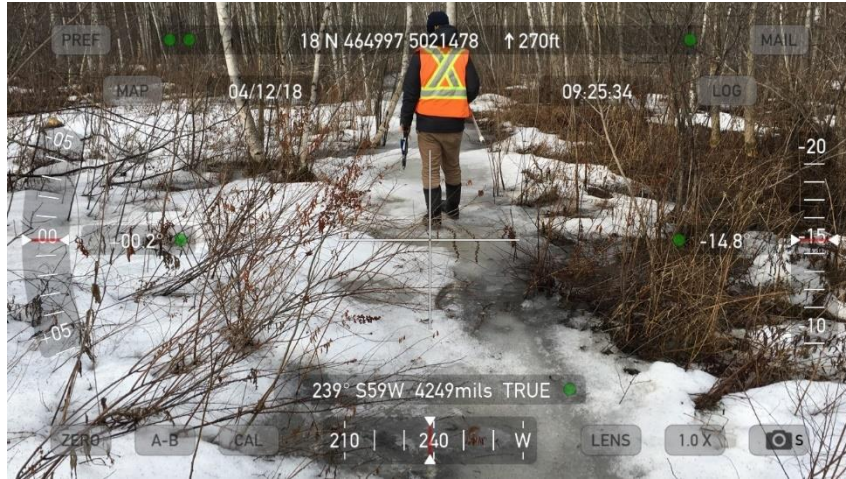
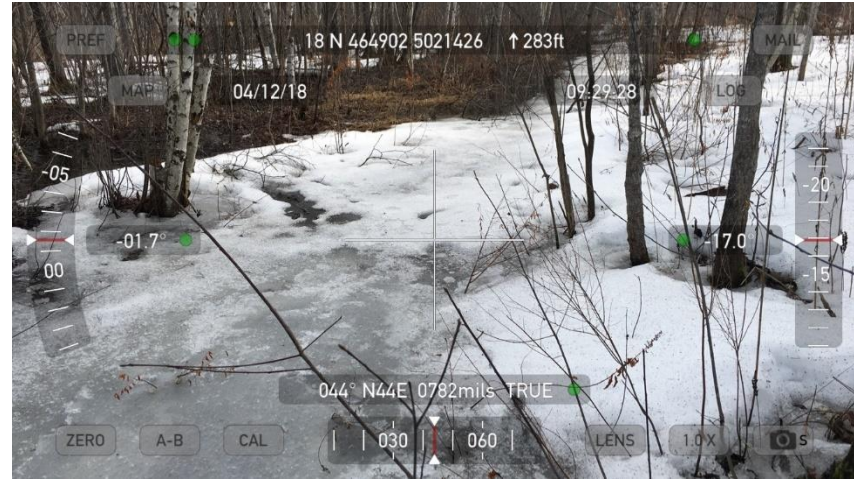
Reach 3

Upstream view

Downstream view

Channels R3, R4 and R9

This chain of classification descriptors leads to a management directive of **Conservation** for this reach. The feature may be maintained or be realigned using natural channel design techniques to enhance their overall productivity. If realigned, the features may be relocated on or off the Site. In either case, the riparian corridors must be maintained or enhanced. If catchment drainage will be removed due to diversion of stormwater flows, lost functions should be restored through enhanced lot level controls (e.g. restore original catchment using clean roof drainage).
