**PHASE 1 ENVIRONMENTAL SITE ASSESSMENT  
ENHANCED AND UPDATED  
1546 SCOTT STREET  
OTTAWA, ONTARIO**

Updated June 2022

Project No. 0490-02

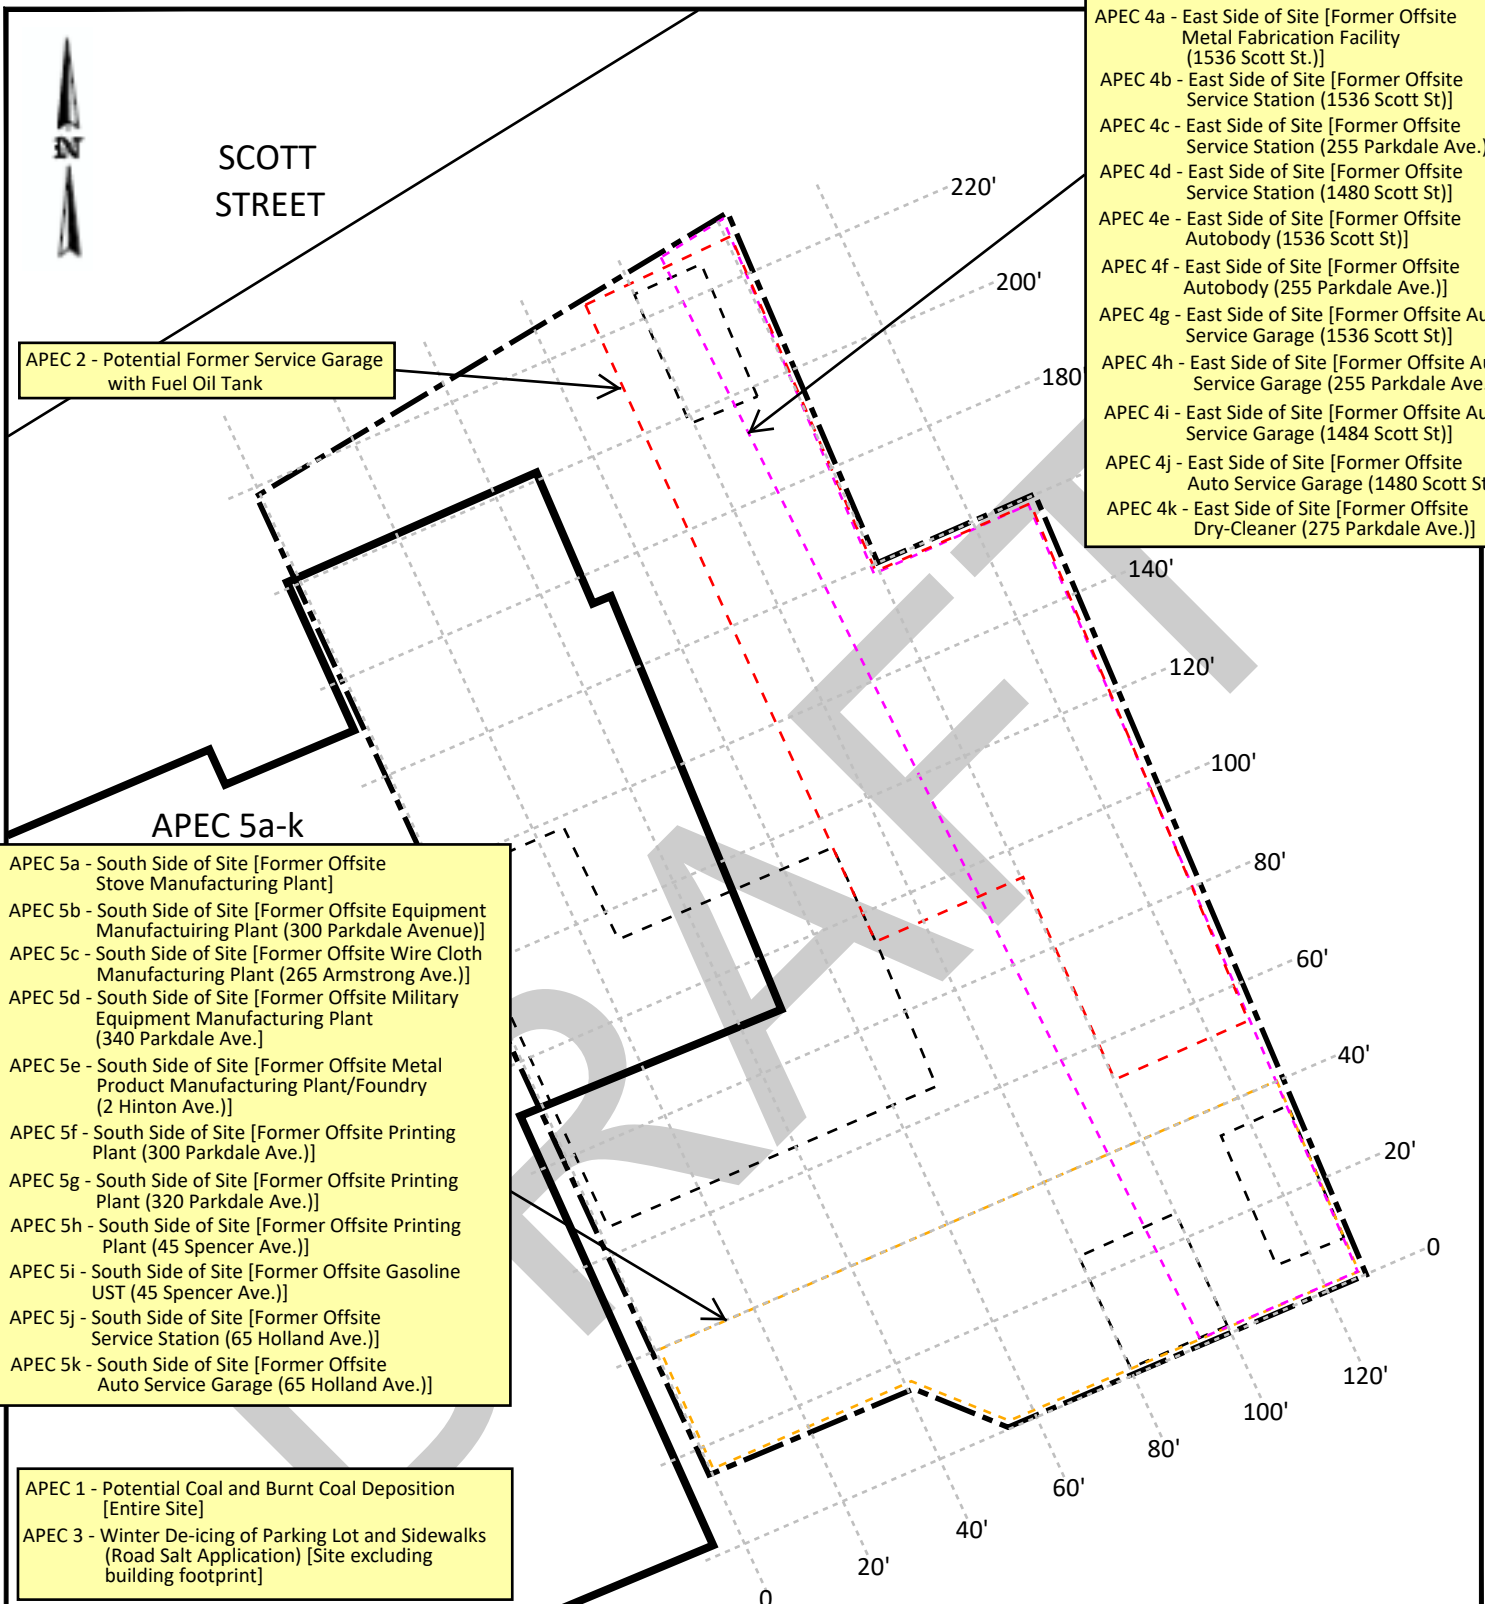
# APECs 4a-k

- APEC 4a - East Side of Site [Former Offsite Metal Fabrication Facility (1536 Scott St.)]
- APEC 4b - East Side of Site [Former Offsite Service Station (1536 Scott St)]
- APEC 4c - East Side of Site [Former Offsite Service Station (255 Parkdale Ave.)]
- APEC 4d - East Side of Site [Former Offsite Service Station (1480 Scott St)]
- APEC 4e - East Side of Site [Former Offsite Autobody (1536 Scott St)]
- APEC 4f - East Side of Site [Former Offsite Autobody (255 Parkdale Ave.)]
- APEC 4g - East Side of Site [Former Offsite Auto Service Garage (1536 Scott St)]
- APEC 4h - East Side of Site [Former Offsite Auto Service Garage (255 Parkdale Ave.)]
- APEC 4i - East Side of Site [Former Offsite Auto Service Garage (1484 Scott St)]
- APEC 4j - East Side of Site [Former Offsite Auto Service Garage (1480 Scott St)]
- APEC 4k - East Side of Site [Former Offsite Dry-Cleaner (275 Parkdale Ave.)]

APEC 2 - Potential Former Service Garage with Fuel Oil Tank

- APEC 5a-k**
- APEC 5a - South Side of Site [Former Offsite Stove Manufacturing Plant]
  - APEC 5b - South Side of Site [Former Offsite Equipment Manufacturing Plant (300 Parkdale Avenue)]

- APEC 5e - South Side of Site [Former Offsite Metal Product Manufacturing Plant/Foundry (2 Hinton Ave.)]
  - APEC 5f - South Side of Site [Former Offsite Printing Plant (300 Parkdale Ave.)]

APEC 1 - Potential Coal and Burnt Coal Deposition [Entire Site]  
 APEC 3 - Winter De-icing of Parking Lot and Sidewalks (Road Salt Application) [Site excluding building footprint]

The APECs identified in this P1ESA are illustrated on Figure 4 and defined in Table 3.

site via groundwater flow and contaminant transport mechanisms. This assessment yielded offsite PCAs that are considered of potential environmental concern to subsurface media quality beneath the site (Figure 3). These offsite PCAs were used to establish onsite APECs that corresponds to the direction of the offsite PCAs (Figure 2, Table 3). The APECs defined are as follows:

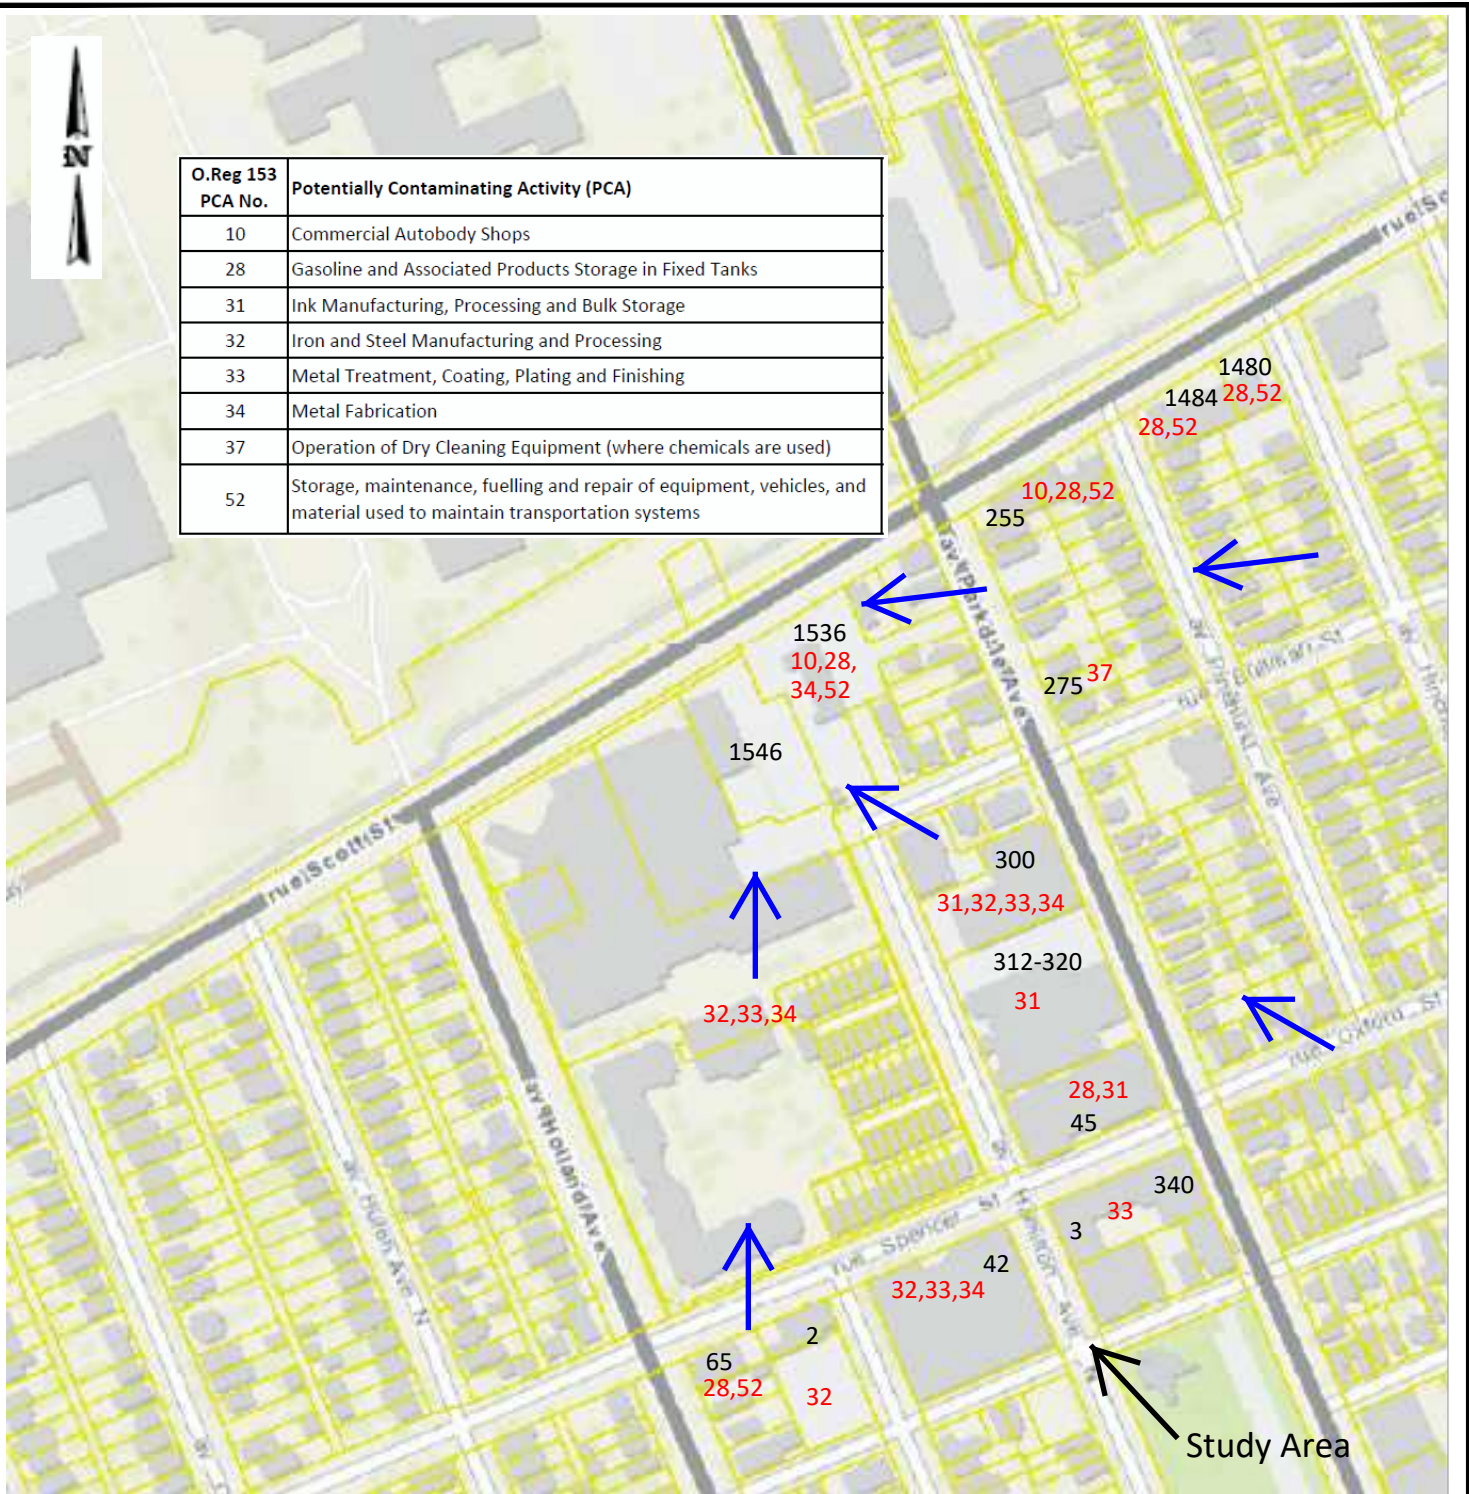
| <b>FIGURE 3</b> | |

- Site Boundary
- 1546** Municipal Address
- Offsite PCA and O.Reg. PCA Number
- Inferred Groundwater Flow Direction

The Phase 1 ESA study area includes the site as well as surrounding lands falling within a 250 m radius of the site boundaries. The aerial extent of coverage of the Phase 1 ESA study area is depicted on Figure 3. As illustrated, it generally extends to Hinchey Avenue to the east, Armstrong Street to the south, Huron Avenue to the west and Lyndale Avenue to the north. The search area focusses on the site and surrounding properties falling within the inferred up-gradient groundwater flow field (UGFF) of the study area. The UGFF is used throughout the records review process to define surrounding properties that may pose a potential concern to groundwater, and potentially soil, quality beneath the site. Specifically, the study area is used to define surrounding properties that may, in the event of a contaminant release, represent a concern with respect to contaminant migration towards the site via groundwater flow (advection) and other contaminant transport mechanisms (diffusion and dispersion).

The regional topography of the study area is illustrated on Figure 3. The source of this figure is the Topographical Map acquired from the City of Ottawa Interactive Map Interface (geoOttawa, online). As illustrated, regional topography generally trends towards the Ottawa River located approximately 810 and 1440 m to the north and west, respectively.

Surrounding properties with PCAs that fall within the inferred up-gradient groundwater flow field (UGFF) of the study area that in the event of a release, could pose an environmental concern to groundwater, and possibly soil, quality beneath the site are illustrated on Figure 3 and listed as follows:
