**PHASE 2 ENVIRONMENTAL SITE ASSESSMENT  
(ENHANCED)  
1546 SCOTT STREET  
OTTAWA, ONTARIO**

September 27, 2021  
Project No. 0394-05

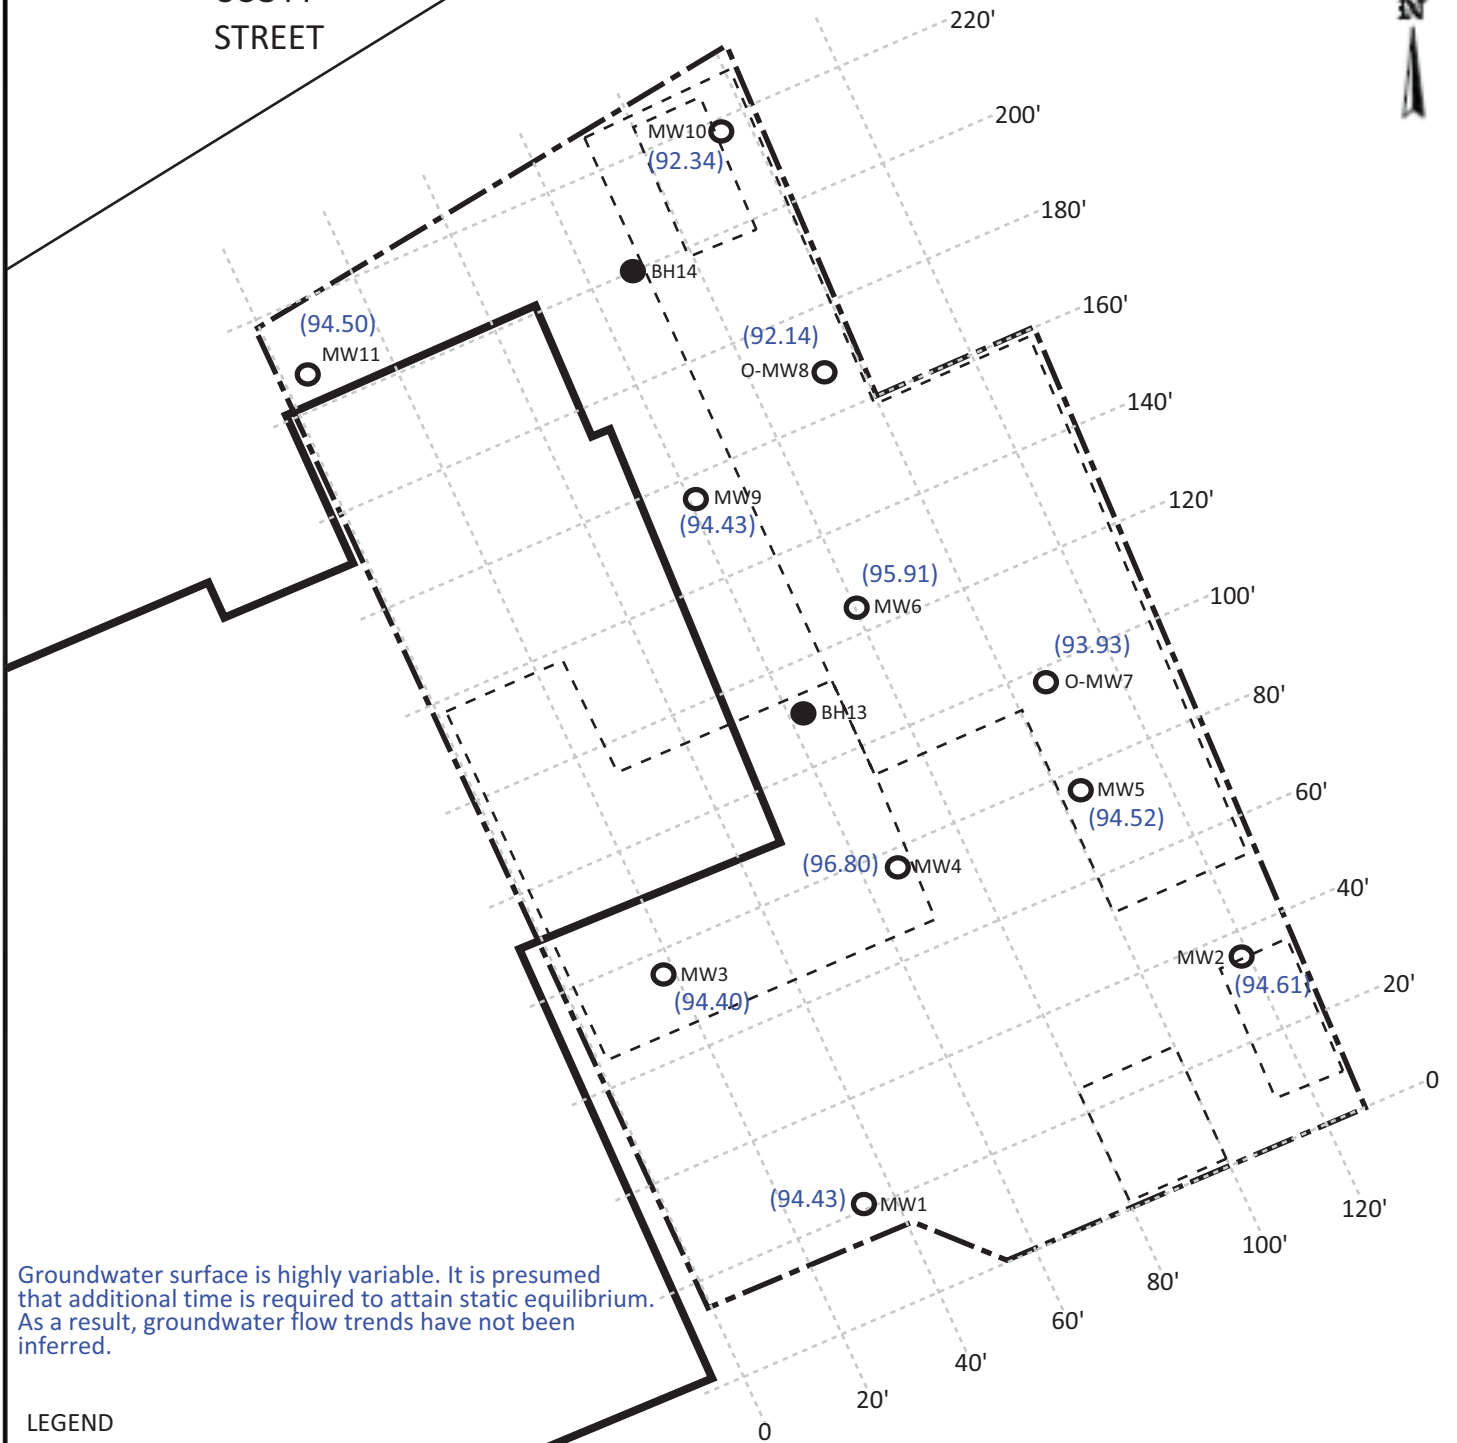
Groundwater surface is highly variable. It is presumed that additional time is required to attain static equilibrium. As a result, groundwater flow trends have not been inferred.

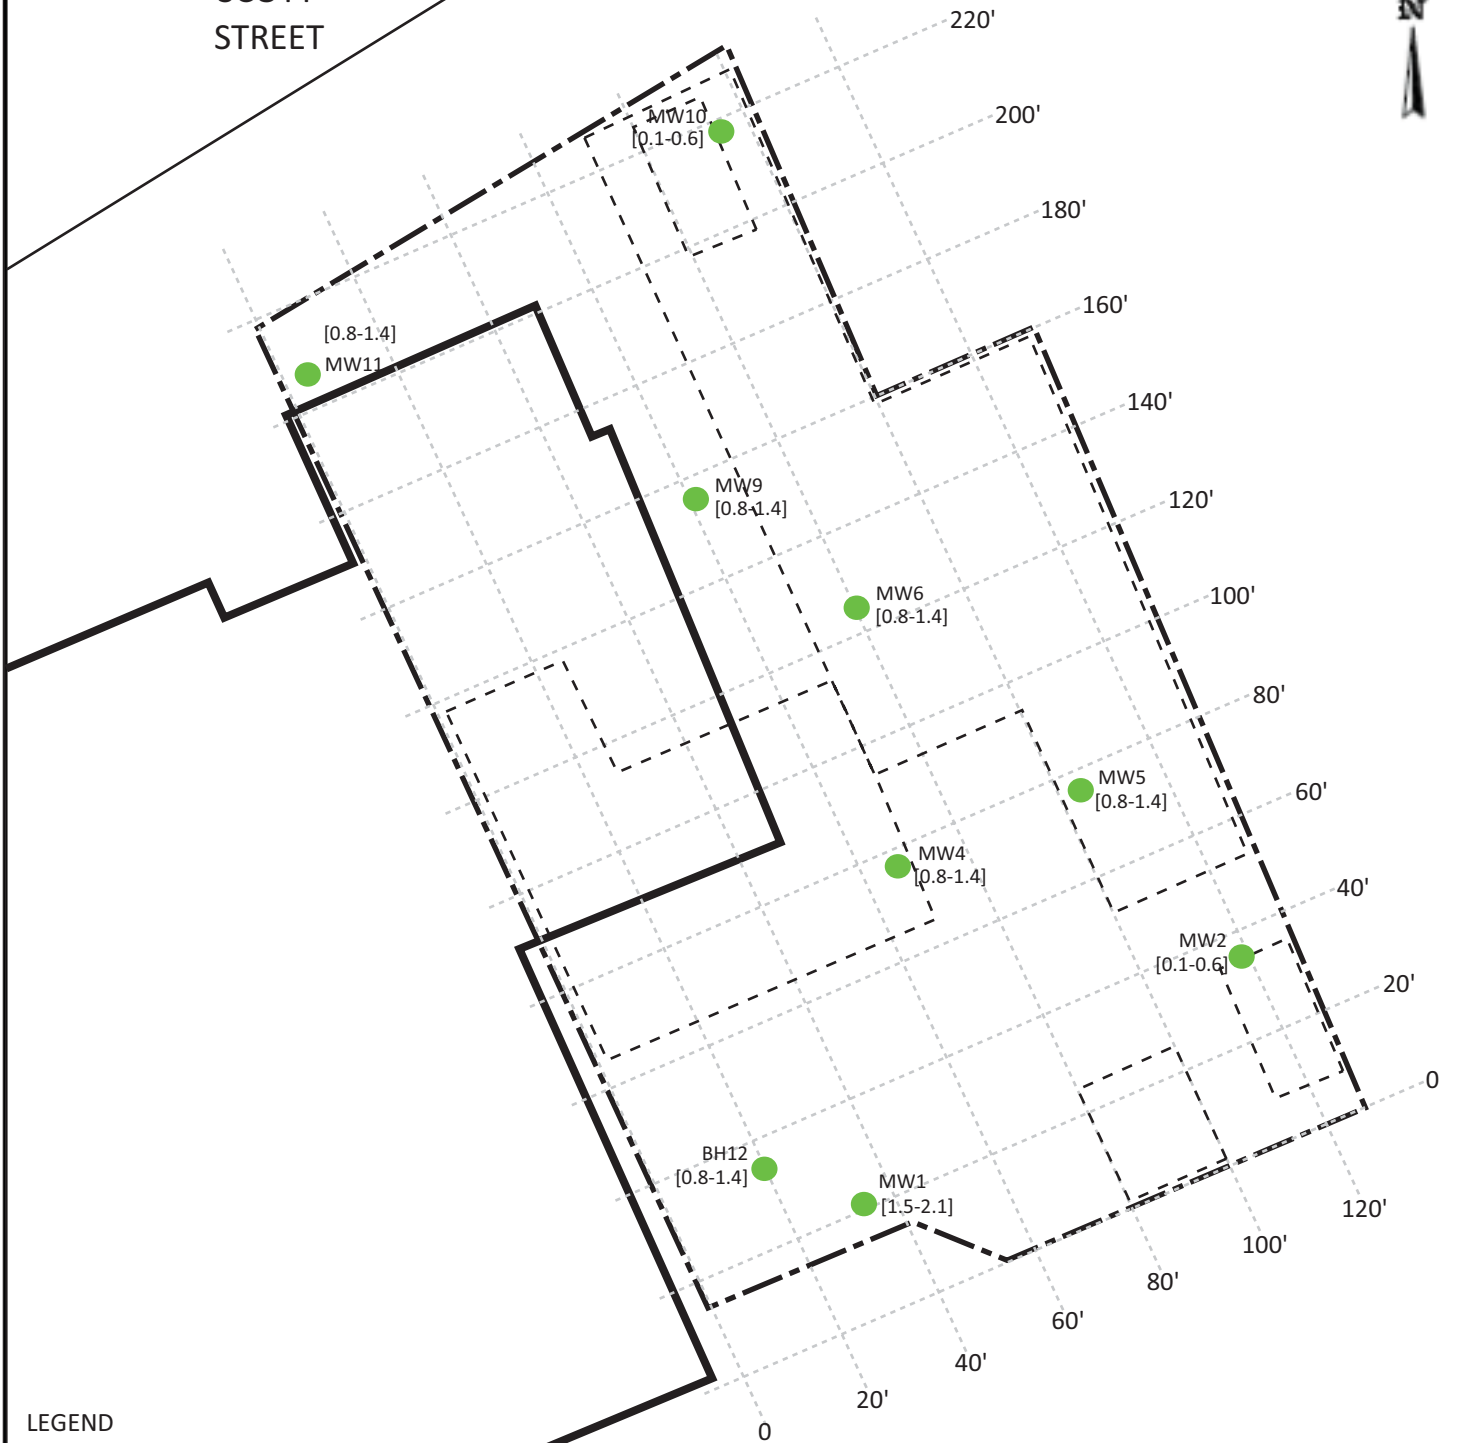
Date: AUGUST 2020  
 FIGURE 6a

The soil testing program was designed to assess whether onsite soil quality has been adversely affected by onsite PCAs/APECs. To accomplish this objective, selected soil samples from the fill layer and native soil formation were analyzed for the COPCs associated with the APECs. A synopsis of the soil laboratory results is provided for the site in Table 15. Laboratory results at individual soil sample locations are illustrated in plan view on Figures 6a to 6e.

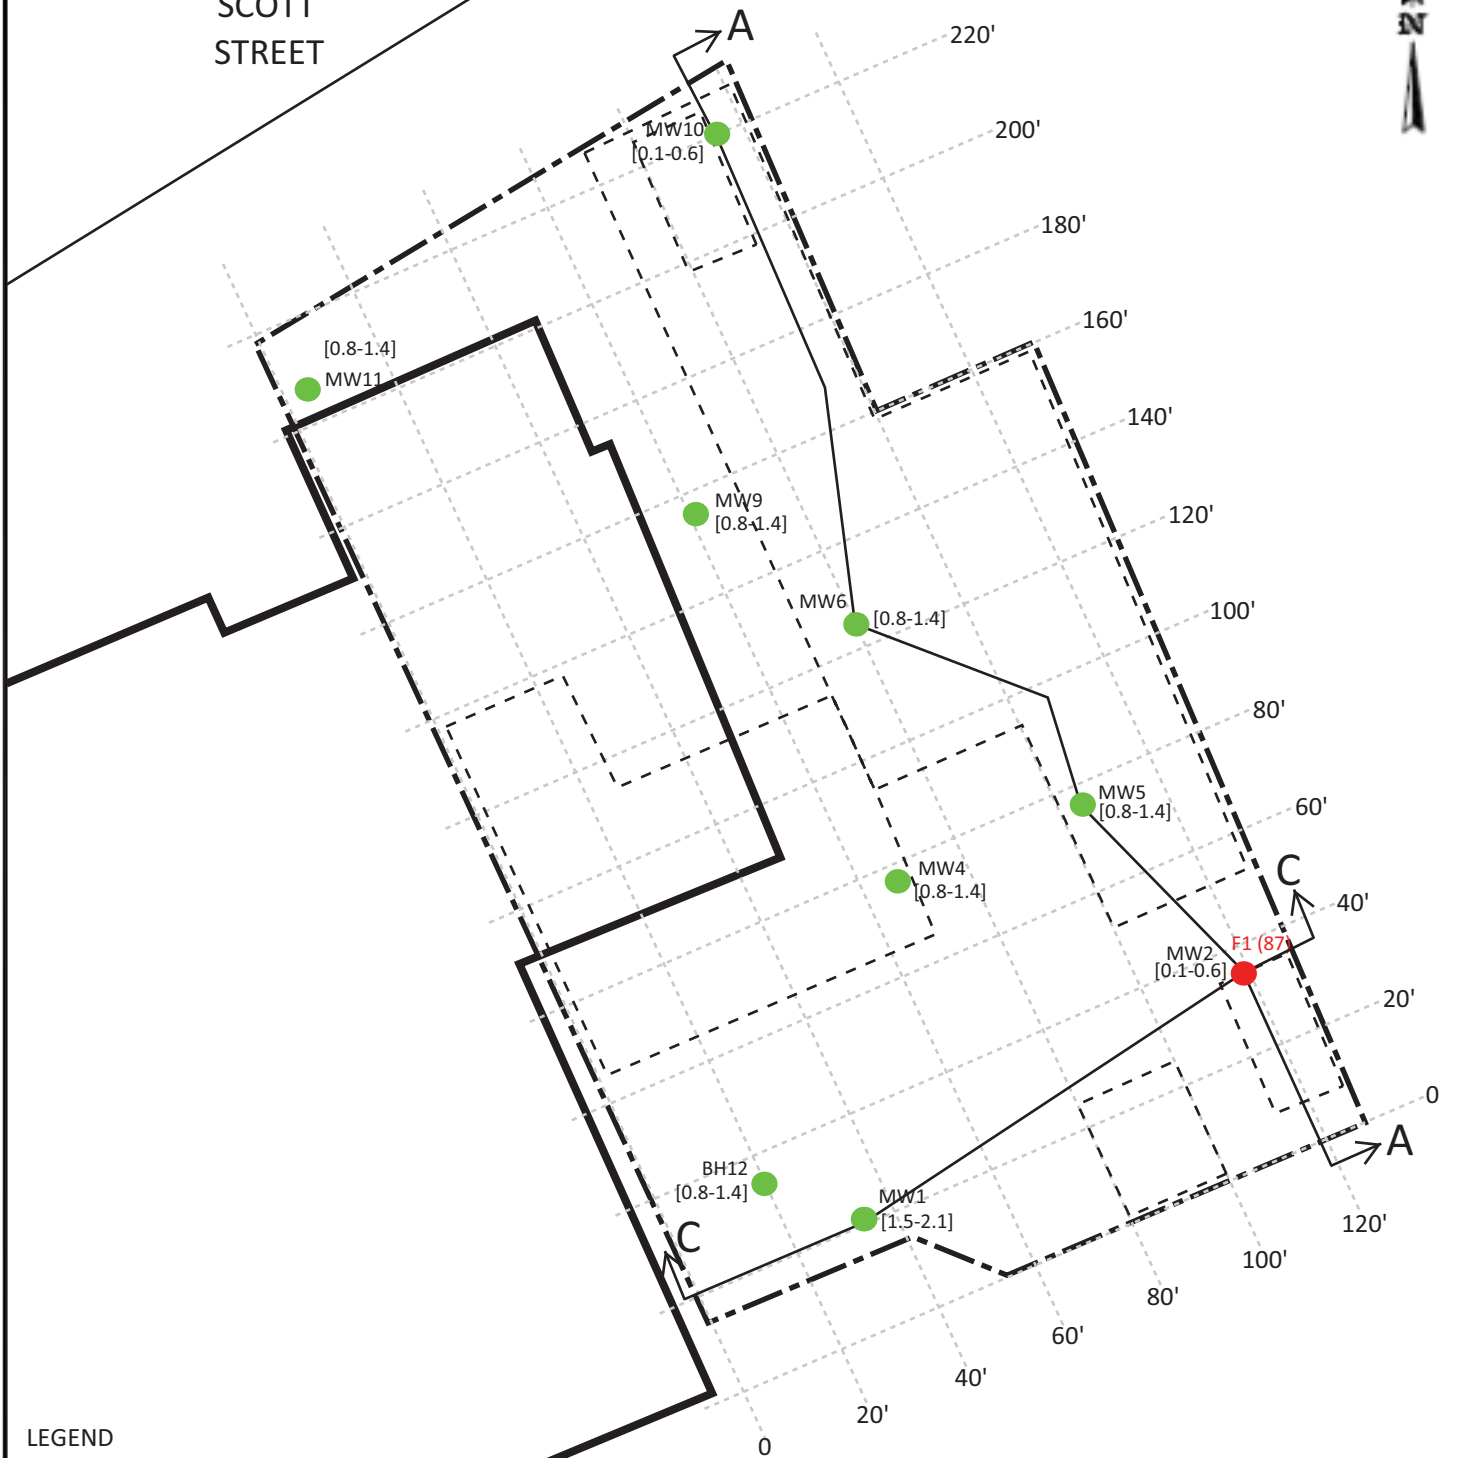
FIGURE 6c

- Site Boundary
- Former Building
- Building
- Soil quality meets PHC Standards
- Soil quality exceeds PHC F1 Standard (55 mg/kg)
- [0.1-0.6] Analyzed soil sample depth interval in metres (m)
- F1 (87) PHC F1 (concentration in mg/kg)

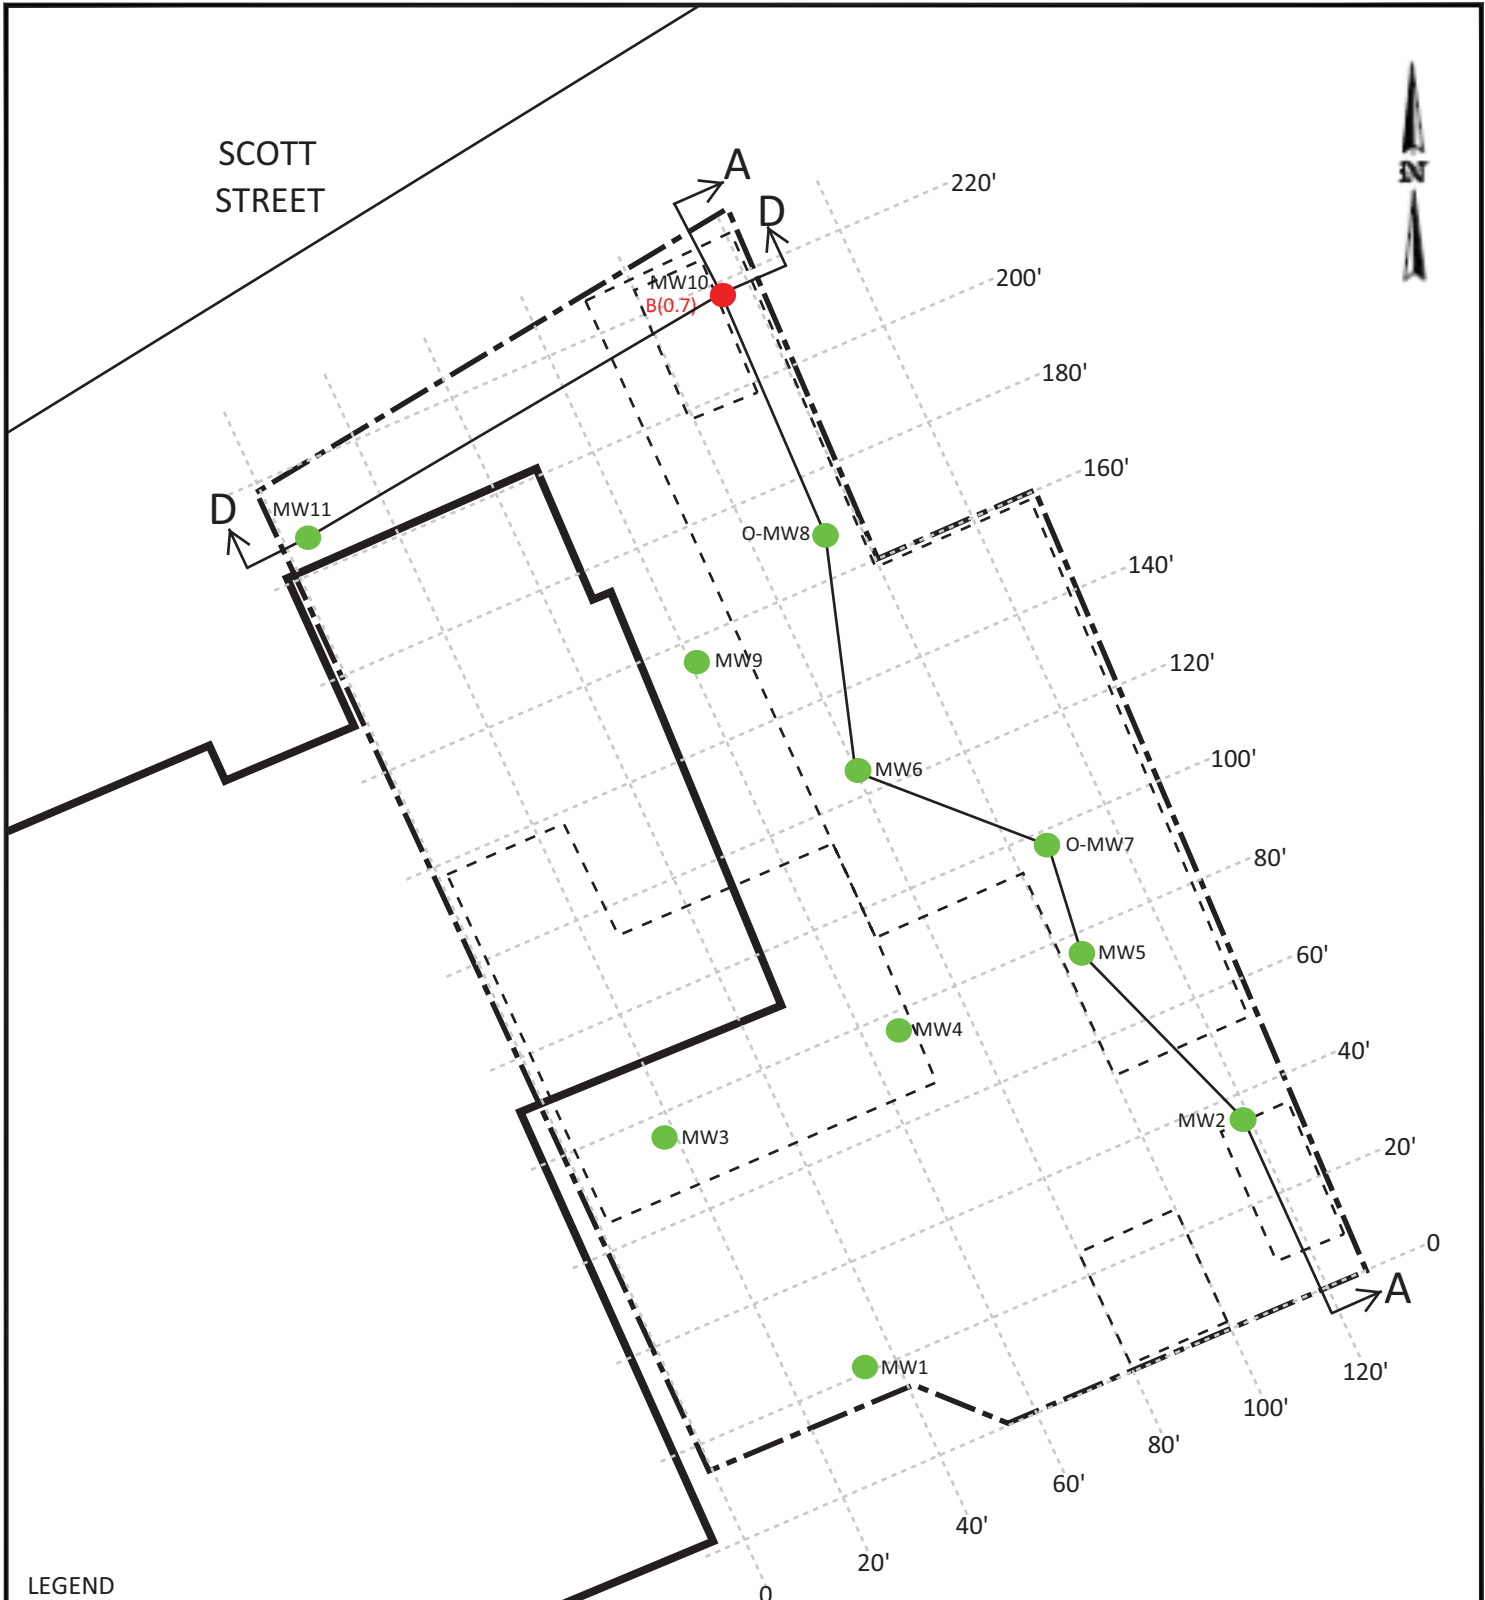
FIGURE 7b

- Site Boundary
- Former Building
- Building
- Groundwater Quality meets BTEX Standards
- Groundwater Quality exceeds Benzene Standard (0.5 ug/L)
- B(0.7) Benzene (Concentration in ug/L)

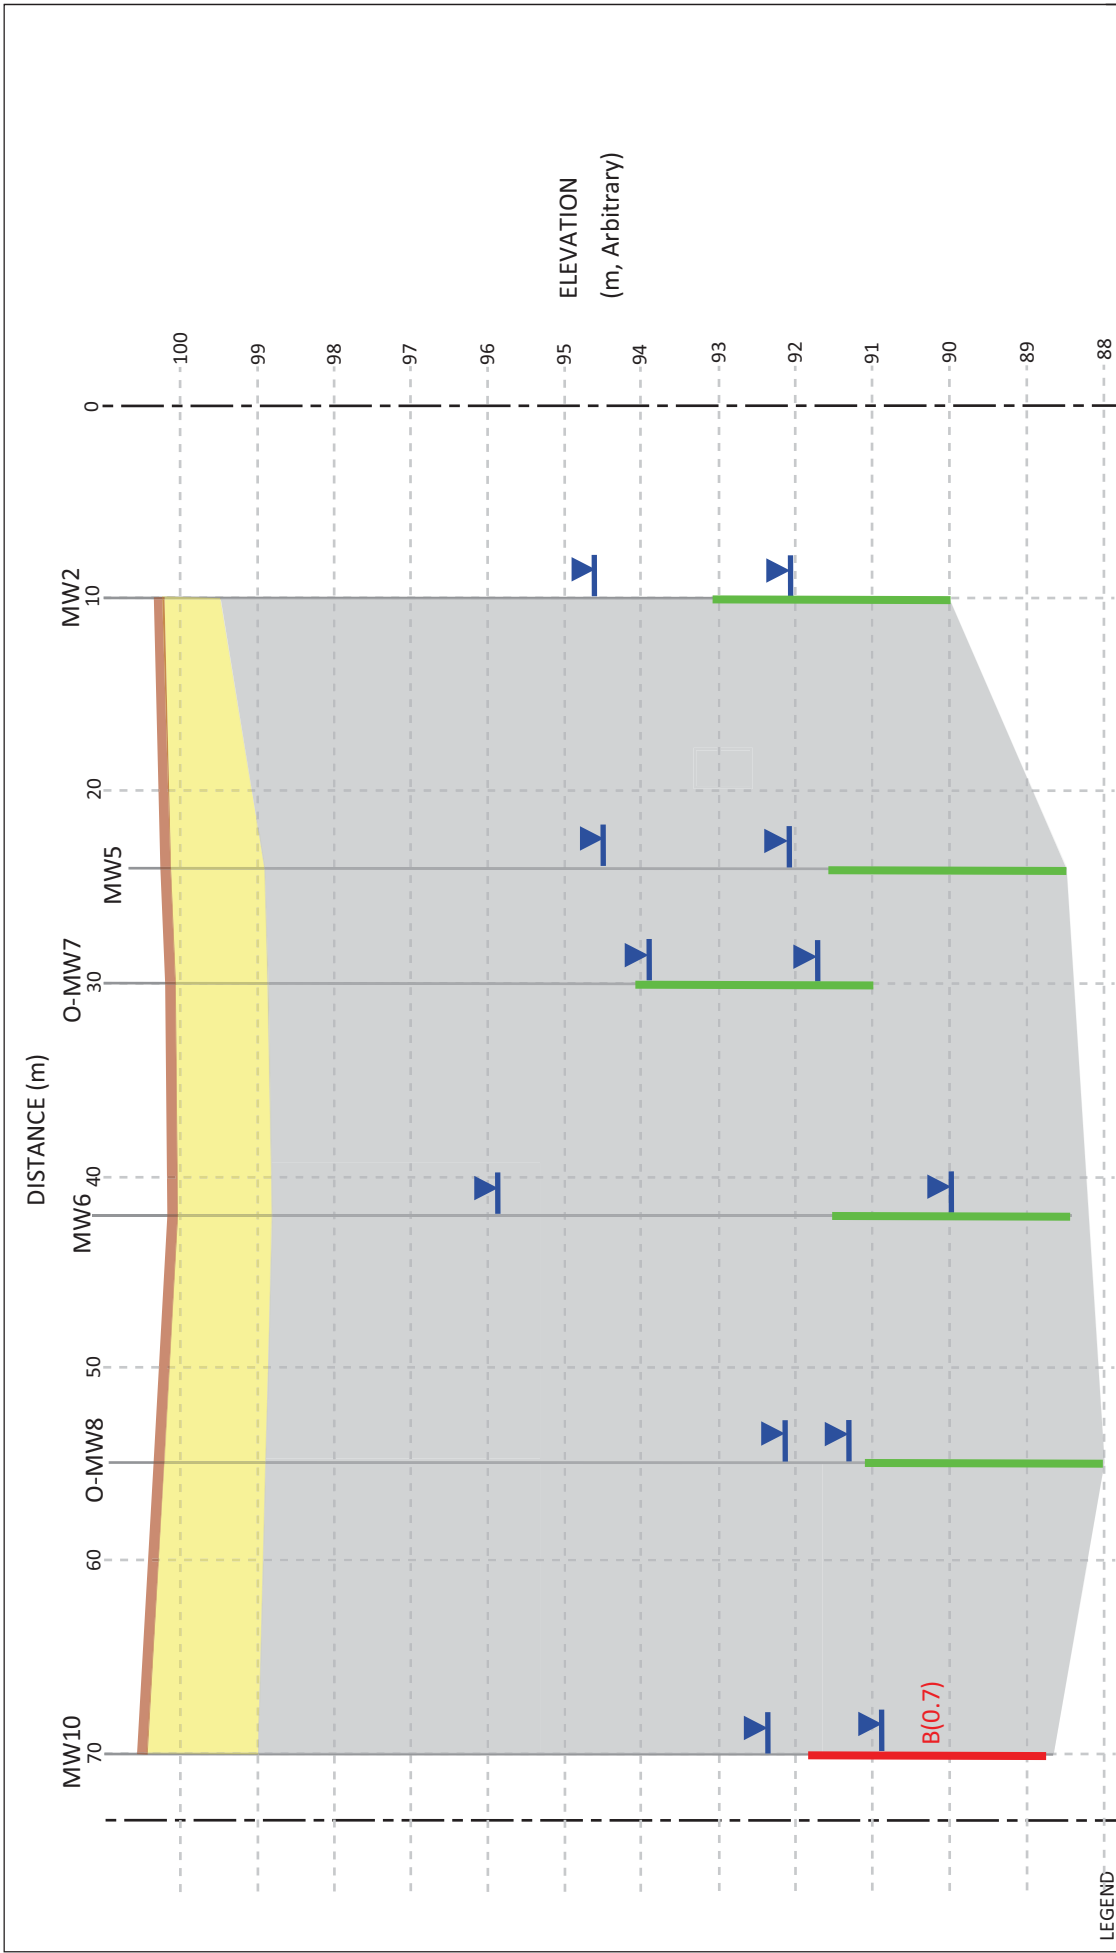
Title: GROUNDWATER QUALITY, BTEX - SECTION A-A	
	Project: PHASE 2 ENVIRONMENTAL SITE ASSESSMENT 1546 SCOTT STREET, OTTAWA, ONTARIO
	Project Number: 0394-05
	Client: STARBANK DEVELOPMENTS 2000 CORP.
Date:	
GRID SCALE, AS INDICATED.	
FIGURE 9a

As illustrated on Figure 8a, 8b, 9a, 9b and 10a to 10d, the soil stratigraphy encountered in the boreholes generally consists of sand and/or sand and gravel overlying limestone bedrock encountered at 0.8 to 2.9 m bg. Based on the bedrock cores acquired at MW3 and MW9, the upper 300 to 500 mm of the limestone bedrock formation is weathered and the underlying competent bedrock formation consists of numerous horizontal limestone layers that range in thickness from 50 to 600 mm. The limestone layers are separated by laterally continuous open fractures with apertures of up to 2 mm.

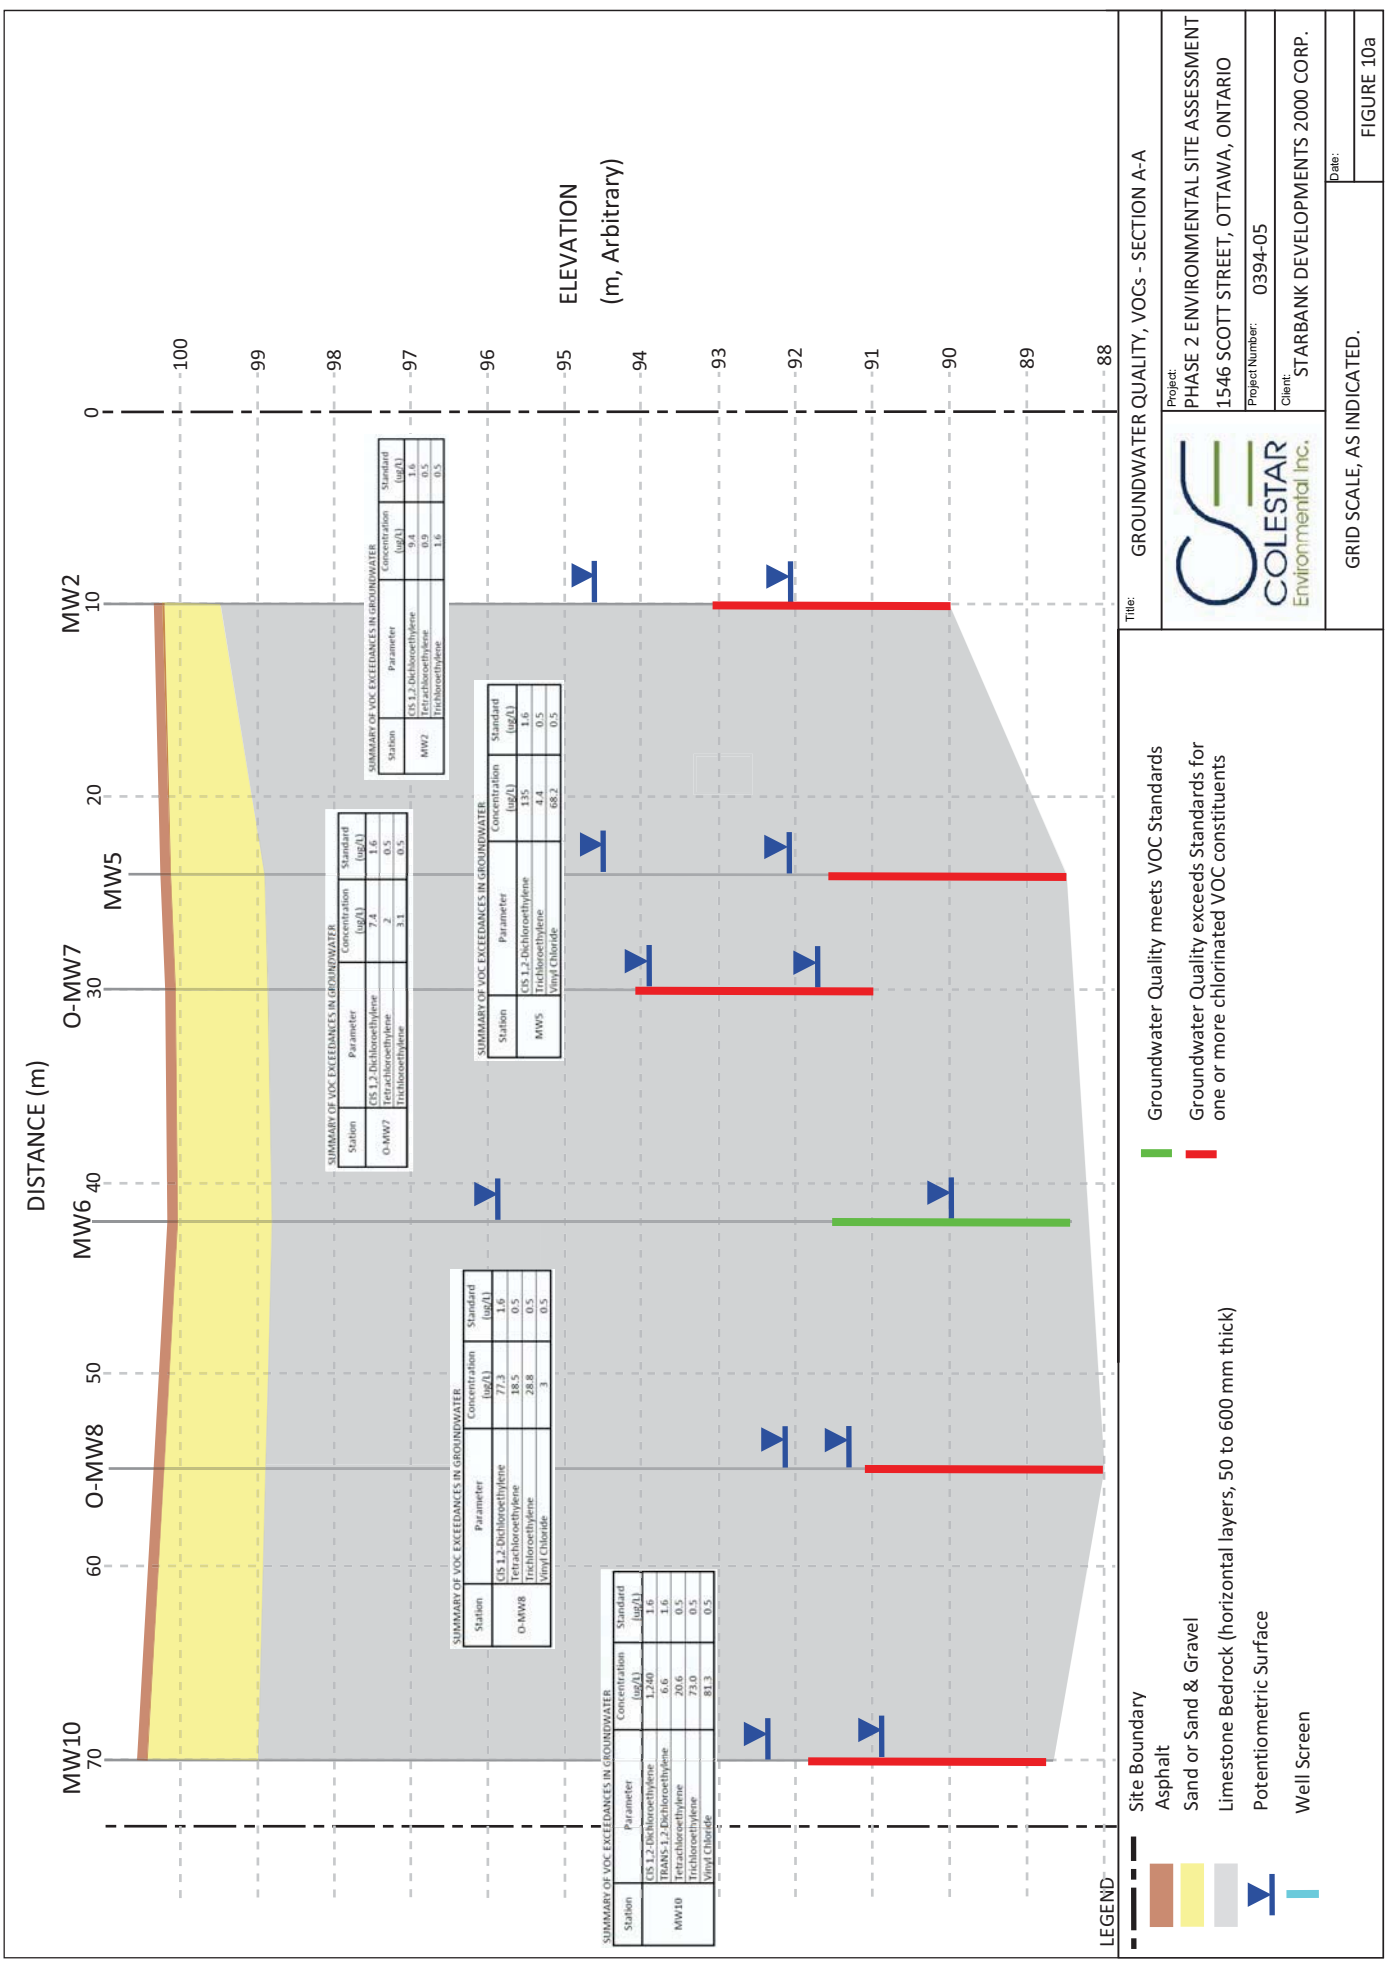
**Figure:** FIGURE 10a

- Site Boundary
- Asphalt
- Sand or Sand & Gravel
- Limestone Bedrock (horizontal layers, 50 to 600 mm thick)
- Potentiometric Surface
- Well Screen

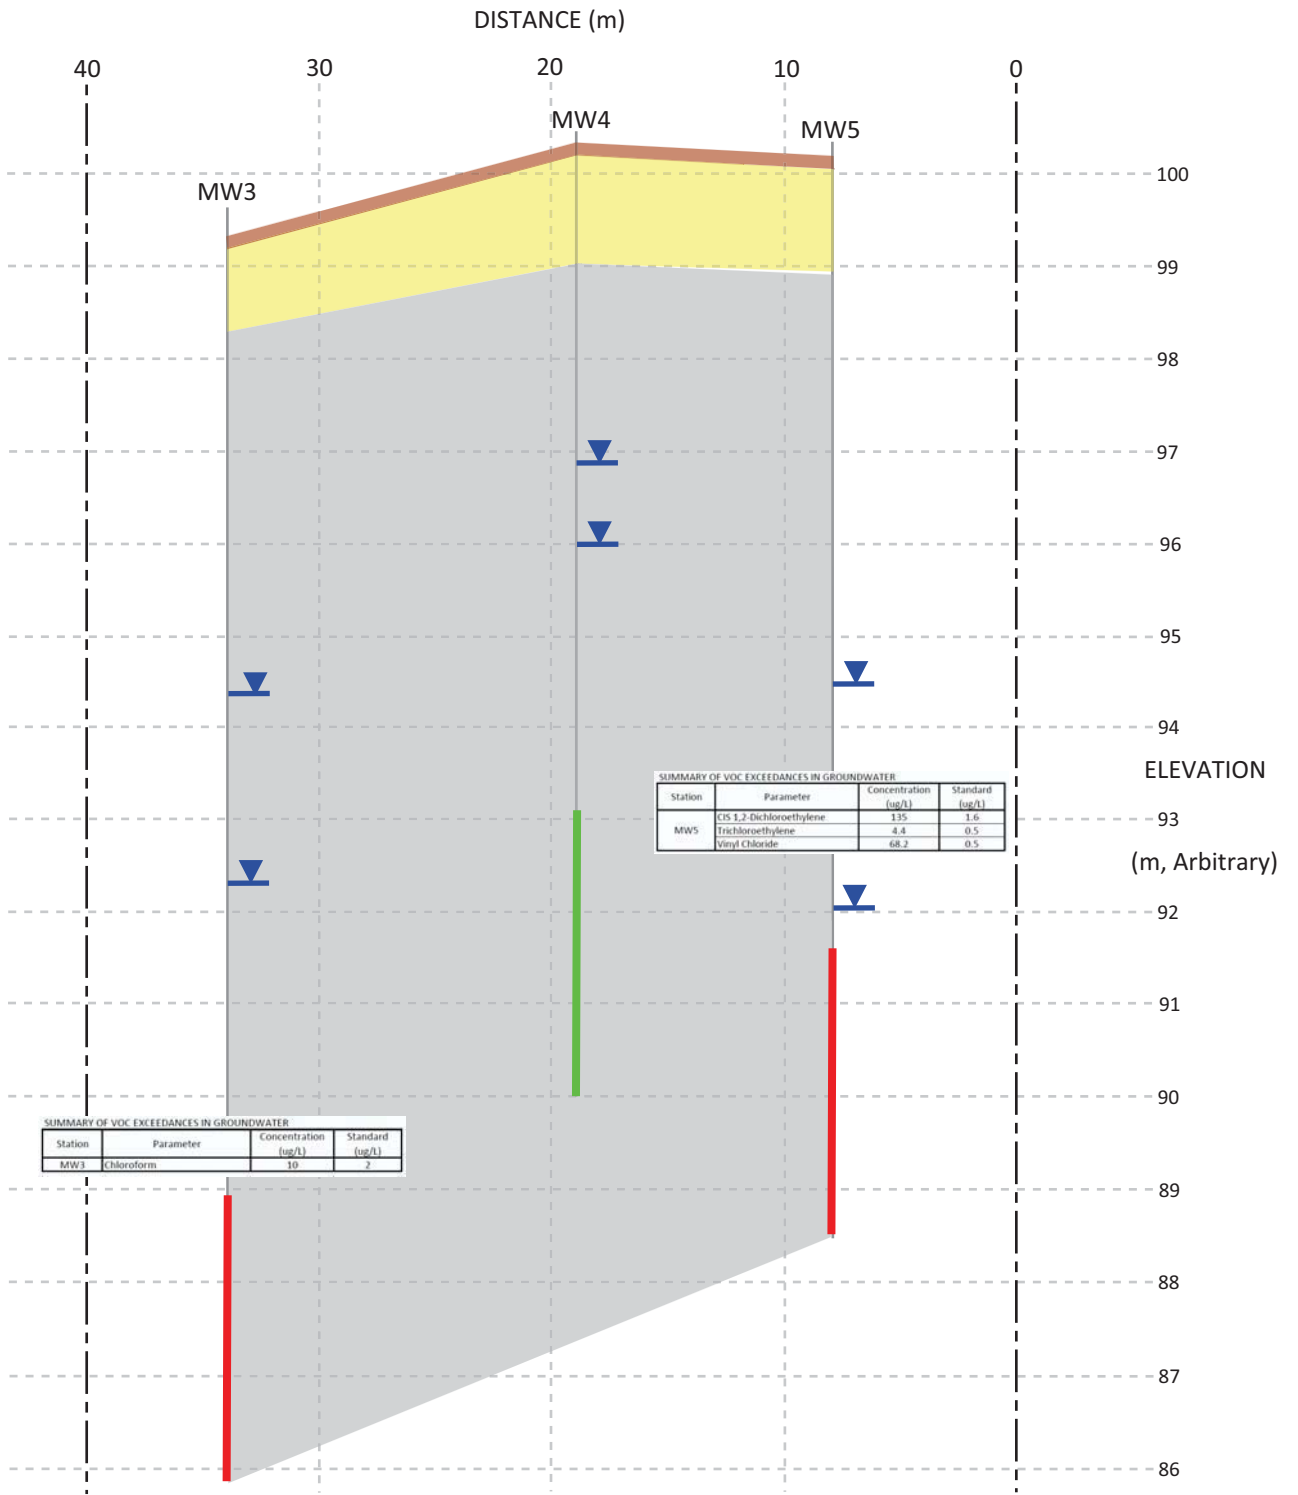
FIGURE 10b

SUMMARY OF VOC EXCEEDANCES IN GROUNDWATER			
Station	Parameter	Concentration (ug/L)	Standard (ug/L)
MW3	Chloroform	10	2

SUMMARY OF VOC EXCEEDANCES IN GROUNDWATER			
Station	Parameter	Concentration (ug/L)	Standard (ug/L)
MW5	CIS 1,2-Dichloroethylene	135	1.6
	Trichloroethylene	4.4	0.5
	Vinyl Chloride	68.2	0.5

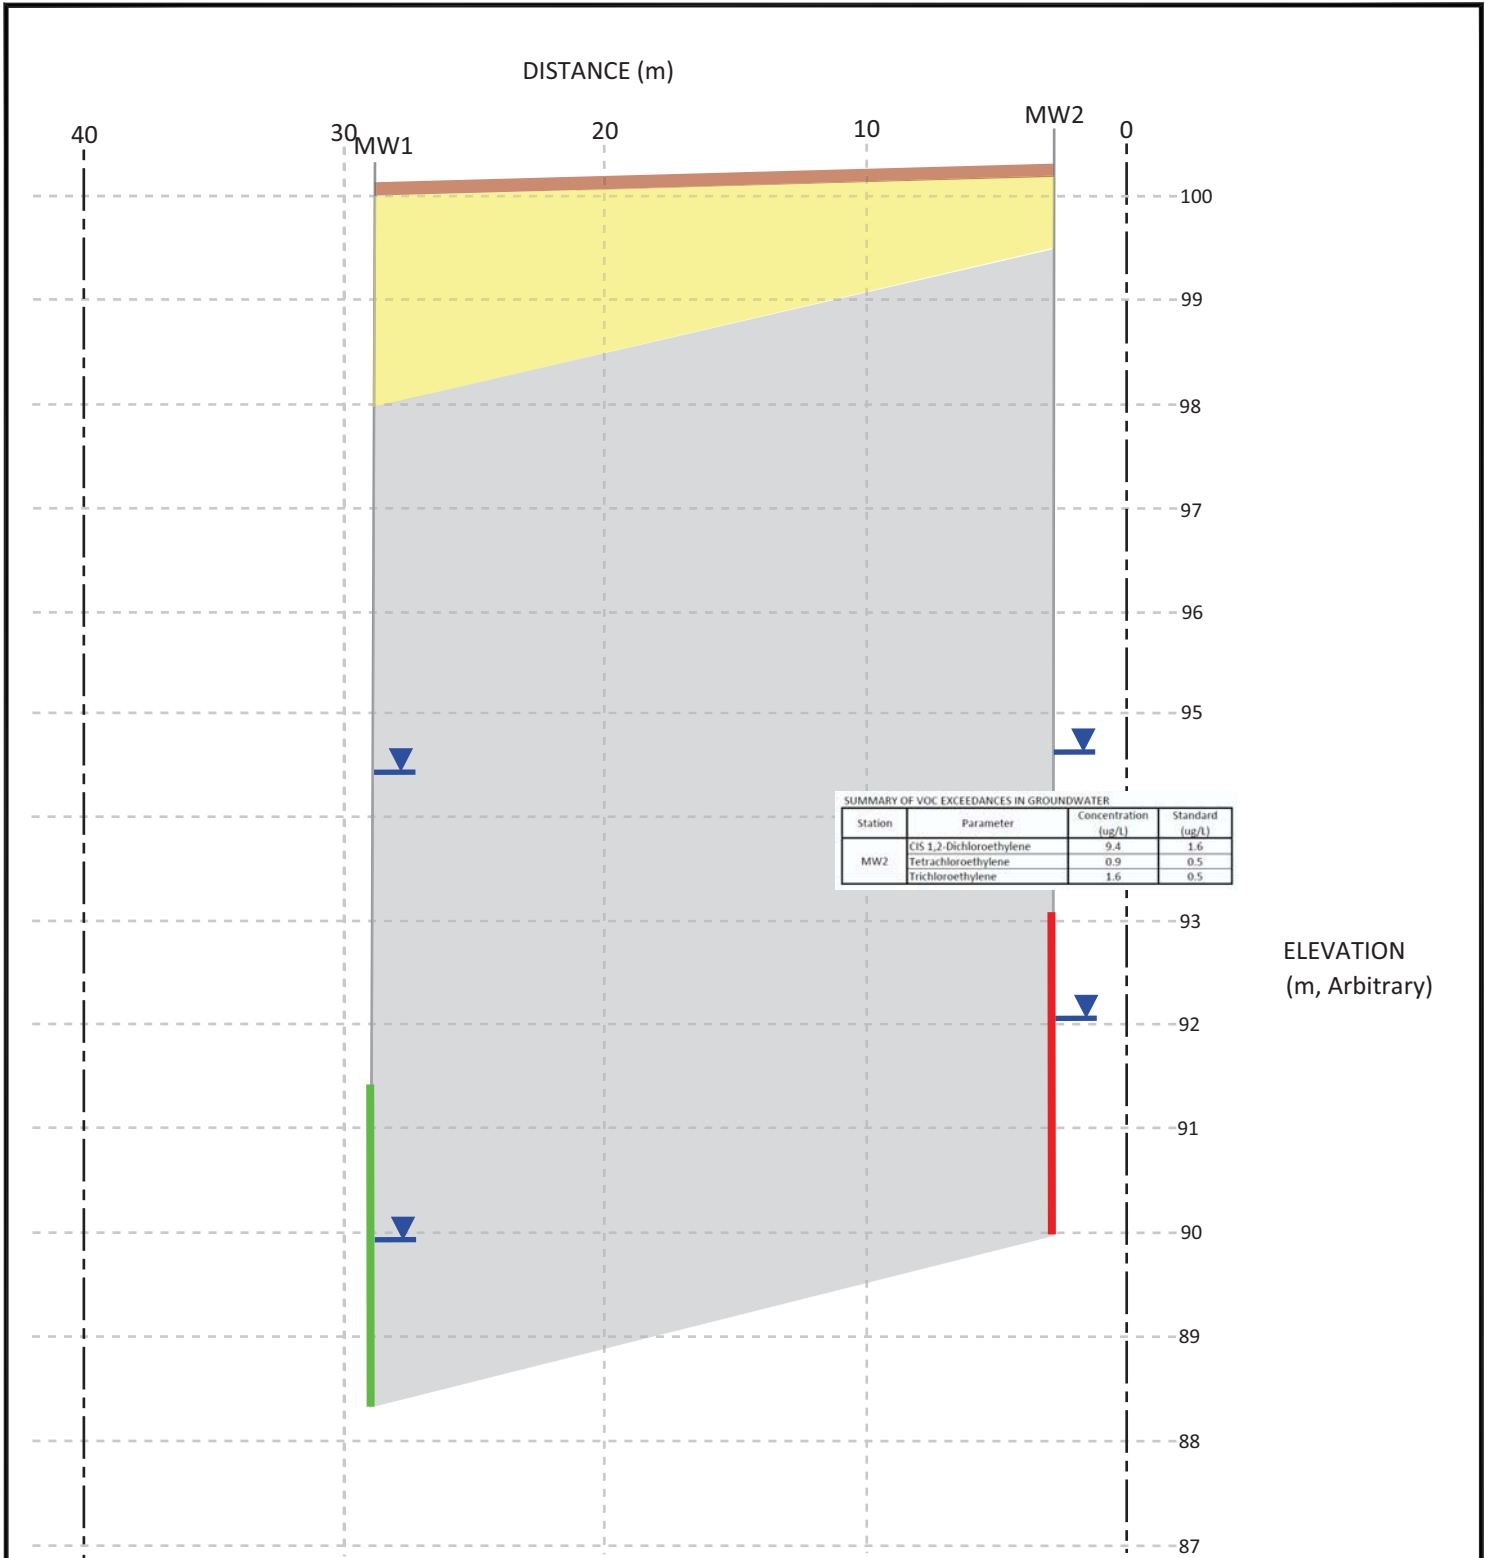
FIGURE 10c

- Site Boundary
- Asphalt
- Sand or Sand & Gravel
- Limestone Bedrock (horizontal layers, 50 to 600 mm thick)
- Potentiometric Surface
- Groundwater Quality meets VOC Standards
- Groundwater Quality exceeds Standards for one or more chlorinated VOC constituents

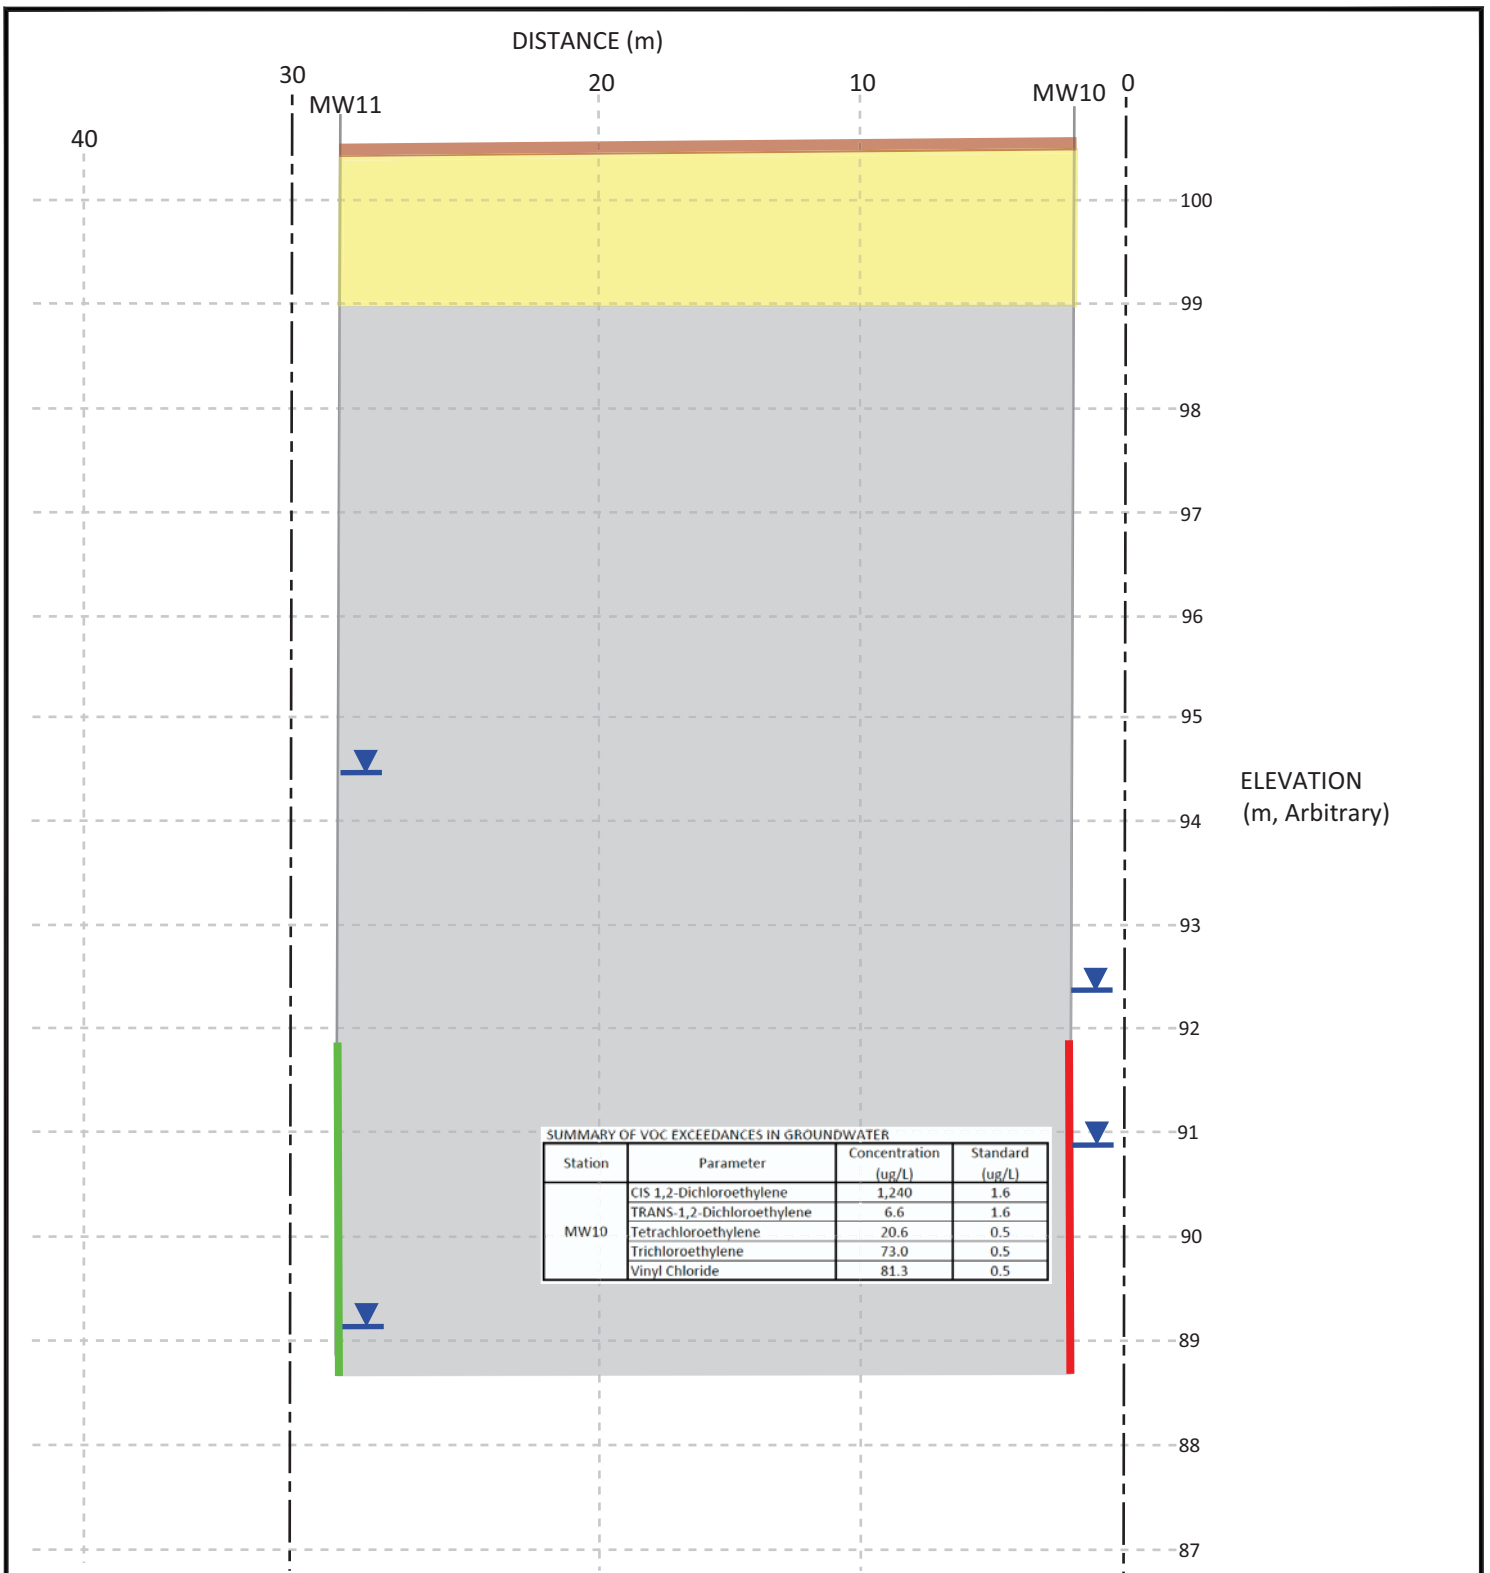
FIGURE 10d

- Site Boundary
- Asphalt
- Sand or Sand & Gravel
- Limestone Bedrock (horizontal layers, 50 to 600 mm thick)
- Potentiometric Surface
- Groundwater Quality meets VOC Standards
- Groundwater Quality exceeds Standards for one or more chlorinated VOC constituents
