December 1, 2022
File: PE4752-LET.05

Subject: **Phase I-Environmental Site Assessment Update
961 to 979 Wellington Street West and
26 to 40 Armstrong Avenue
Ottawa, Ontario**

MAGIL LAURENTIAN REALTY INVESTMENTS INC.
PHASE I - ENVIRONMENTAL SITE ASSESSMENT
961-979 WELLINGTON STREET WEST & 26-40 ARMSTRONG STREET
 OTTAWA, ONTARIO
 Title: **SURROUNDING LAND USE PLAN**

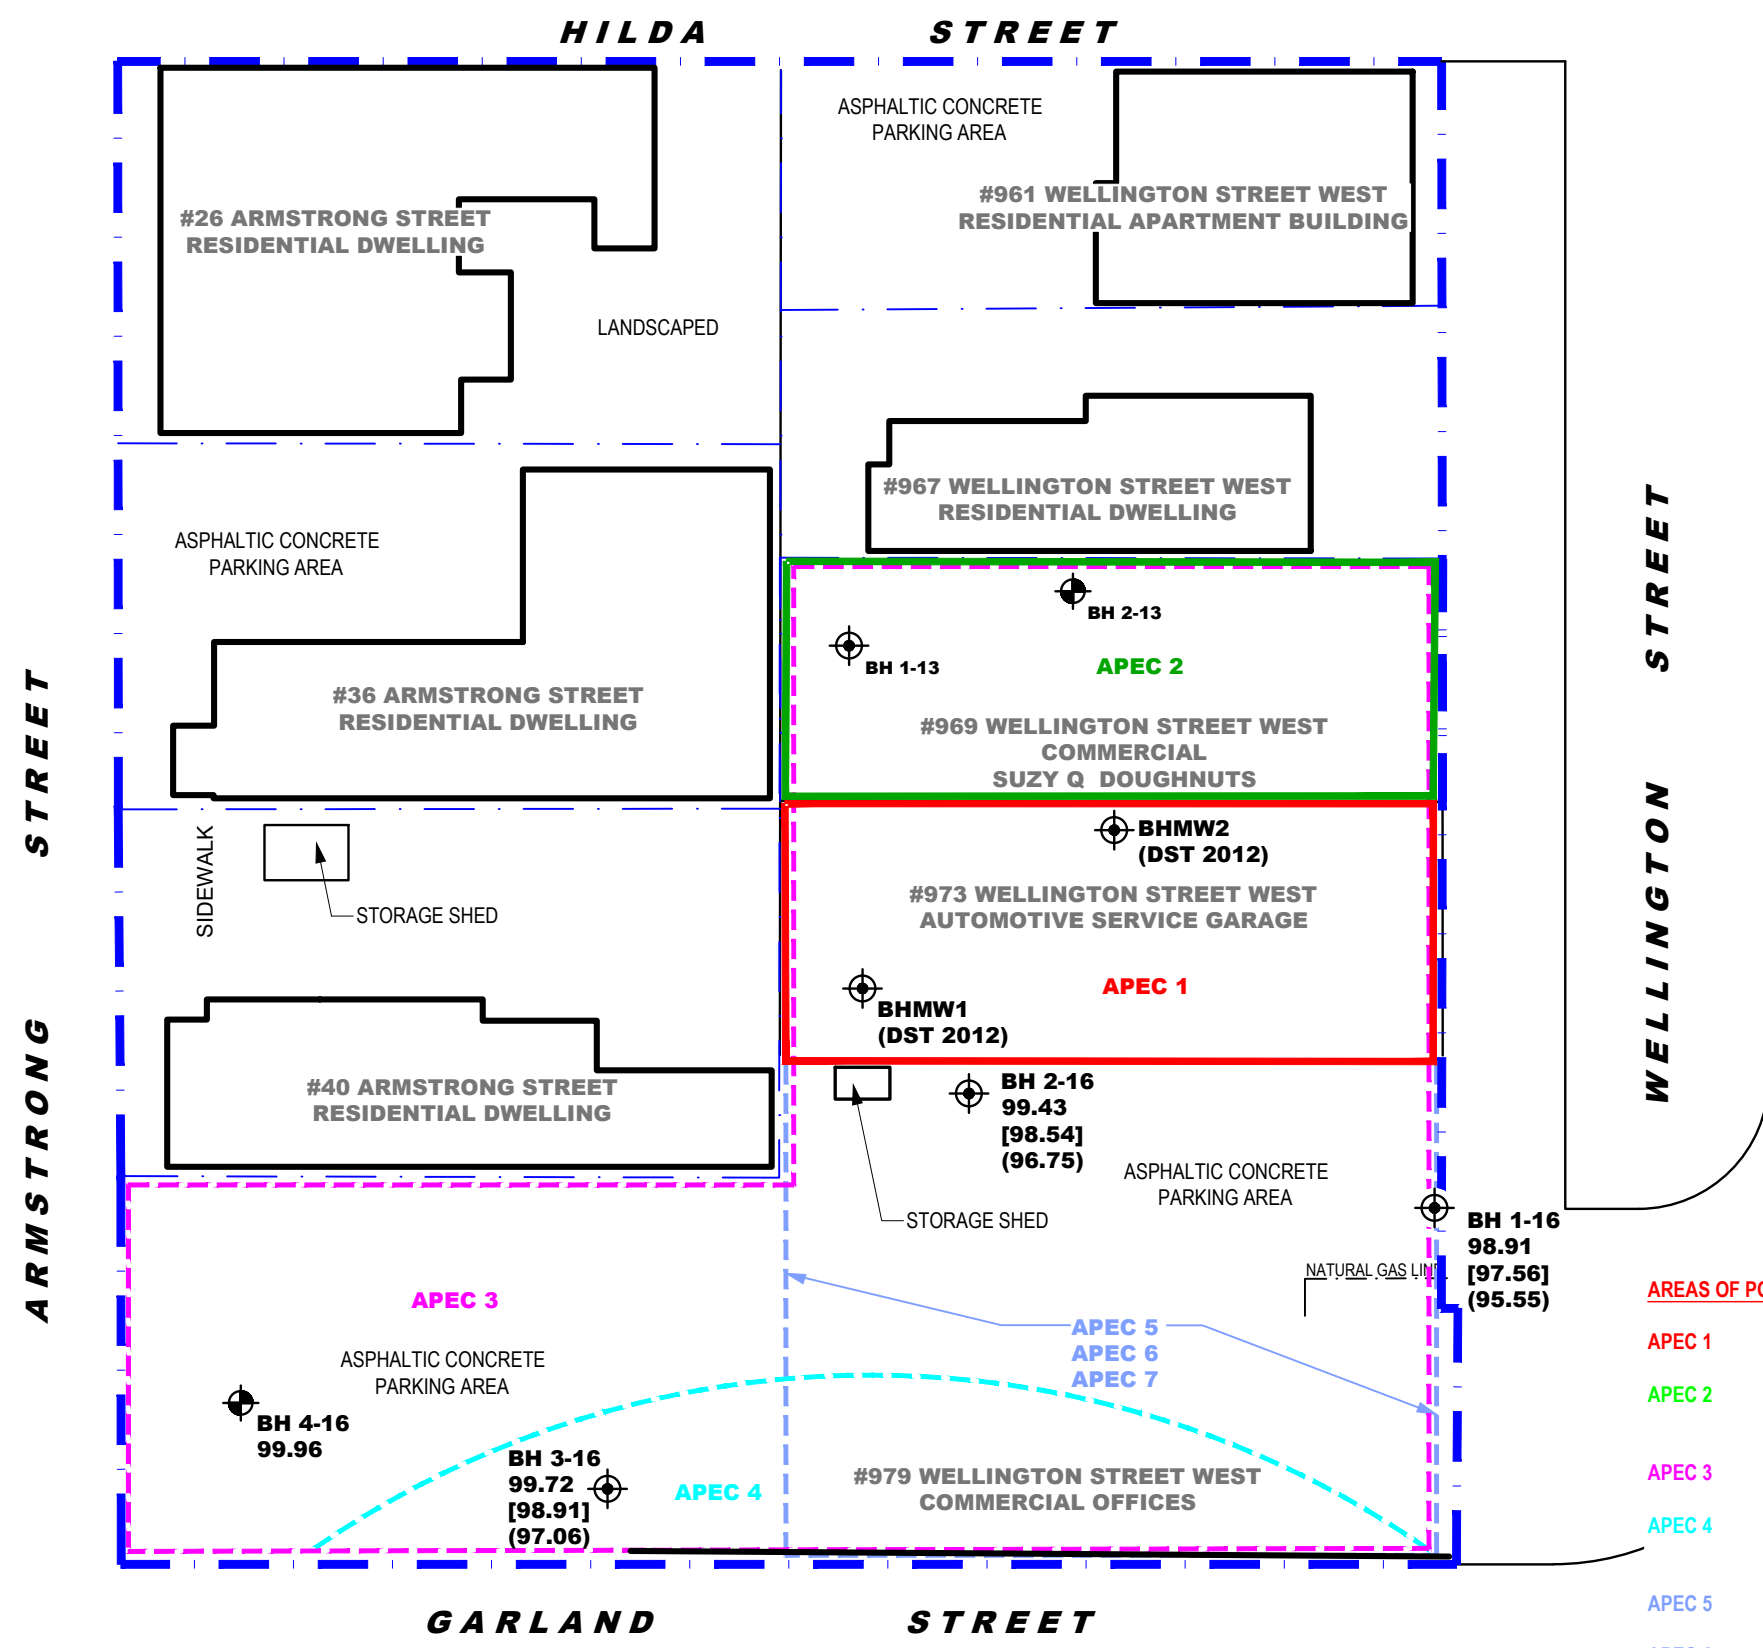
- AREAS OF POTENTIAL ENVIRONMENTAL CONCERN:**
- APEC 1** RESULTING FROM AUTOMOTIVE SERVICE GARAGE AT 973 WELLINGTON STREET WEST
 - APEC 2** RESULTING FROM FORMER AUTO BODY SHOP AND PAINT BOOTH AT #969 WELLINGTON STREET WEST
 - APEC 3** FILL MATERIAL OF UNKNOWN QUALITY ACROSS SITE
 - APEC 4** RESULTING FROM POSSIBLE HISTORICAL SERVICE GARAGE AT 987 WELLINGTON STREET WEST (907 GARLAND STREET)
 - APEC 5** RESULTING FROM FORMER CLEANERS AT 992 WELLINGTON STREET WEST
 - APEC 6** RESULTING FROM FORMER CLEANERS AT 14 SPADINA AVENUE
 - APEC 7** RESULTING FROM FORMER EXCAVATION CONTRACTOR / UNDERGROUND STORAGE TANK AT 3 IRVING AVENUE
