**Phase I Environmental Site Assessment**

1940 Carling Avenue  
Ottawa, Ontario

November 4, 2021

Report: PE4842-1R

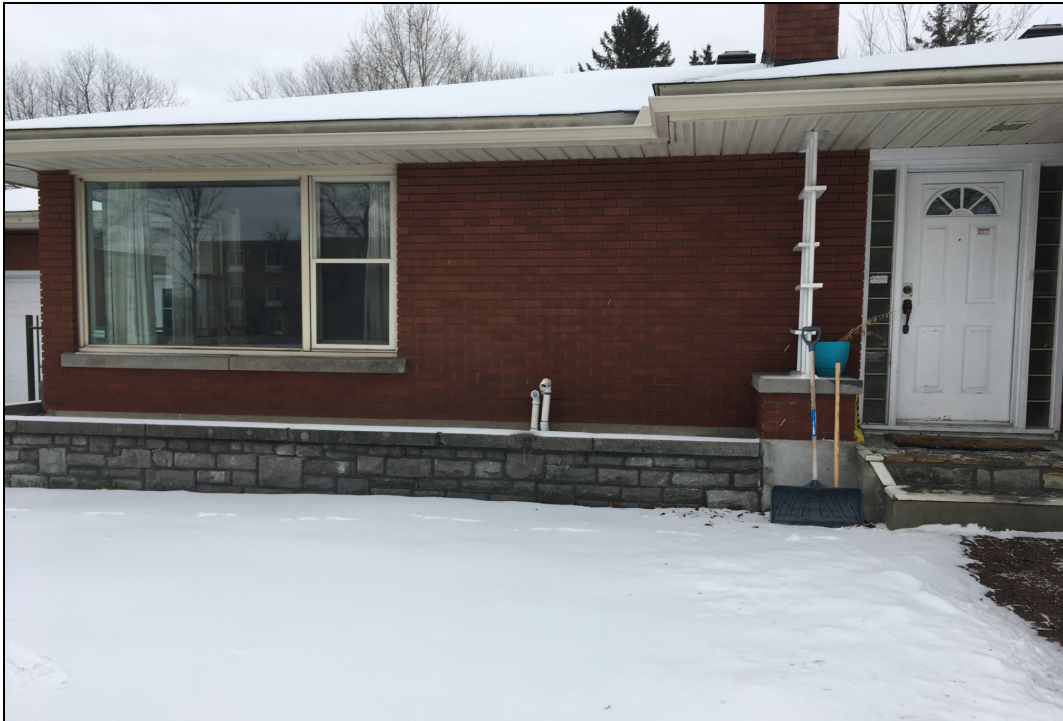
Photo 1: View of on-site residence from Carling Avenue, looking southeast.

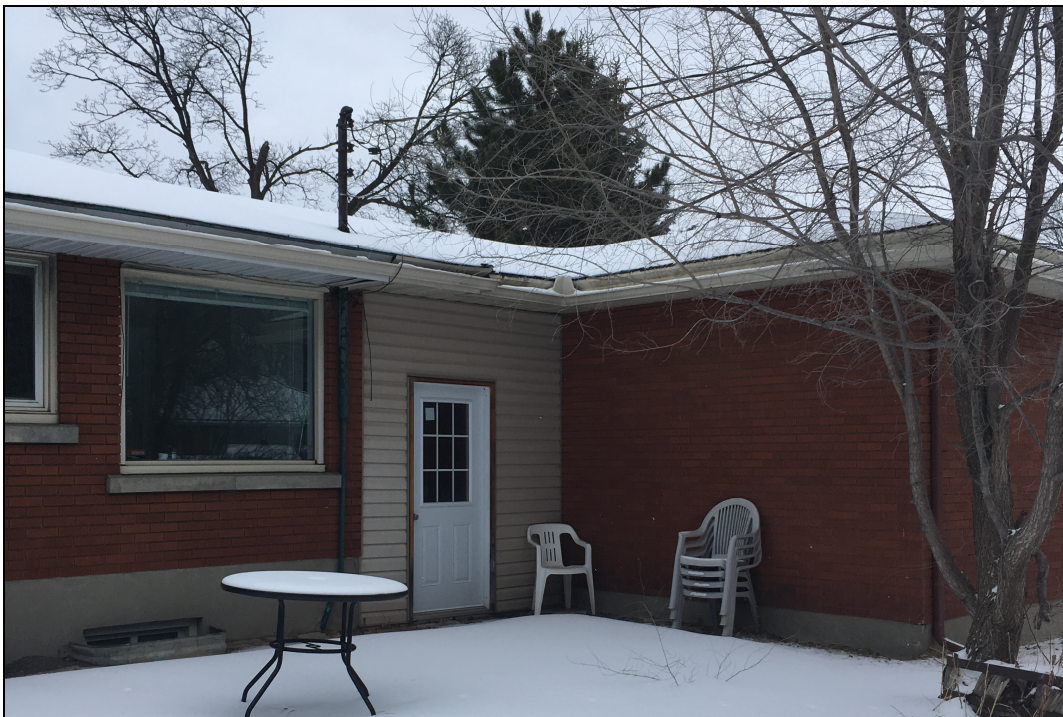
The house and garage are finished on the exterior with brick, with the exception of the storage area connecting the garage and house. This storage area appears to have originally been a breezeway, complete with roof and concrete pad foundation, but is suspected to have been enclosed at a later time with vinyl siding and drywall. The building has a sloped, asphalt shingled roof. The residence is heated by a natural gas-fired furnace.

Photo 4: Rear of on-site residence, looking north; vinyl siding delineates storage area between the house and garage.

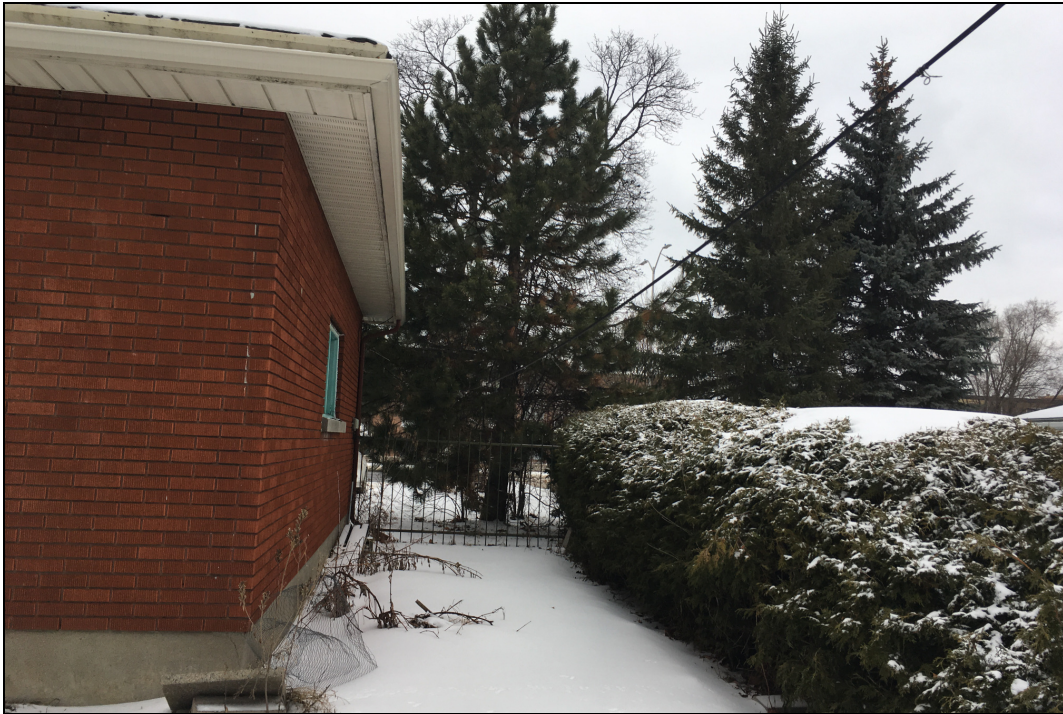
Photo 5: East side of on-site residence, looking northwest from rear.

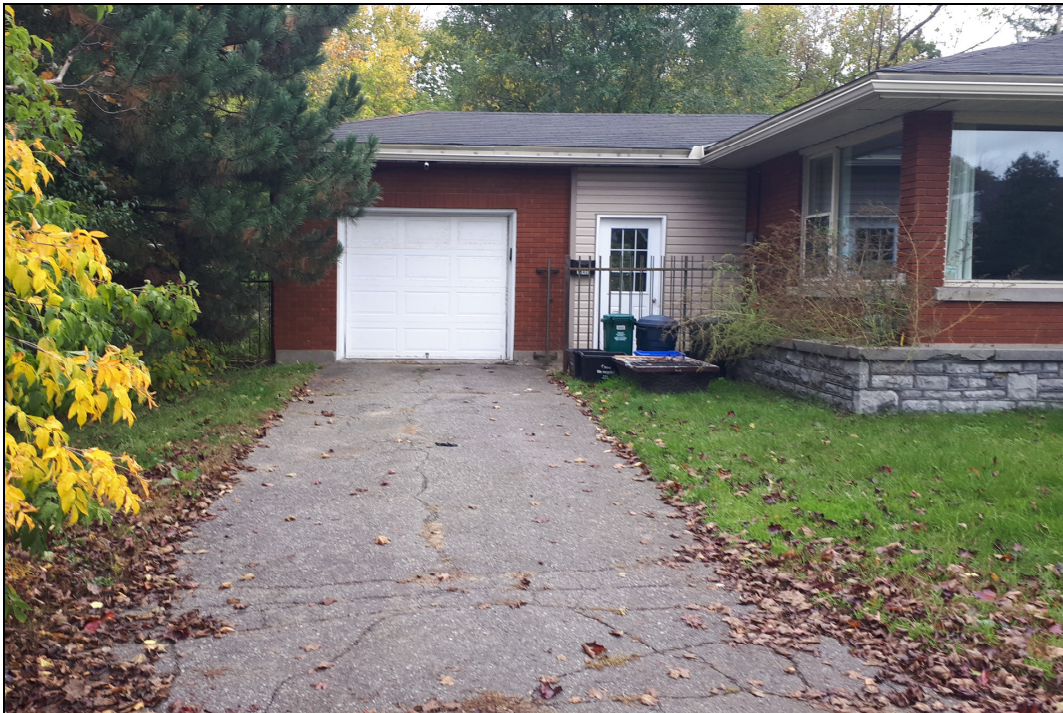
Photo 8: Driveway and (private) garage, looking southeast.
