42 NORTHSIDE ROAD BELLS CORNERS
 42 NORTHSIDE ROAD, NEPEAN
 OTTAWA, ON

PRE-DEVELOPMENT VEGETATION

DRAWN BY: NG-RP **L-TP1**

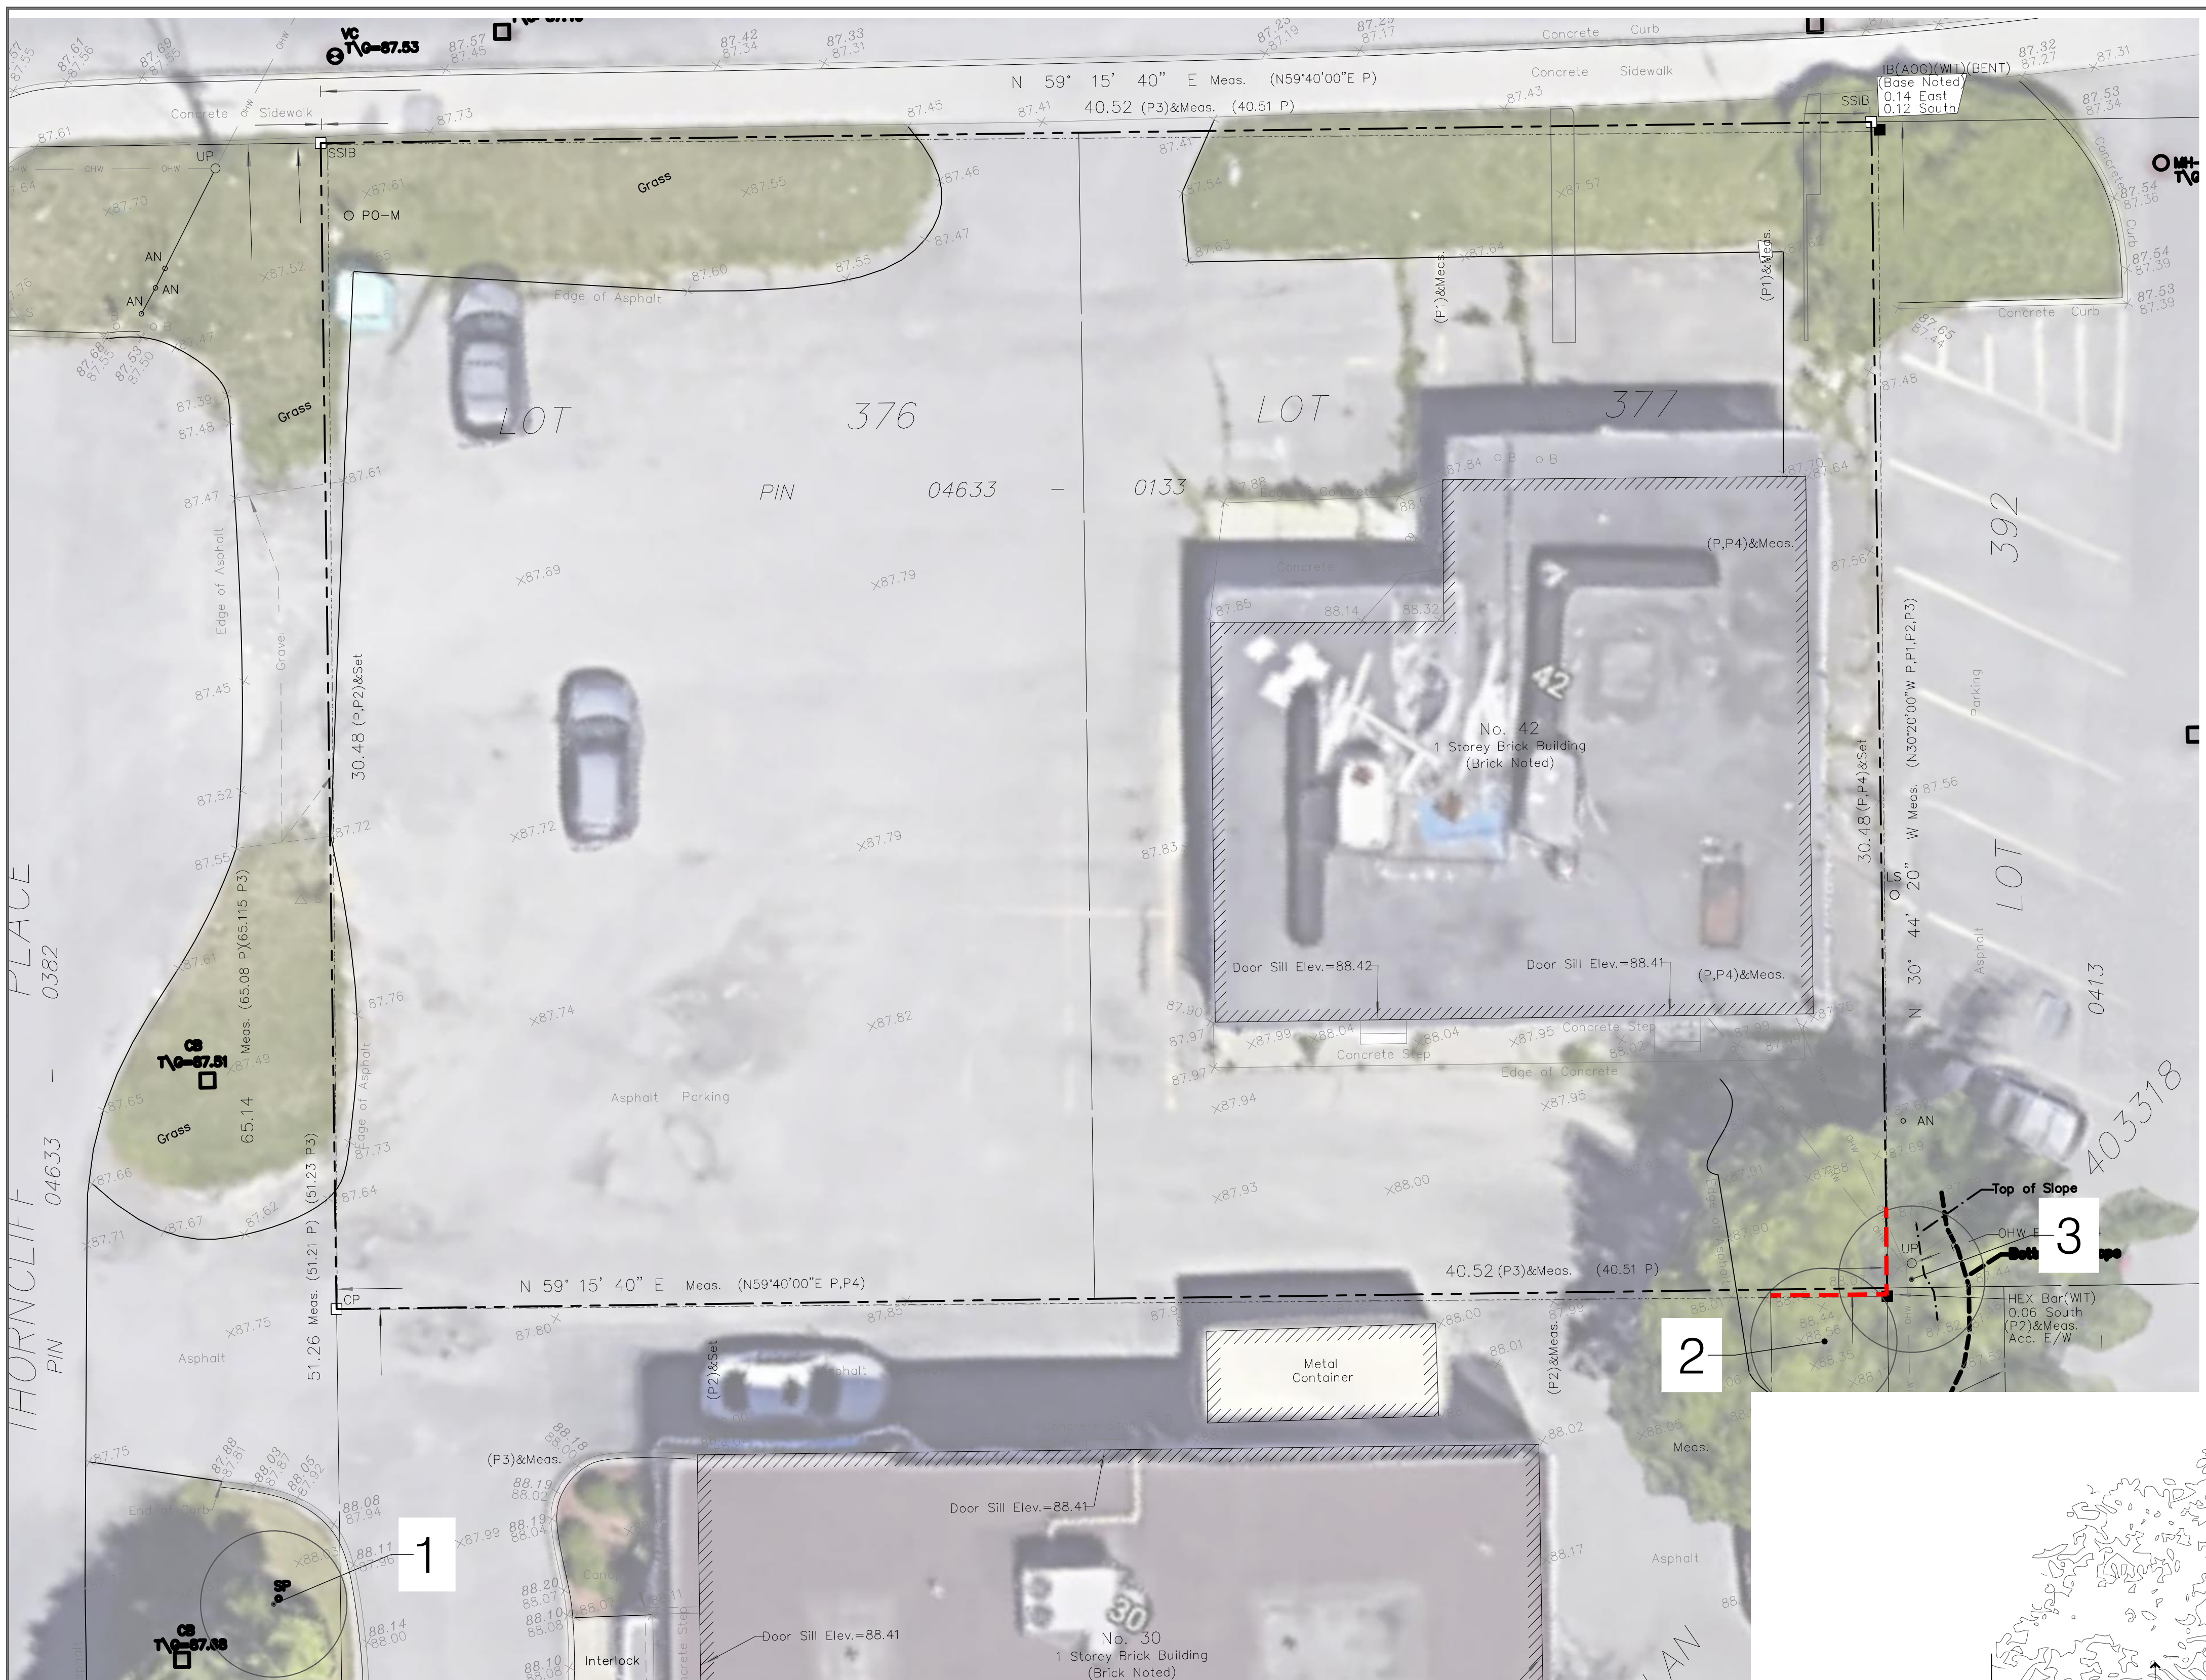
1 PRE-DEVELOPMENT VEGETATION PLAN

NO.	SPECIES	DBH (CM)	HEALTH	COMMENTS
1	Norway Maple / Acer Platanoides	40	Poor	Broken branch union, internal rot

NO.	SPECIES	DBH (CM)	HEALTH	COMMENTS
2	Honey Locust/ Gleditsia Triacanthos	20,22, 22,22, 45	Fair	5 stems joined at 1.3m
3	American Elm / Ulmus americana	40	Poor	Poorly pruned under hydro lines. Senescing.

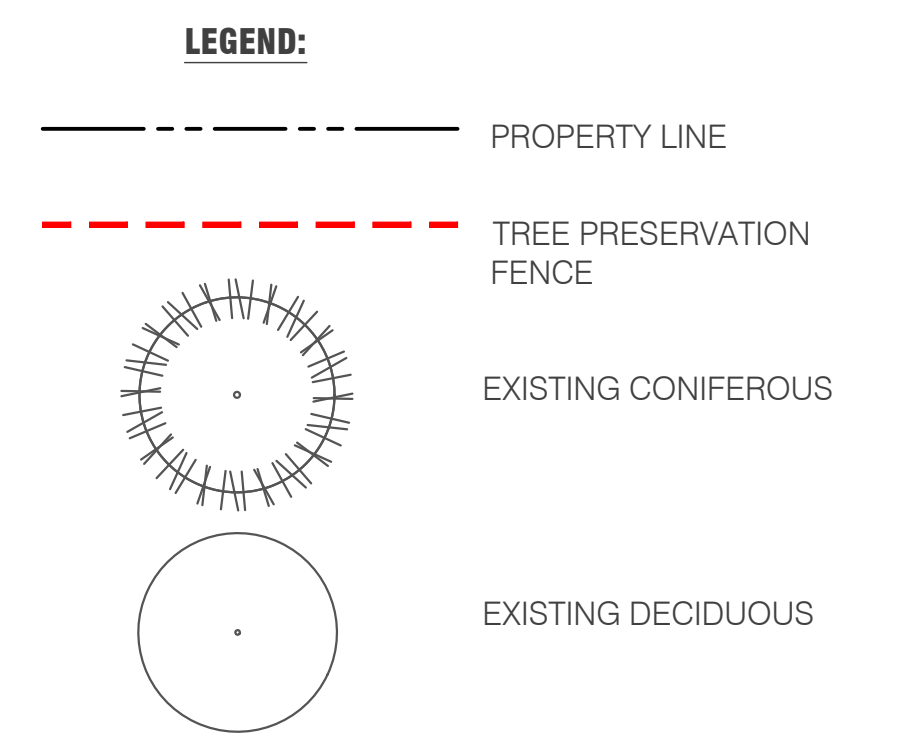
TREES ON CITY PROPERTY

TREES ON ADJACENT PROPERTY
