Phase I - Environmental Site Assessment

Vacant Land
301 Palladium Drive
Ottawa, Ontario

November 4, 2011

Report: PE2482-1

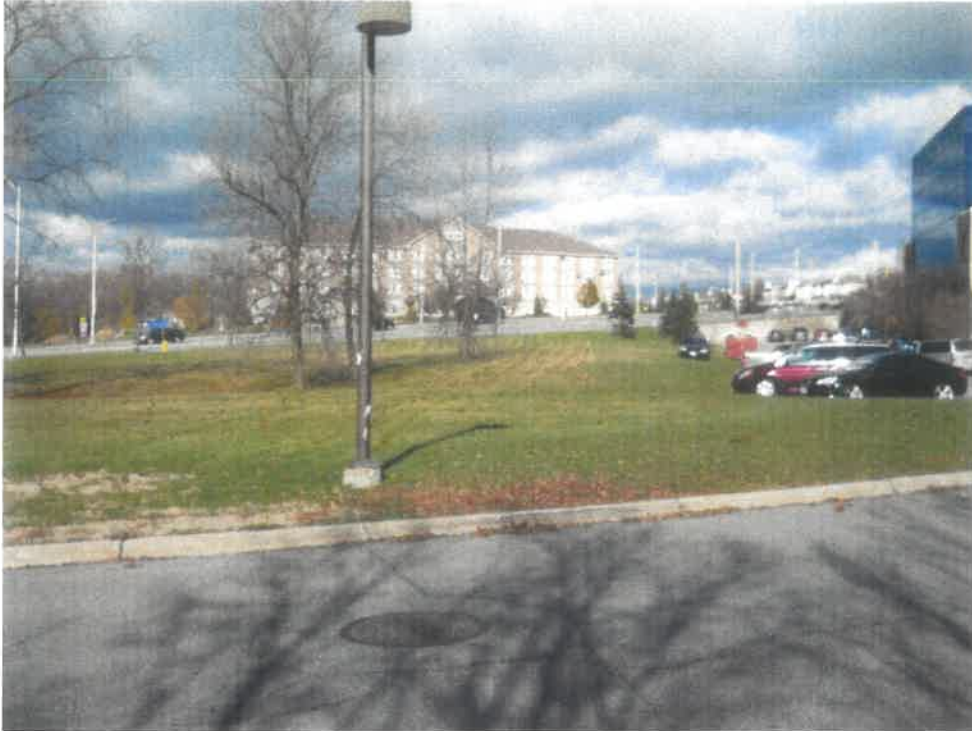
Photograph 1: View of the site looking north. Photograph illustrates on-site and regional topography which slopes to the south-southeast.

The entire site is vacant and is covered with grass and some mature trees. Site drainage consists primarily of infiltration. The site topography is sloped downward to the south-southwest, while the regional topography slopes down to the southwest. A topographical low was observed near the south-central portion of the site. The current site features are illustrated in the site photographs in the Appendix of this report.

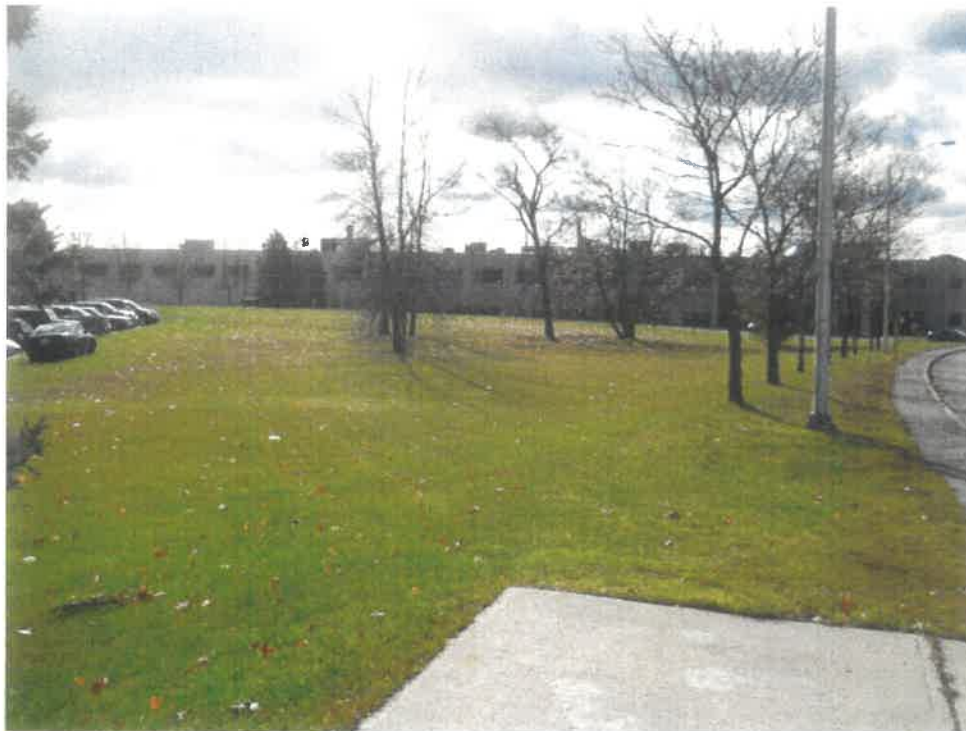
Photograph 2: View of the site, looking south. Photograph illustrates mature trees in the centre of the property.

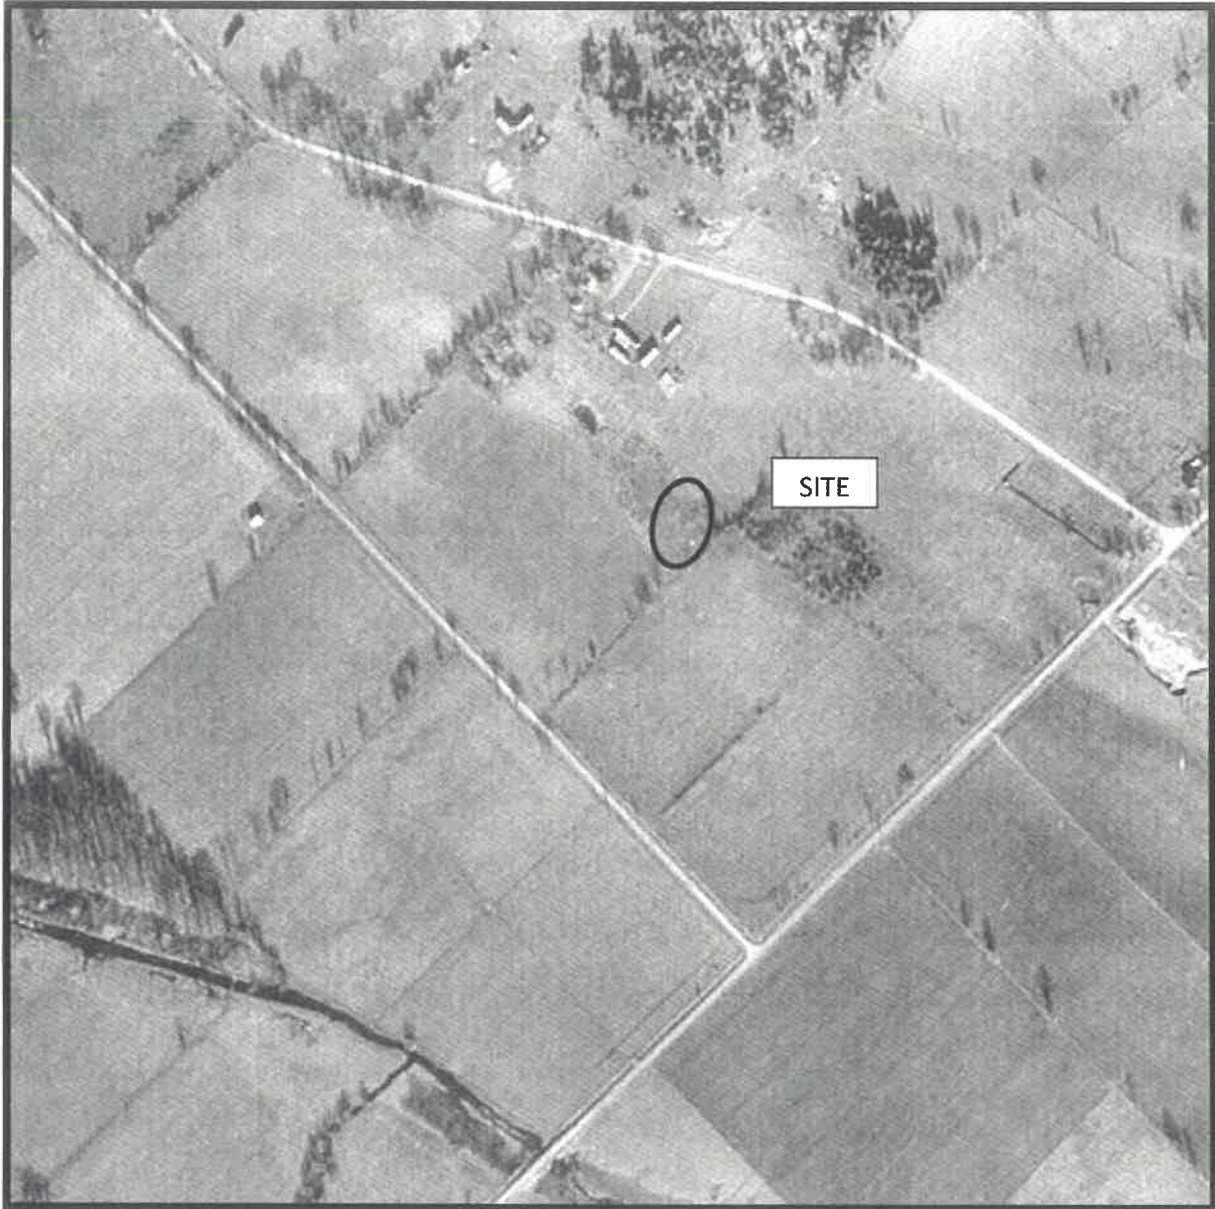
AERIAL PHOTOGRAPH
1971

- 1971 The site appears to be vacant and overgrown with vegetation. What appears to be a drainage ditch is present to the west of the site. A cluster of mature trees is present to the southeast of the site. A farmstead and associated agricultural land is present to the northeast of the site. The properties to the south and west of the site appear to be used for agricultural purposes.

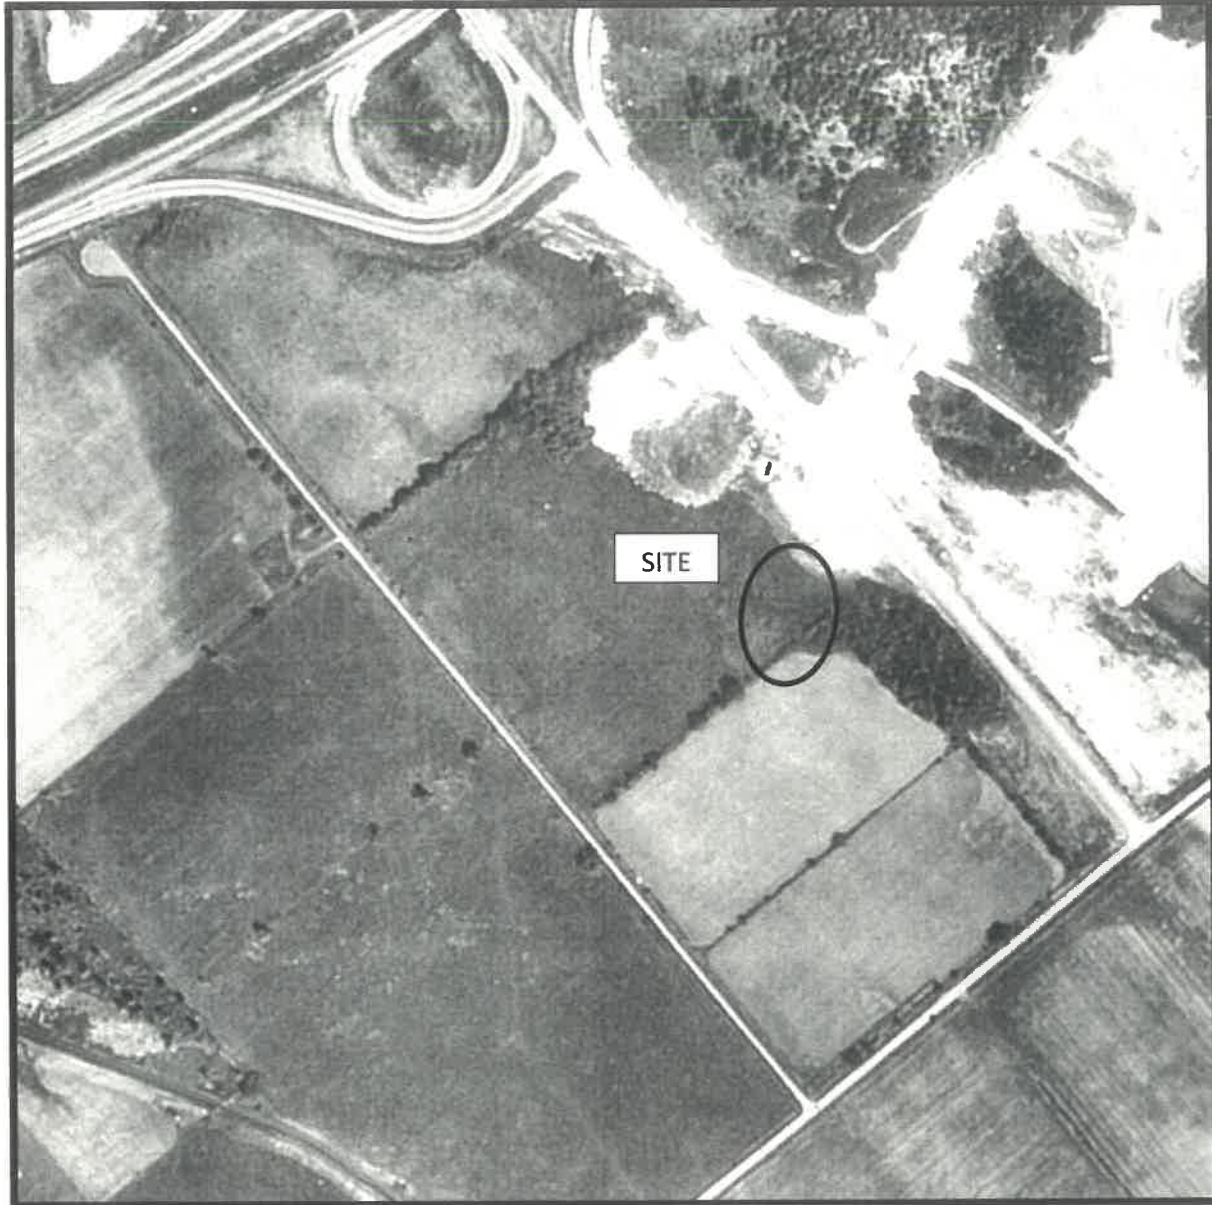
AERIAL PHOTOGRAPH
1979

- 1979 The farmstead to the northeast of the site appears to have been cleared. Terry Fox Drive has been constructed to the east of the site. Preliminary grading is apparent further east of the site. Highway 417 and the Terry Fox Drive interchange have been constructed further north of the site. No other significant changes have been made to the subject site or neighbouring properties.

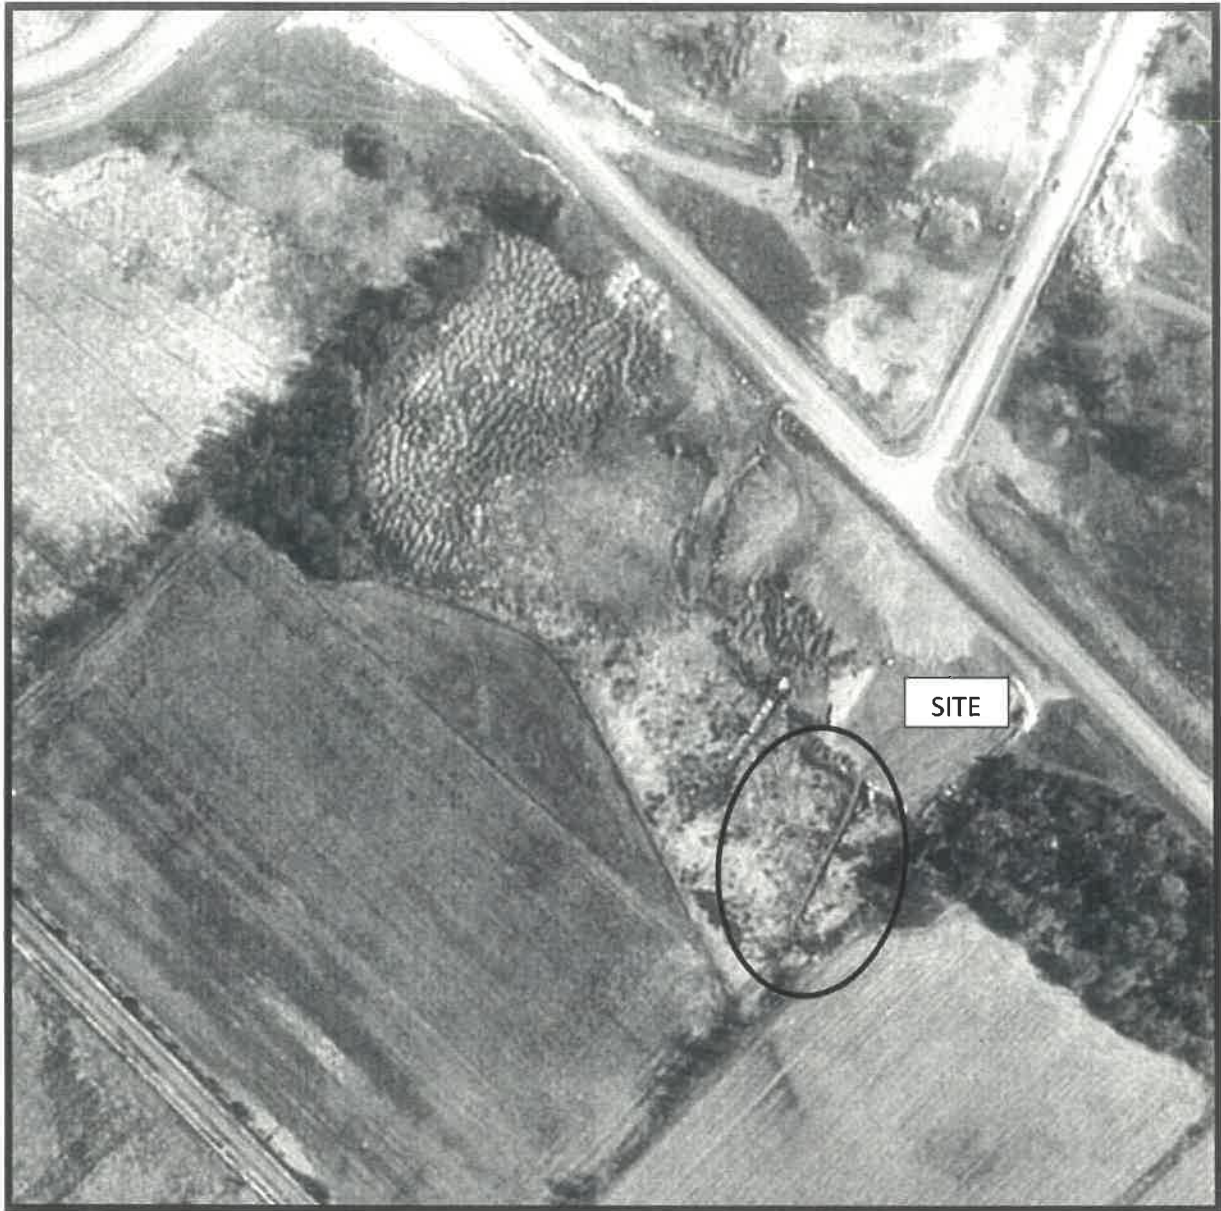
AERIAL PHOTOGRAPH
1983

- 1983 No significant changes had been made to the subject site or neighbouring properties.
- 1990 Palladium Drive has been constructed to the north of the site. Neighbouring properties to the east, southeast, northwest and further southwest of the site have been developed with what appear to be the present day commercial buildings. The properties to the east of Terry Fox Drive have been developed with residential dwellings. No other significant changes had been made to the subject site or neighbouring properties.

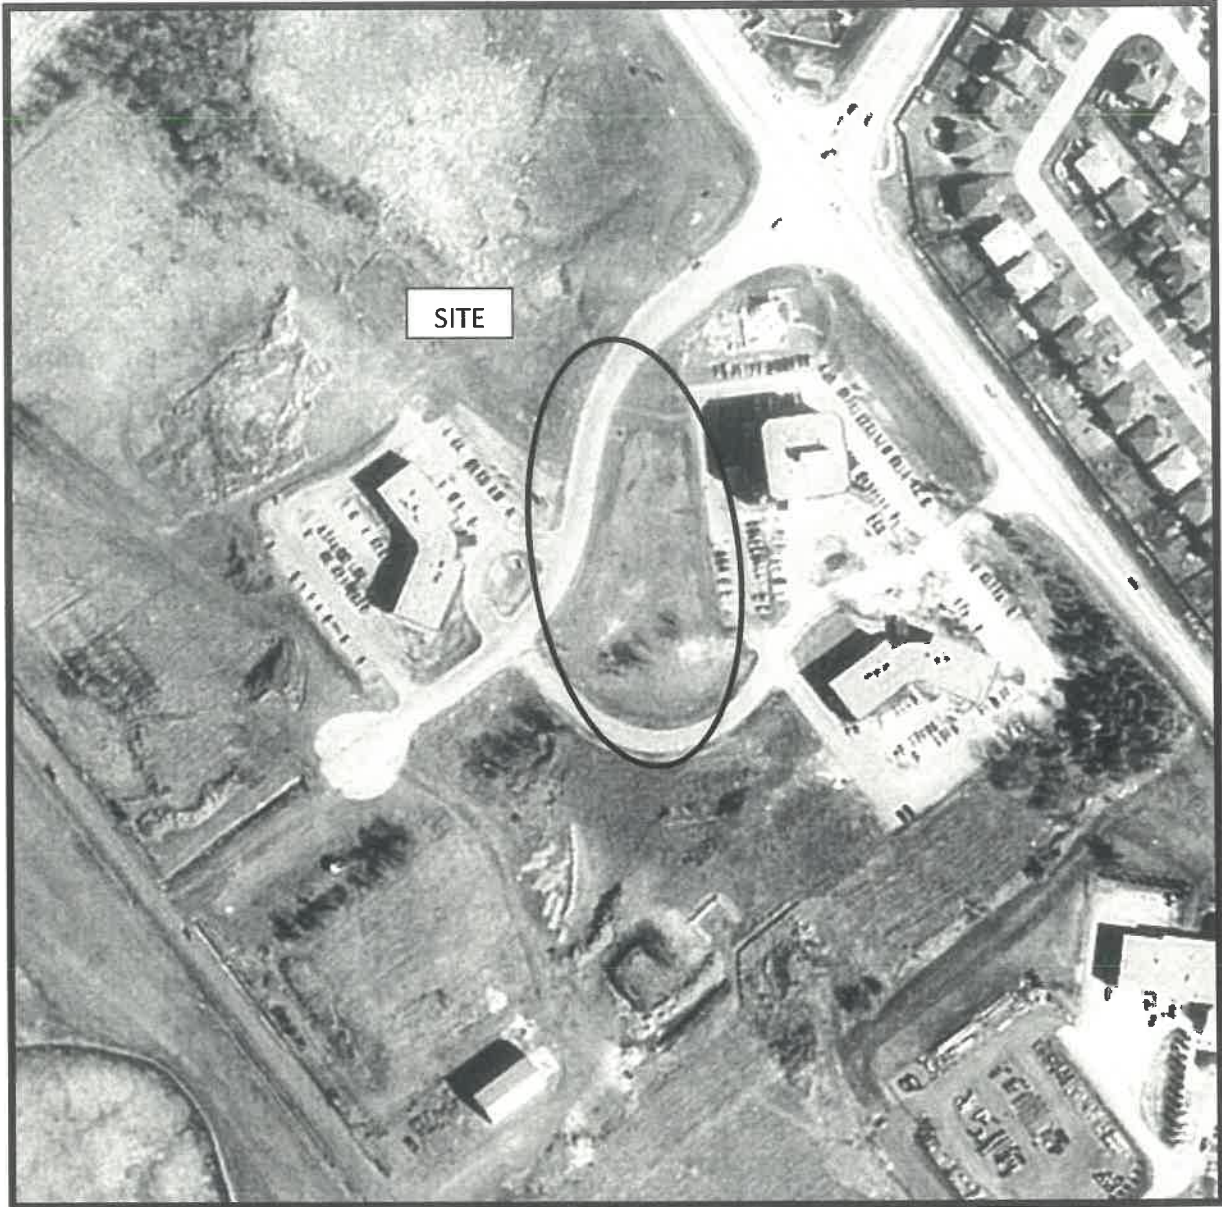
AERIAL PHOTOGRAPH
1992

- 1992 Increased residential development is apparent to the east of Terry Fox Drive. No other significant changes had been made to the subject site or neighbouring properties.

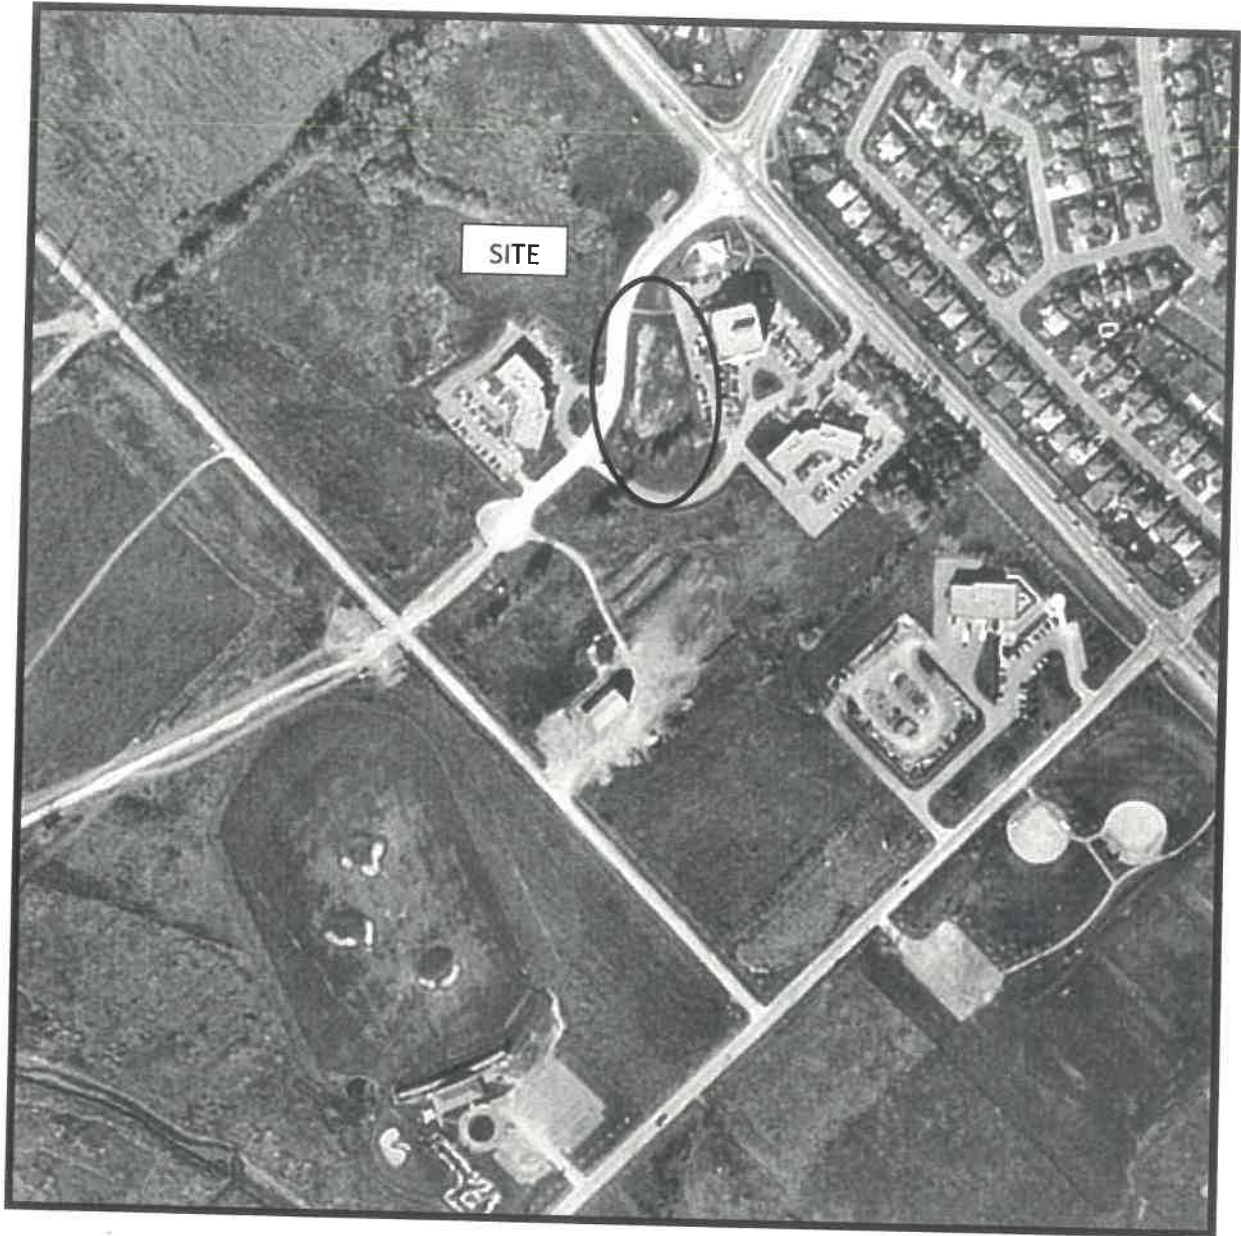
AERIAL PHOTOGRAPH
1994

- 1994 No significant changes had been made to the subject site or neighbouring properties.
