# A CULTURAL HERITAGE IMPACT STATEMENT

109 – 115 DALHOUSIE STREET, OTTAWA

V3 February 2022  
COMMONWEALTH HISTORIC RESOURCE MANAGEMENT  
For: ETHOS Development

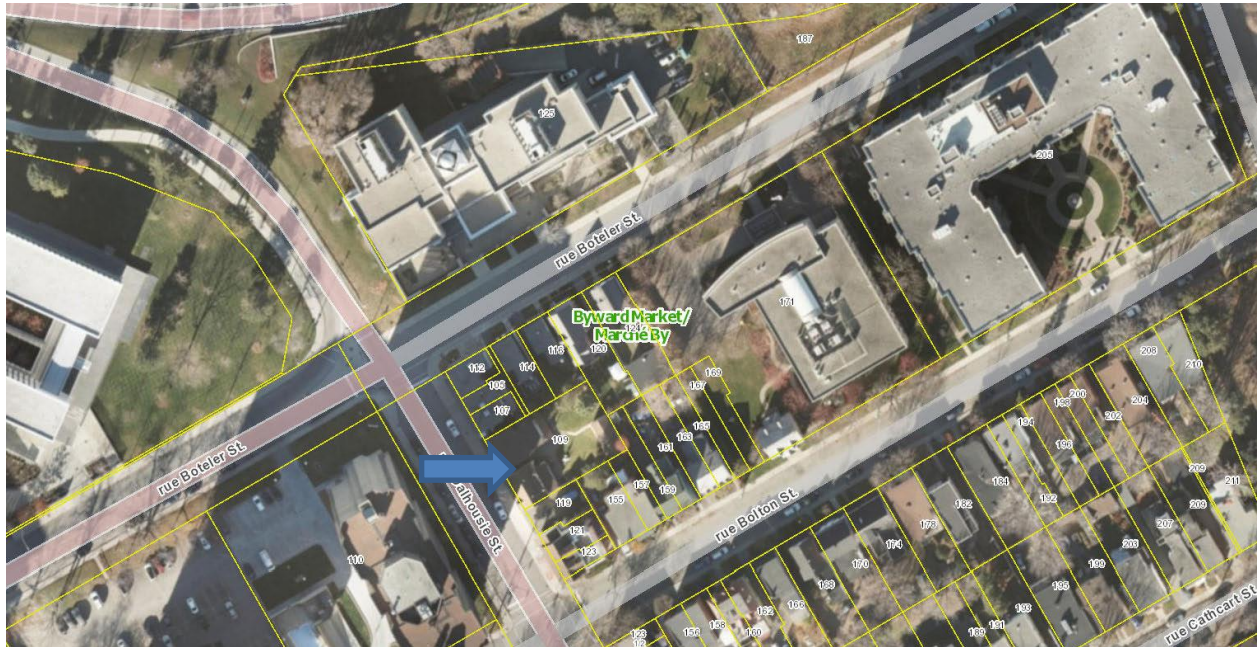
Figure 1: Aerial view illustrating the built context within the block and adjacent to the development site. The development site sits on an extra deep lot in the centre of a collection of eight heritage properties. Site arrowed. Source: Geottawa

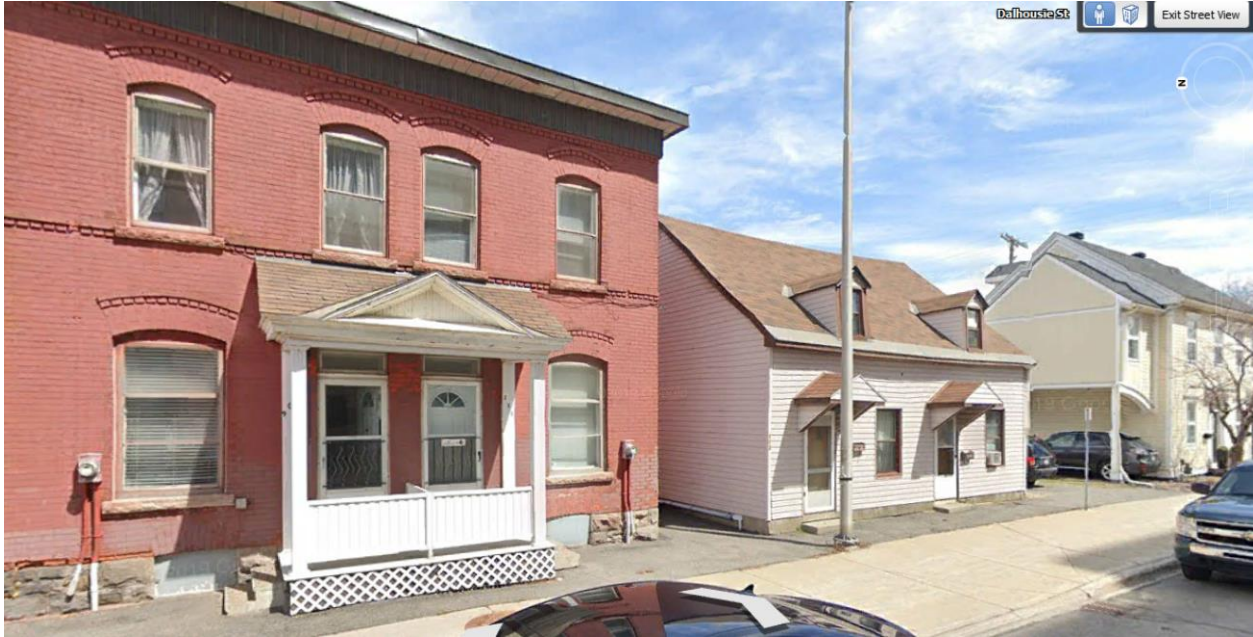
Figure 3: Street view looking south-east to 109-111 Dalhousie Street circa 1906 (left), 113-115 Dalhousie Street circa 1876 (right centre) and 121-123 Dalhousie Street circa 1870. Source: Google Earth

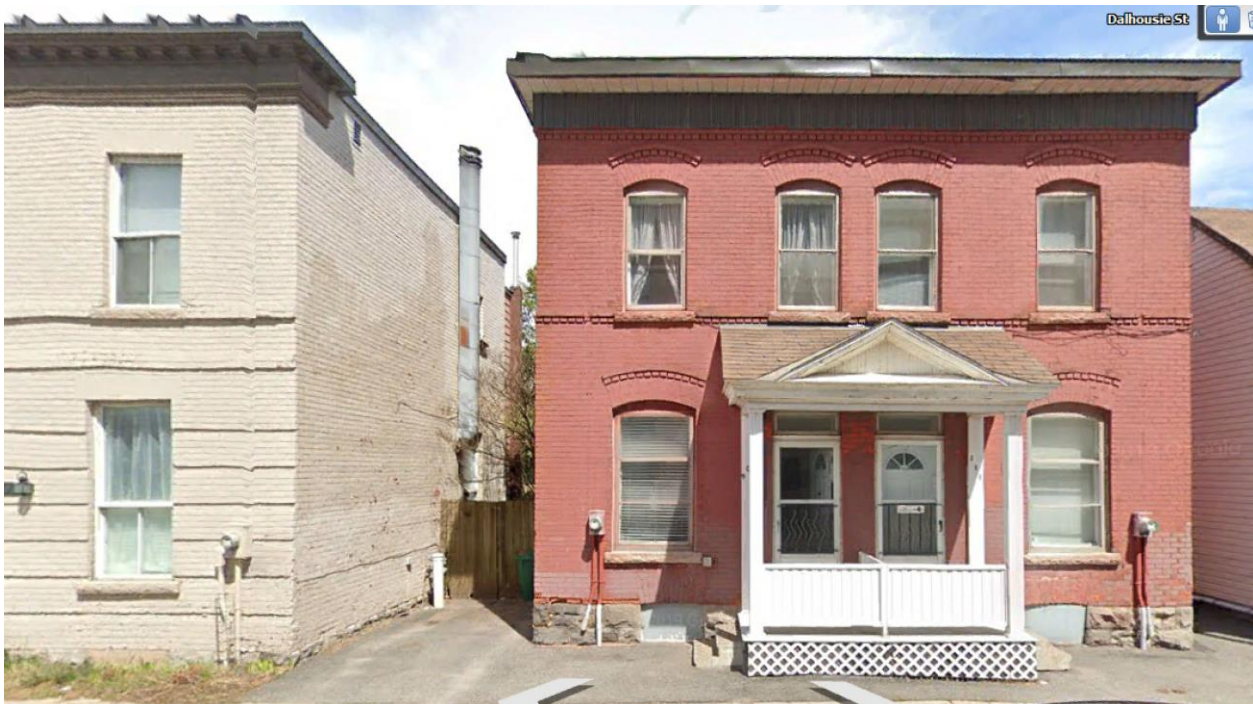
Figure 4: Street view of 109-111 Dalhousie Street (right) within the development site and the adjacent apartment building to the north (left). Source: Google Earth

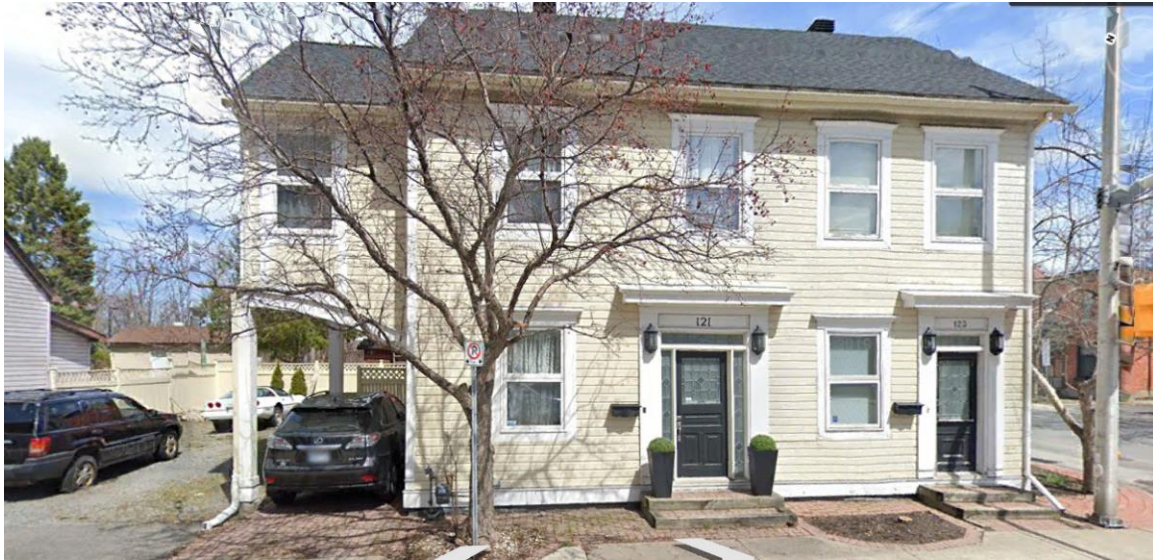
Figure 5: Street view of 121-123 Dalhousie Street an early wood frame side-by-side row house constructed prior to 1870. The parking area to the left of the building is associated the building. Source: Google Earth

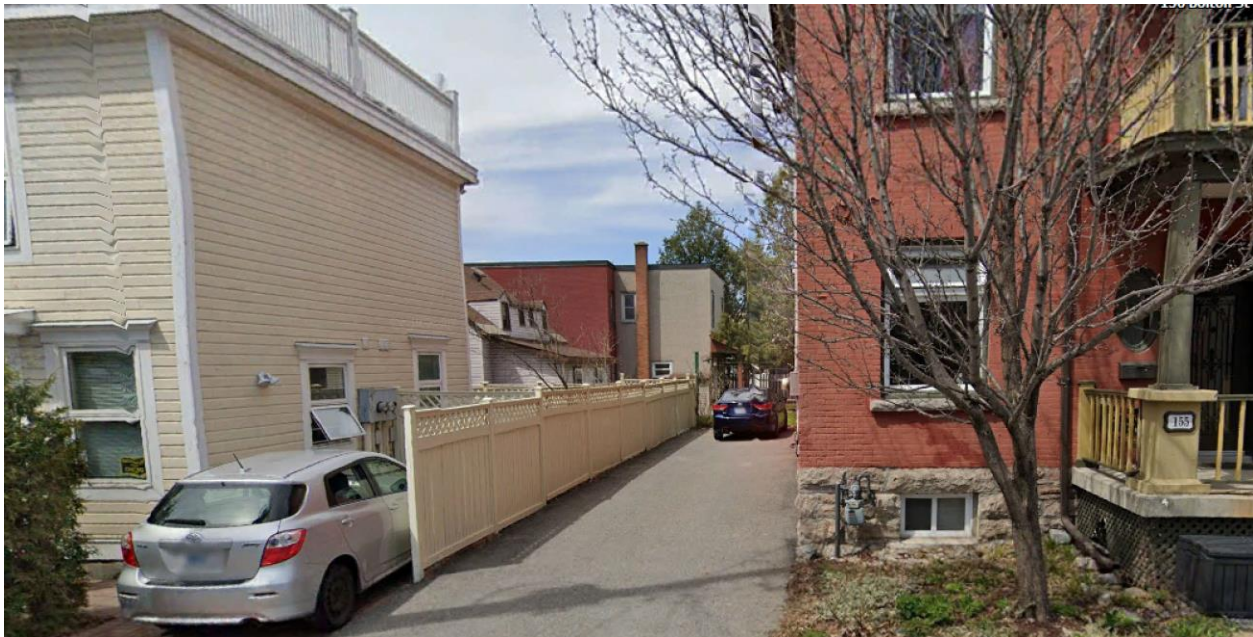
Figure 9: View to the back of the development site from Bolton Street with the gabled dormers of 113-115 Dalhousie Street in view with the brick and vinyl clad property at 109-111 in the centre of the image. Source: Google Earth

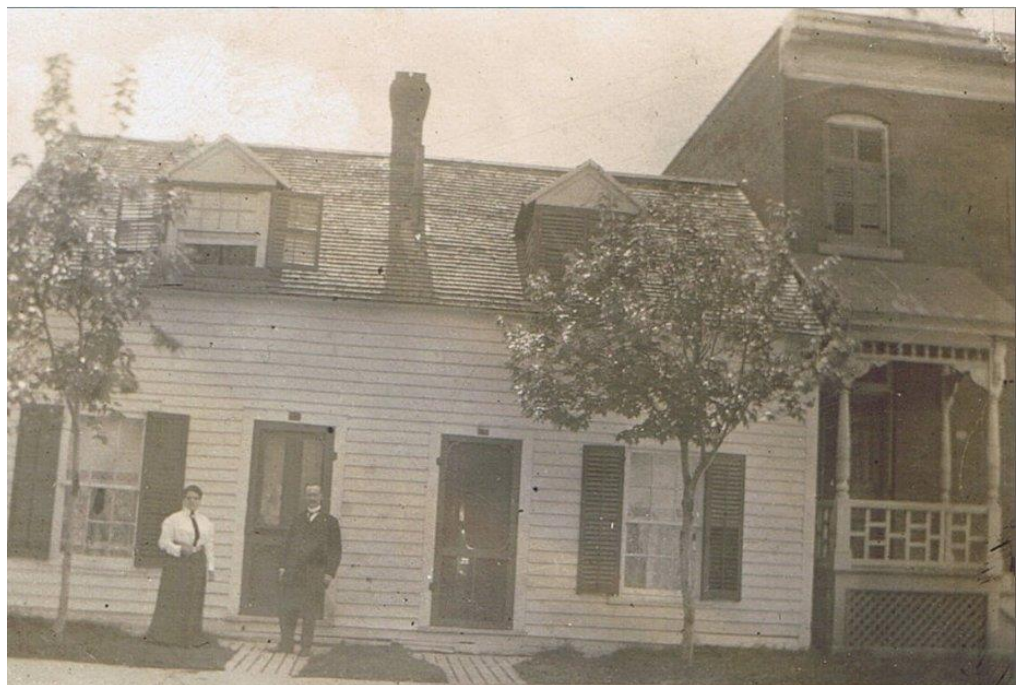
Figure 14: Historic photograph (n.d.) of a worker's cottage and a brick clad house in Lowertown. Note the exterior finishes – wood siding and shingles, baseboard at the base of the wall and simple corner board and window and door trim. Note the lack of entrance canopies, the minimal eave overhang, and the single hung multi-pane sash. Note the cornice detailing on the brick building. Source: Library and Archives Canada.

Other images in Lowertown neighbourhood provide reference for the treatment of doors, windows, and the roof cladding. (See Figures 14, 15, 16 and 17).

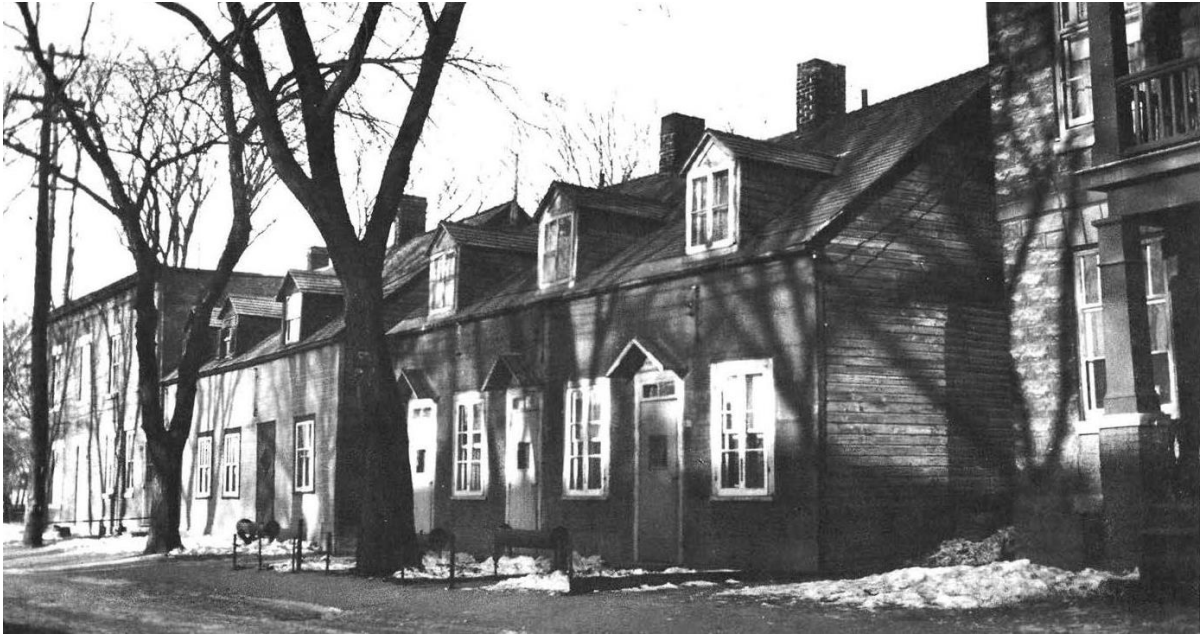
Figure 15: Historic photograph (n.d.) of workers cottages in Lowertown. Note the exterior finishes – wood siding and shingles, baseboard at the base of the wall and simple corner board and window and door trim. Note the entrance canopies, the minimal eave overhang, and the single hung multi-pane sash. Source: Newton, M. (1980). *The Search for Heritage in Ottawa's Lower Town*. *Urban History Review / Revue d'Histoire Urbaine*, 9 (2), 21–37. <https://doi.org/10.7202/1019334ar>

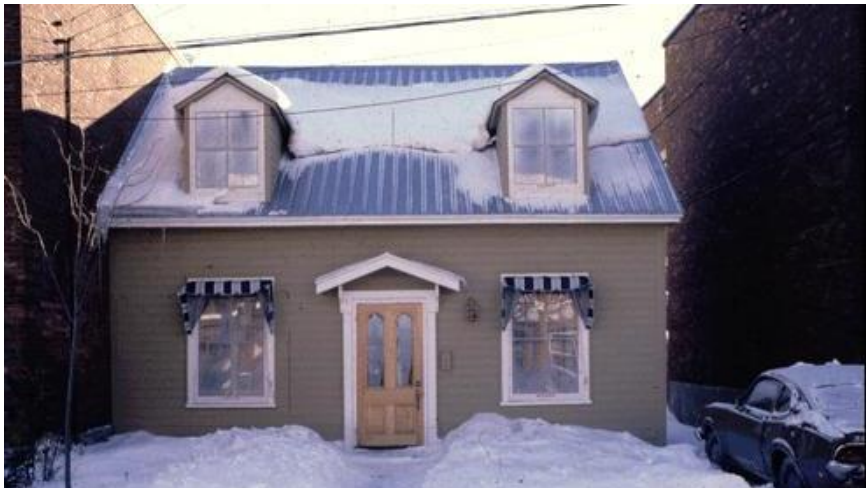
Figure 16: View of a restored worker's cottage in Lowertown. Note the metal roof. Source: Historic Places Canada

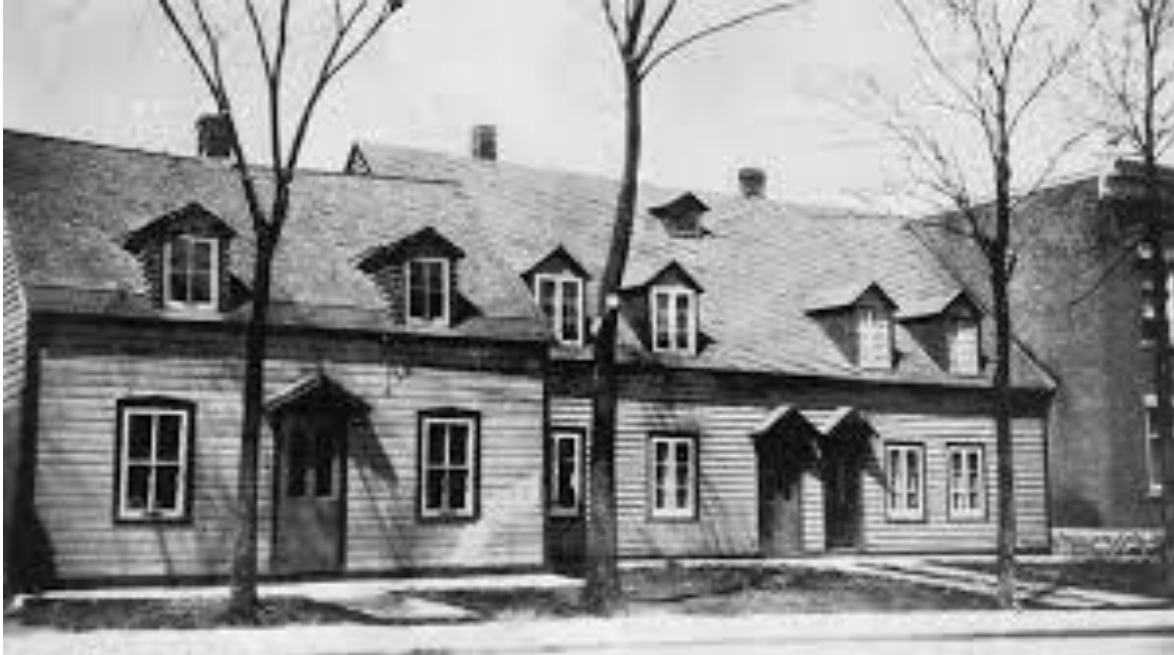
*Figure 17: Historic photograph of worker's cottages in Lowertown. n.d. The finishes and detailing – wood-siding, roof finishes dormers, windows both doubles hung (left) and casement (right) and simple entrance canopies are typical of the area. Source: Canadian Inventory of Historic Buildings (CIHB)*

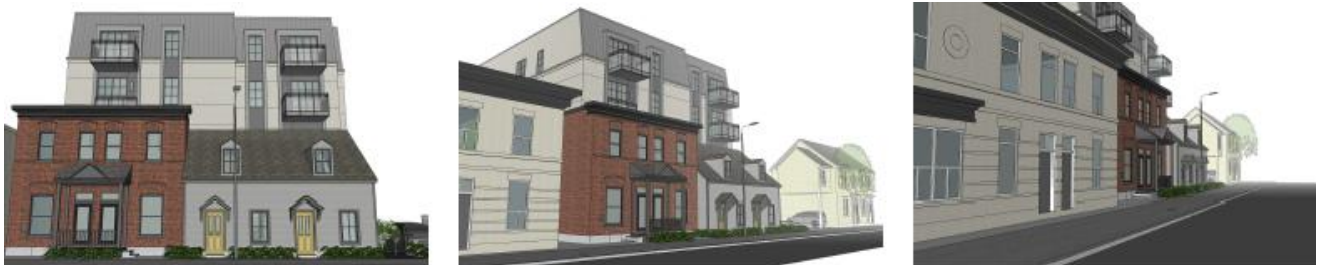
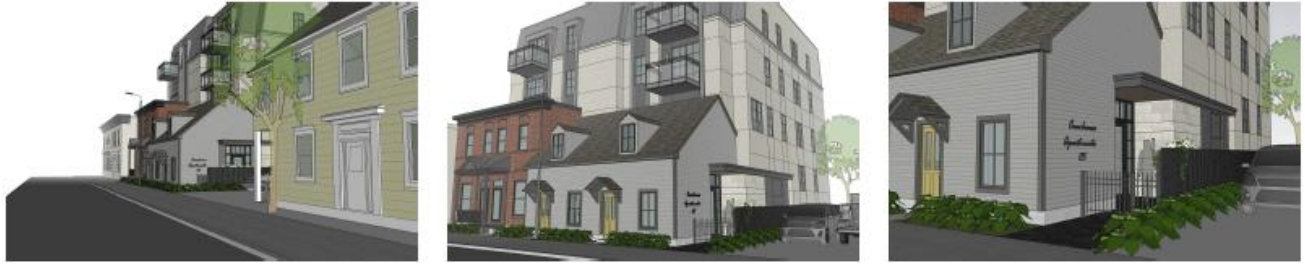
Figure 18 & 19: Rendered perspective views of the development site with the two retained row houses and the infill development behind. Source: Rosaline J. Hill Architects Inc. 2021.

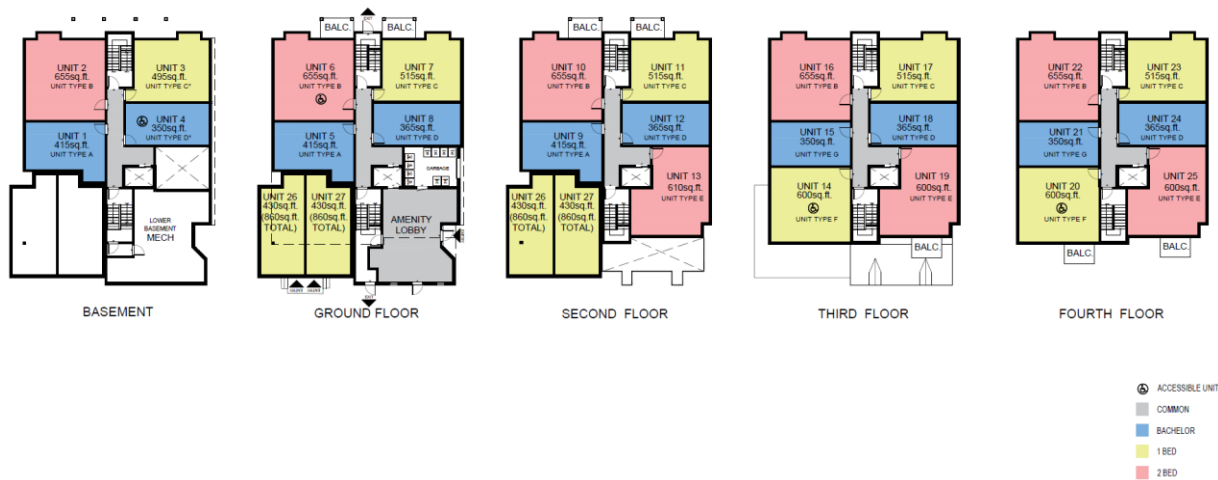
Figure 21: Plan views of the proposed development including the two retained row houses and the infill development behind. The 25 units are colour coded to indicate number of bedrooms. Source: Rosaline Hill Architects Inc. 2022

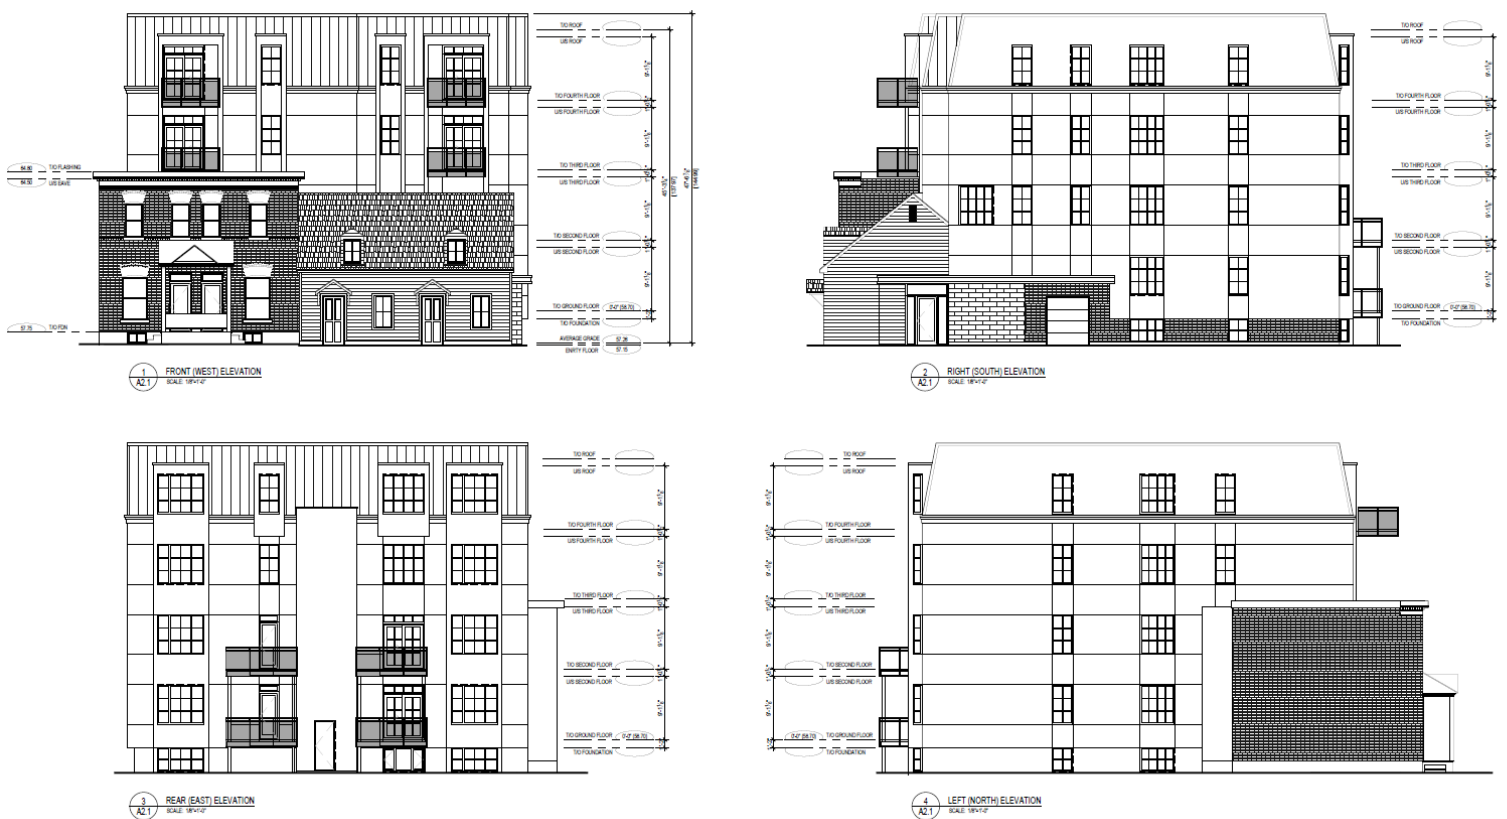
Figure 22: Elevations of the development. Note the modified mansard treatment of the 4<sup>th</sup> floor. Source: Rosaline Hill Architects Inc. 2022

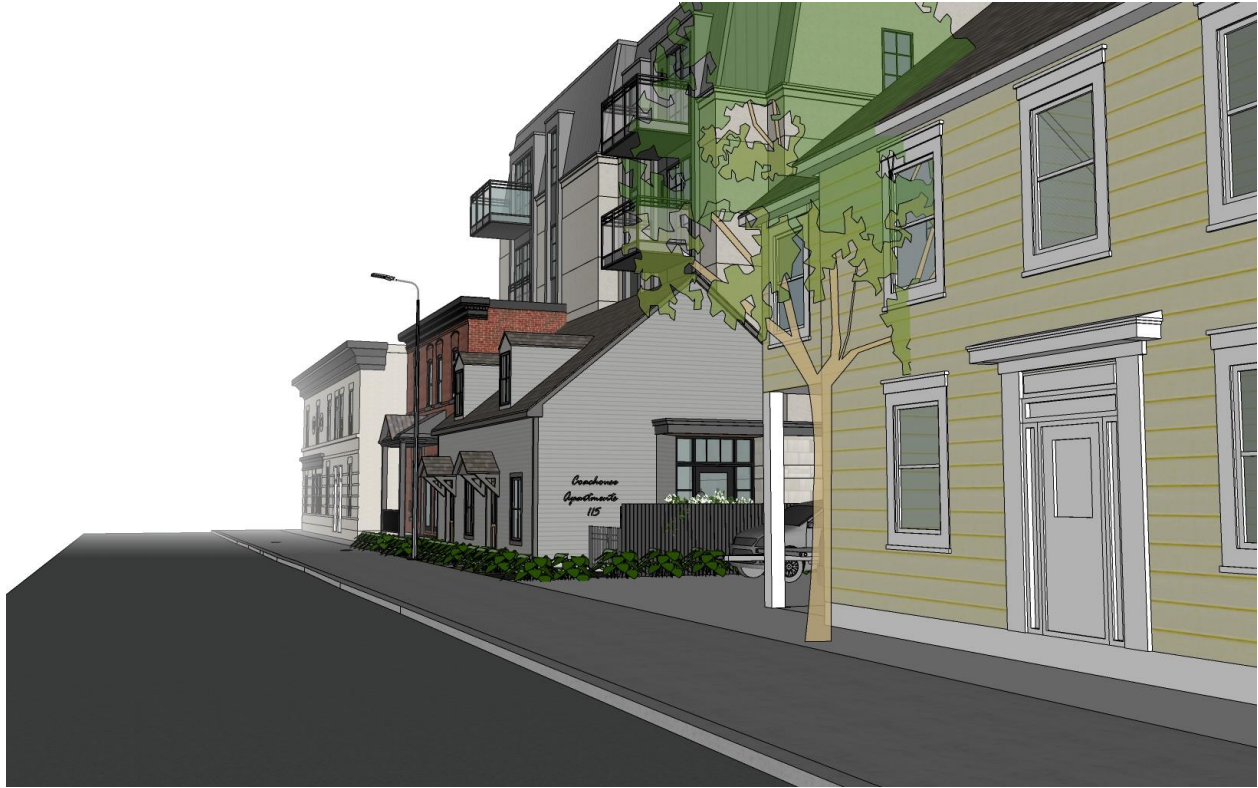
Figure 23: Street view with the two historic buildings shifted next to each other. The mansard treatment of the front façade helps to reduce the visual impact. Source Roseline Hill Architects 2022.

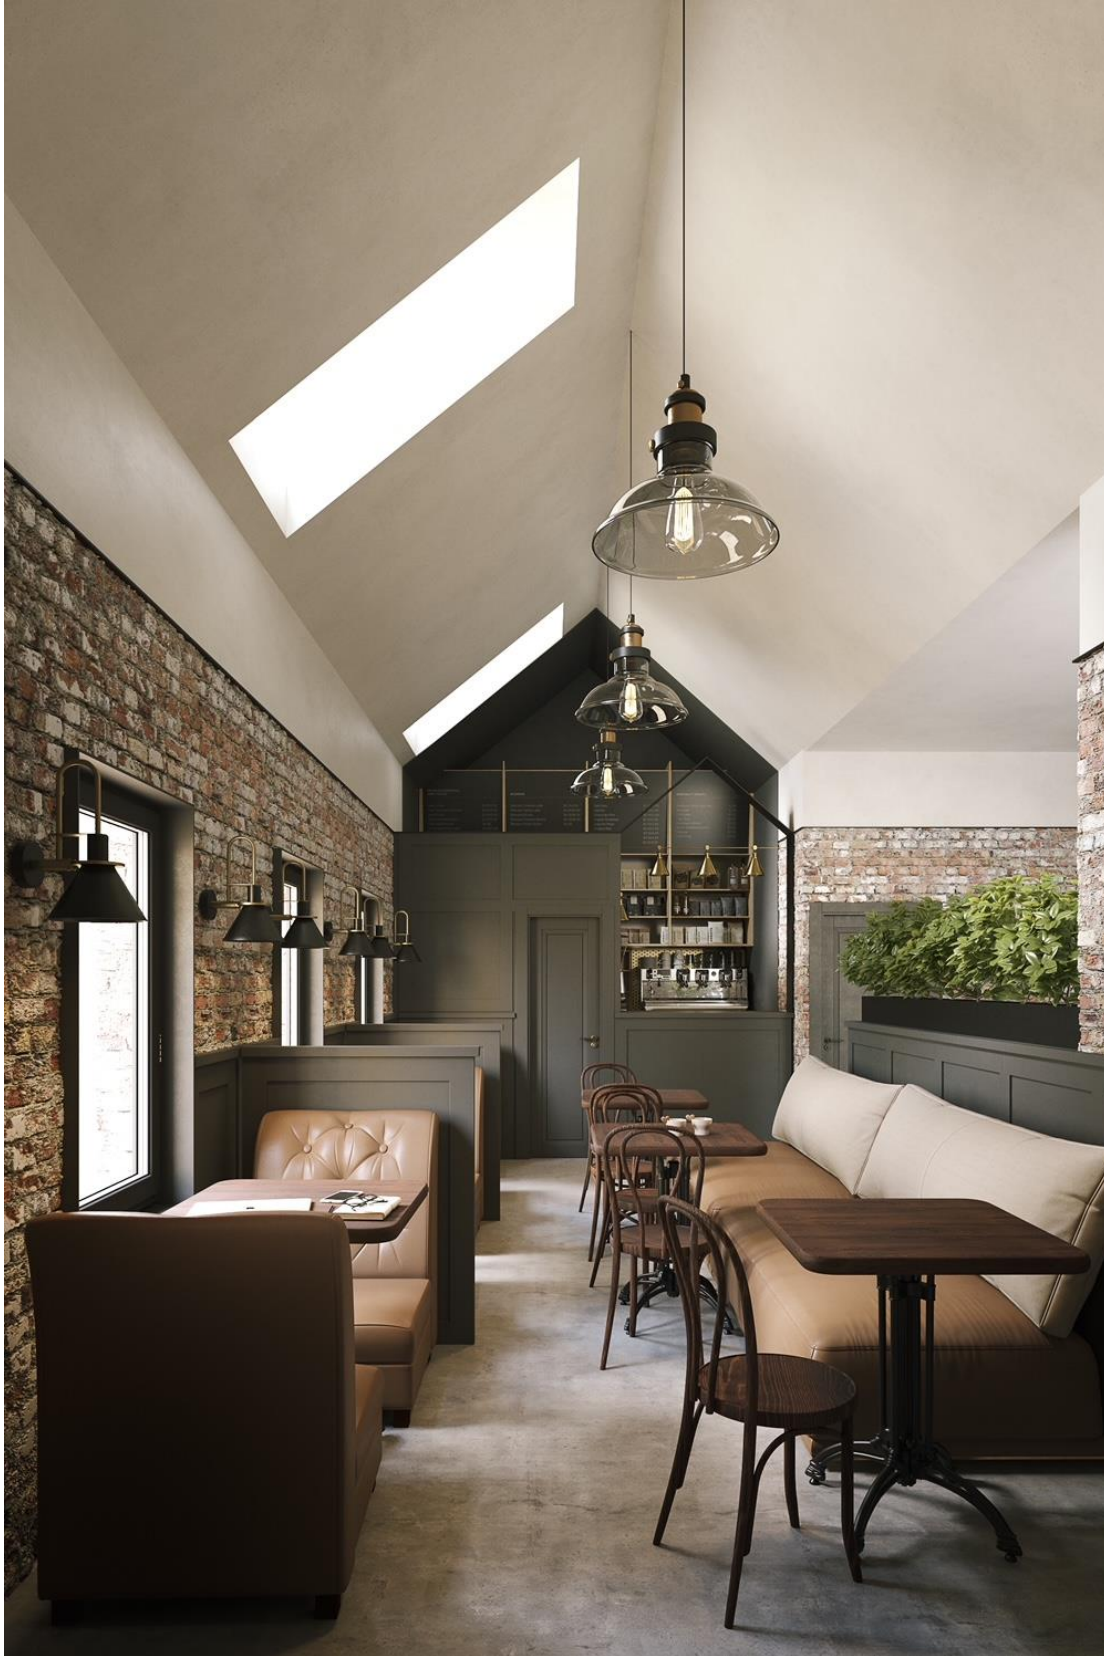
Figure 24: Artists rendering of the Interior perspective suggesting the treatment of the cottage with the interior opened up and serving as an amenity area for the building.

The cottage will be removed from the site while the new apartment is under construction. When placed back on site, it will be set next to the brick semi-detached, be adapted as indoor amenity space that flows into the entrance and elevator foyer. The rear portion of the structure will be demolished and replaced with a masonry accent wall. The second-floor structure within the cottage will be removed creating a cathedral ceiling. The entrance doors have been modified to make them accessible entrances. The stone wall although not a traditional feature, is intended to accentuate the glazed entrance doors to the interior.

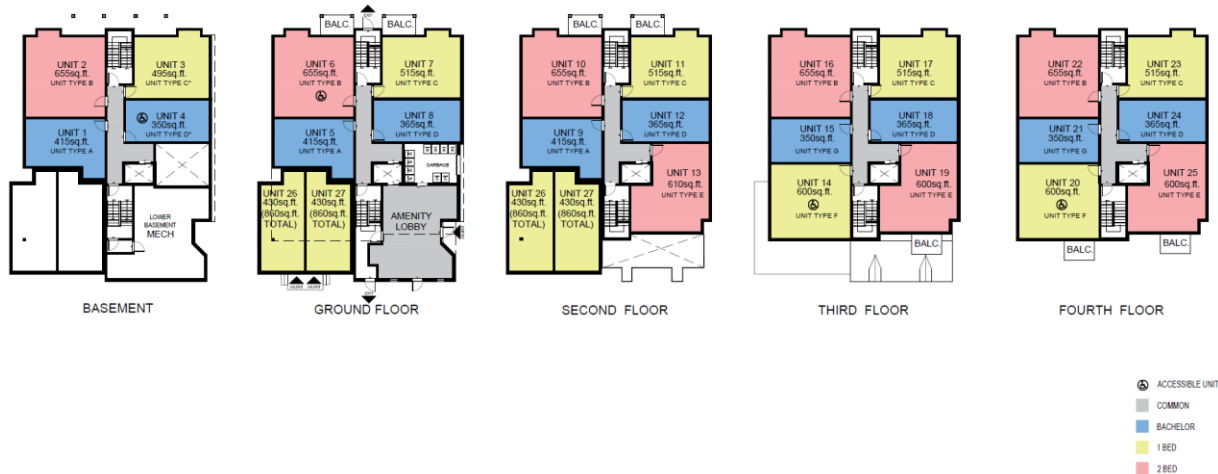
Figure 25: Plan views of the proposed development including the two retained row houses and the infill development behind. The 25 units are colour coded to indicate number of bedrooms. Source: Rosaline Hill Architects Inc. 2022

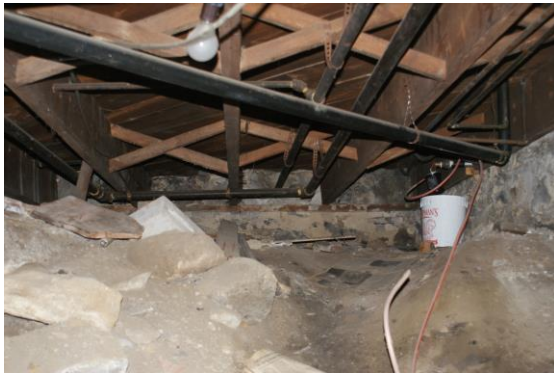
The building has a crawl space that is not accessible from the interior. The interior of the crawl space was visible from the hole adjacent to the entrance. There appeared to be a concrete mass below the wall separating the two units, related to the water and sewer connections.

Figure 26: View documenting the crawl space below the worker's cottage. Source: Commonwealth

The exterior wall sill plate was evident on the west elevation where the asphalt surfacing had eroded adjacent to one of the entrances. The wall thickness below the sill plate measured approximately 12" thick; an 8" timber sill plate with an accumulation of various exterior finishes that measures 4" in thickness. The exterior finishes include the vinyl siding applied to strapping; pebble dash stucco applied to an expanded metal lath; and strapping applied to the exterior board sheathing secured to the timber frame structure. The exterior walls excluding the interior and exterior finishes measured 6" in thickness which would be consistent with a timber frame structure.

The existing foundations below the small cottage will have to be raised and a new foundation inserted below the small cottage. The building will have to be moved to facilitate the proposed new infill development behind the two buildings, and to facilitate the construction of a new foundation.

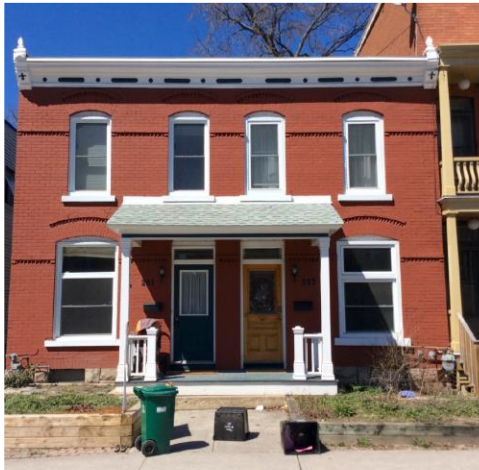
Figure 27: Elevation of 281-283 Clarence illustrating many of the same features. Built in 1898 in an Italianate style including two storey, flat roof, double entrance doors, corbelled brick banding, arched headed windows scaled between ground and second floor, masonry foundation, painted red brick and heavy metal cornice. Source City of Ottawa inventory.
