Phase One Environmental Site Assessment

187 Boteler Street
Ottawa ON K1N 0A4

September 18, 2023

Project No.: 122151611

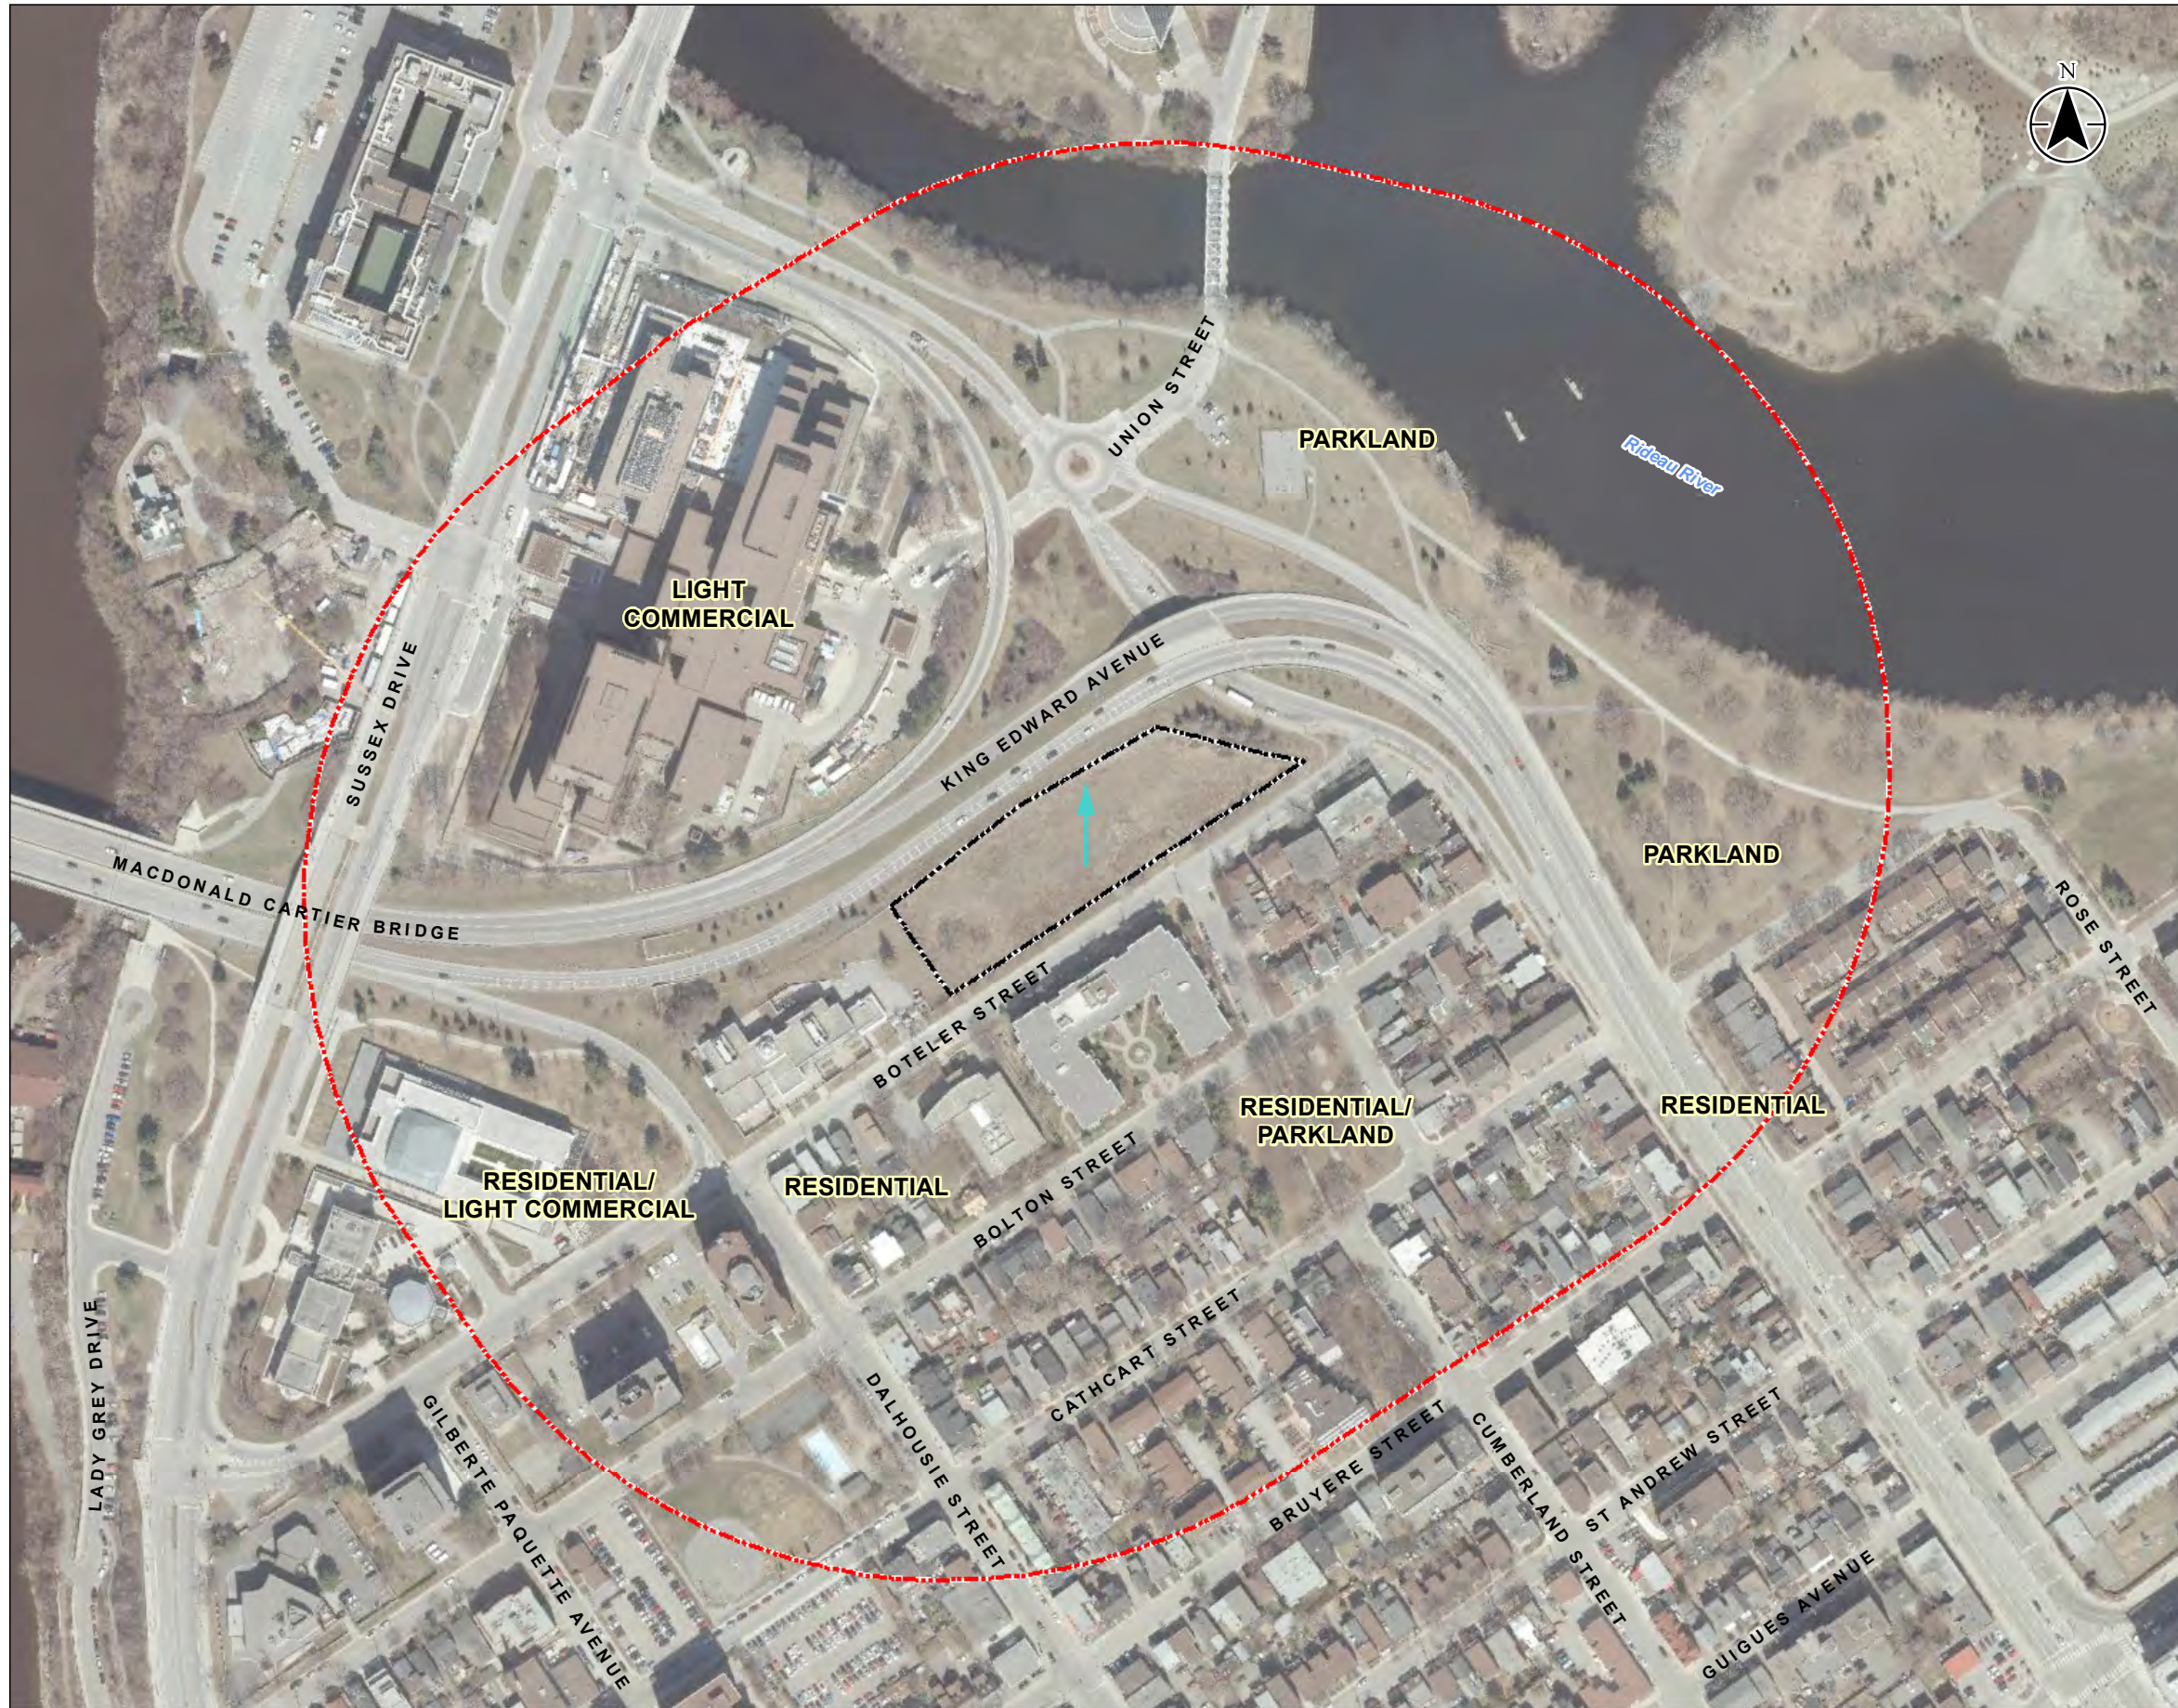
Title: Site Plan and Surrounding Land Use

Area of Potential Environmental Concern (APEC)	Location of APEC	Potentially Contaminating Activity (PCA)	Location of PCA	Contaminants of Potential Concern	Media Potentially Impacted
1	Across entire Phase One Property	30 - Importation of Fill Material of Unknown Quality	On-Site	PAHs PHCs Metals and Inorganics PCBs VOCs	Soil Groundwater
2	Northeast corner	Former coal storage area, based on QP _{ESA} opinion this is a PCA, even though the MECP did not assign it a PCA number	On-Site	PAHs PHCs BTEX Metals and Inorganics	Soil Groundwater

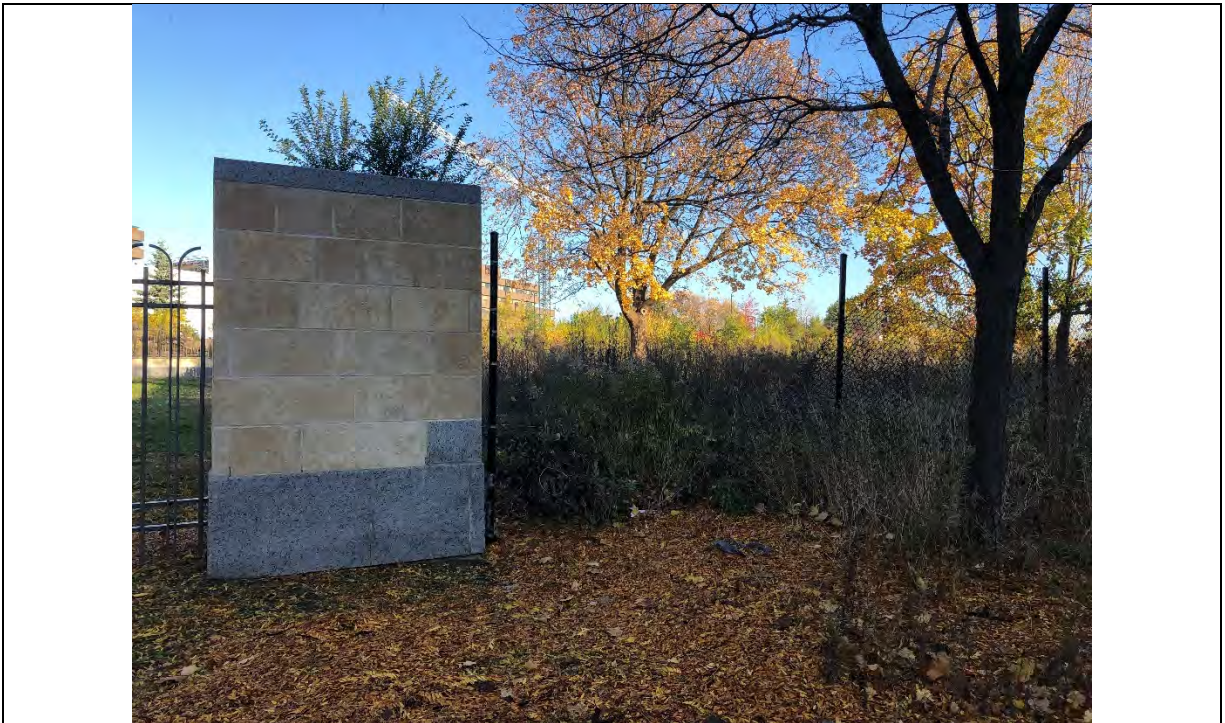
Photo 004 Damaged fence at the southwestern corner of the Phase One Property, facing north

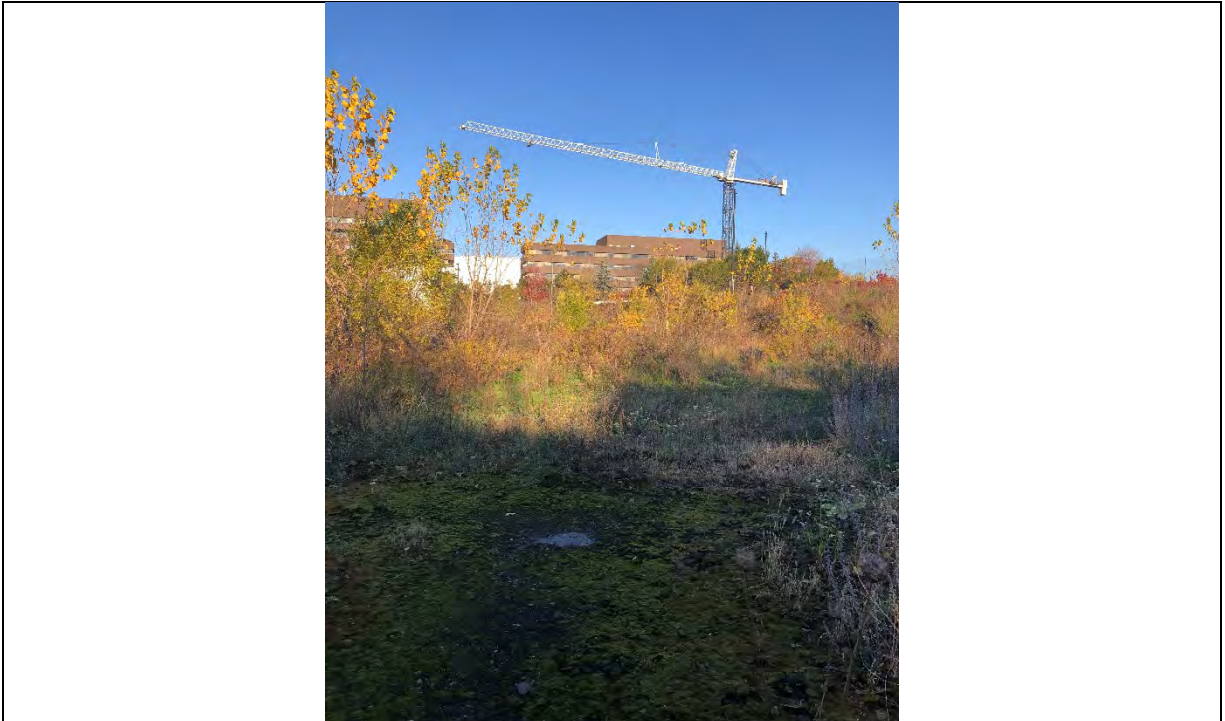
Photo 007 View of the Phase One Property from the Site entrance showing overgrown vegetation with Government of Canada Building at 125 Sussex Drive in the background, facing northeast

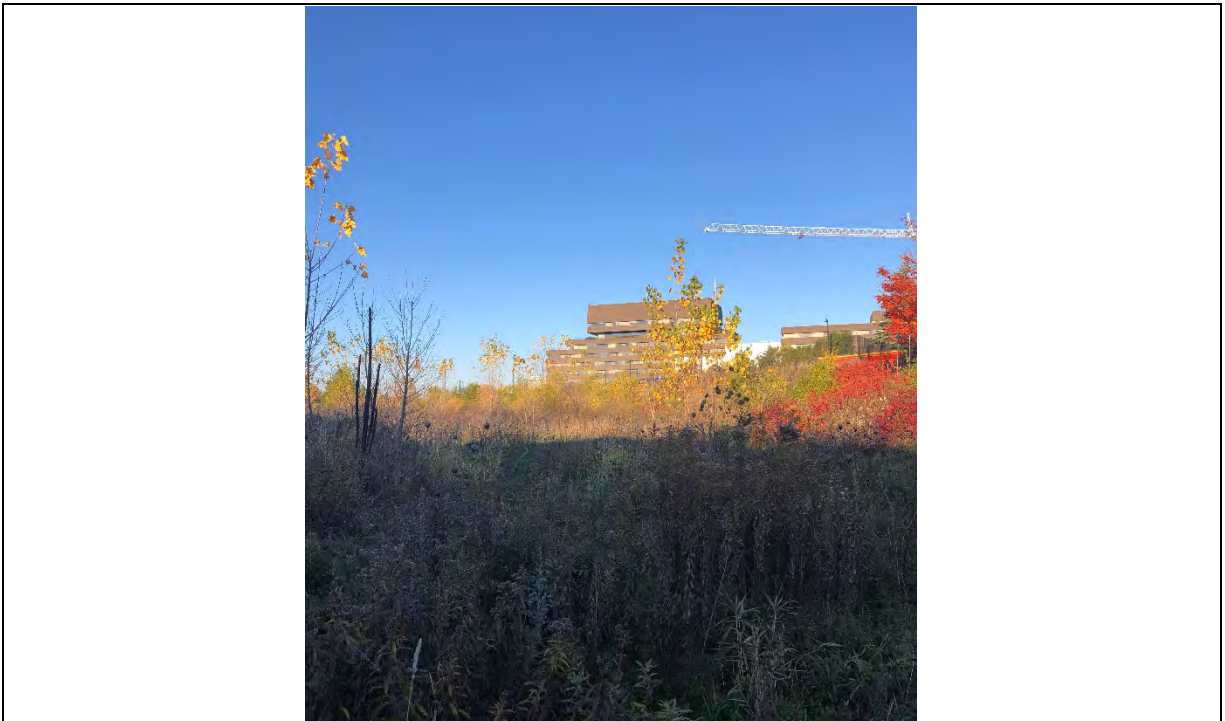
Photo 008 View of the Phase One Property showing overgrown vegetation from the southeastern corner of the Site, facing northwest

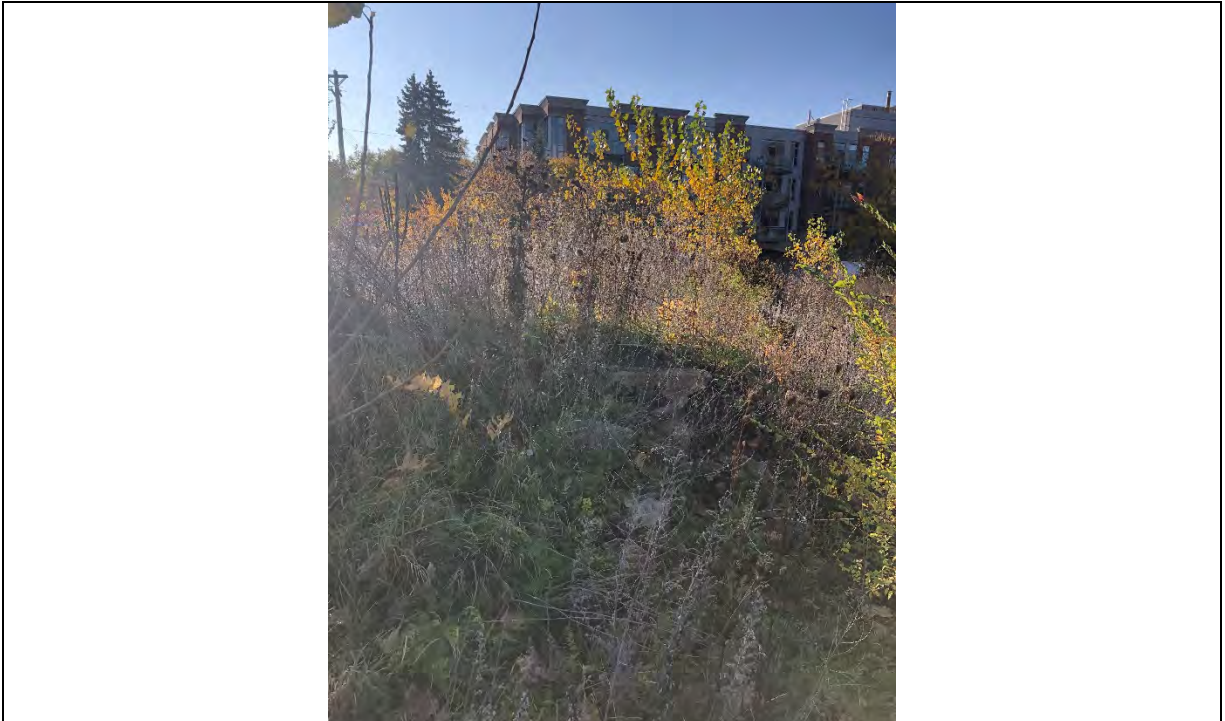
Photo 009 View of piled debris covered by overgrown vegetation near the centre of the Phase One Property, facing south

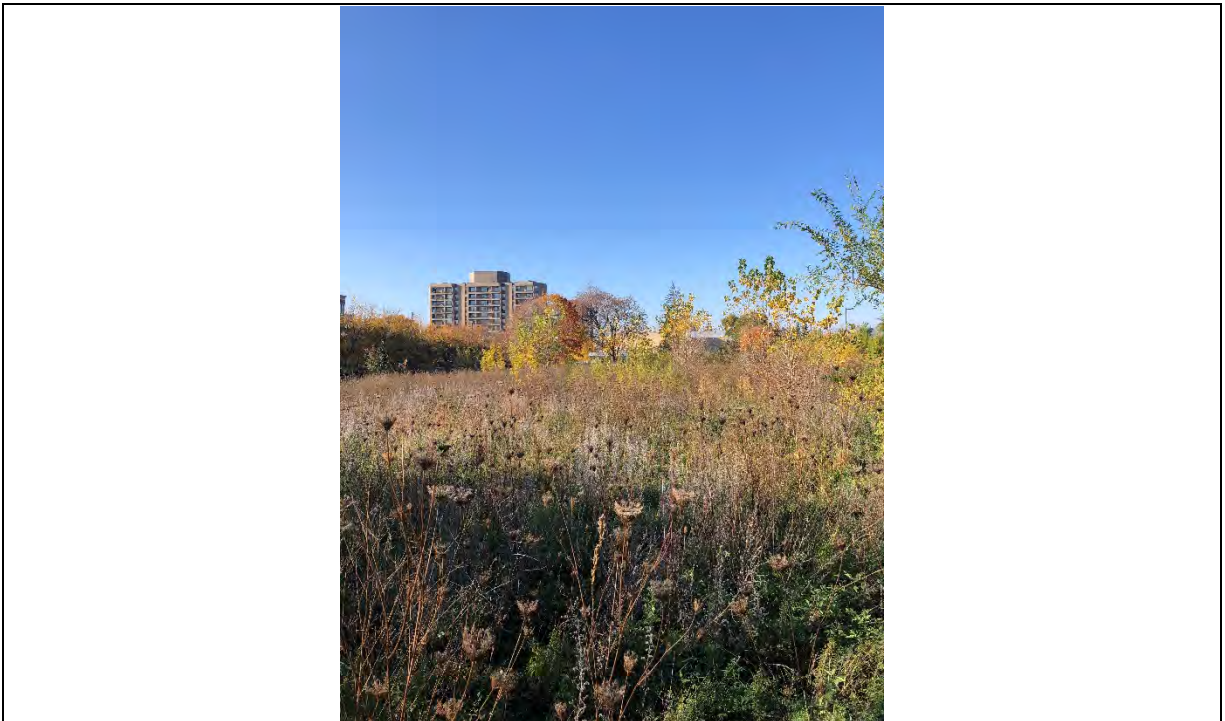
Photo 010 View of the Phase One Property with overgrown vegetation from the eastern portion of the Site, facing west. The Rideau Falls Apartments located at 110 Boteler Street can be seen in the background.

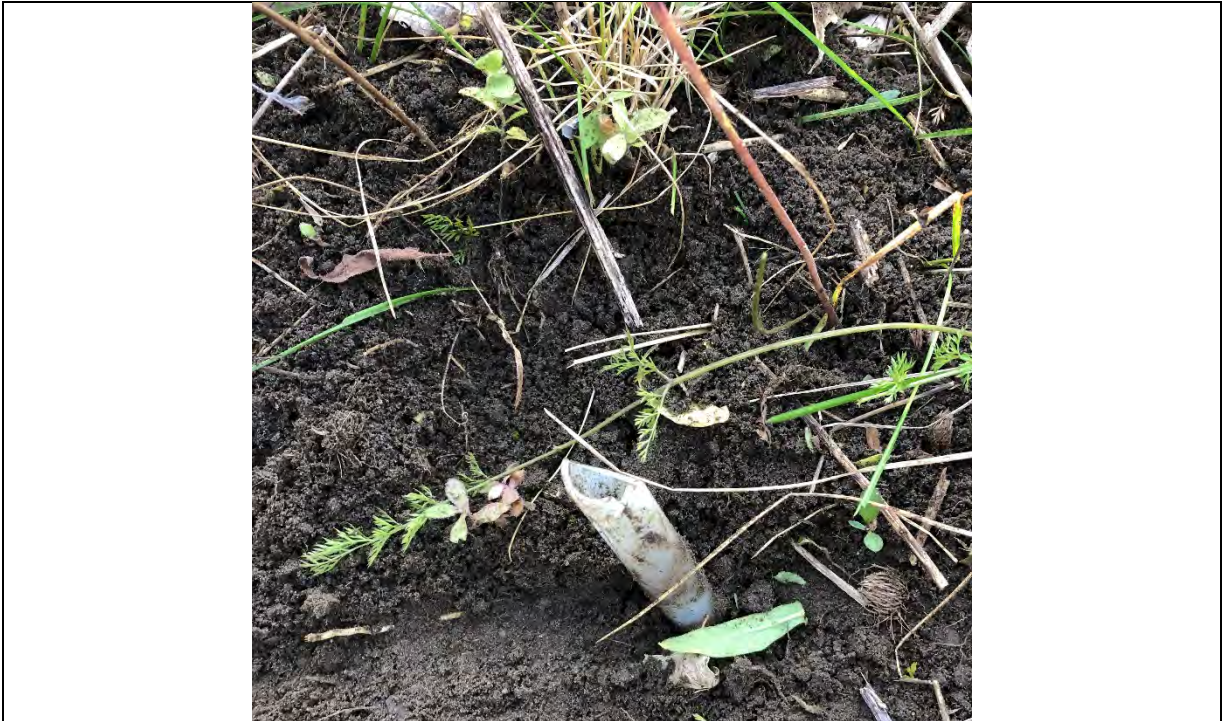
Photo 011 View of Waterra tubing at a destroyed monitoring well location at the Site with no visible well casing, roadbox or monument cover
