Phase One Environmental Site Assessment

1971 and 1975 St. Laurent Boulevard
Ottawa, Ontario

Pinchin File: 313334

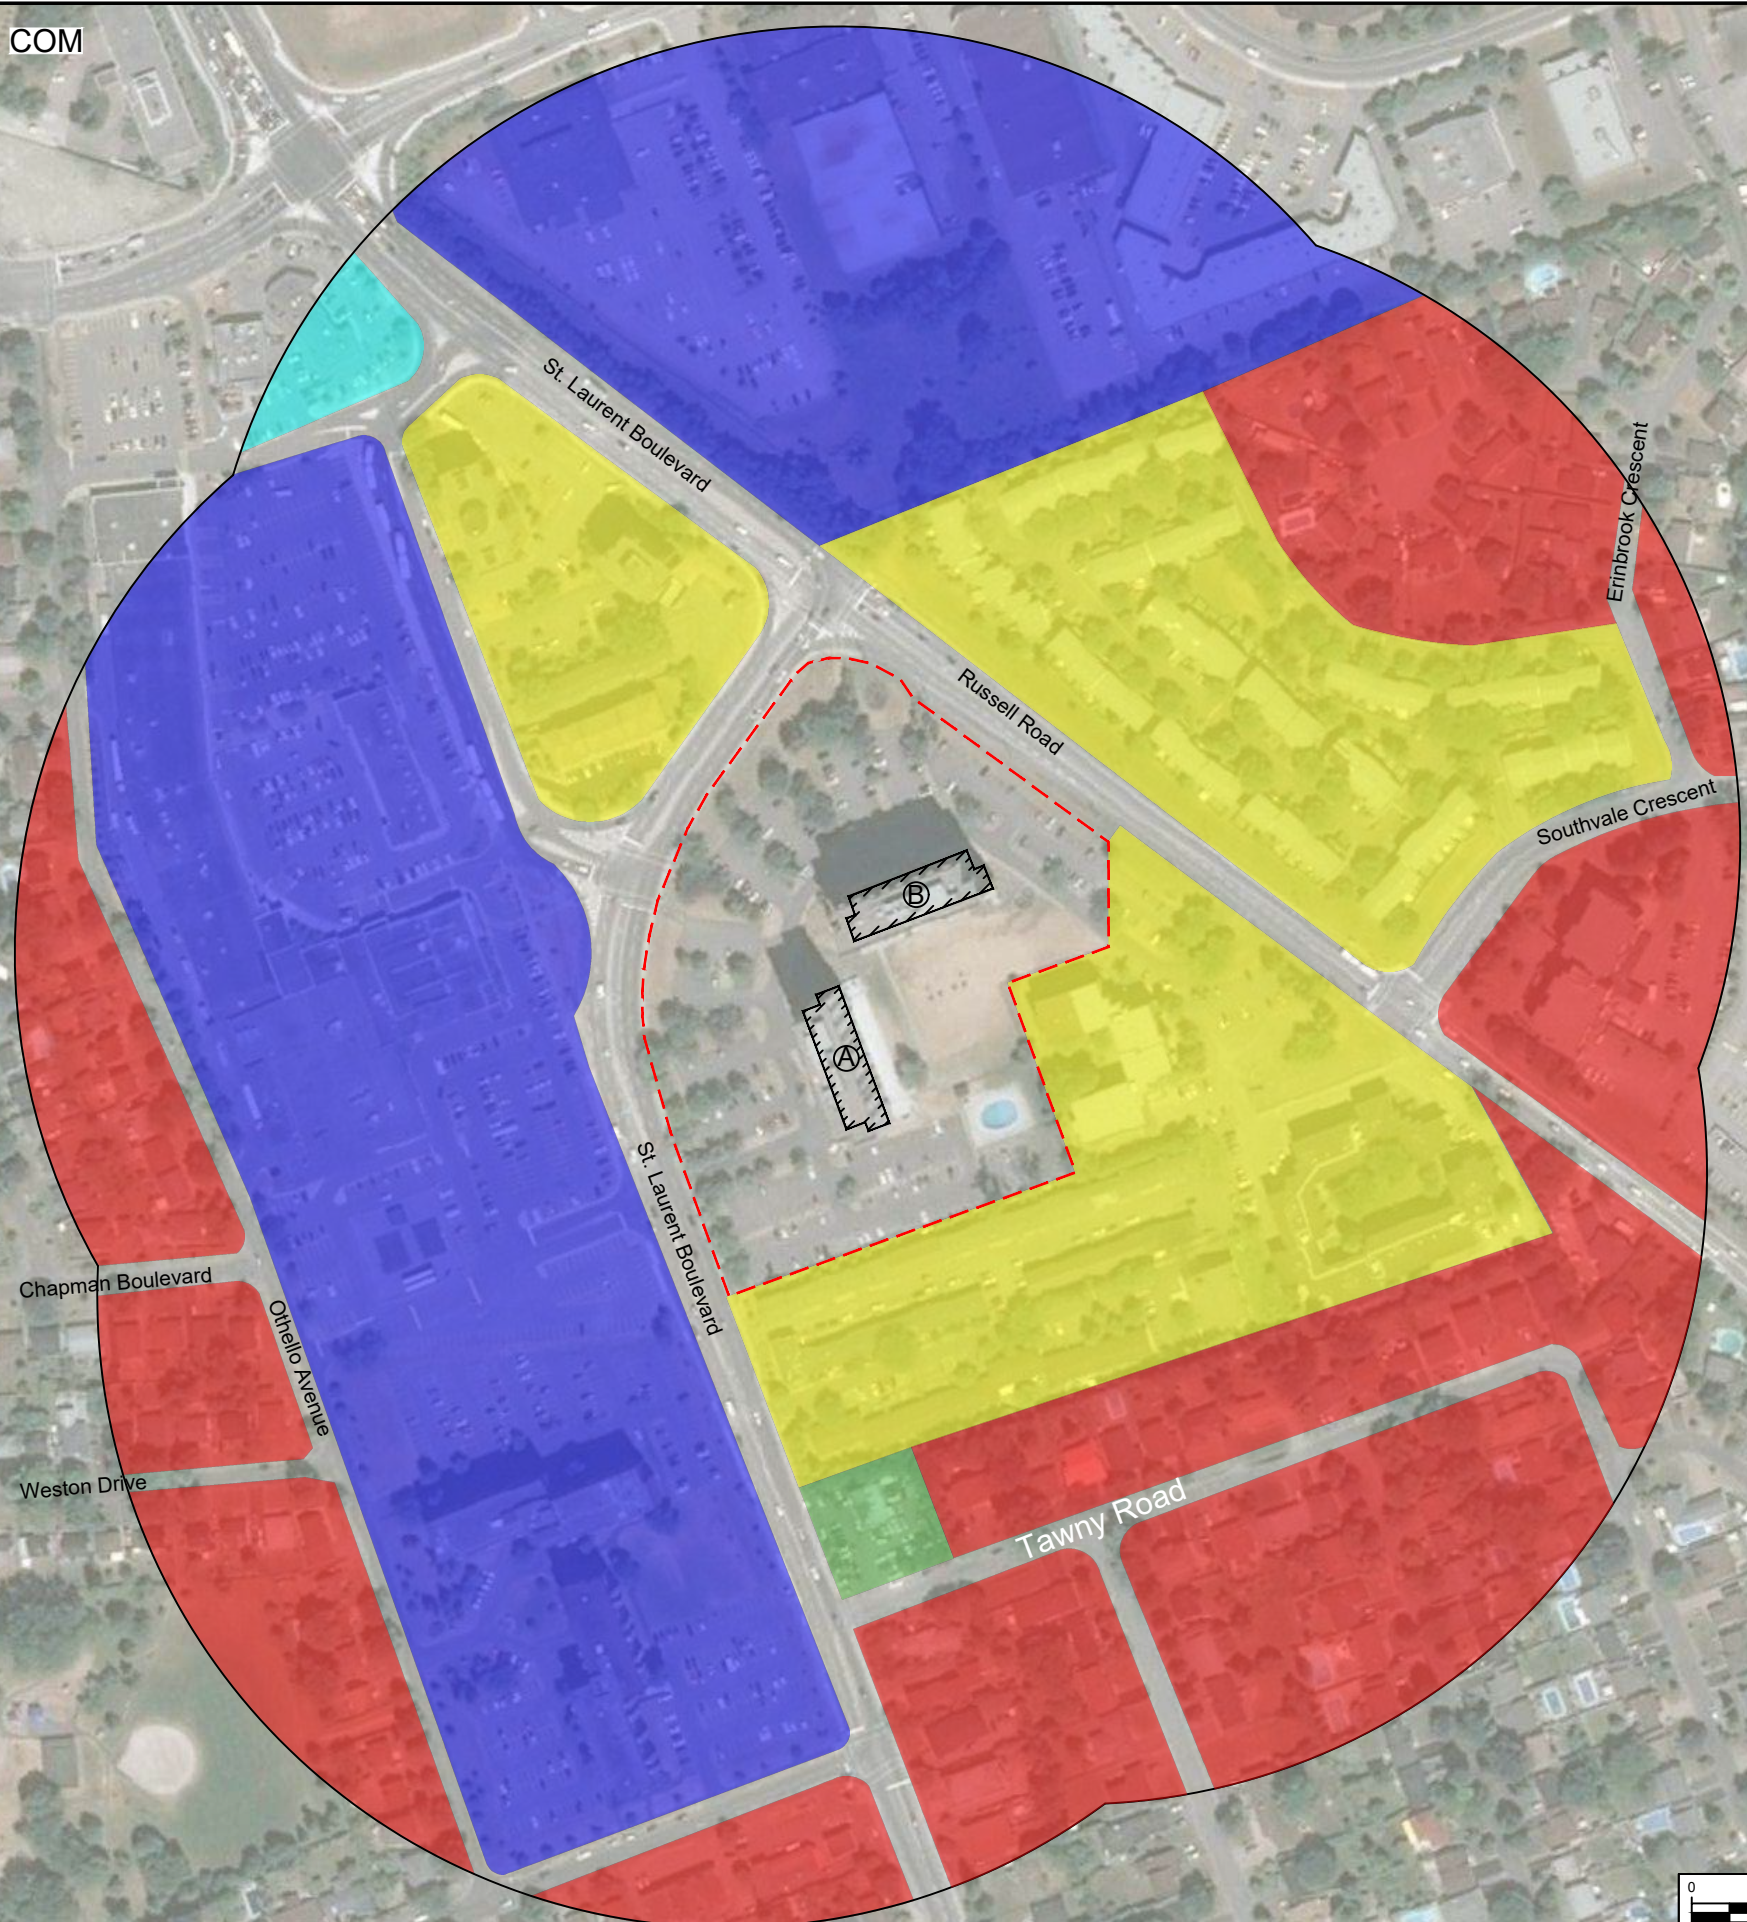
PROJECT NUMBER: 313334	SCALE: AS SHOWN
DRAWN BY: KL	REVIEWED BY: AK
DATE: AUGUST 2022	FIGURE NUMBER: 2

FIGURE NAME: SITE AND SURROUNDING LAND USE PLAN

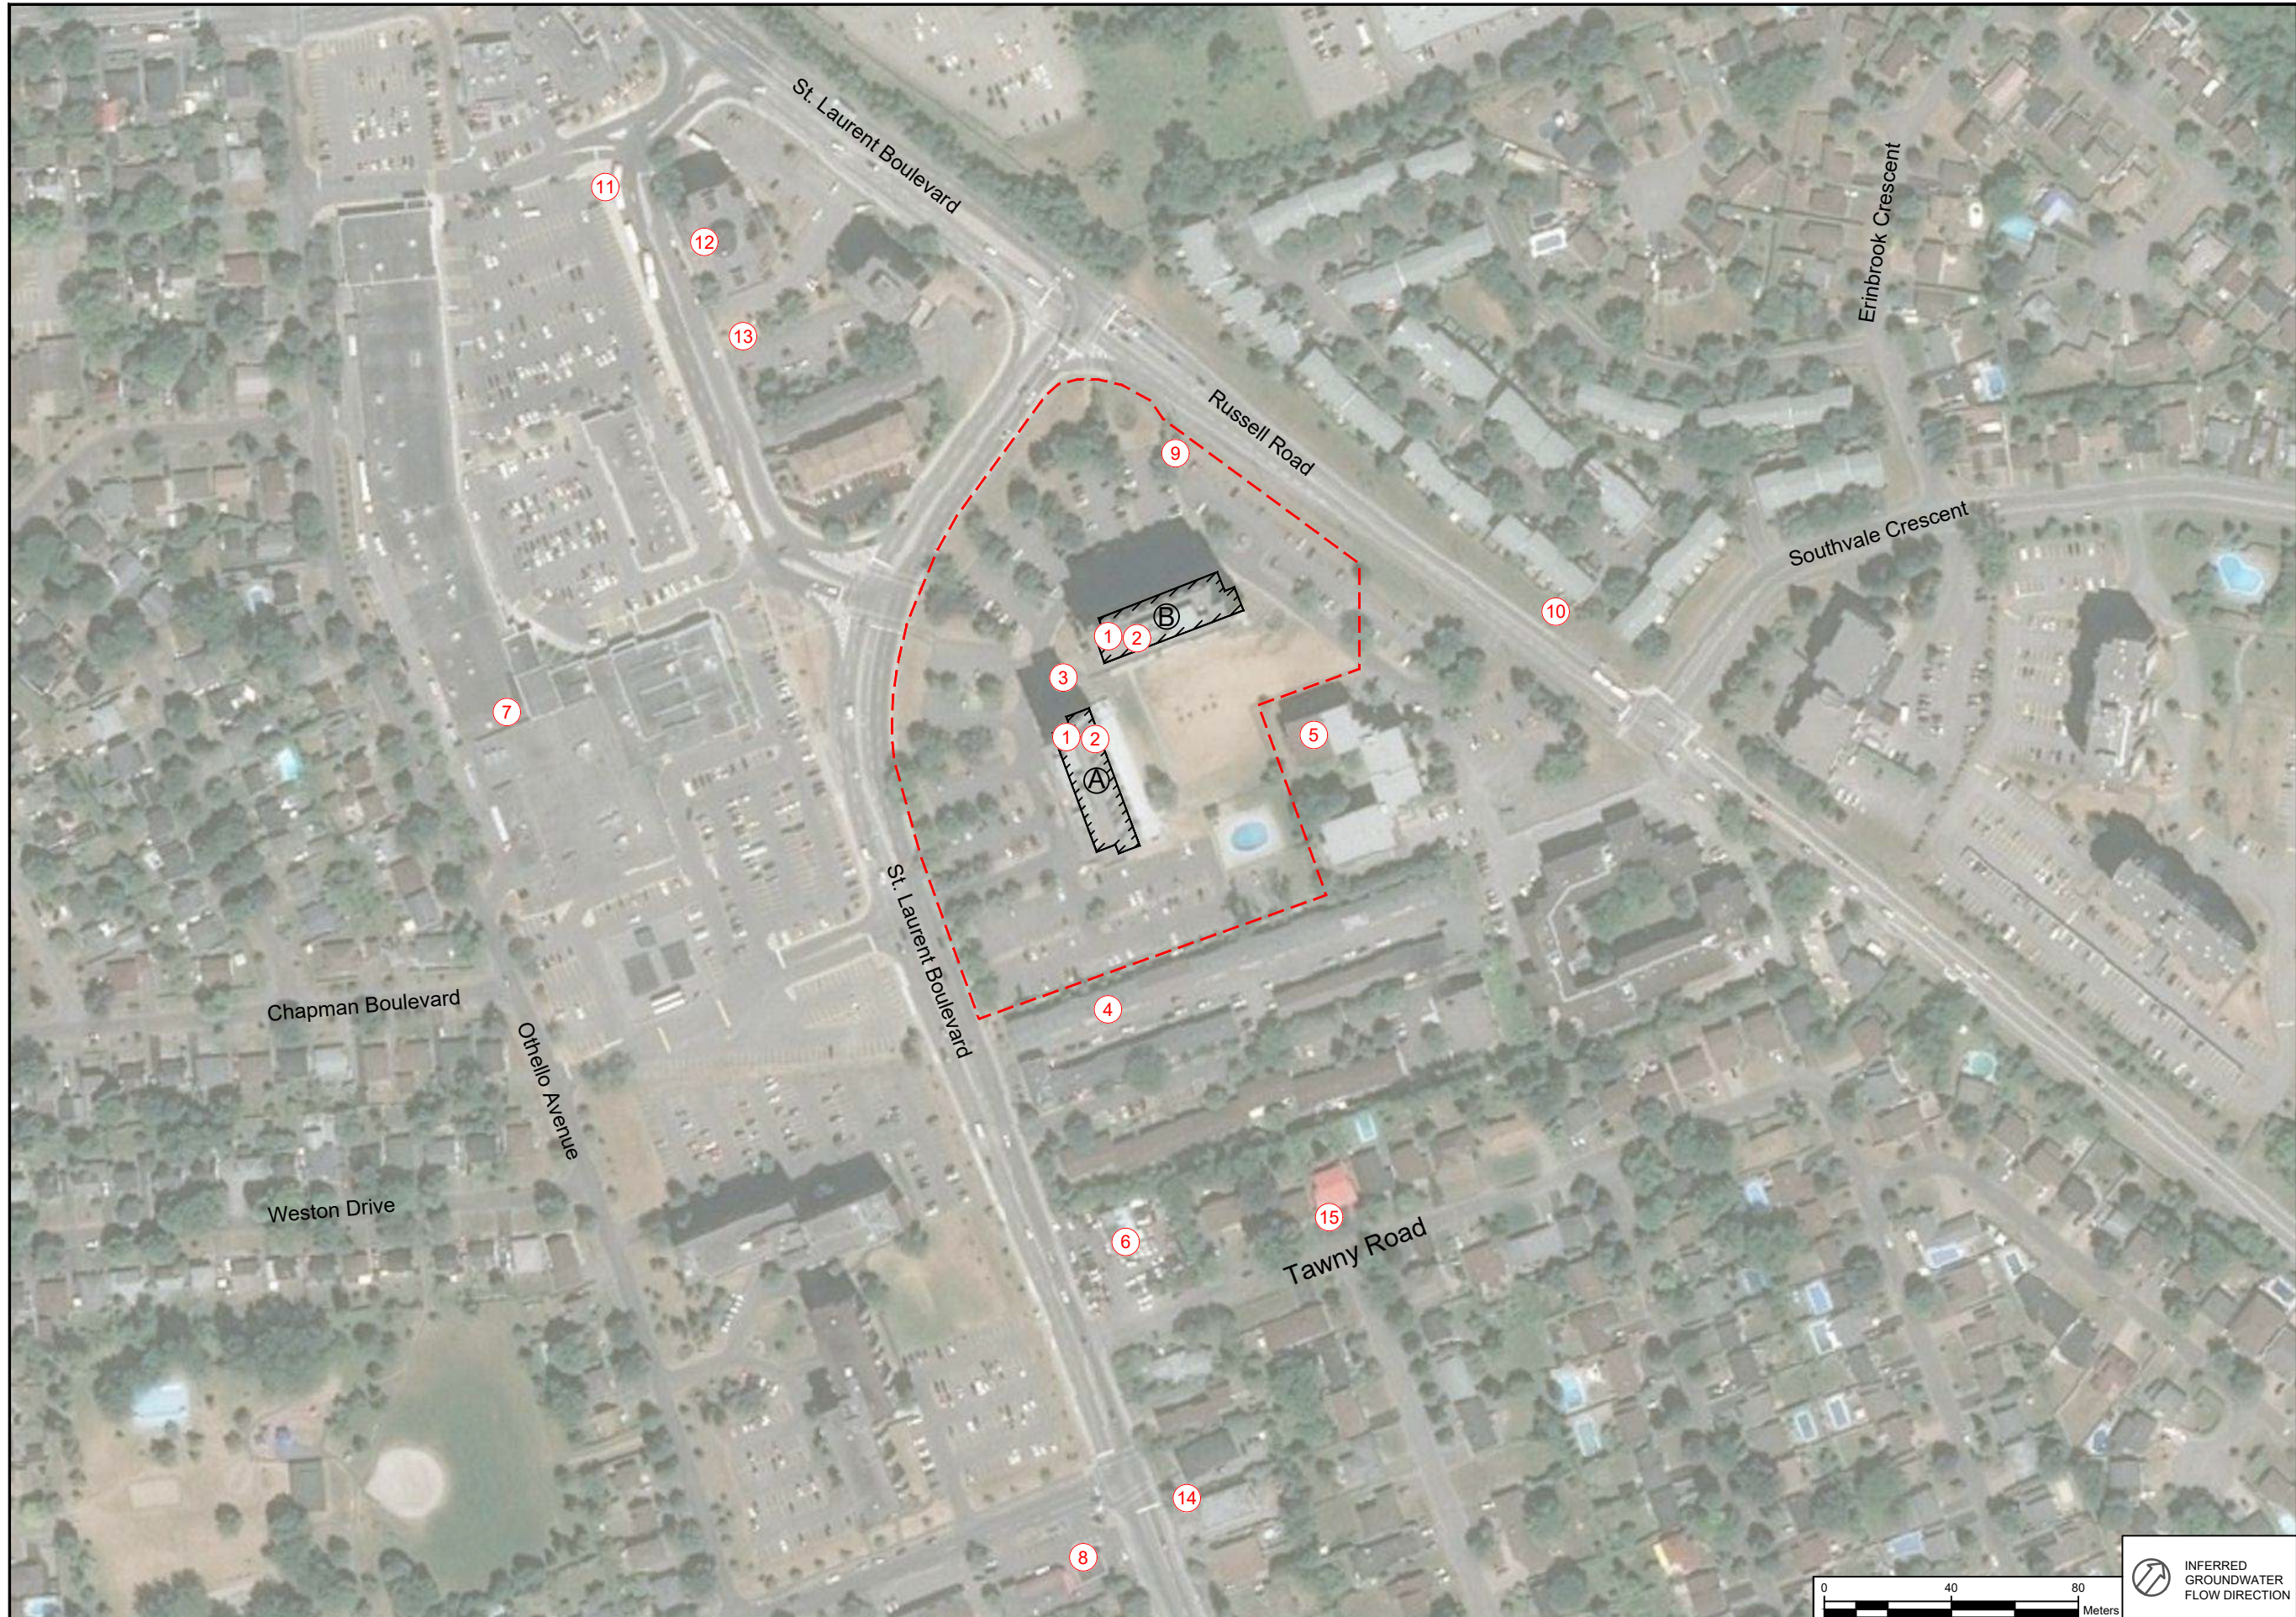
INFERRED GROUNDWATER FLOW DIRECTION

Based on general hydrogeological principles and Pinchin's familiarity with subsurface conditions at and near the Phase One Property and the surrounding properties within the Phase One Study Area, the unconfined groundwater beneath the Phase One Property is expected to flow in an east direction. The nearest surface water body is Greens Creek, located approximately 1.5 kilometres (km) northeast of the Phase One Property at an elevation of approximately 80 mamsl.

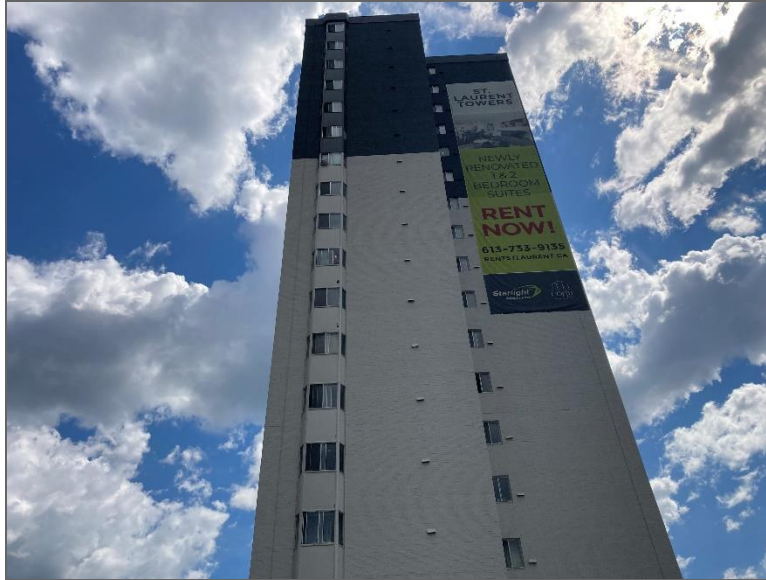
Photo 1 – Site Building A (northwest elevation).

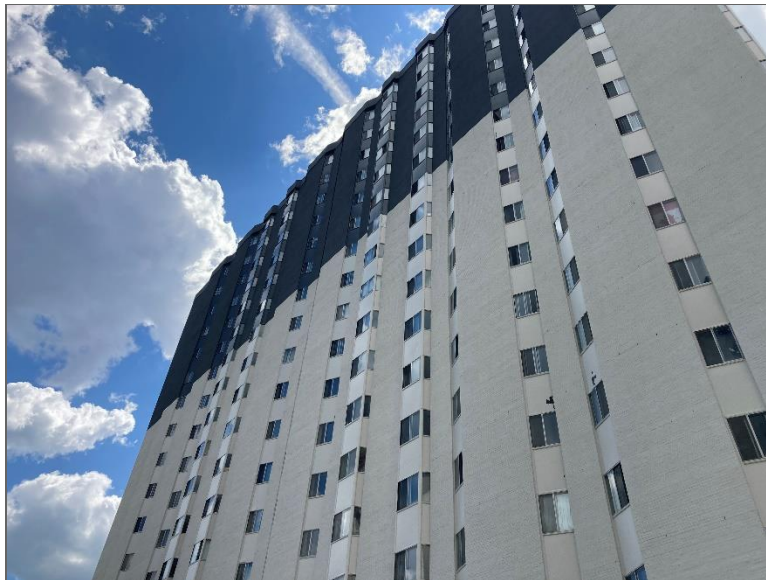
Photo 2 – Site Building A (northeast elevation).

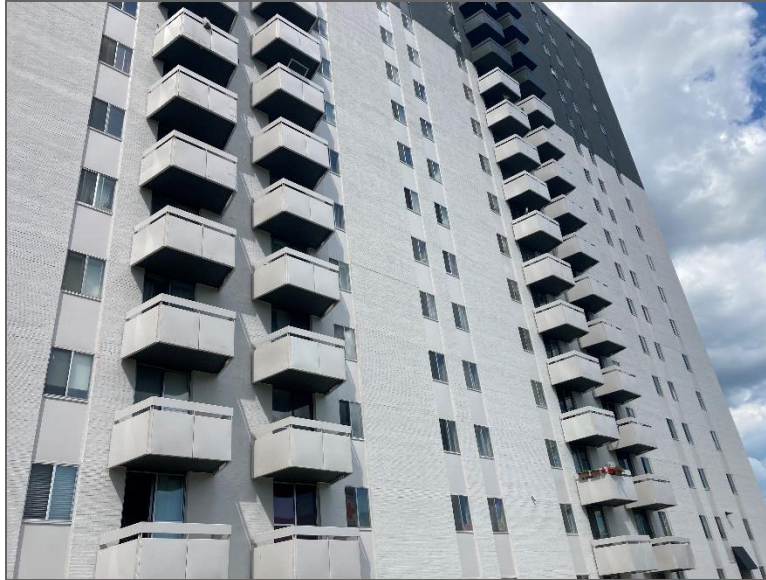
Photo 3 – Site Building B (southeast elevation).

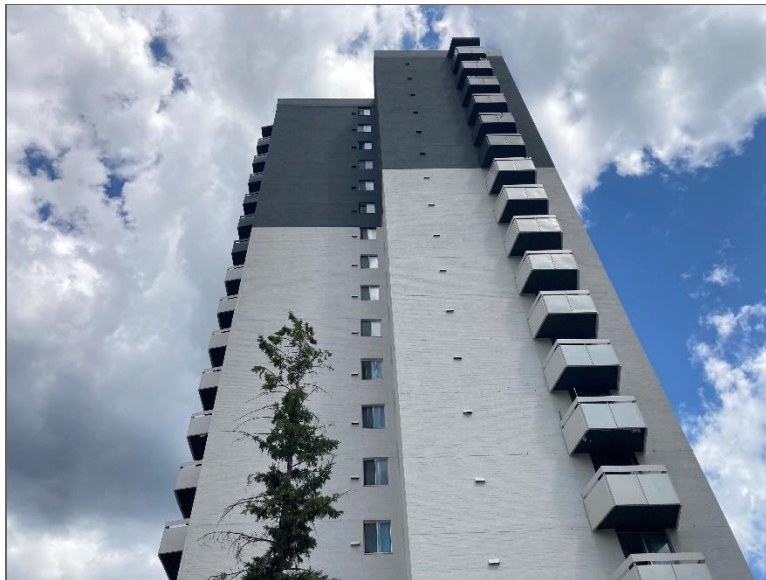
Photo 4 – Site Building B (southwest elevation).

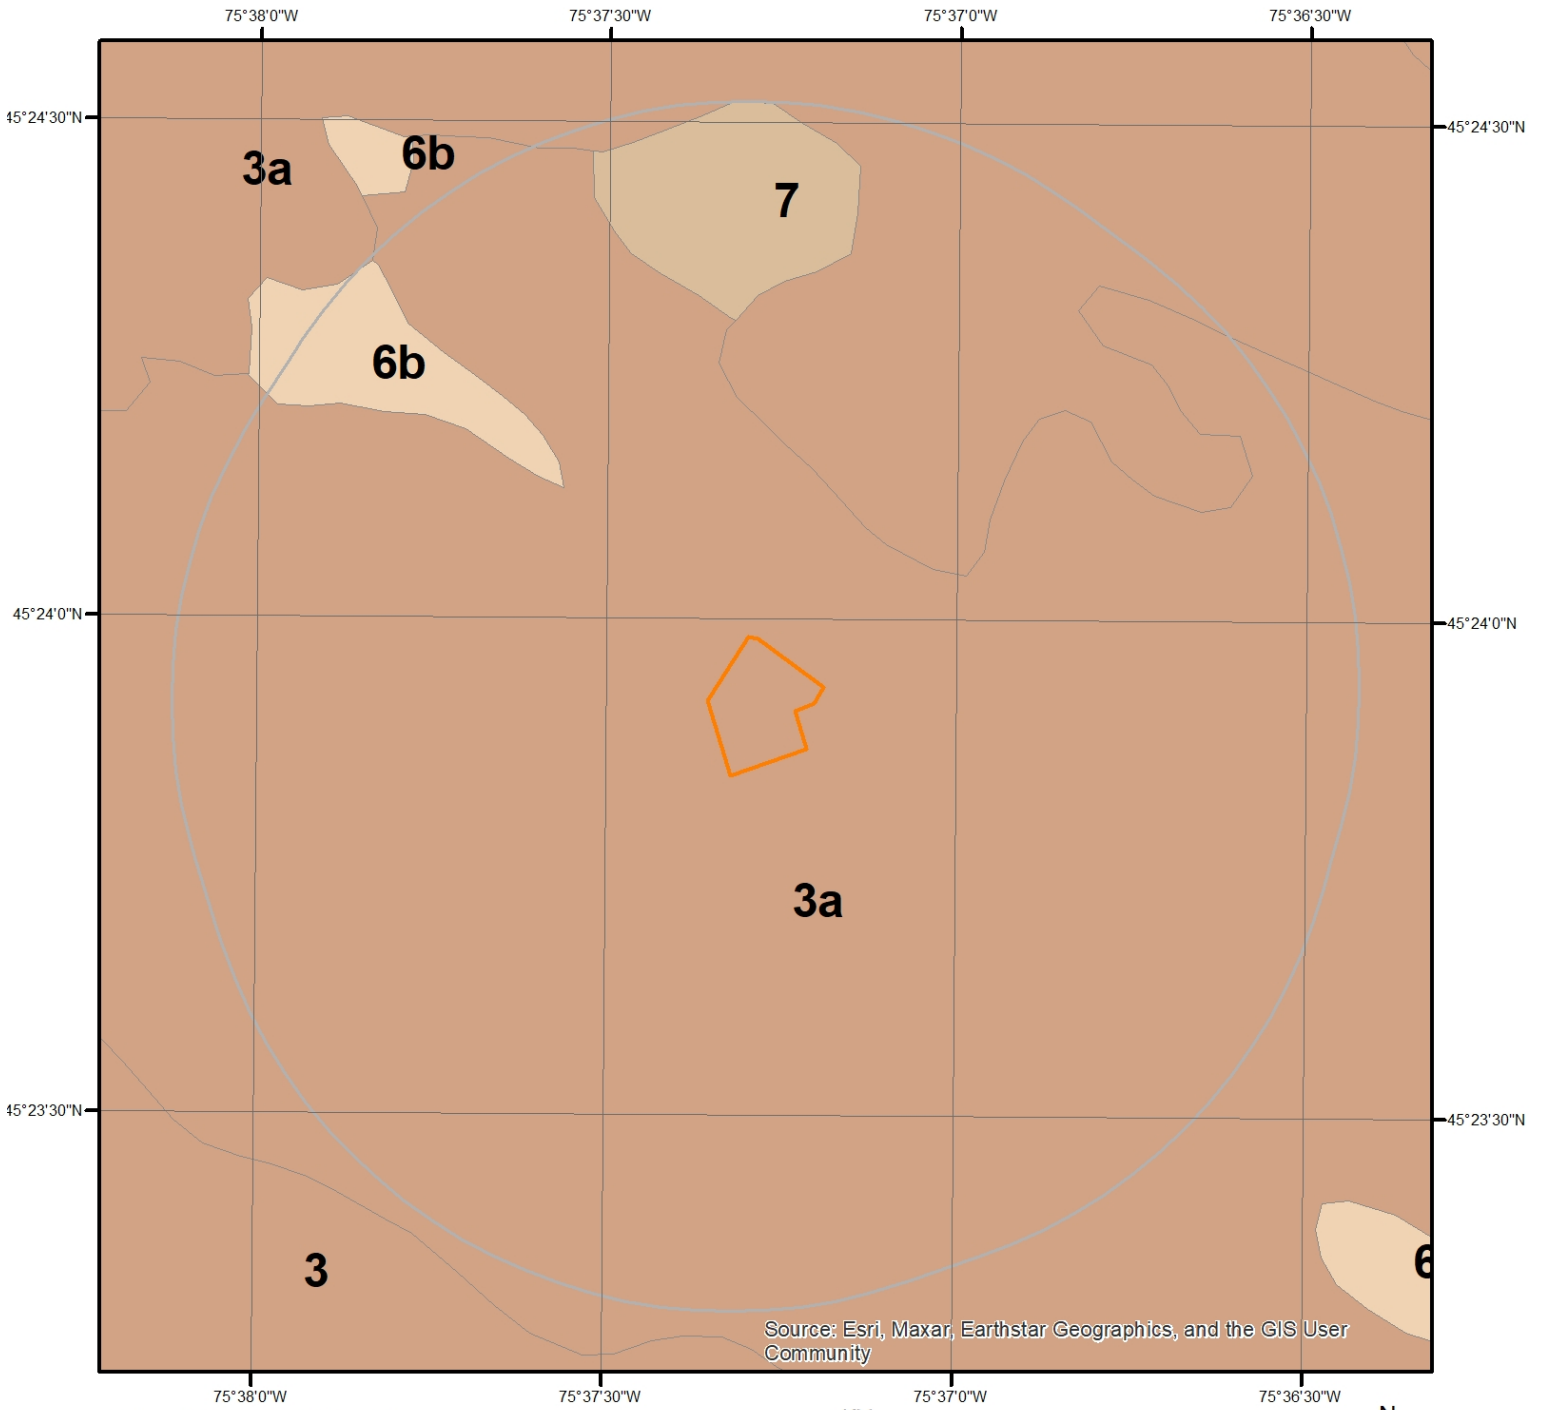
4.3.5 Well Records

6.1 General Requirements

A review of the available physiographical data indicates that the Phase One Property and the surrounding properties located within the Phase One Study Area are located within alluvial deposits consisting of stratified gravel, sand, silt and clay. Bedrock is expected to consist of sedimentary rocks consisting of limestone, dolomite, shale, argillite, sandstone, quartzite, and/or grit. The topography is considered to be mainly flat to rolling low local relief with dry surface water drainage conditions.
