# HYDROGEOLOGICAL ASSESSMENT AND TERRAIN ANALYSIS, CORKERY COMMUNITY CENTRE, 3447 OLD ALMONTE ROAD, OTTAWA, ON

Project No.: CCO-21-3339-01

McIntosh Perry ('MP') was retained by the City of Ottawa ('the Client') to conduct a Scoped Hydrogeological Assessment and Terrain Analysis in support of the City of Ottawa Site Plan Approval (SPA) process for the construction of an addition to the Corkery Community Centre, located at 3447 Old Almonte Road, Ottawa, Ontario (collectively referred to as 'the Site').

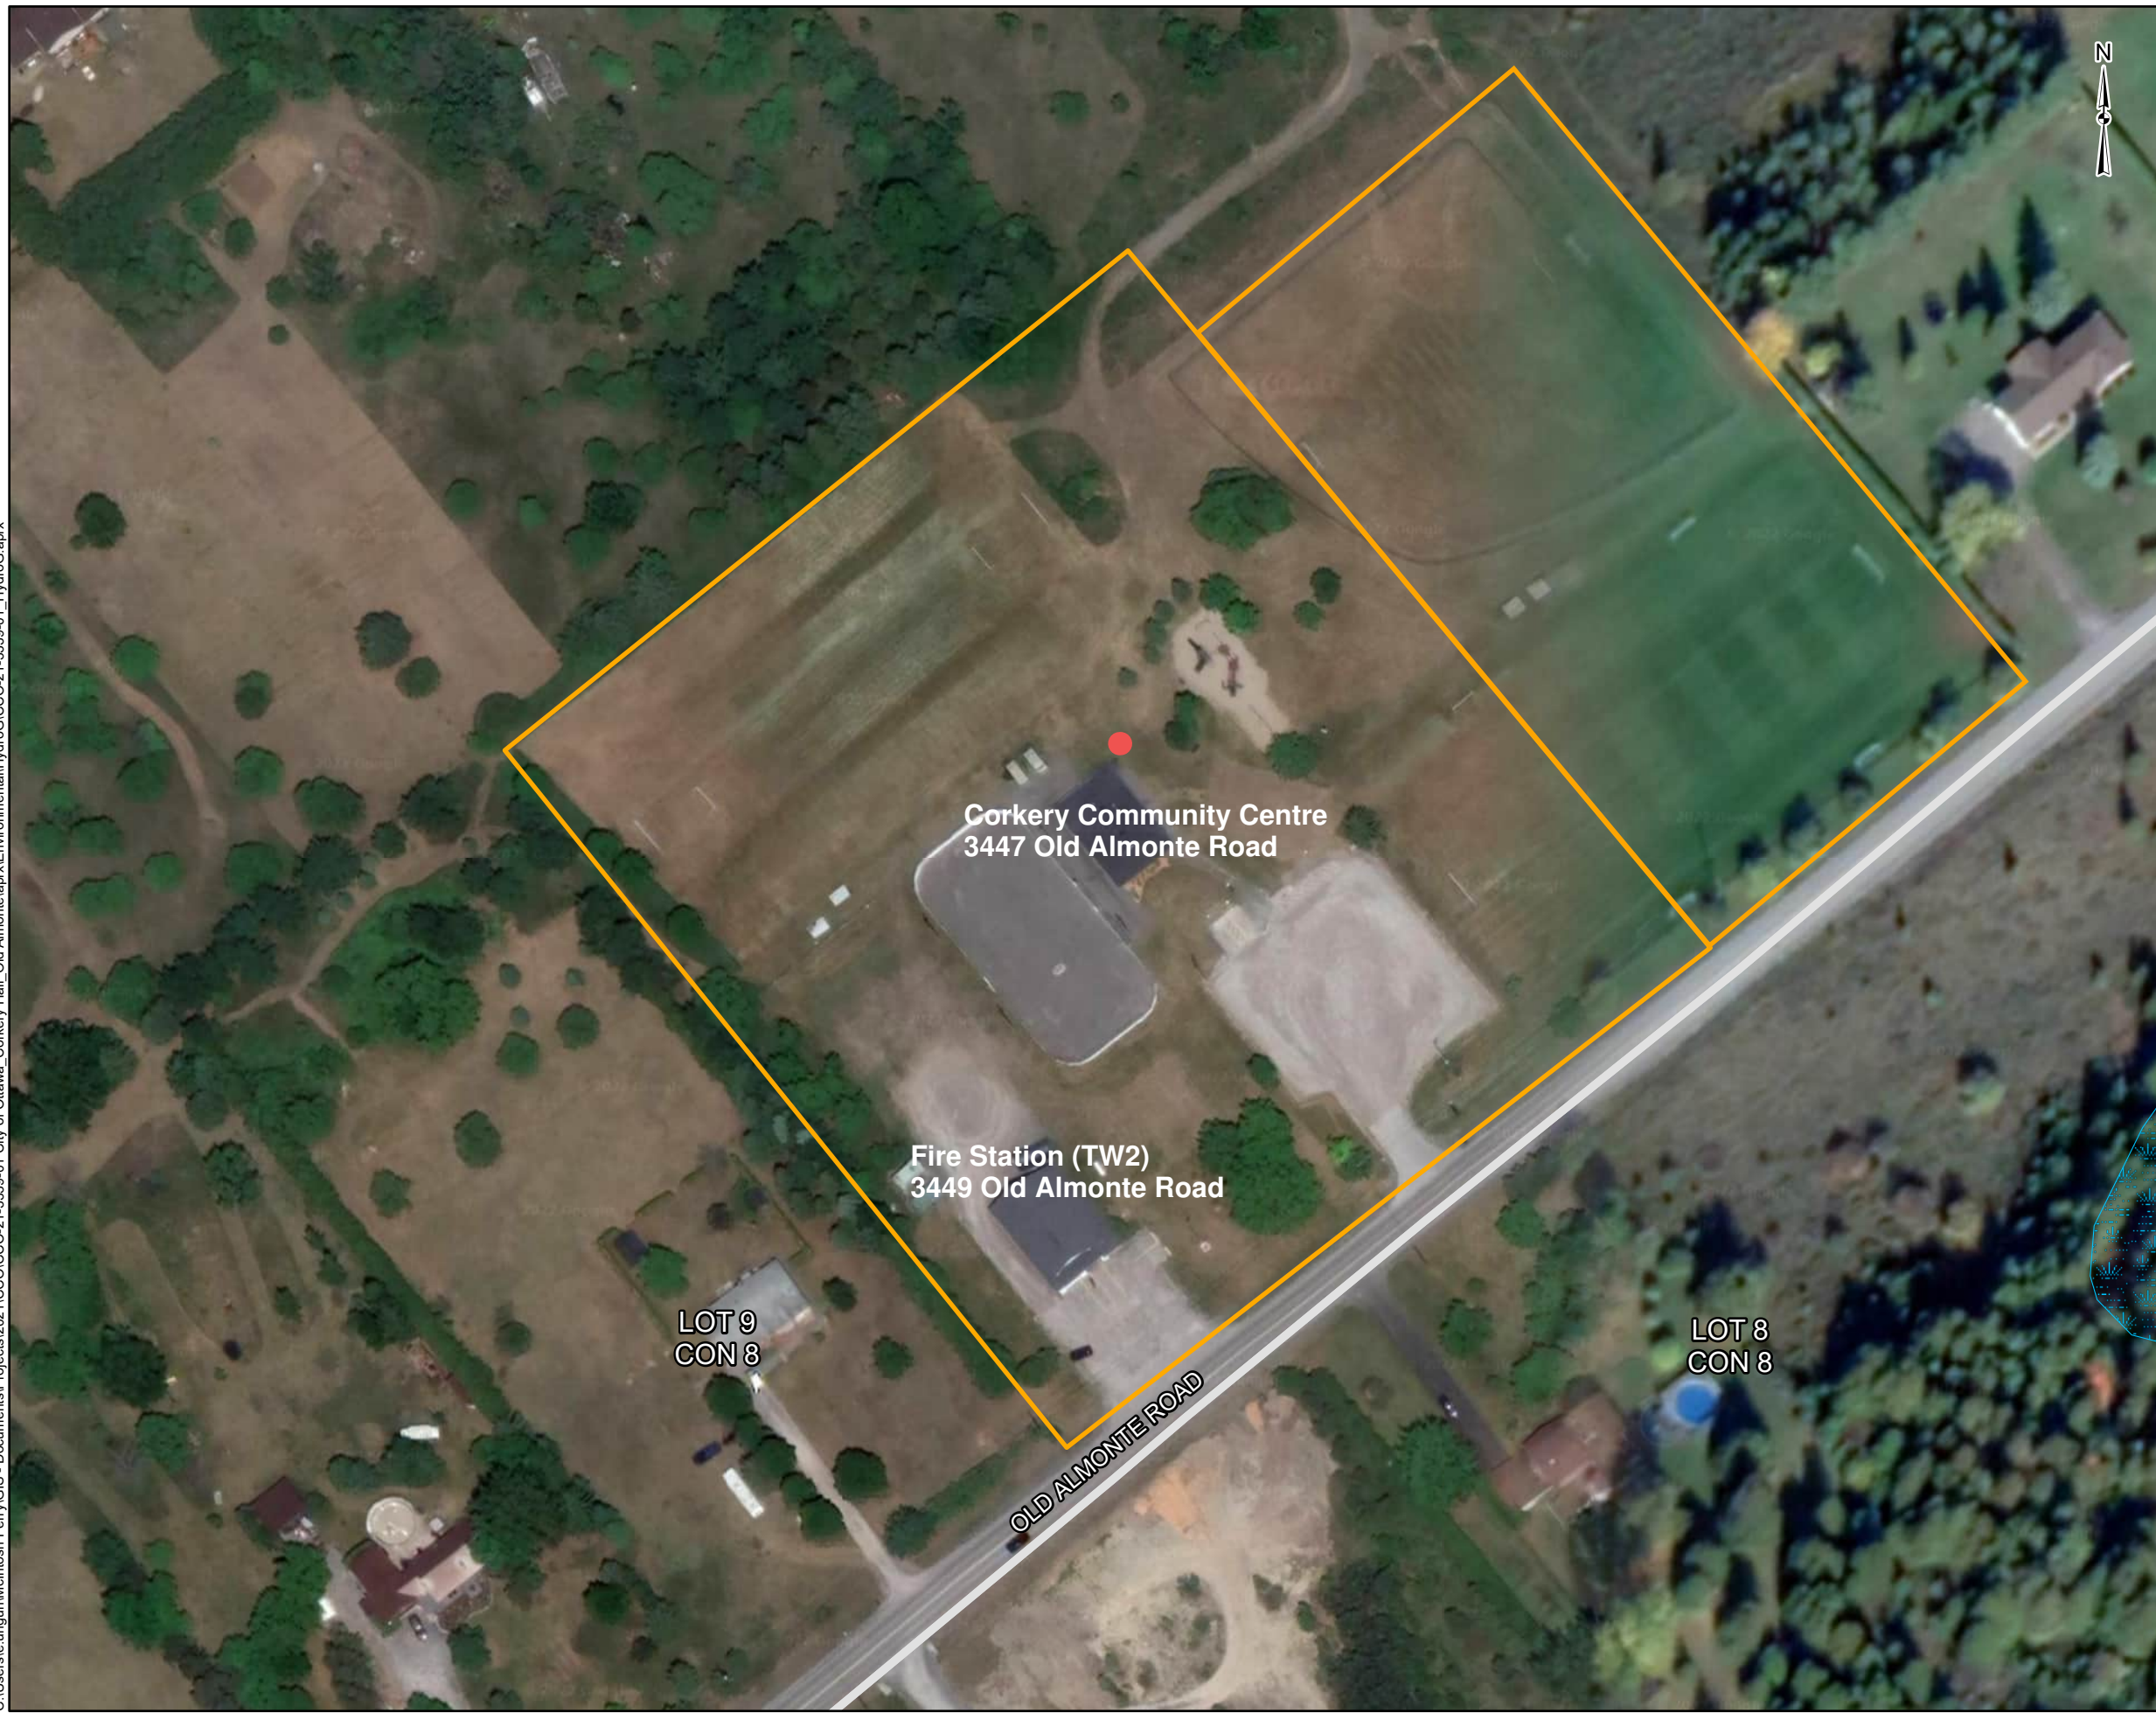
At the present time, the Site is occupied by the Corkery Community Centre. At the time of investigation, on-Site conditions consisted primarily of one building, an outdoor skating rink, a play structure, and three soccer fields. Based on a review of aerial photographs (GeoOttawa), it appears that the Site was developed between 1991 and 1999. *It should be noted that Ontario Parcel data available on public provincial online mapping as well as the City of Ottawa's GeoOttawa GIS online mapping service suggest that the property parcel containing the Corkery Community Centre also encompasses Ottawa Fire Station 84 even though both facilities have separate entrances on Old Almonte Road as well as individual civic addresses. McIntosh Perry's scope of work for this assignment did not include legal surveying to establish property parcel boundaries and as such, this report accounts for both possibilities.*
