HYDROGEOLOGICAL ASSESSMENT AND TERRAIN ANALYSIS, CORKERY COMMUNITY CENTRE, 3447 OLD ALMONTE ROAD, OTTAWA, ON

Project No.: CCO-21-3339-01

Revision 1: August 2, 2022

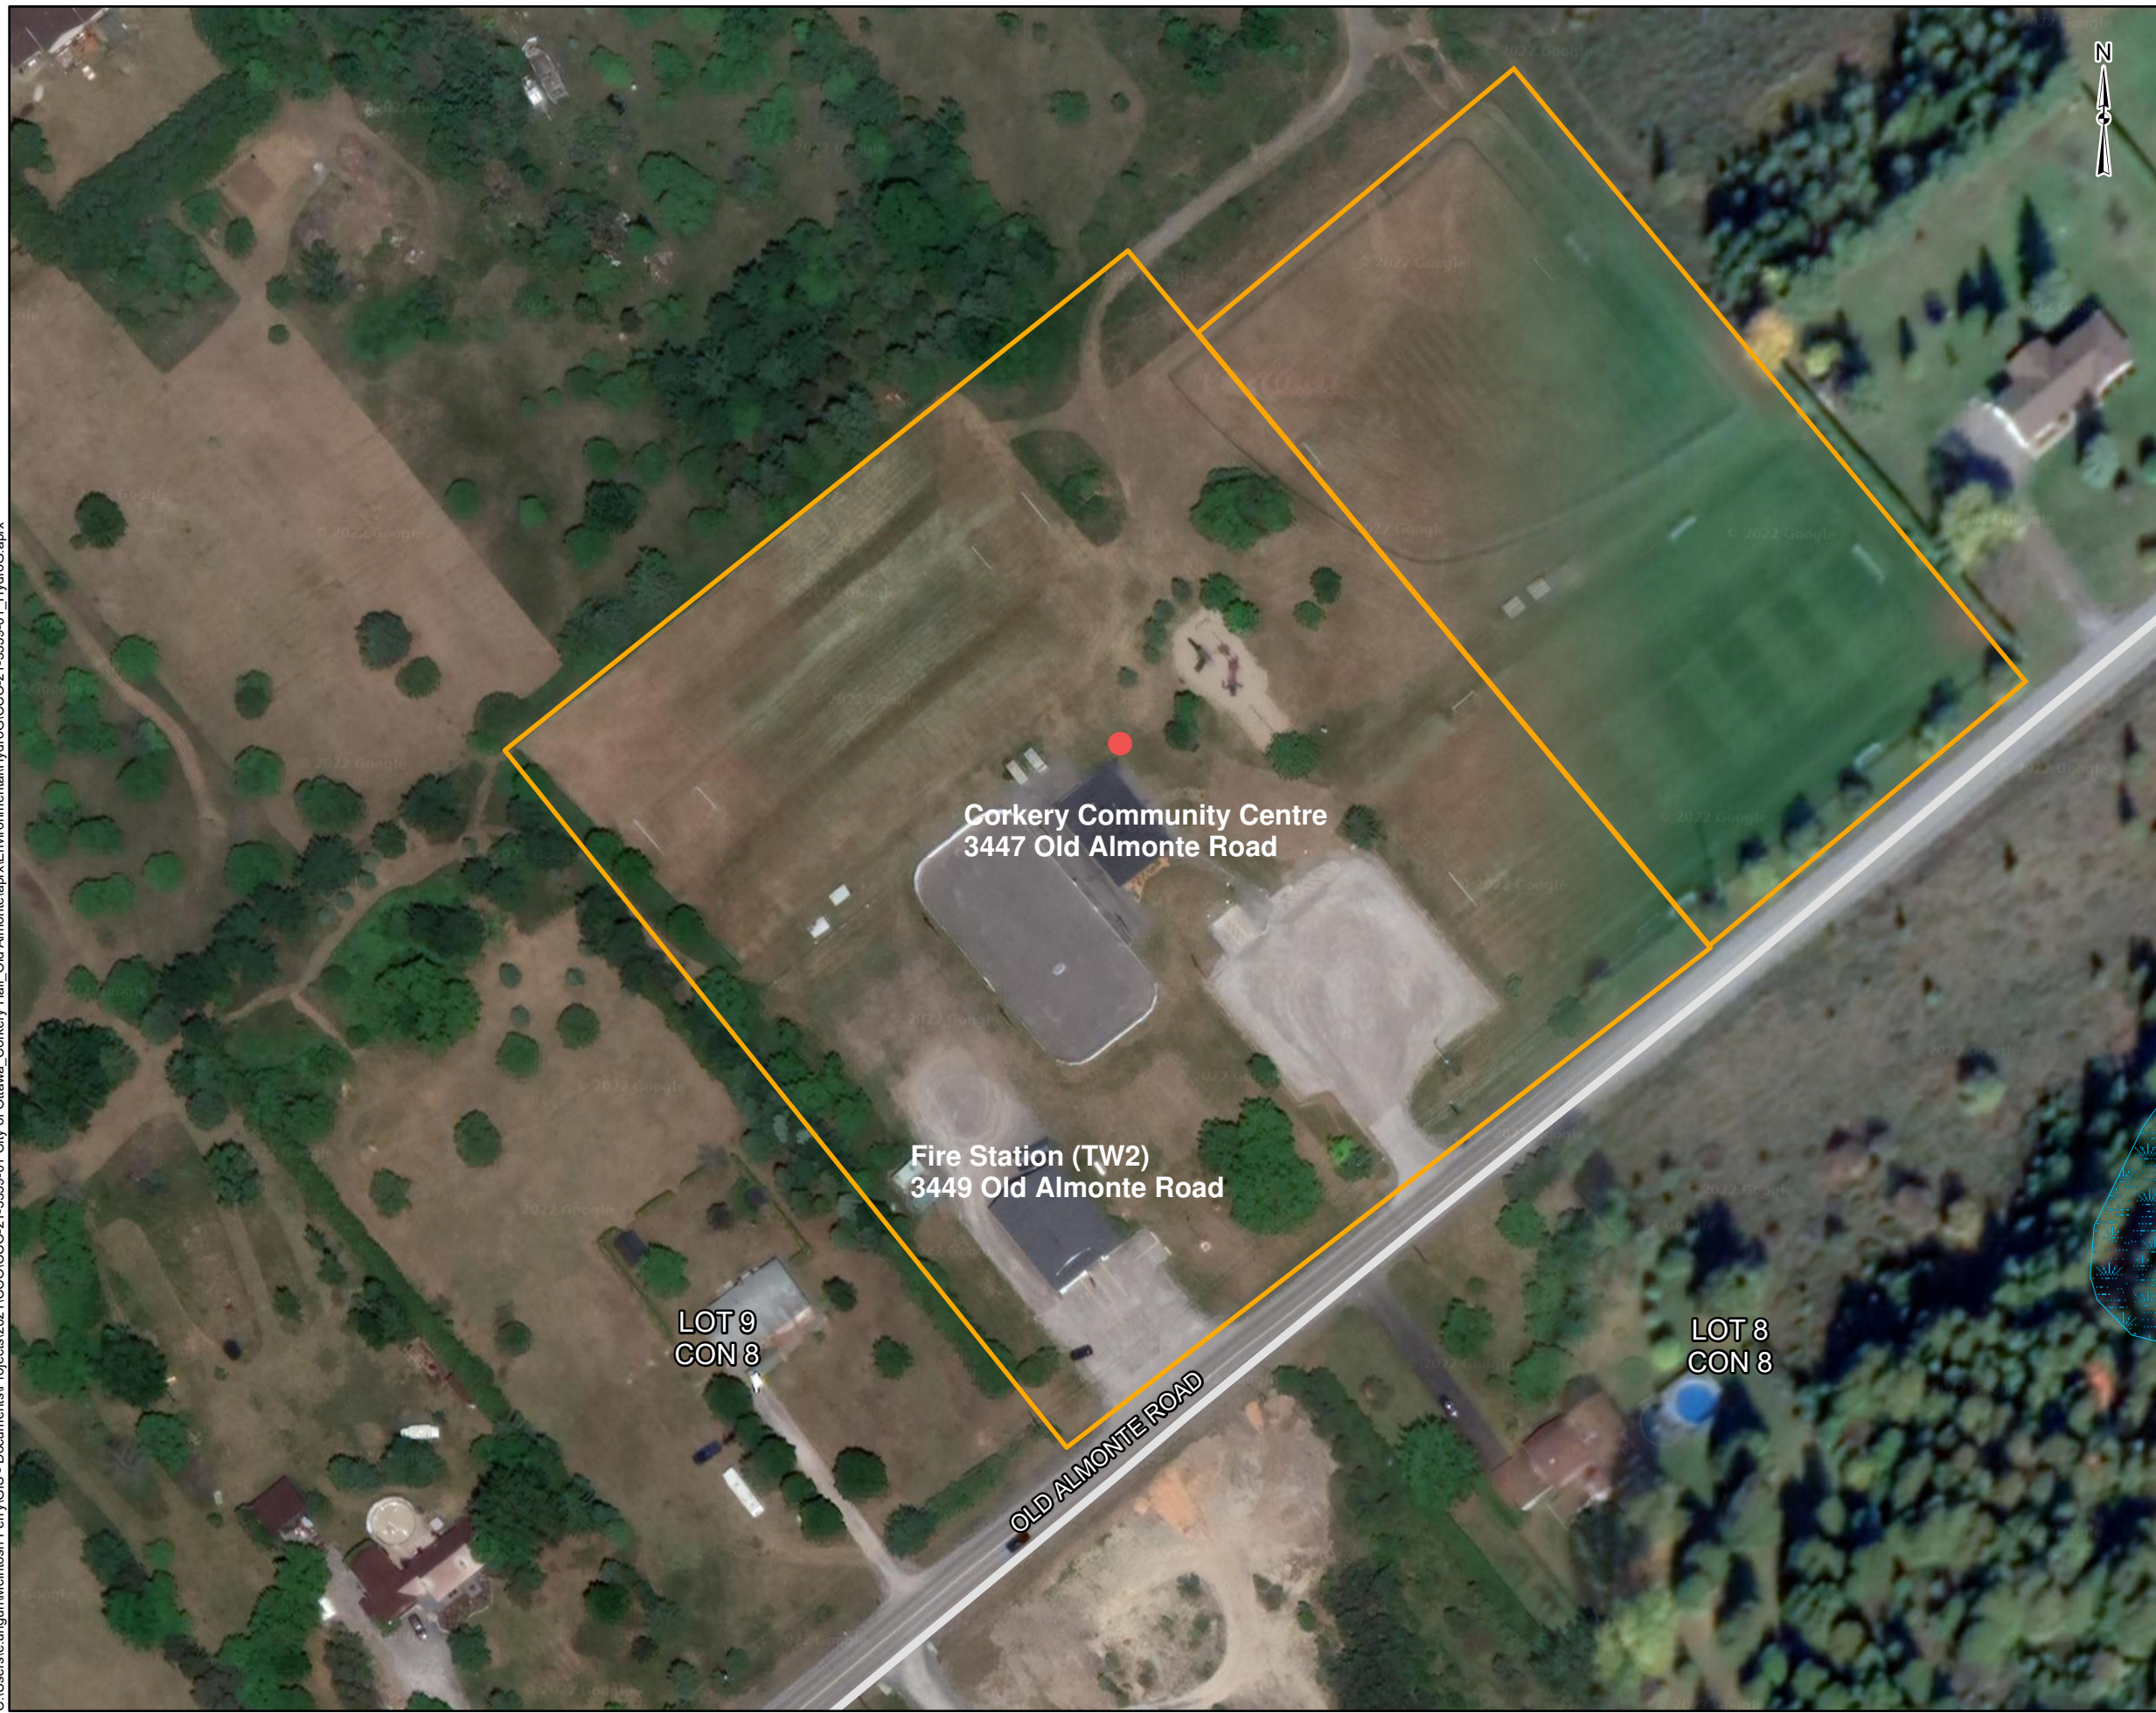
At the present time, the Site is occupied by the Corkery Community Centre. At the time of investigation, on-Site conditions consisted primarily of one building, an outdoor skating rink, a play structure, and three soccer fields. Based on a review of aerial photographs (GeoOttawa), it appears that the Site was developed between 1991 and 1999. It should be noted that Ontario Parcel data available on public provincial online mapping as well as the City of Ottawa's GeoOttawa GIS online mapping service suggest that the property parcel containing the Corkery Community Centre also encompasses Ottawa Fire Station 84 even though both facilities have separate entrances on Old Almonte Road as well as individual civic addresses. McIntosh Perry's scope of work for this assignment did not include legal surveying to establish property parcel boundaries and as such, this report accounts for both possibilities.

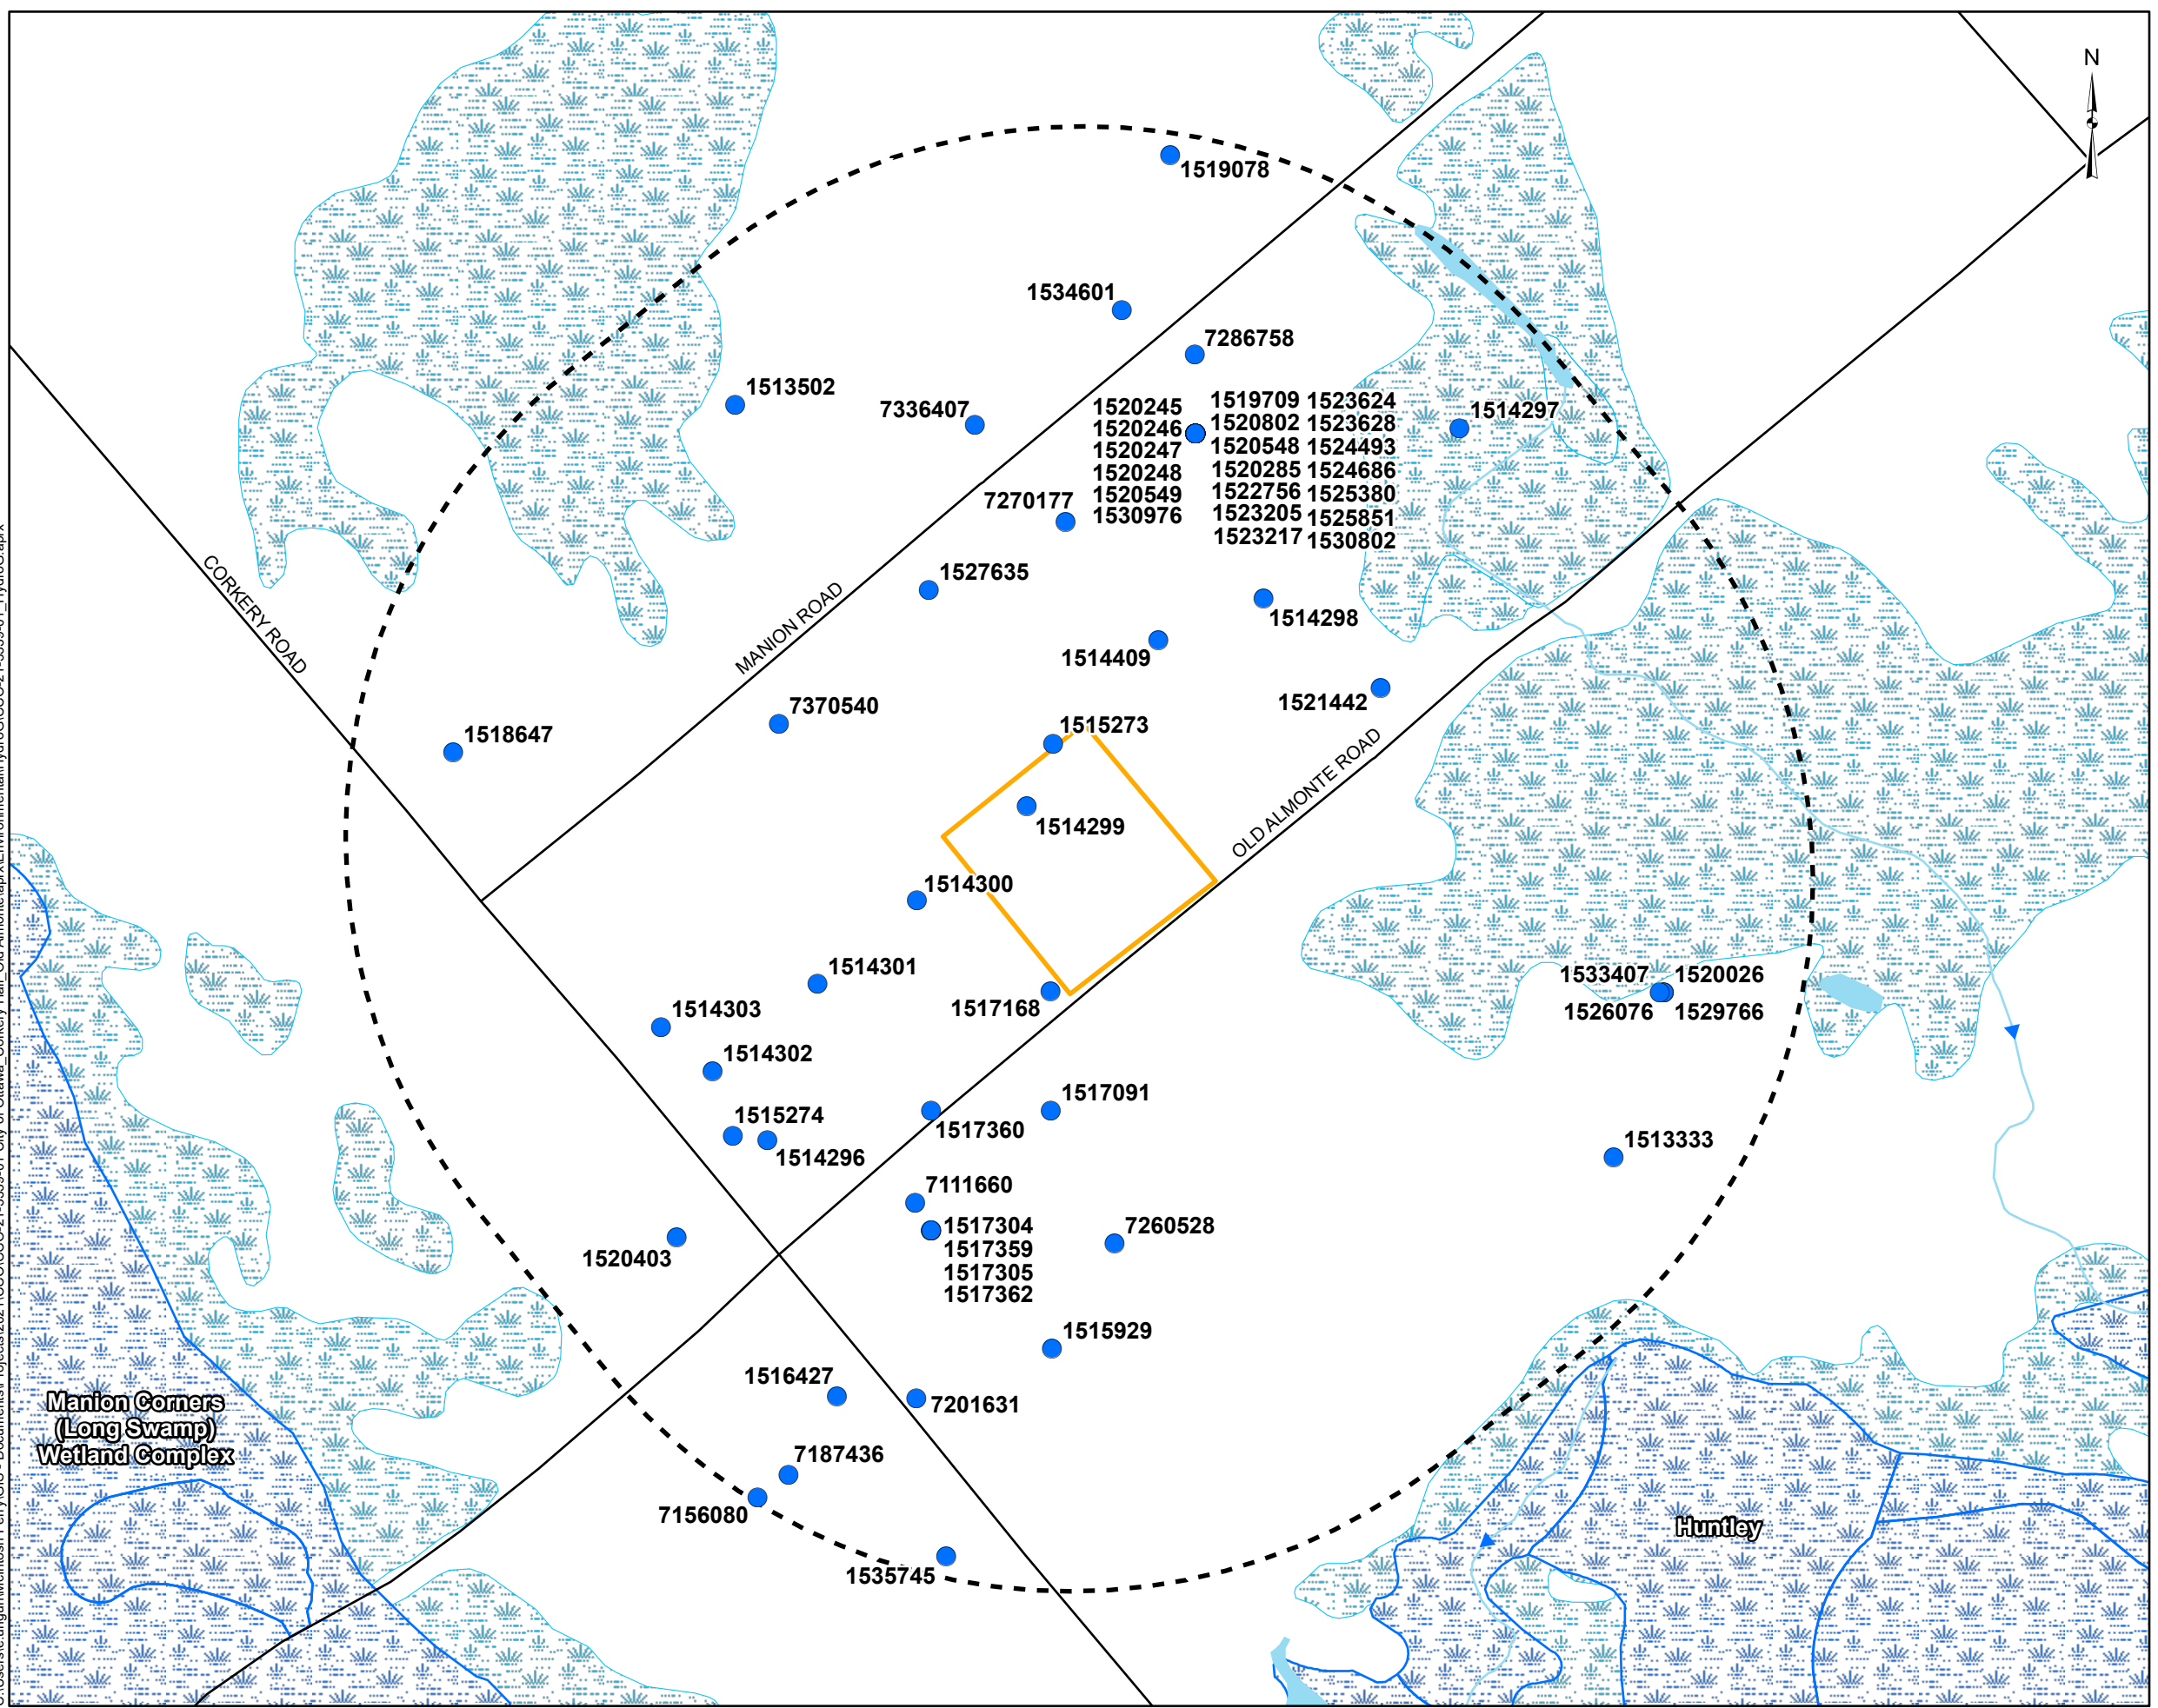
Driller-reported well yields ranged from 9.0 – 136.4 L/min, generally at or above the recommended minimum rate of 13.7 L/min for residential occupancies.

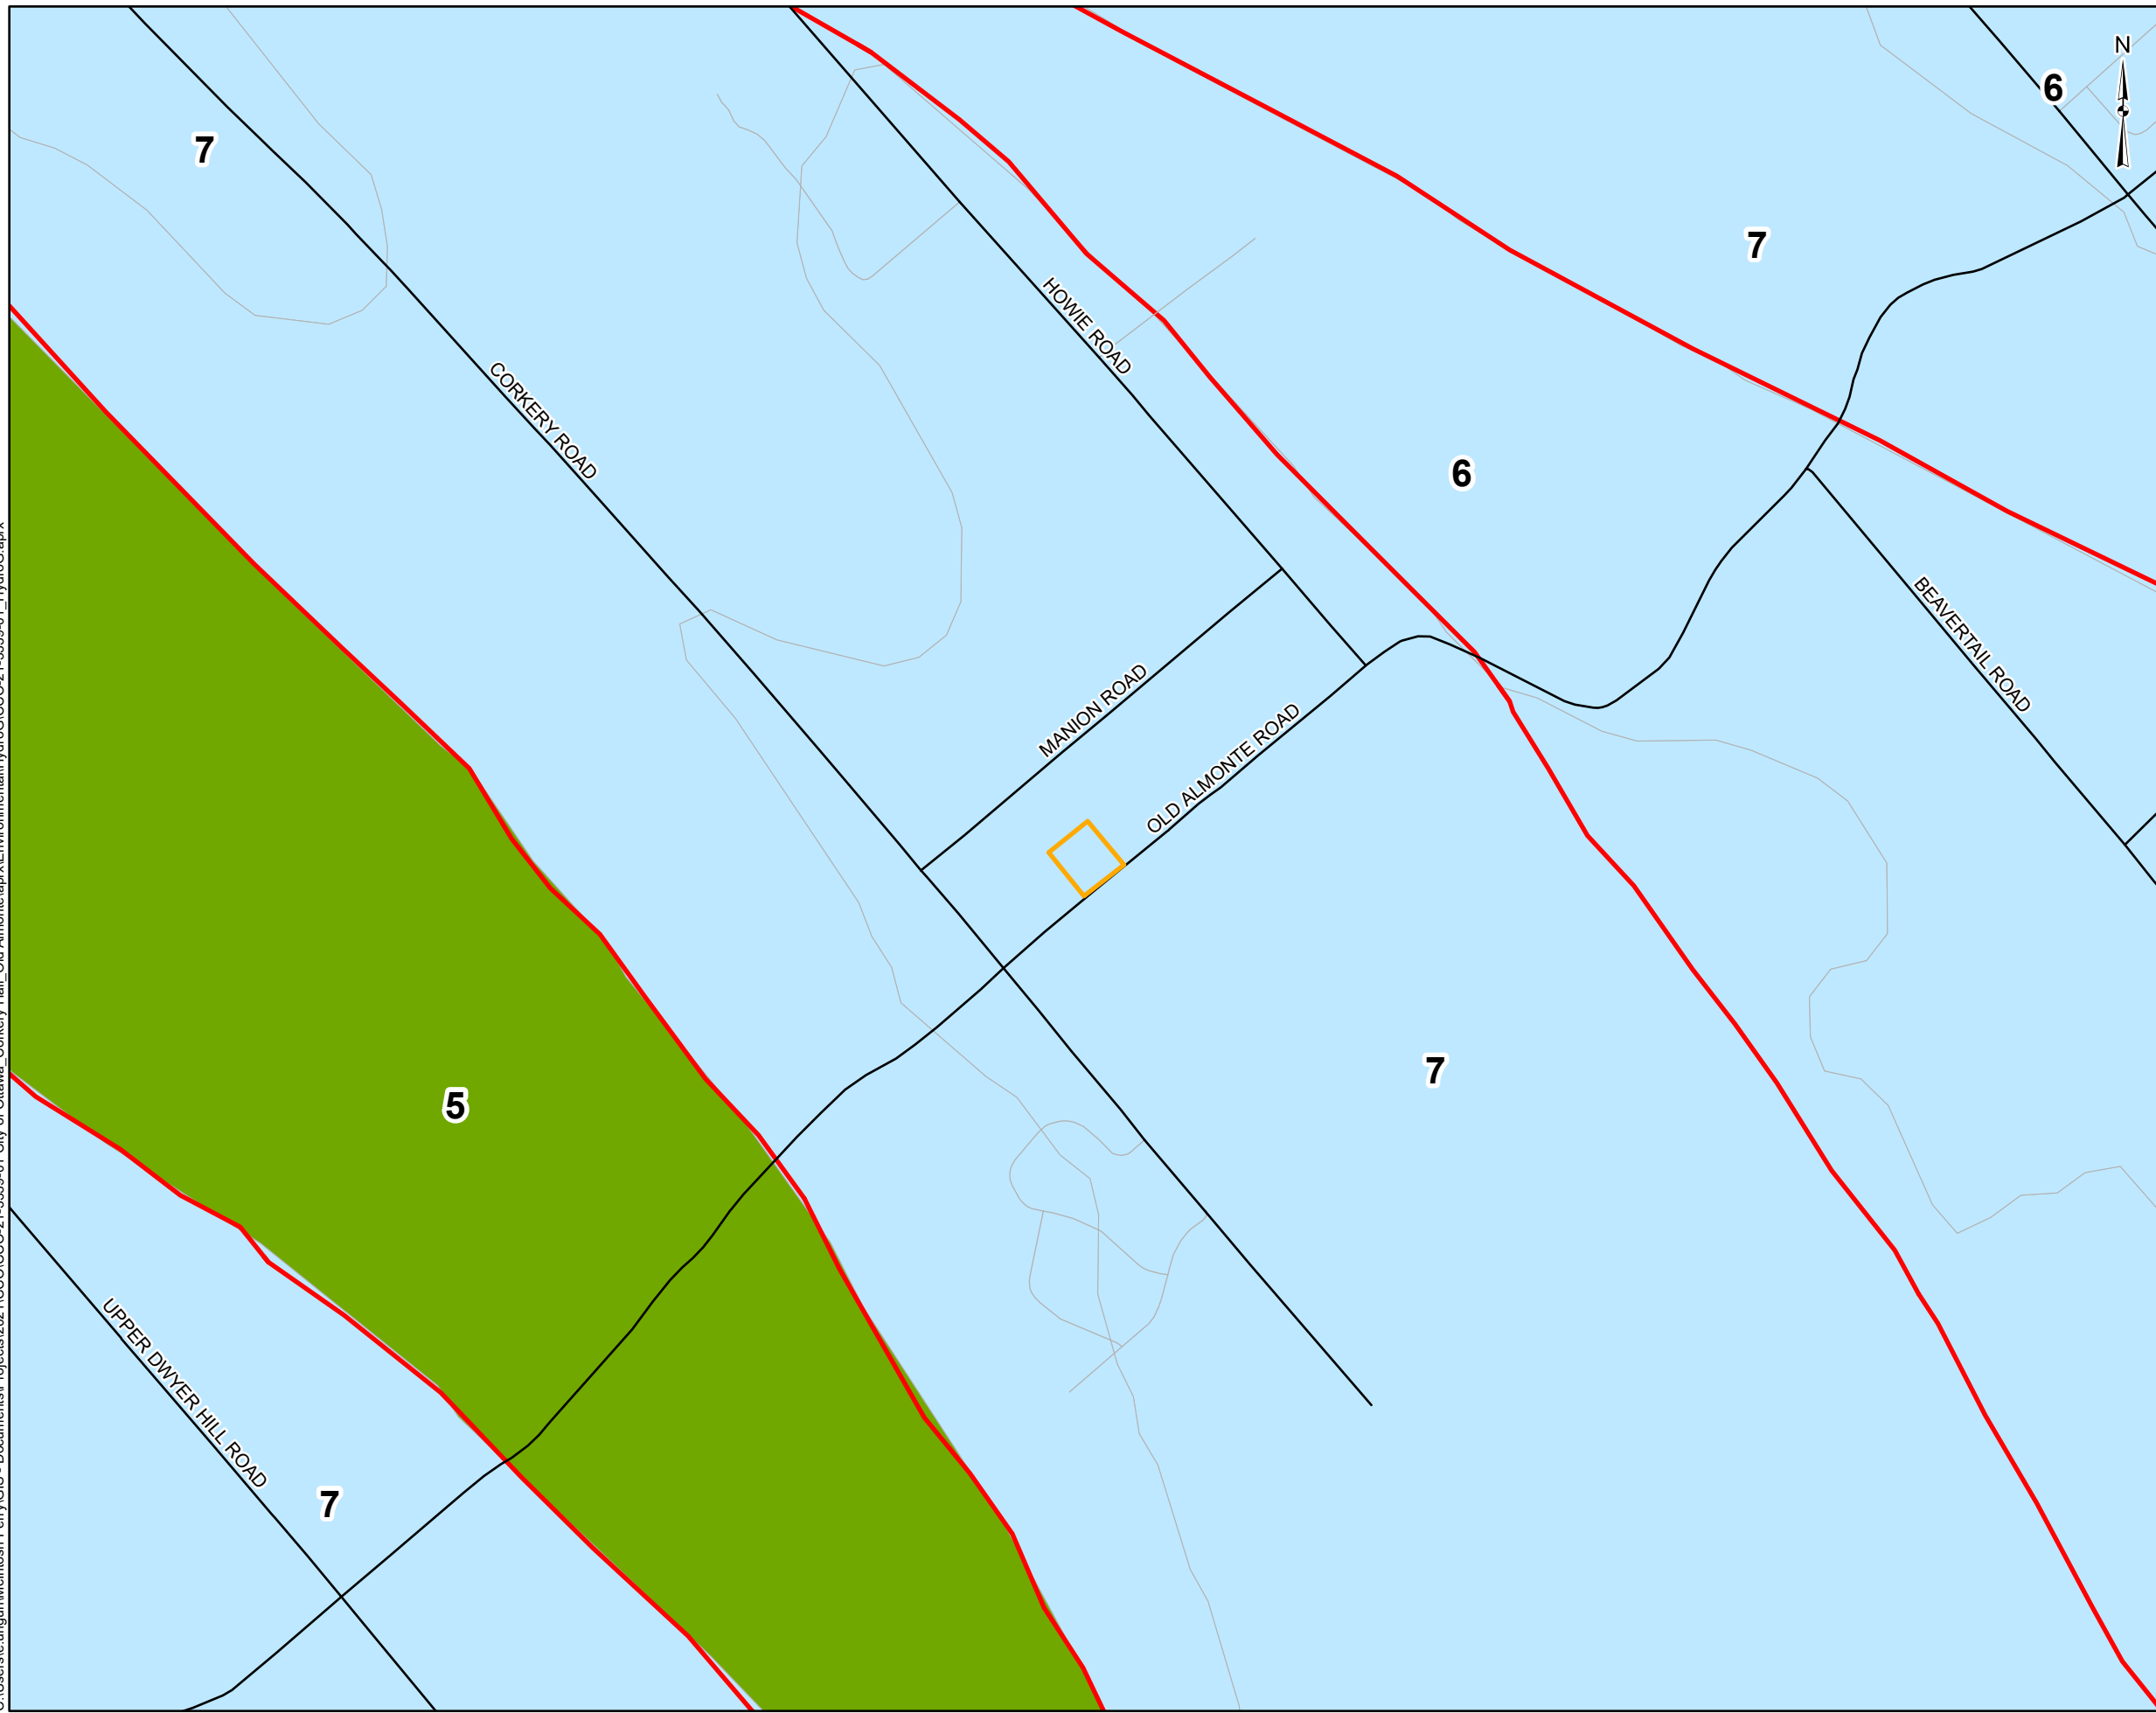
CLIENT:	CITY OF OTTAWA	
PROJECT:	HYDROGEOLOGICAL ASSESSMENT AND TERRAIN ANALYSIS, CORKERY COMMUNITY CENTRE	
TITLE:	MECP WWIS SUMMARY	
 <small>115 Walgreen Road, RR3, Carp, ON K0A1L0 Tel: 613-836-2184 Fax: 613-836-3742 www.mcintoshperry.com</small>	PROJECT NO: CCO-21-3339-01	FIGURE:
	Date	Feb., 07, 2022
	Checked By	PM
		4

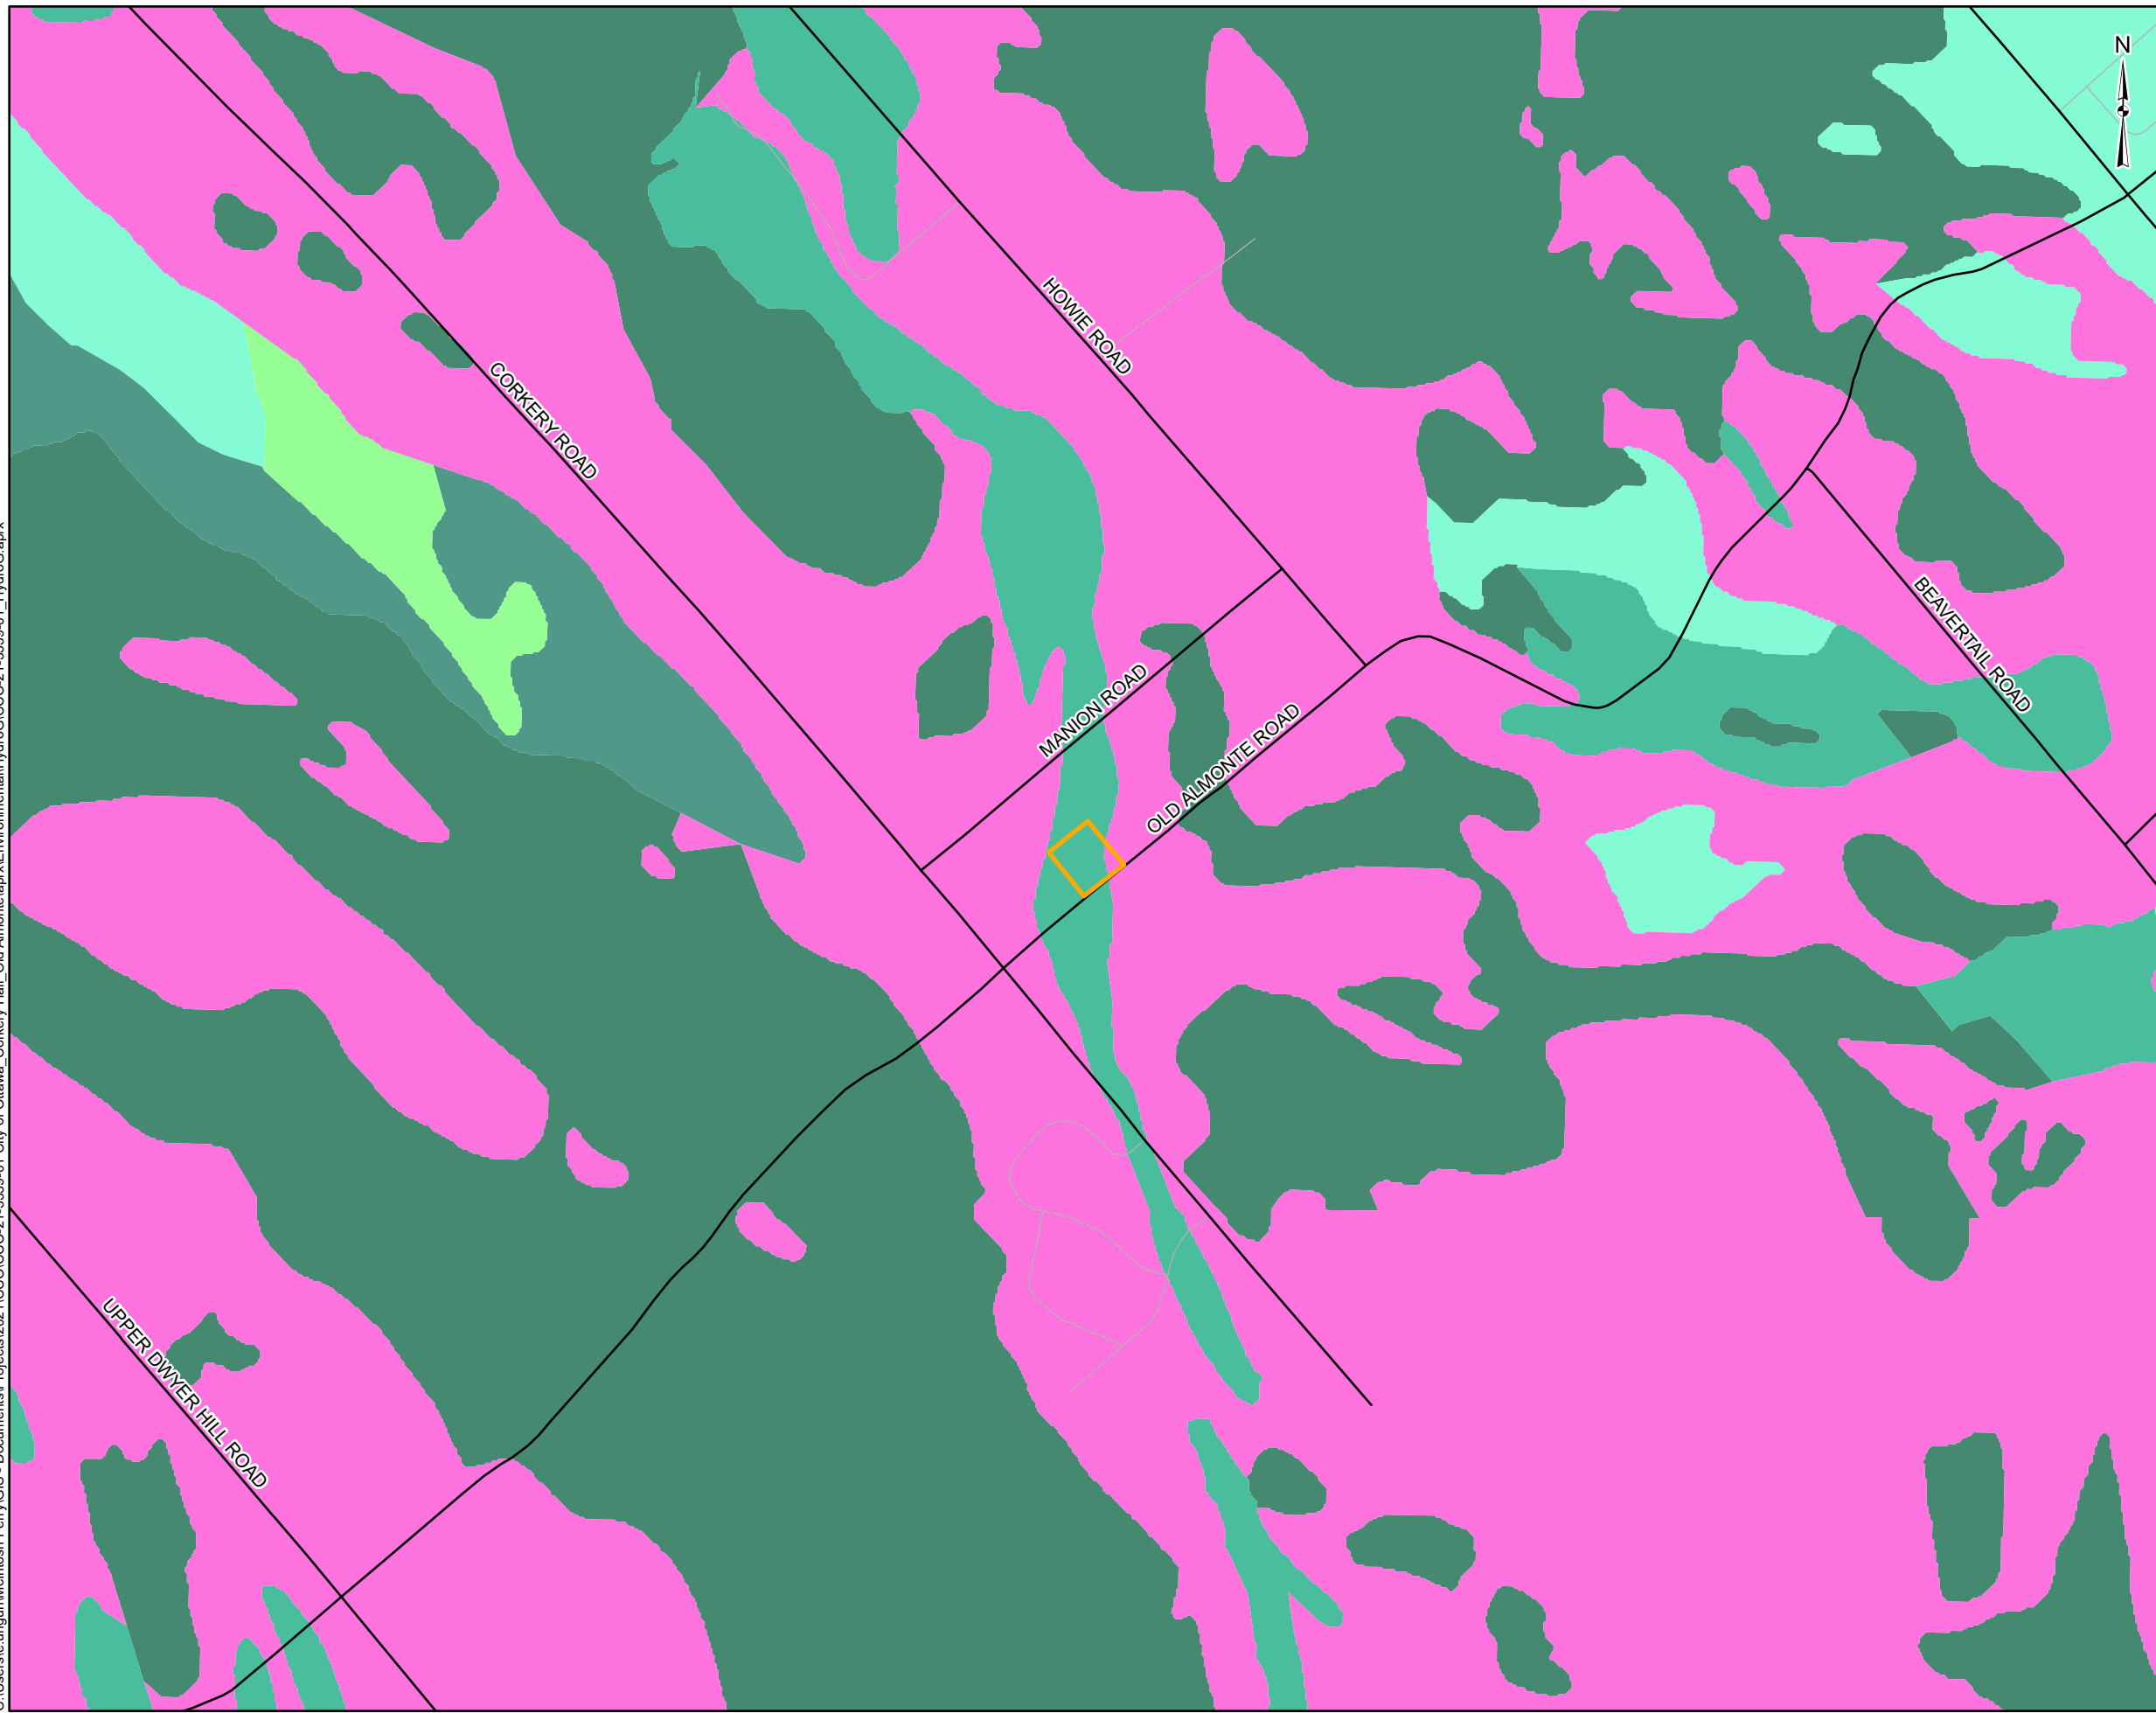
On-site overburden in the area of the subject site is listed by the Ontario Geological Survey (OGS) as bedrock-drift complex in a Paleozoic terrain, and fine-textured glaciomarine deposits, which typically indicates shallow overburden. This assertion is supported by MECP WWIS records, which indicate an average depth to bedrock of approximately 2.2 m below ground surface (bgs) for listed wells within 500 m of the Site.

Where boreholes were advanced to refusal, overburden across the site was found to be relatively shallow (< 2.1 m), having an average overburden thickness of 1.7 m (EXP, 2021).

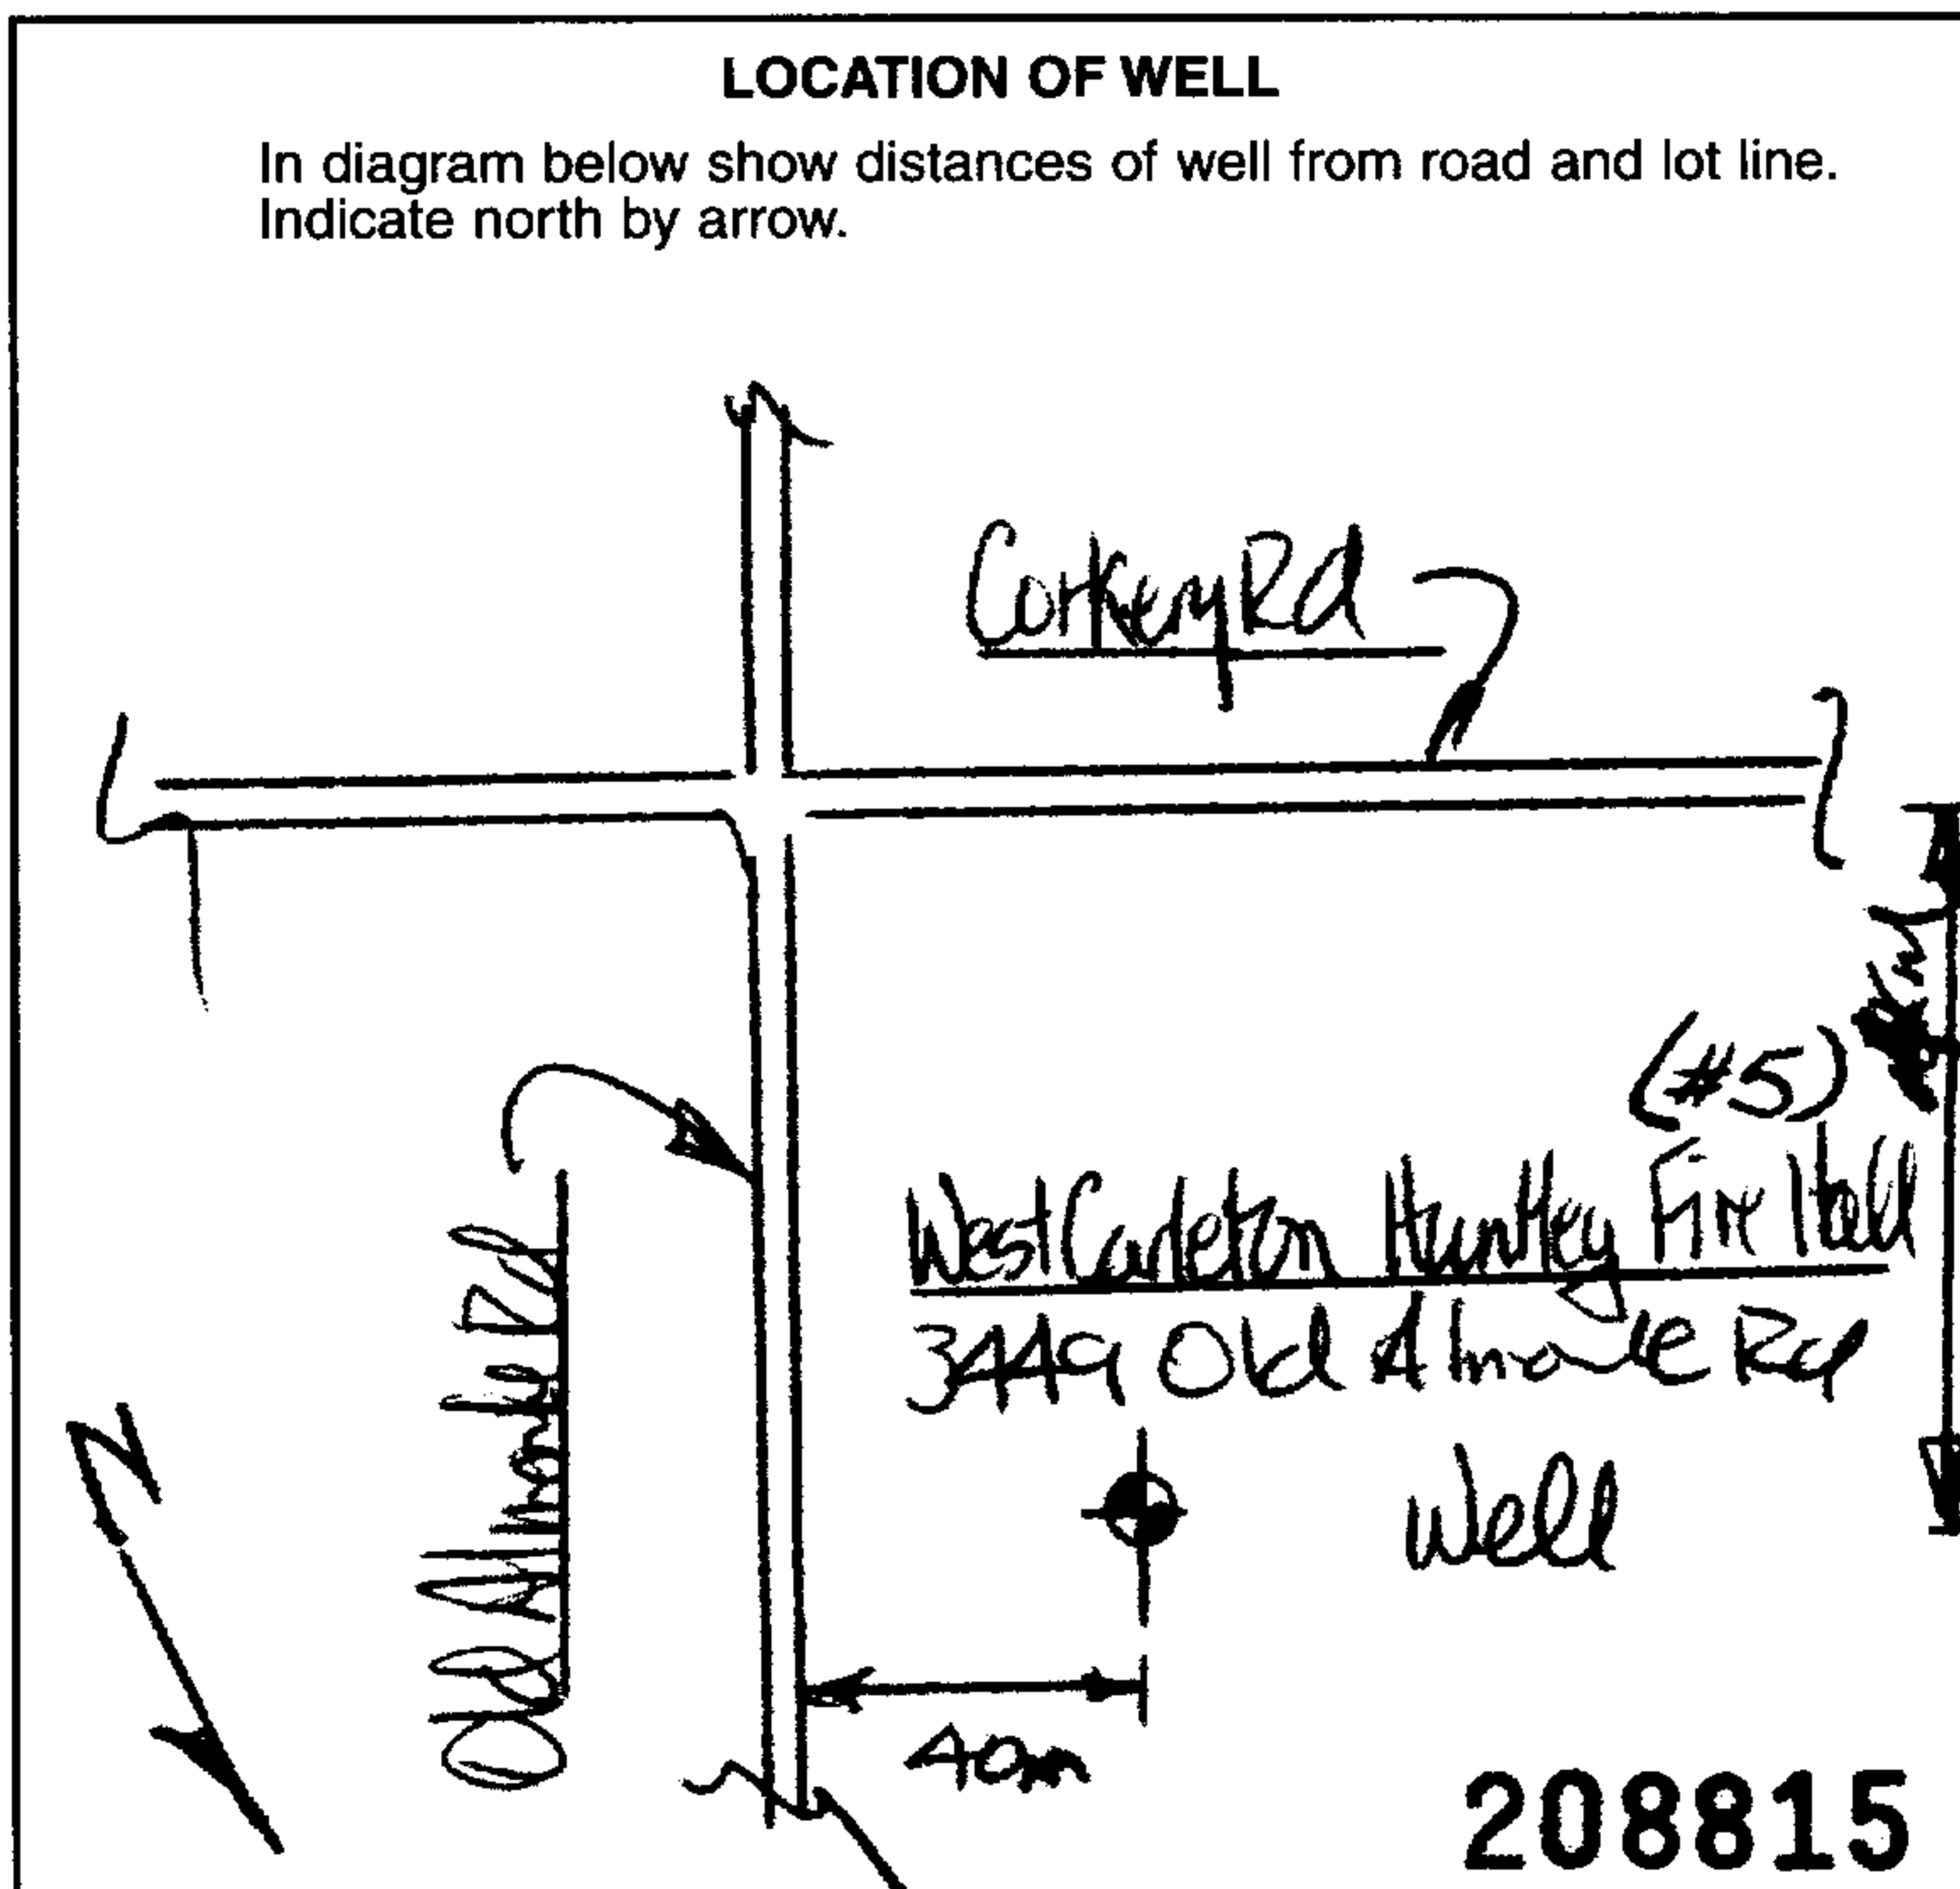
71 PUMPING TEST

Pumping test method <input checked="" type="checkbox"/> Pump <input type="checkbox"/> Bailer	Pumping rate 12 GPM	Duration of pumping 15-16 Hours 0 Mins
Static level 82 feet	Water level end of pumping 95 feet	Water levels during Pumping
		15 minutes 90 feet 30 minutes 94 feet 45 minutes 95 feet 60 minutes 95 feet
If flowing give rate GPM	Pump intake set at 150 feet	Water at end of test <input type="checkbox"/> Clear <input checked="" type="checkbox"/> Cloudy
Recommended pump type <input type="checkbox"/> Shallow <input checked="" type="checkbox"/> Deep	Recommended pump setting 150 feet	Recommended pump rate 10 GPM

The MECP water well record for TW1 (1530802) indicates that the total depth of the well is 72.5 m, with the pump set at 45.72 m. The well is reportedly completed in limestone with red-green shale and sandstone, with water found at 67.7 m and a static water level of 25 m at the time of drilling. The record for TW1 is provided in Appendix D. During the pumping test, TW1 was observed to be in good condition, with at least 0.6 m of stickup as required by O.Reg. 903.

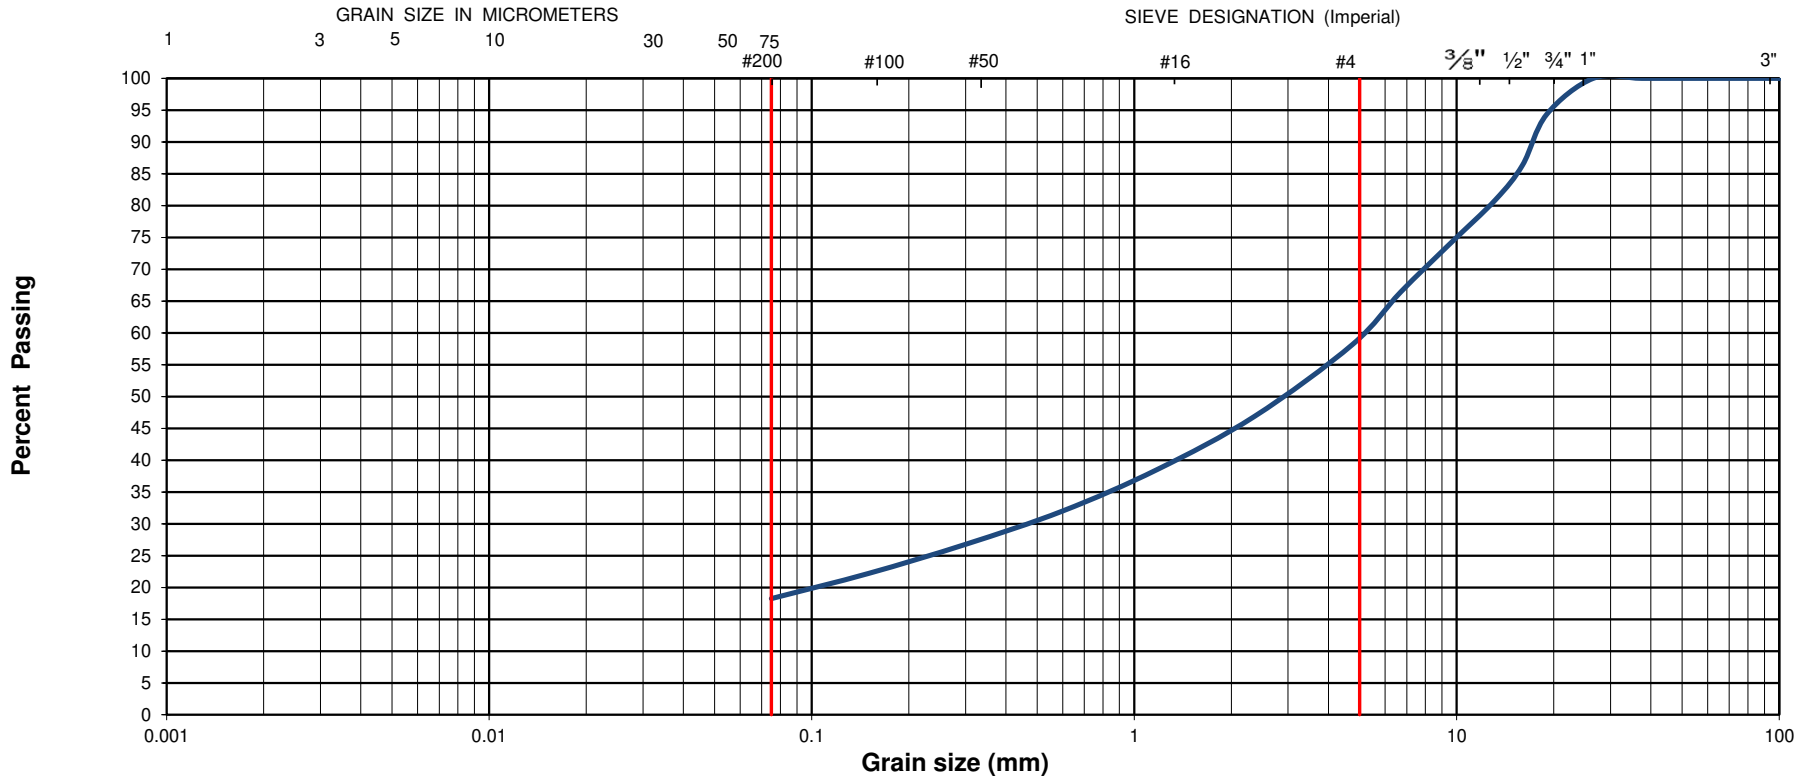
CLAY AND SILT	SAND			GRAVEL	
	Fine	Medium	Coarse	Fine	Coarse

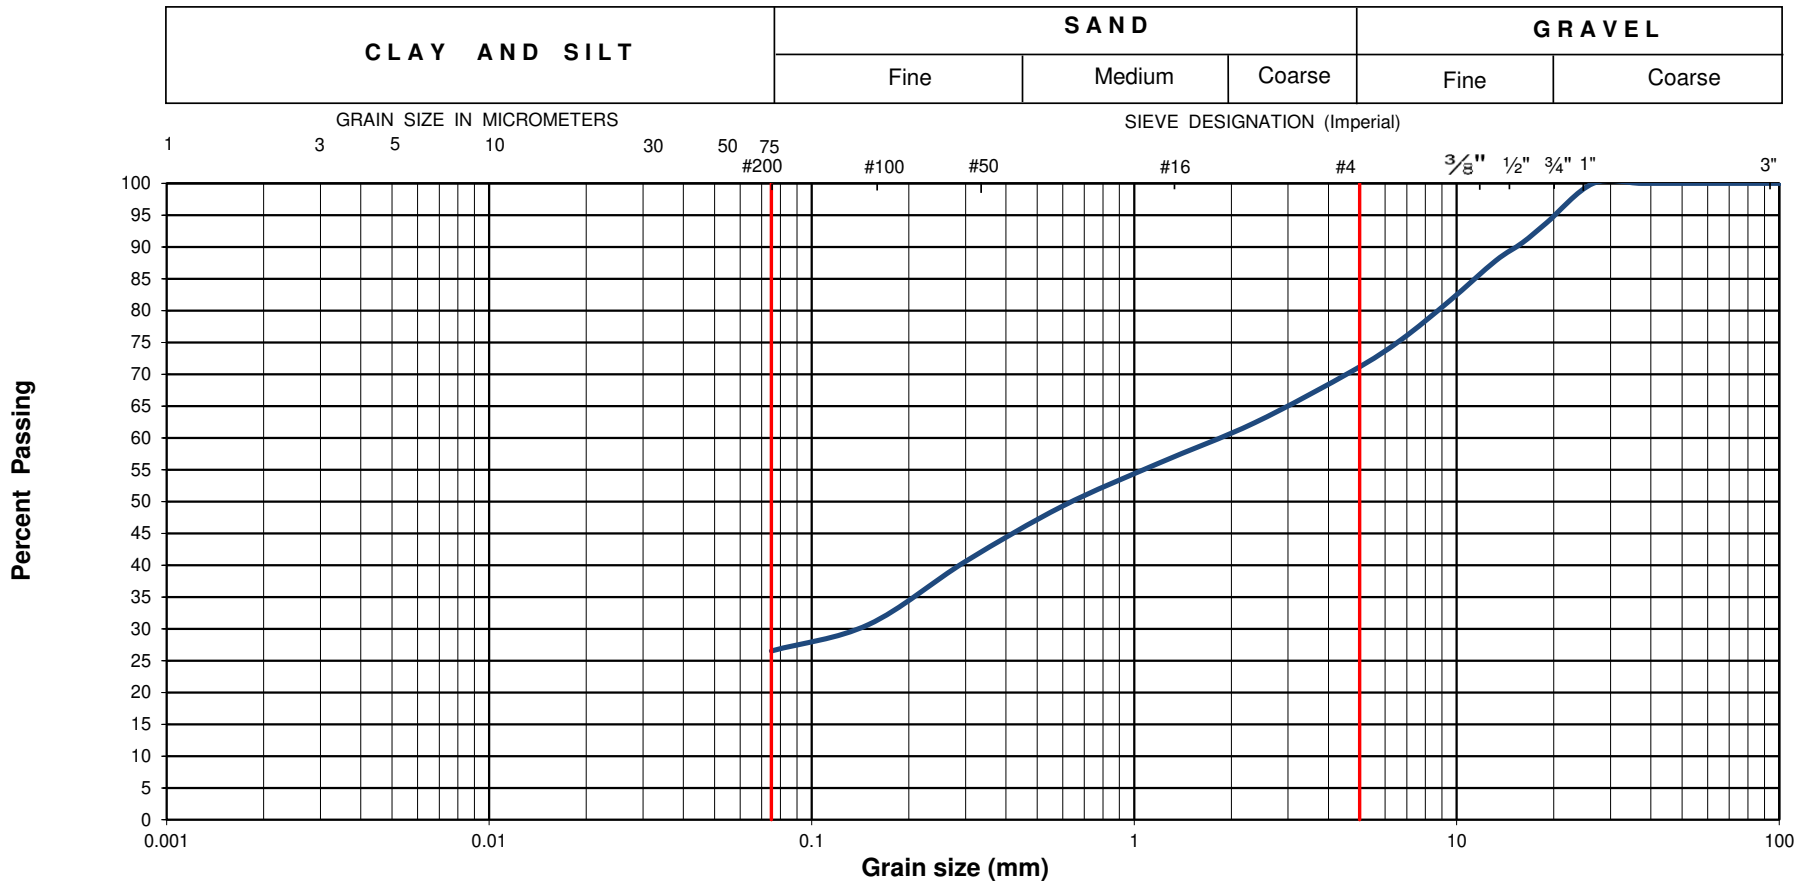
Unified Soil Classification System

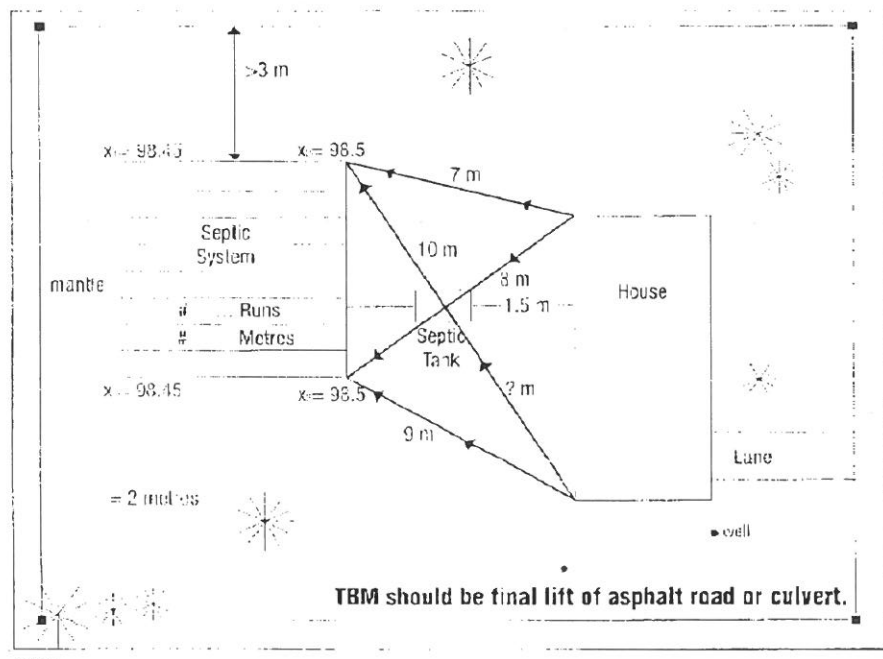
NOTE

NOTE: All as-built drawings must be cross-referenced to the house in two (2) locations.

Drilled well	• 15 metres to septic tank	Dug well	• 15 metres septic tank
	• 15 – 18 metres to distribution pipes		• 30 – 33 metres to distribution pipes
