# HYDROGEOLOGICAL ASSESSMENT AND TERRAIN ANALYSIS, CORKERY COMMUNITY CENTRE, 3447 OLD ALMONTE ROAD, OTTAWA, ON

Project No.: CCO-21-3339-01

McIntosh Perry ('MP') was retained by the City of Ottawa ('the Client') to conduct a Scoped Hydrogeological Assessment and Terrain Analysis in support the City of Ottawa Site Plan Approval (SPA) process for the construction of an addition to the Corkery Community Centre, located at 3447 Old Almonte Road, Ottawa, Ontario (collectively referred to as 'the Site').

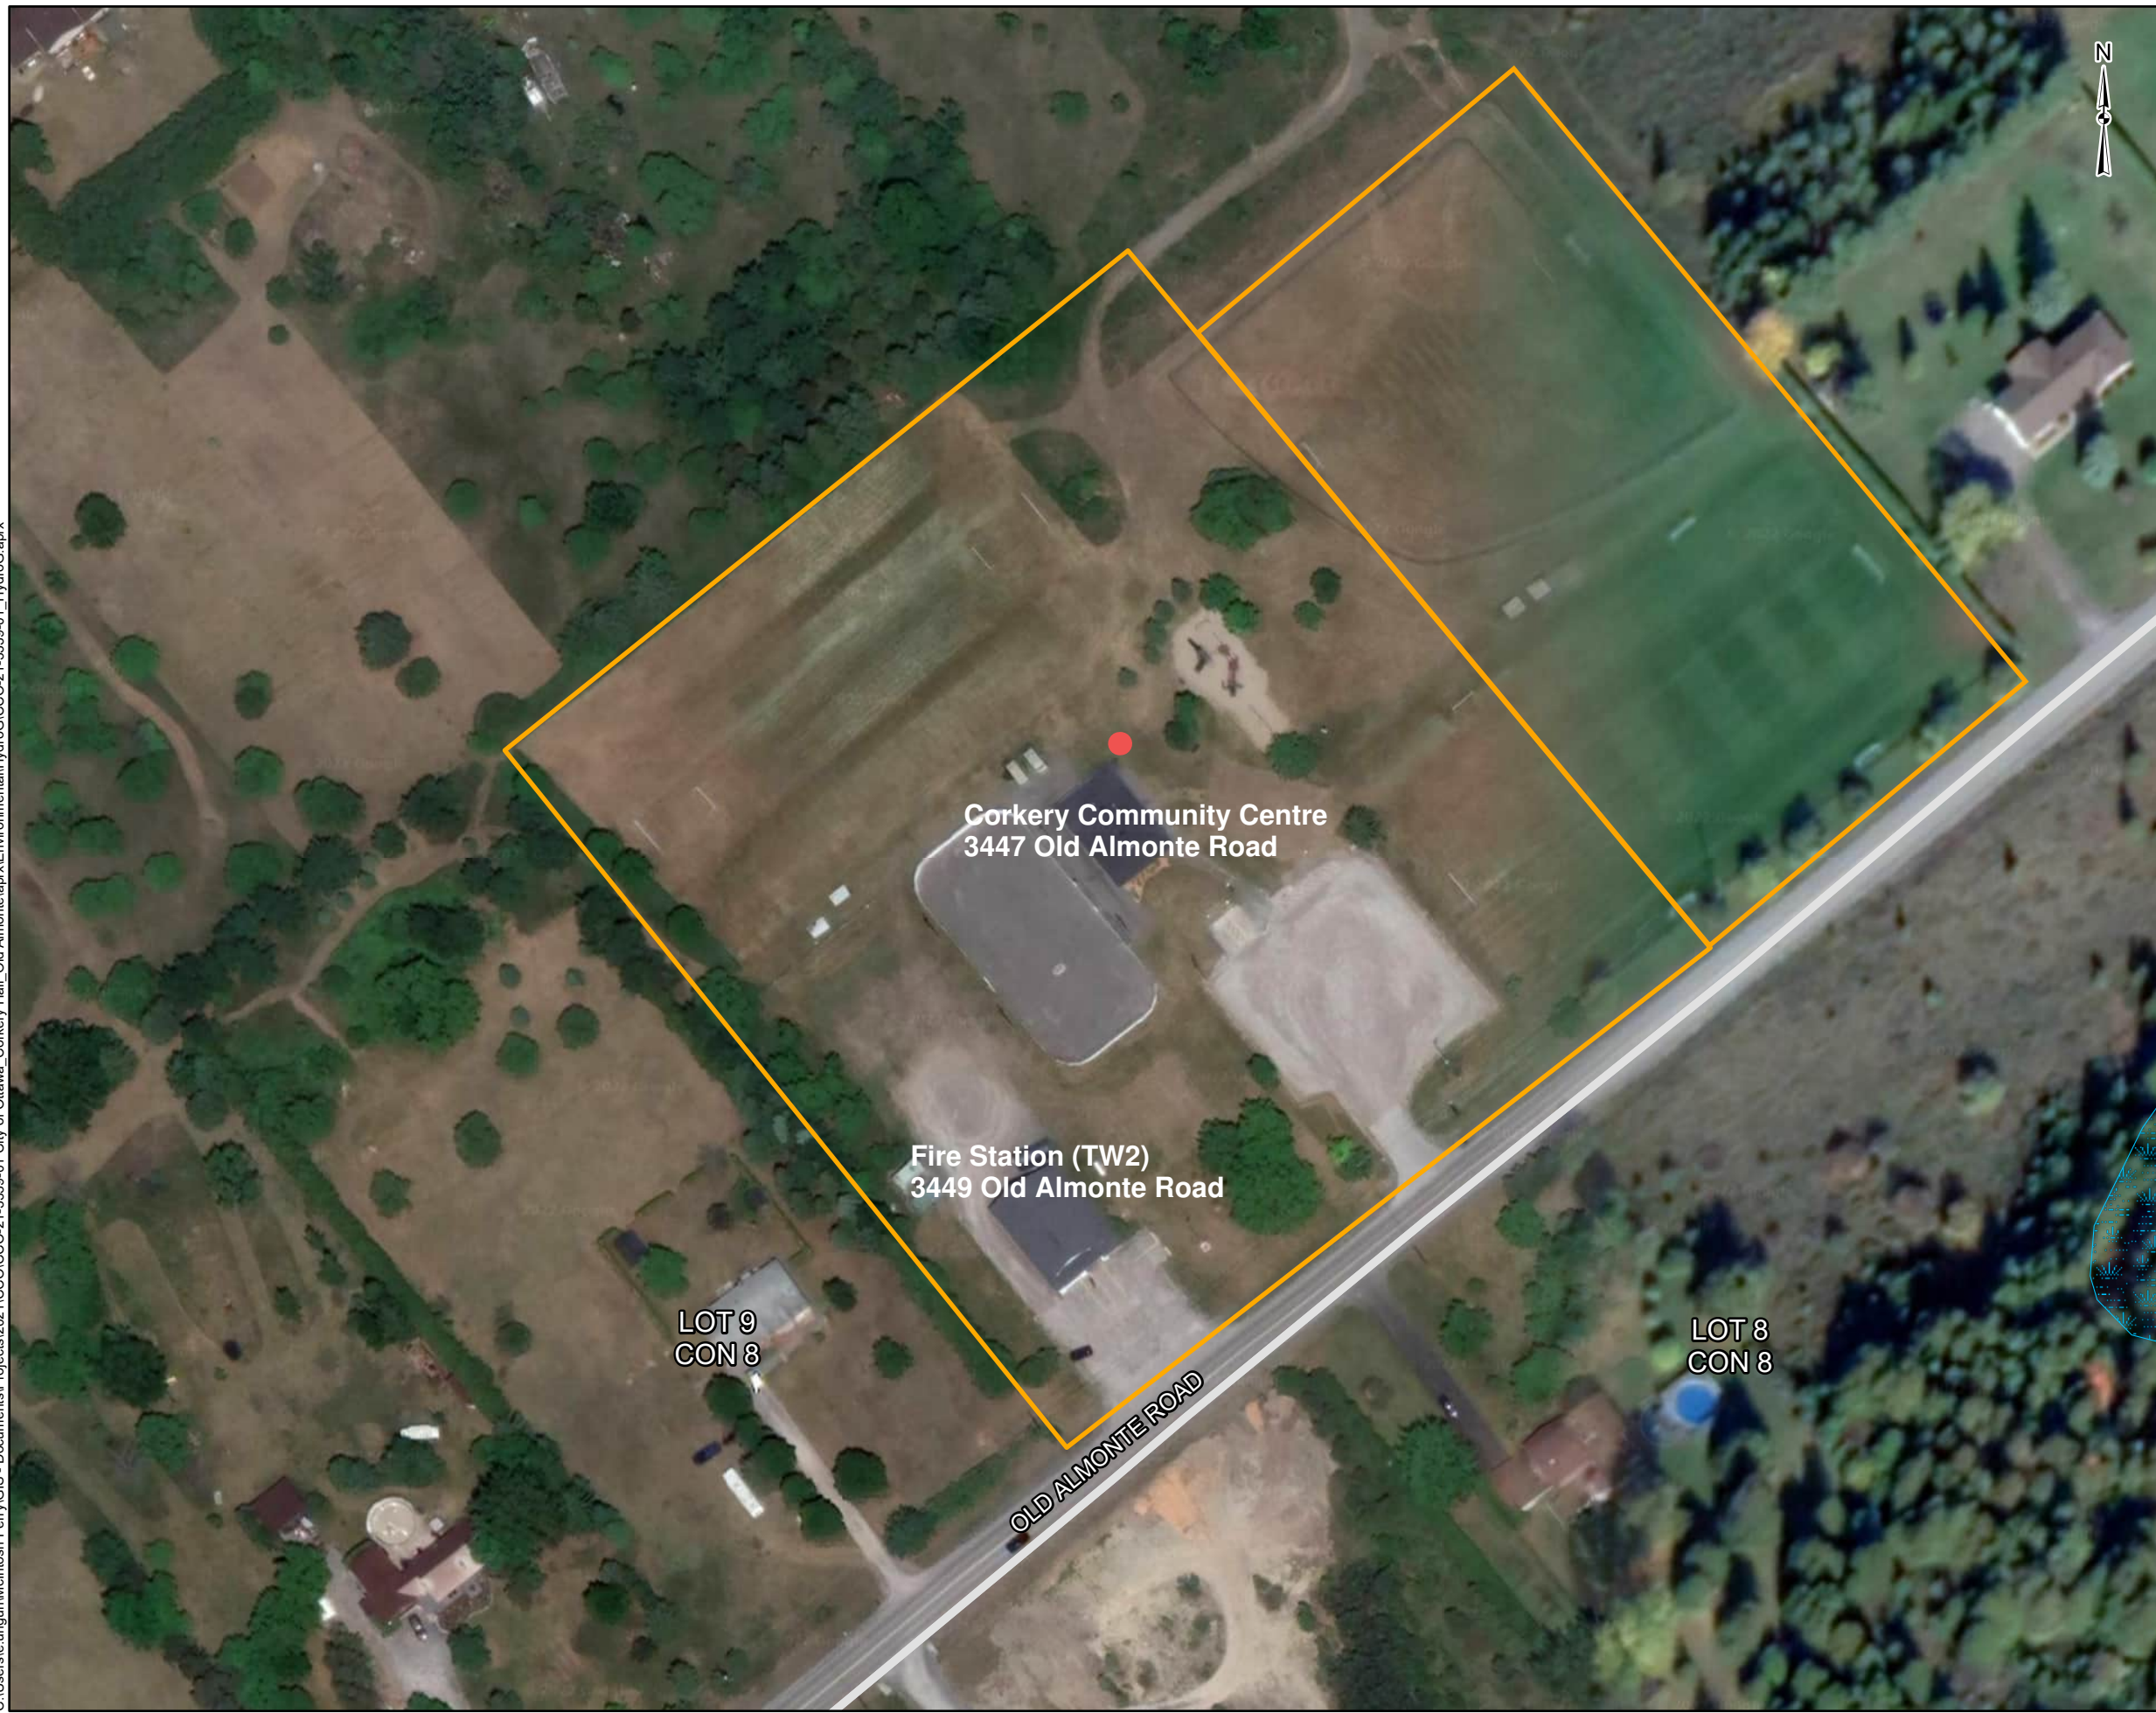
At the present time, the Site is occupied by the Corkery Community Centre. At the time of investigation, on-Site conditions consisted primarily of one building, an outdoor skating rink, a play structure, and three soccer fields. Based on a review of aerial photographs (GeoOttawa), it appears that the Site was developed between 1991 and 1999. *It should be noted that Ontario Parcel data available on public provincial online mapping as well as the City of Ottawa's GeoOttawa GIS online mapping service suggest that the property parcel containing the Corkery Community Centre also encompasses Ottawa Fire Station 84 even though both facilities have separate entrances on Old Almonte Road as well as individual civic addresses. McIntosh Perry's scope of work for this assignment did not include legal surveying to establish property parcel boundaries and as such, this report accounts for both possibilities.*

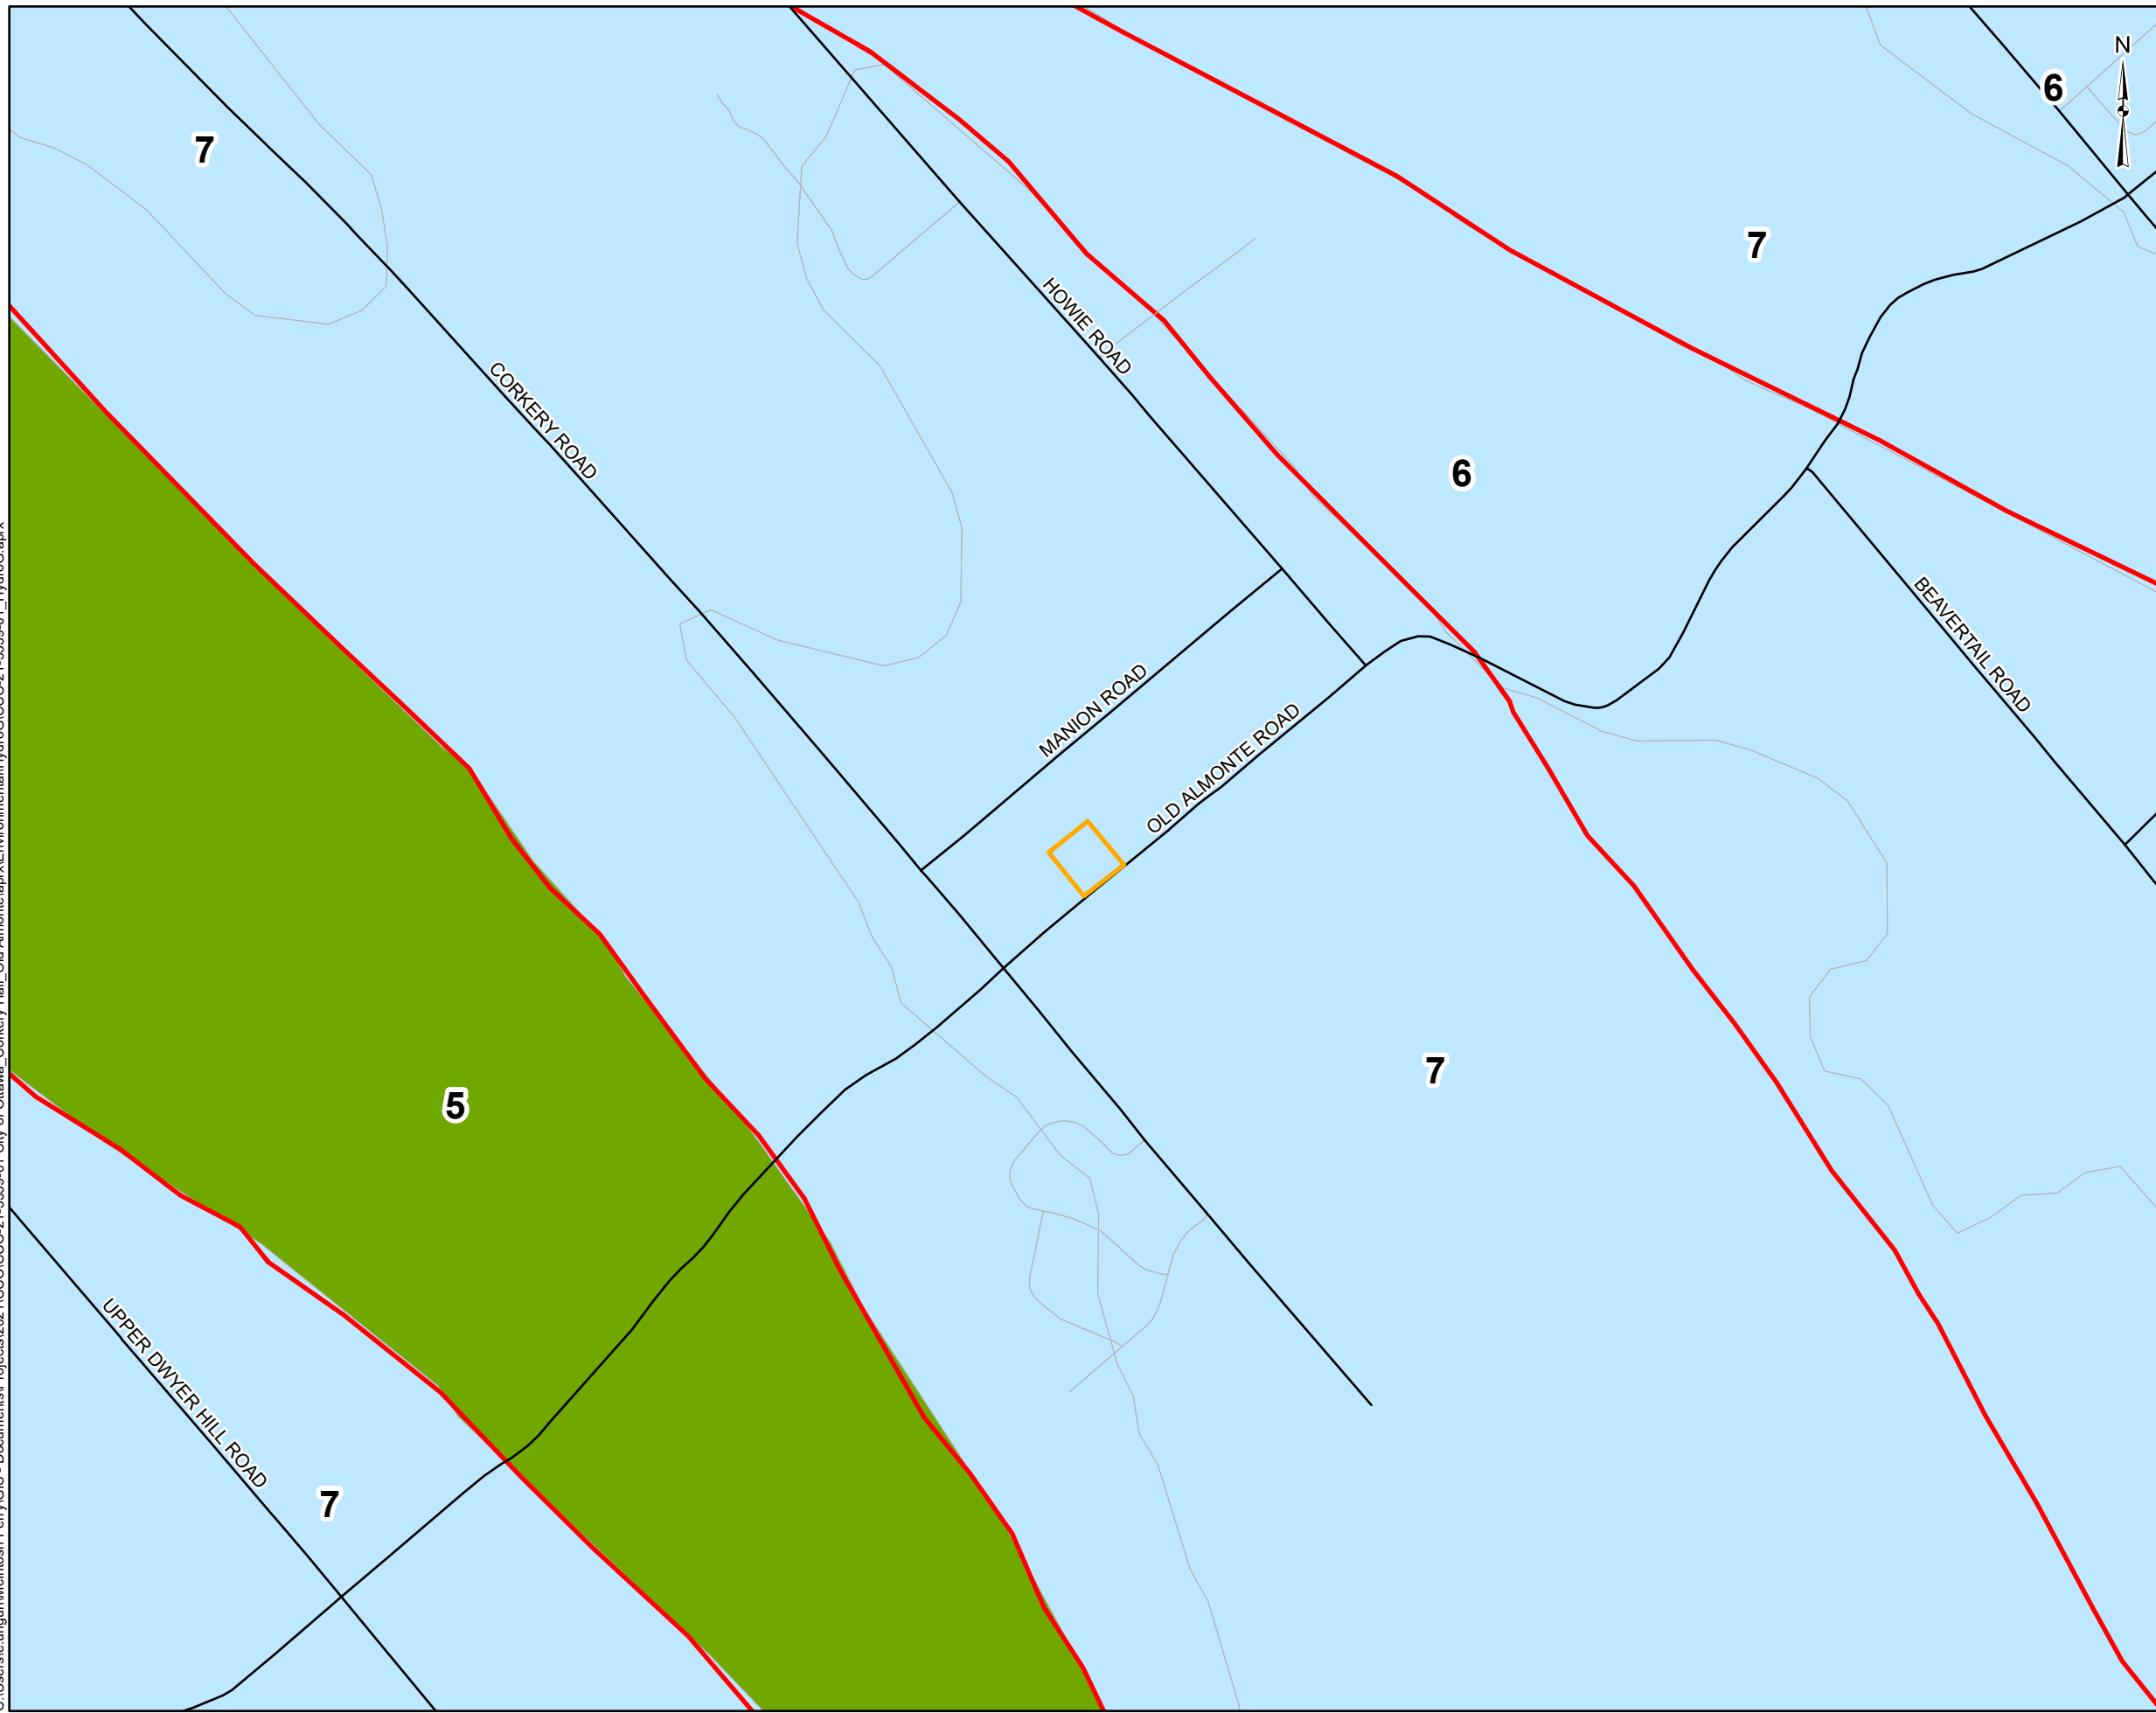
CLIENT:		CITY OF OTTAWA	
PROJECT:		HYDROGEOLOGICAL ASSESSMENT AND TERRAIN ANALYSIS, CORKERY COMMUNITY CENTRE	
TITLE:		MECP WWIS SUMMARY	
<b>McINTOSH PERRY</b> <small>115 Walgreen Road, RR3, Carp, ON K0A1L0          Tel: 613-836-2184 Fax: 613-836-3742          www.mcintoshperry.com</small>	PROJECT NO: CCO-21-3339-01	FIGURE:	4
	Date	Feb., 07, 2022	
	Checked By	PM

Driller-reported well yields ranged from 9.0 – 136.4 L/min, generally at or above the recommended minimum rate of 13.7 L/min for residential occupancies.
