Muncaster  
Environmental  
Planning Inc.

**RE: 3040 and 3044 Innes Road – Proposed Apartment Building  
Tree Conservation Report and Environmental Impact Statement - Updated**

This Environmental Impact Statement (EIS) and Tree Conservation Report (TCR) assesses an urban residential development for an approximately 0.28 hectare site on the south side of Innes Road, east of Cleroux Crescent, in the east portion of Blackburn Hamlet, City of Ottawa. The municipal addresses are 3040 and 3044 Innes Road. This report has been updated to address City of Ottawa comments (July 19<sup>th</sup>, 2022).

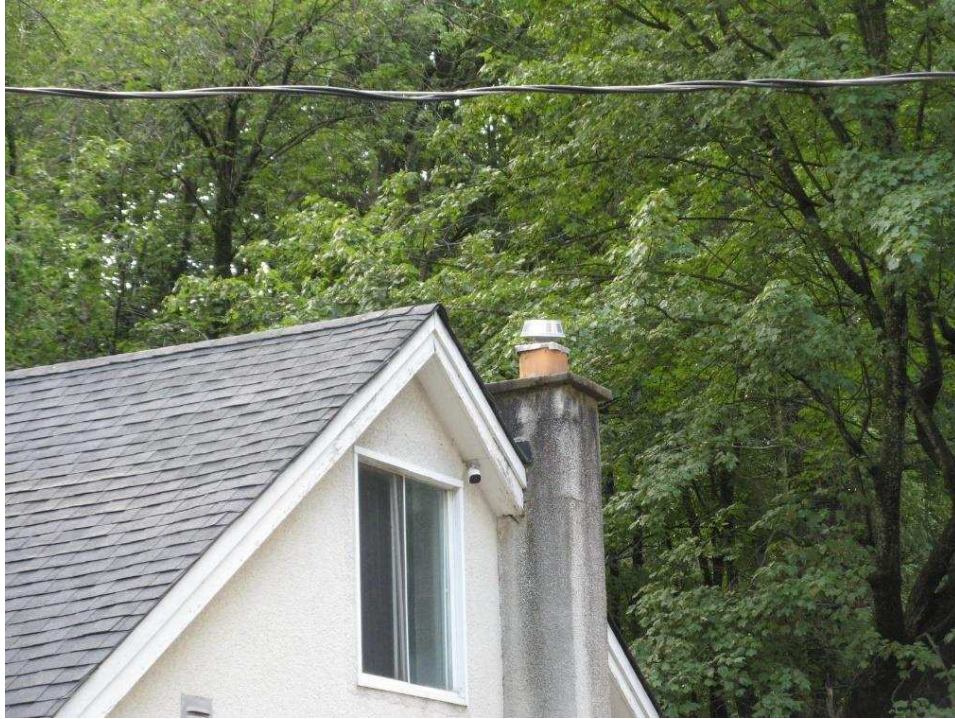
*Photo 1 – Chimneys on the residences (this example is 3044 Innes Road) are vented, preventing potential chimney swift access. View looking southeast*

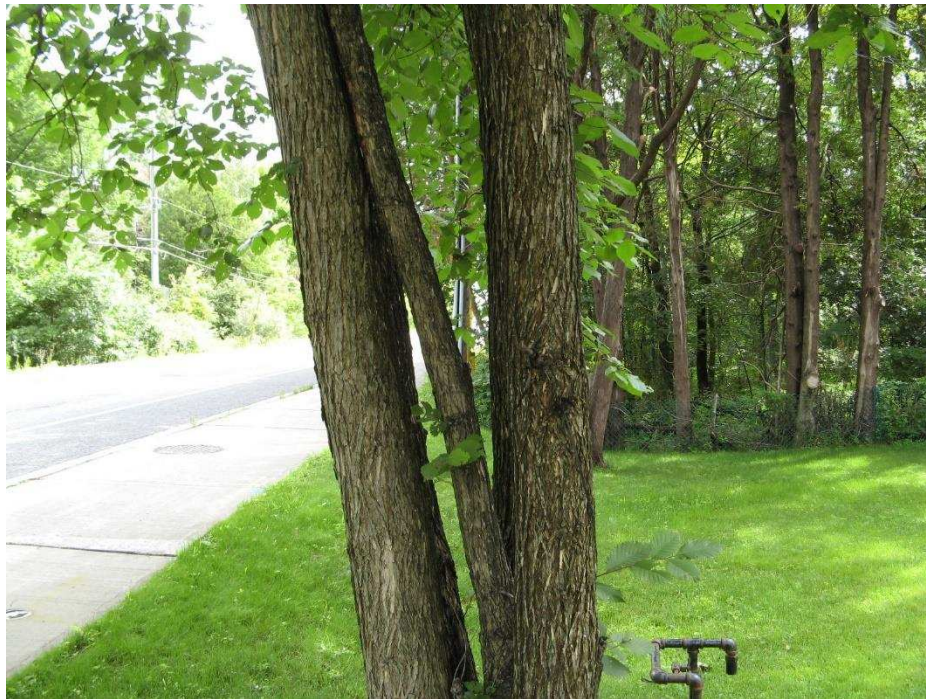
There are several trees along the periphery of 3044 Innes Road. Starting in the north portion, south of Innes Road, a coppice white elm with the largest stems up to 20cm diameter at breast height (dbh) are south of the sidewalk north of 3044 Innes Road (Photo 2). Several white cedars between 10cm and 30cm dbh are along the east fence line (Photo 5). The north cedars and the coppice white elm are on City property. These trees appear to be in generally good condition, with good leaf-out and minimal trunk damage, though many of the cedars have been extensively pruned.

*Photo 2 – Coppice white elm and manicured lawn in the front (north) portion of 3044 Innes Road. Note elm is likely on City property but is planned to be retained. View looking east*

Trees that appear to be all or in part on City land on the south side of Innes Road include a 35cm dbh basswood to the north of 3040 Innes Road and coppice white cedars with individual stems up to 28cm dbh and smaller coppice white elms with individual stems up to 20cm dbh to the north of 3044 Innes Road. These trees appear to be in generally good condition, with good leaf-out and minimal trunk damage. Some stems in the multi-stem trees have been removed. It is anticipated that the east City-owned trees (the coppice white cedars with individual stems up to 28cm dbh and smaller coppice white elms with individual stems up to 20cm dbh) can be retained, but the west City-owned 35cm dbh basswood will likely need to be removed due to the proximity of the north edge of the underground parking in this area.

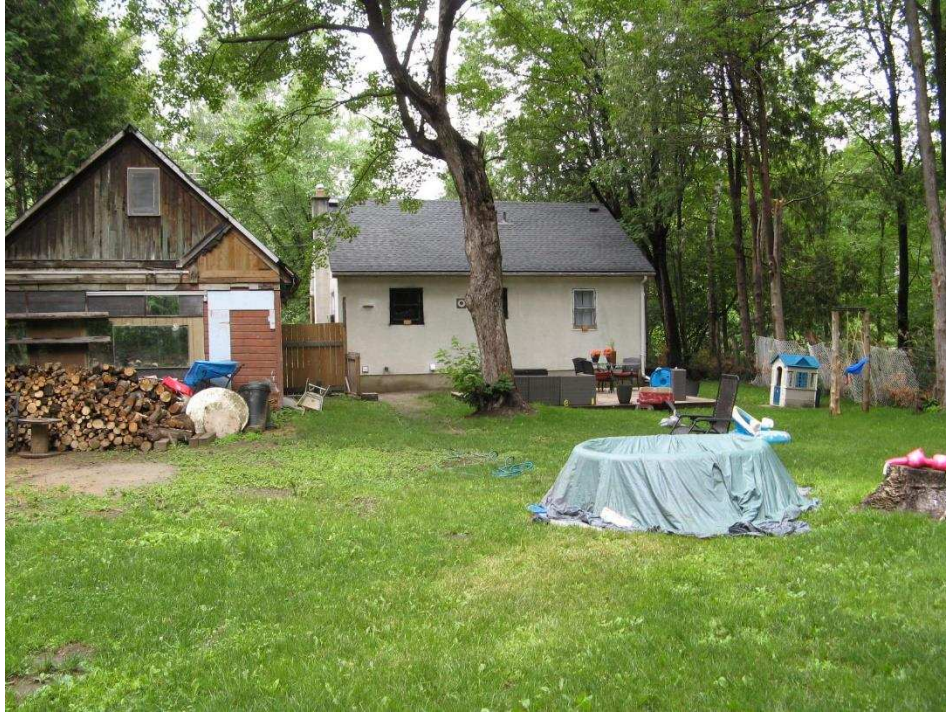
*Photo 3 – Rear yard of 3044 Innes Road. View looking north to red maple in apparently poor condition.*

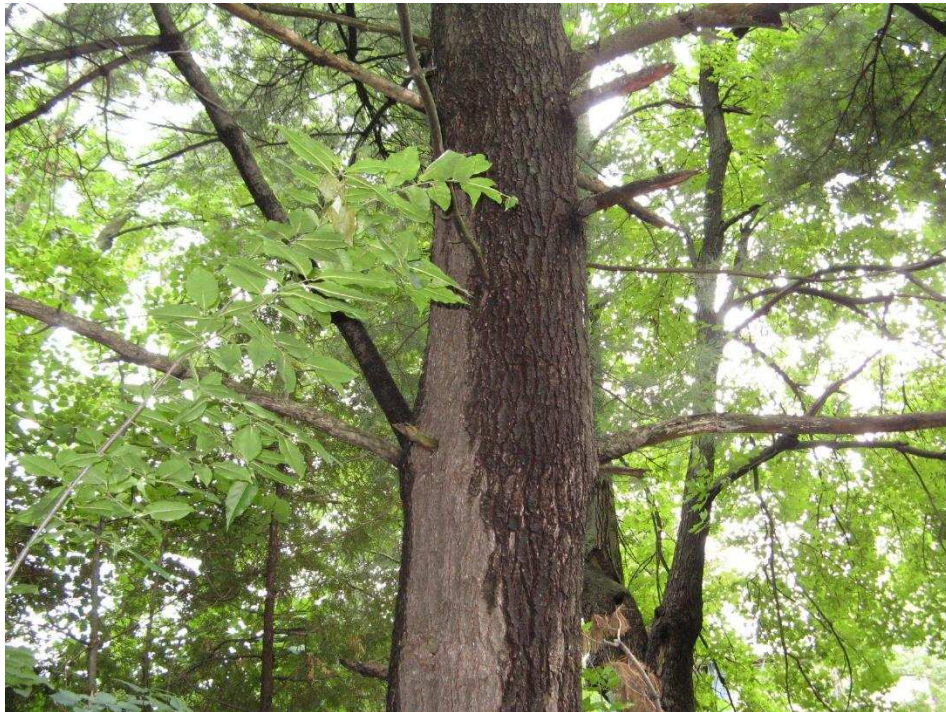
*Photo 4 – Mature white pine in the southwest portion of 3044 Innes Road. View looking west*

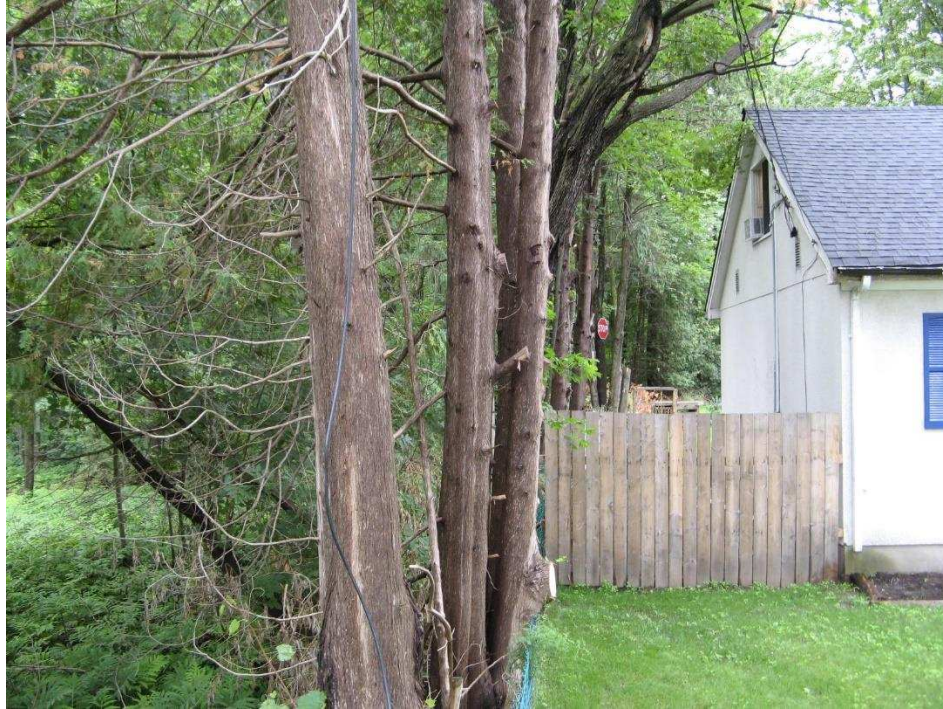
*Photo 5 – White cedars along the east fenceline of 3044 Innes Road, south of Innes Road. Front cedars are on City property but will be retained. View looking south.*

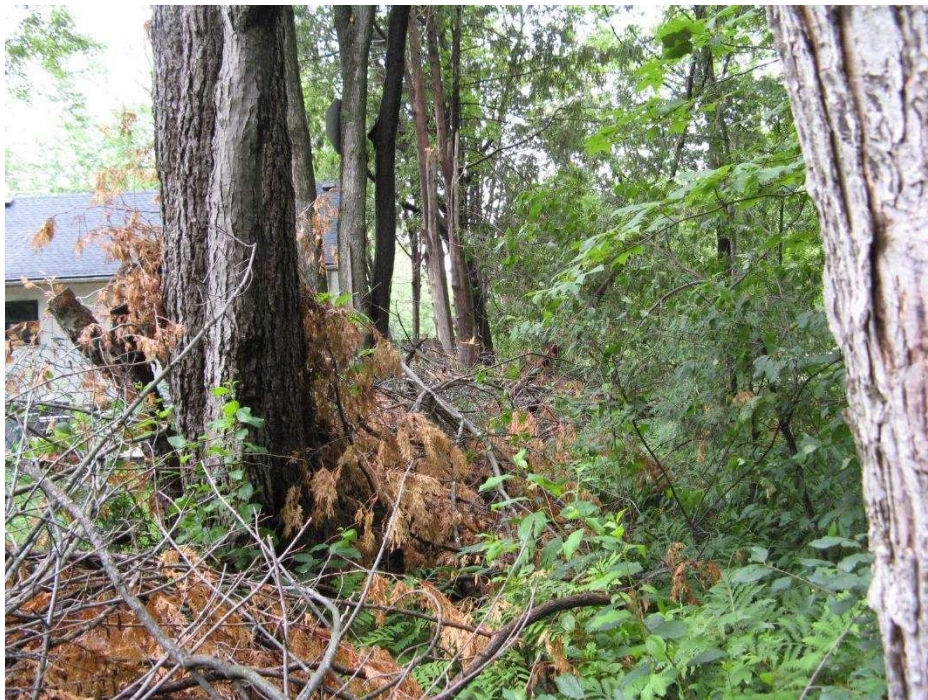
In addition to the white cedars described above, several trees are along the east property line. These include a 48cm dbh sugar maple, a coppice sugar maple with stems up to 30cm dbh, and three red maples (18cm, 20cm, and 50cm dbh) (Photo 6).

*Photo 6 - Maples and cedars along the south portion of the east fenceline of 3044 Innes Road. In forefront is mature sugar maple east of site with critical root zone extending onto the site. View looking north*

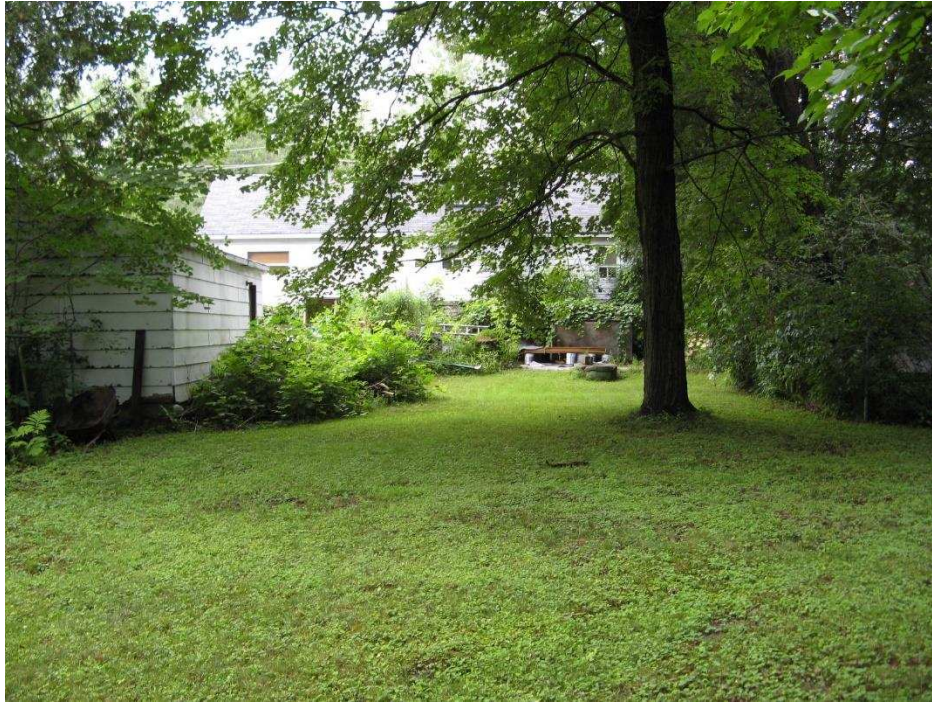
The rear yard of 3040 Innes Road is also a cultural meadow of mowed grassed areas, with three mature red maples (Photo 7). The northern maple (60cm dbh) has been pruned and appeared to be in poor condition with reduced leaf-out. The other two maples (60cm and 75cm dbh) appear to be in better condition. A 22cm dbh Scot's pine is adjacent to the south maples, with a 40cm dbh white cedar and a dead 30cm dbh green ash in the central-west portion of the rear yard.

*Photo 7 – Manicured lawn and one of the mature red maples in the south half of 3040 Innes Road. View looking north*

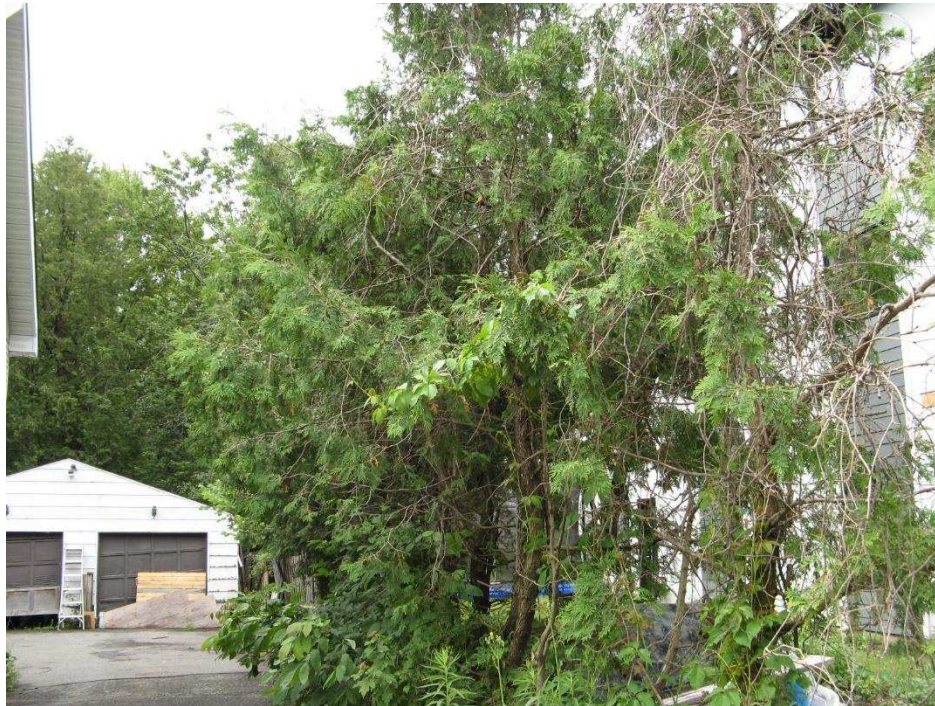
A coniferous hedgerow of ten white cedars between 18cm and 32cm dbh are along the common property line between 3040 and 3044 Innes Road (Photo 8). A 30cm dbh white elm is also in this area, along with a 60cm dbh red maple. The red maple had major trunk damage but the leaf-out was generally good. Grey dogwood, common buckthorn, glossy buckthorn, and regenerating ash are also among and adjacent to the cedar hedgerow. The invasive garlic mustard is common in this area.

*Photo 8 – White cedars between 3040 and 3044 Innes Road. View looking south*

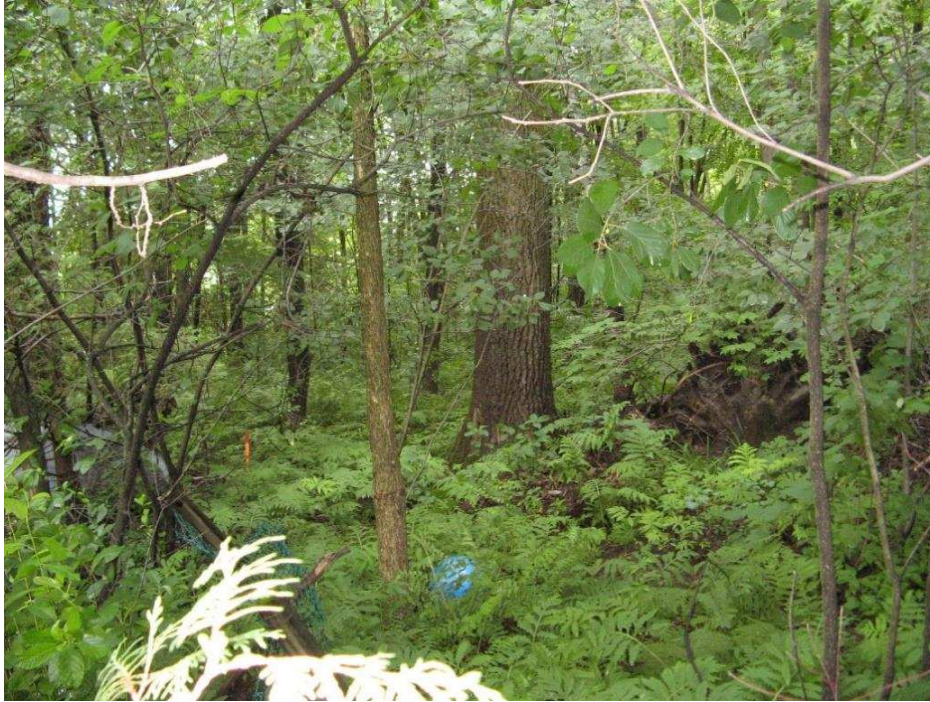
There are no co-owned trees or trees immediately to the south of the site with critical root zones that extend onto the site except an 80cm dbh eastern cottonwood 2.25 metres to the south of the southeast site corner (Photo 9, Tree D on Map 2) and a 55cm dbh twin-stem immediately south of the fence line in the southwest portion of 3040 Innes Road (Tree E on Map 2). The cottonwood appeared to be in poorer condition with reduced leaf-out. The maple to the west appeared to be in better condition, with a few of the maple branches extending north of the tree, overhanging the south edge of 3040 Innes Road.

*Photo 9 - Mature eastern cottonwood to the south of the southeast corner of the site (note stake).  
View looking east*

3. Where the critical root zones (ten times the trunk diameter) of the adjacent trees extend onto the site, where possible tree protection fencing as described above is to be installed along the outer edge of the root zone. Smaller roots are to be cut cleanly on an angle or kept moist until they can be backfilled if applicable. If too much of the root zone will be damaged, the adjacent landowners are to be consulted and the removed tree replaced with new plantings of native tree species in locations approved by the adjacent landowner. This is especially applicable to the red maple in the northeast portion of 2636 Cleroux Crescent. Recommended native species for planting include a mix of coniferous and deciduous species such as sugar maple, red maple, basswood, red oak, tamarack, white pine, and white spruce, along with nannyberry, elderberry, and native dogwood shrubs. Sourcing native species from local seed sources is strongly recommended to ensure adaptability and longevity;

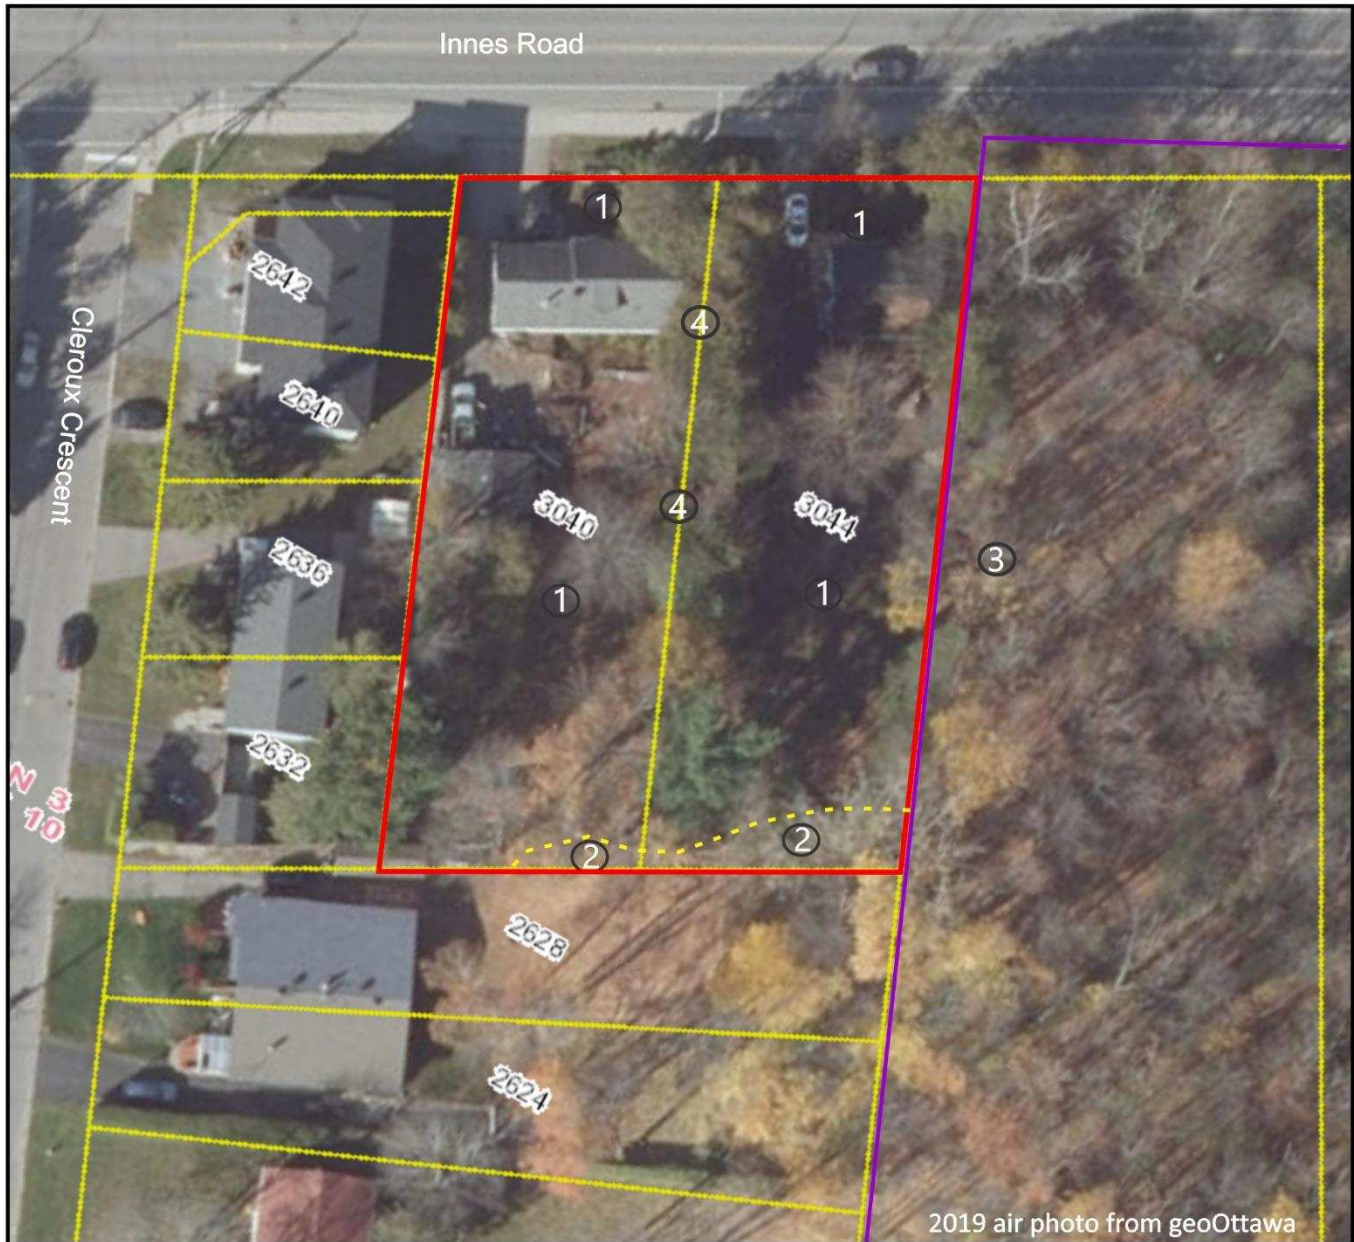
**Map 1**

**EXISTING VEGETATION**

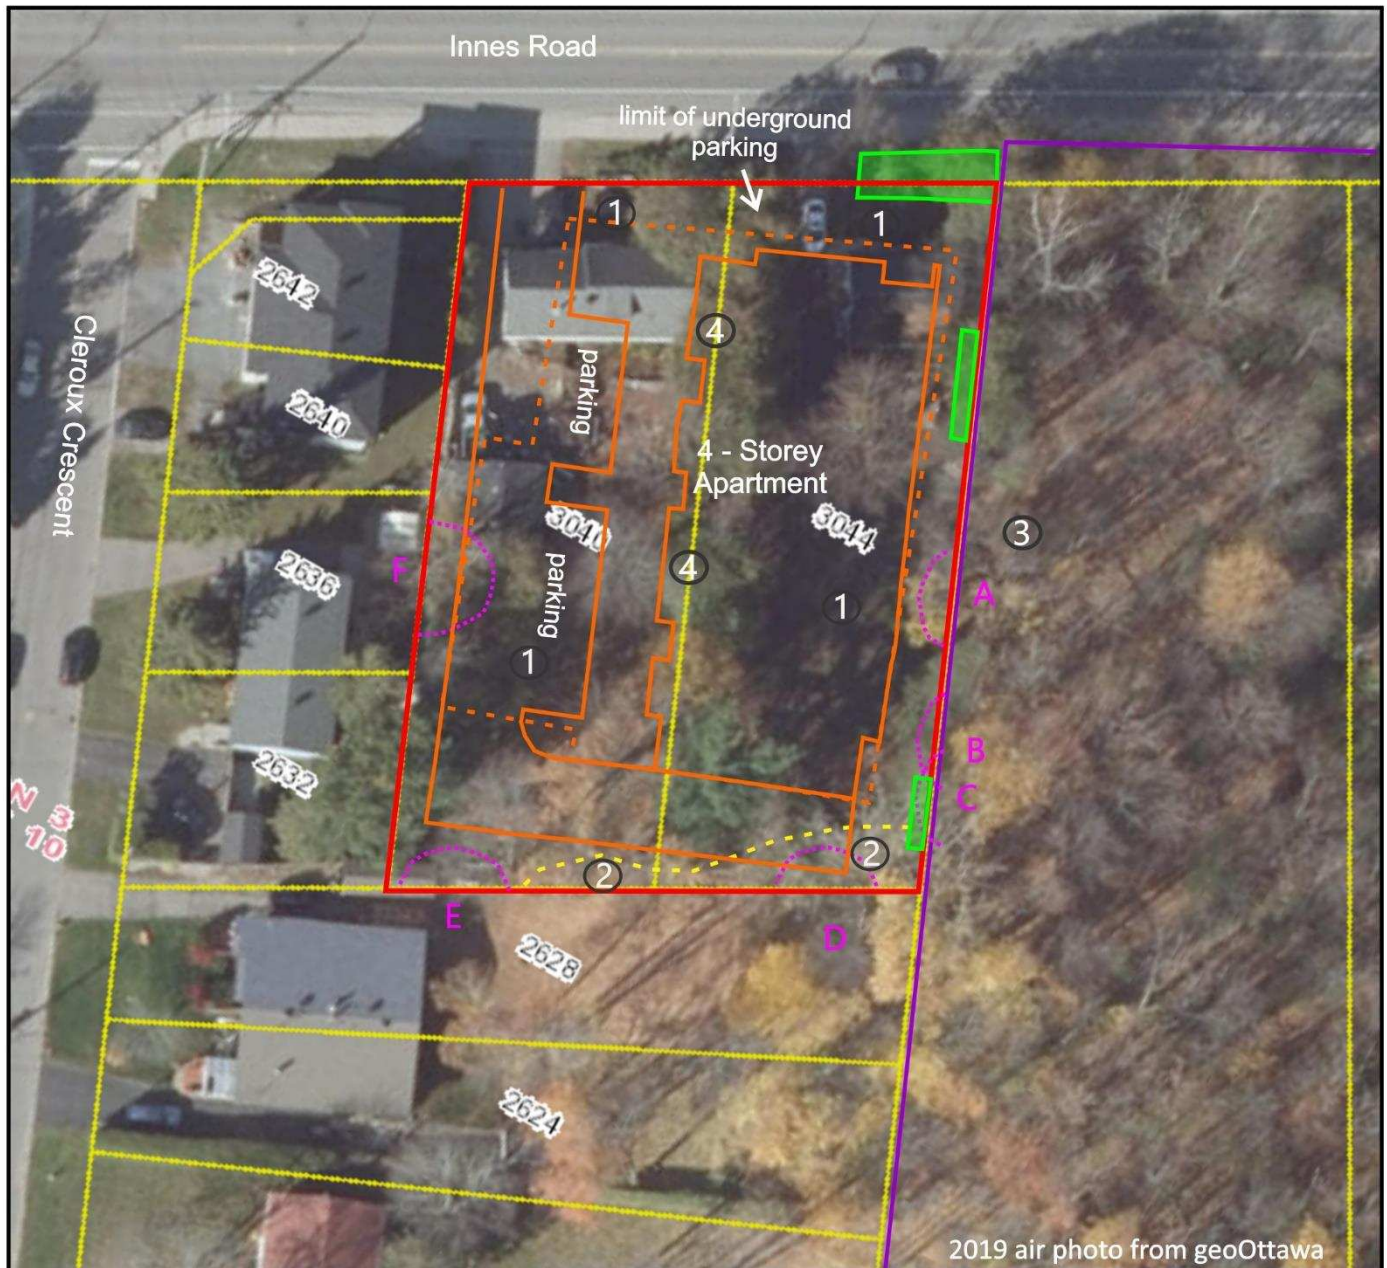
**Map 2**

Potential tree retention is shown with a green lens on Map 2. Due to the building footprint and grading requirements, tree retention appears to be limited to portions of the north and east edges.

The following Table 1 summarizes the adjacent trees with critical root zones (crz) extending onto the site. The tree letter corresponds to the letters on Map 2:

**PROPOSED CONSERVED VEGETATION**

2. Trees to be retained are to be protected with sturdy temporary fencing at least 1.3 metres in height installed from the tree trunk a distance of ten times the retained tree's diameter where possible. Locations of the tree preservation fencing are shown on the Landscape Plan by Lashley + Associates (revised October 26, 2022). Signs, notices, or posters are not to be attached to any tree. No grading, heavy machinery traffic, stockpiling of material, machinery maintenance and refueling, or other activities that may cause soil compaction are to occur within three metres of the critical root zone of the trees to be retained and protected. The root system, trunk, or branches of the trees to be retained are to be protected and not damaged. If any roots of trees to be retained are exposed during site alterations, the roots shall be immediately reburied with soil or covered with filter cloth, burlap or woodchips and kept moist until the roots can be buried permanently. A covering of plastic should be used to retain moisture during an extended period when watering may not be possible. Any roots that must be cut are to be cut cleanly to facilitate healing and as far from the tree as possible. Overhanging branches from retained trees, including those adjacent to the site, that may be damaged during construction are to be pruned by a qualified arborist prior to construction. Exhaust fumes from all equipment during construction will not be directed towards the canopy of the adjacent retained trees.
