March 11, 2022  
File: PE5658-LET.01

Subject: **Phase I - Environmental Site Assessment Update**  
**3130 Woodroffe Avenue**  
**Ottawa, Ontario**

Further to your request and authorization, Paterson Group (Paterson) conducted a Phase I – Environmental Site Assessment (Phase I ESA) Update for the aforementioned site, henceforth referred to as the “Phase I Property”. This report updates a previous Phase I ESA, completed by Paterson in September 2015.

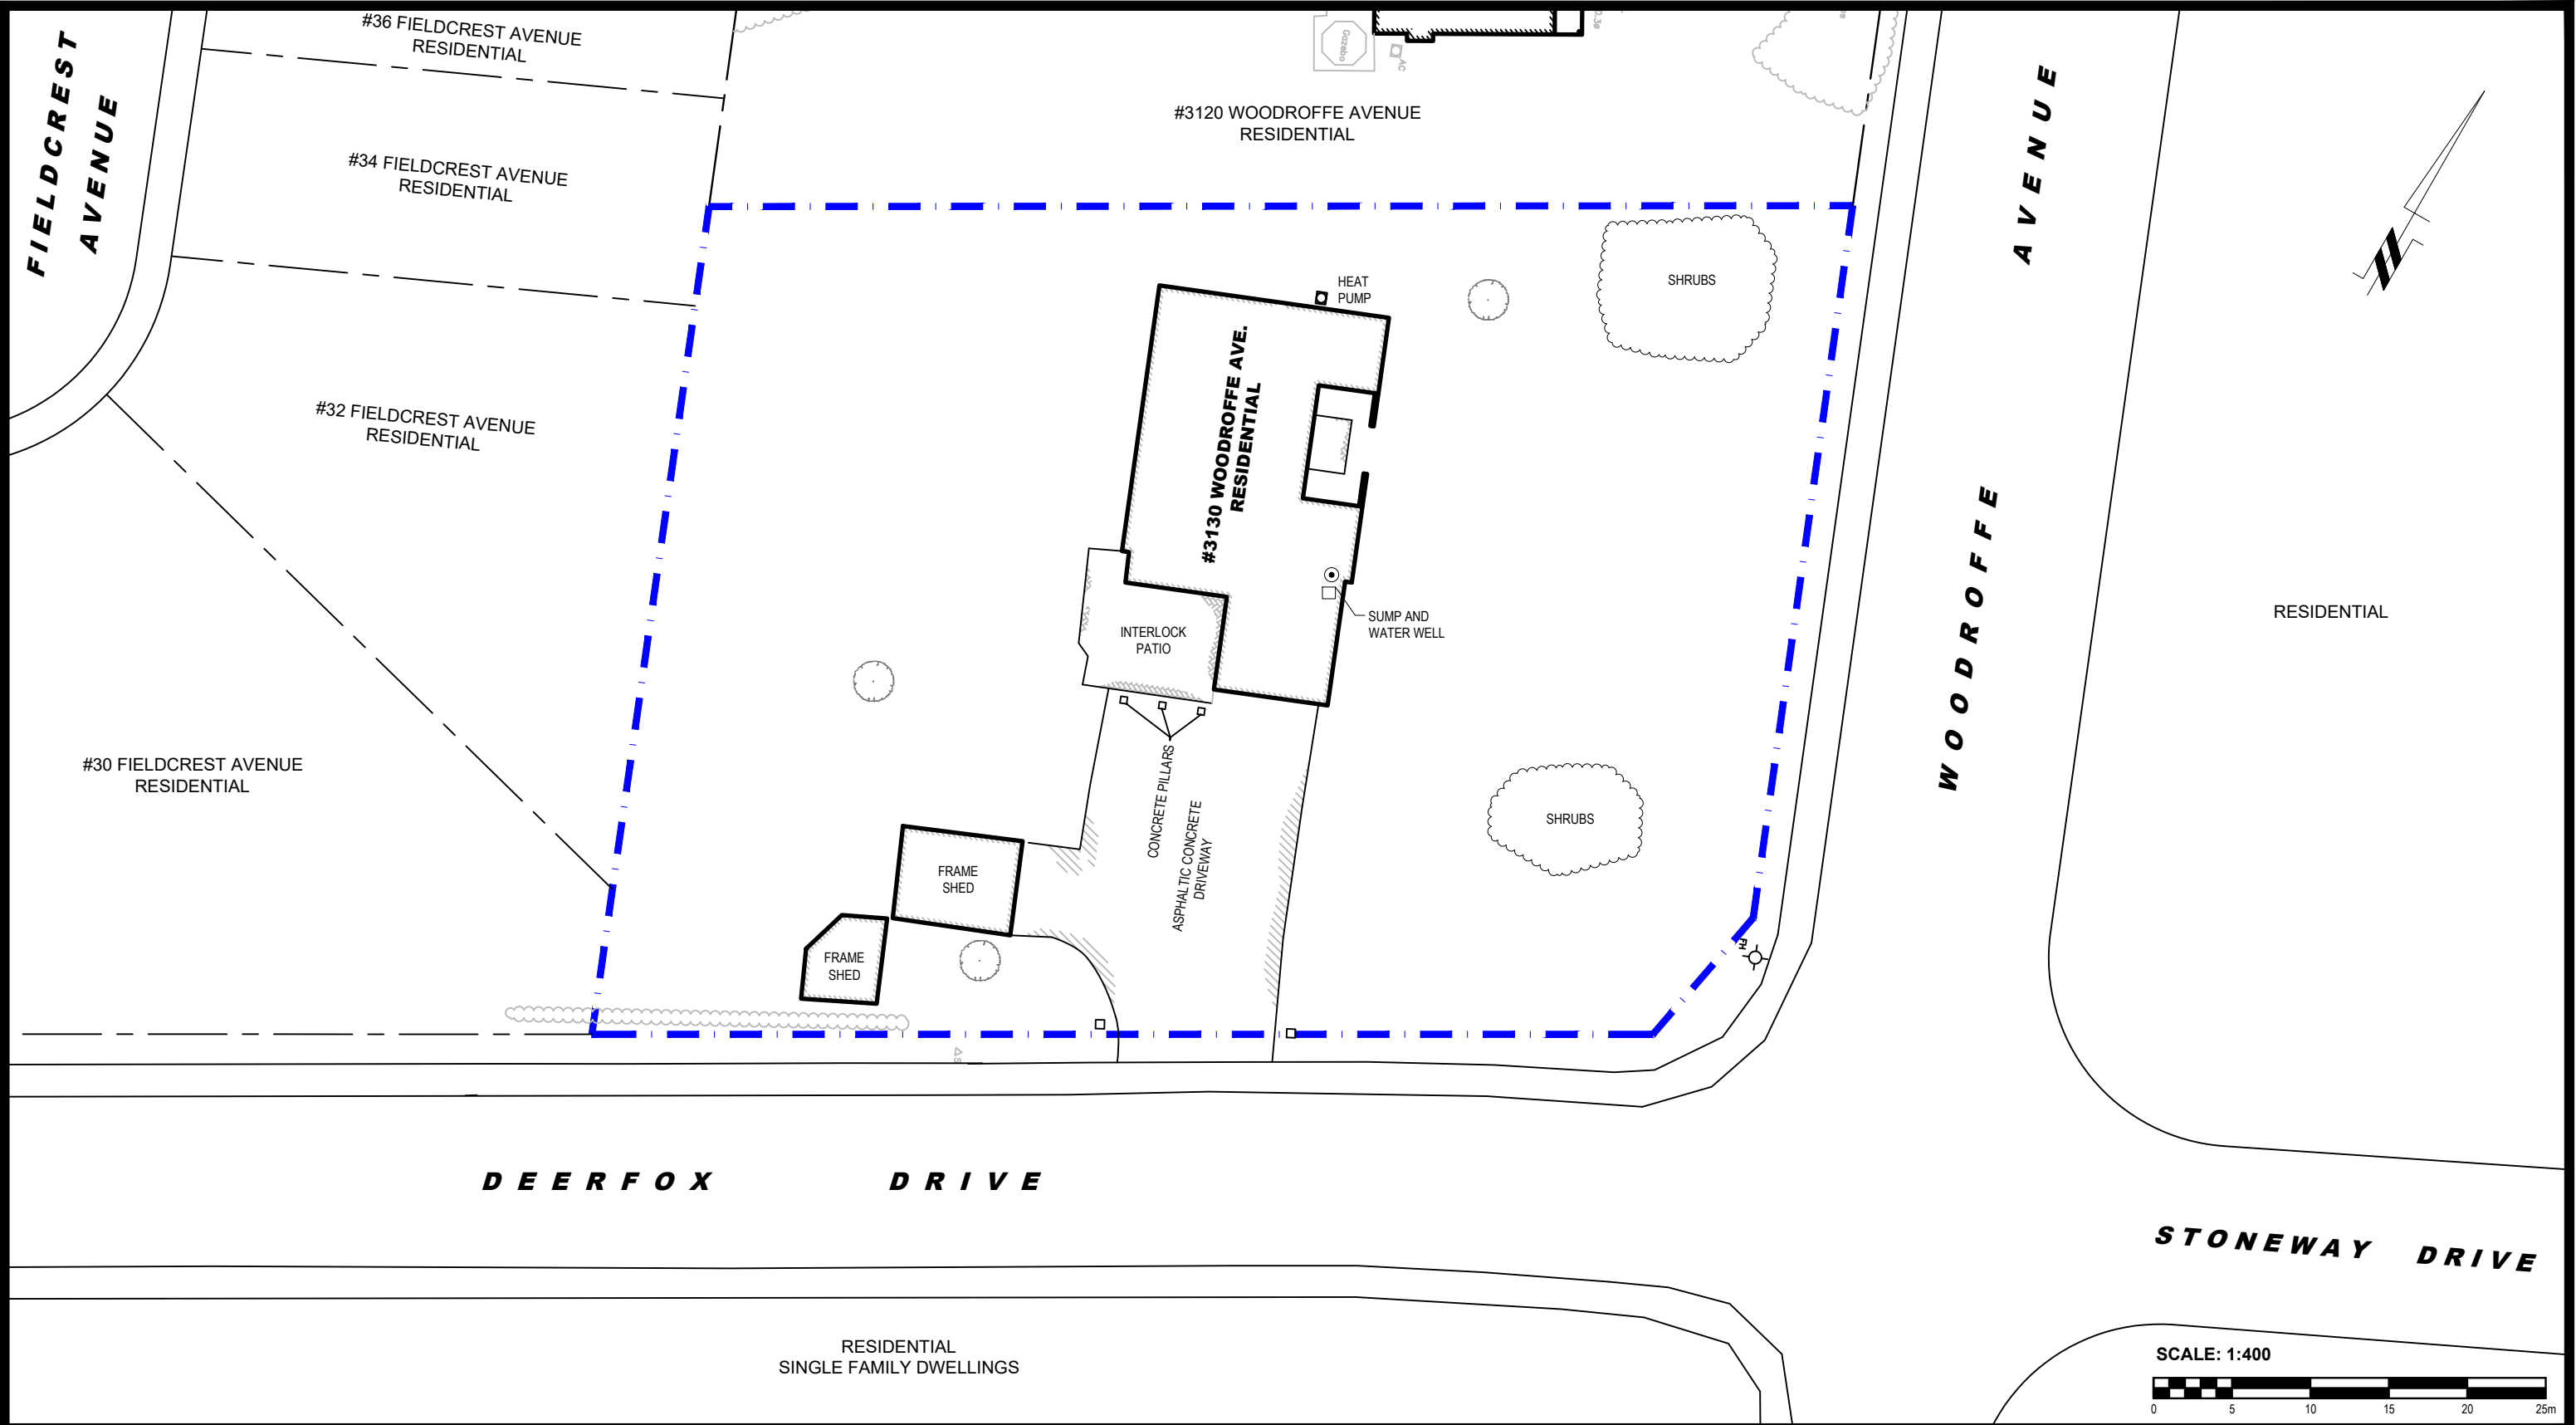
p:\autocad\drawings\environmental\pe5658\pe5658-1 site plan (update).dwg

Water drainage on the property occurs primarily via infiltration throughout the property, as well as via surface run-off towards catch basins present along the adjacent streets. No ponded water, stressed vegetation, or any other indications of potential sub-surface contamination were observed on-site at the time of the site inspection.

The Phase I Property is currently occupied with a two-storey residential dwelling, with one basement level. Built circa 1968, the wood-framed residence is constructed with a poured concrete foundation, and is finished on the exterior with brick and stone in addition to both a sloped-shingled roof as well as a flat rolled membrane style roof. The residence is currently heated via natural gas-fired equipment.

At the time of the site inspection, no chemical storage areas, above ground storage tanks (ASTs), or evidence indicating the presence of any underground storage tanks (USTs), were observed on the Phase I Property.

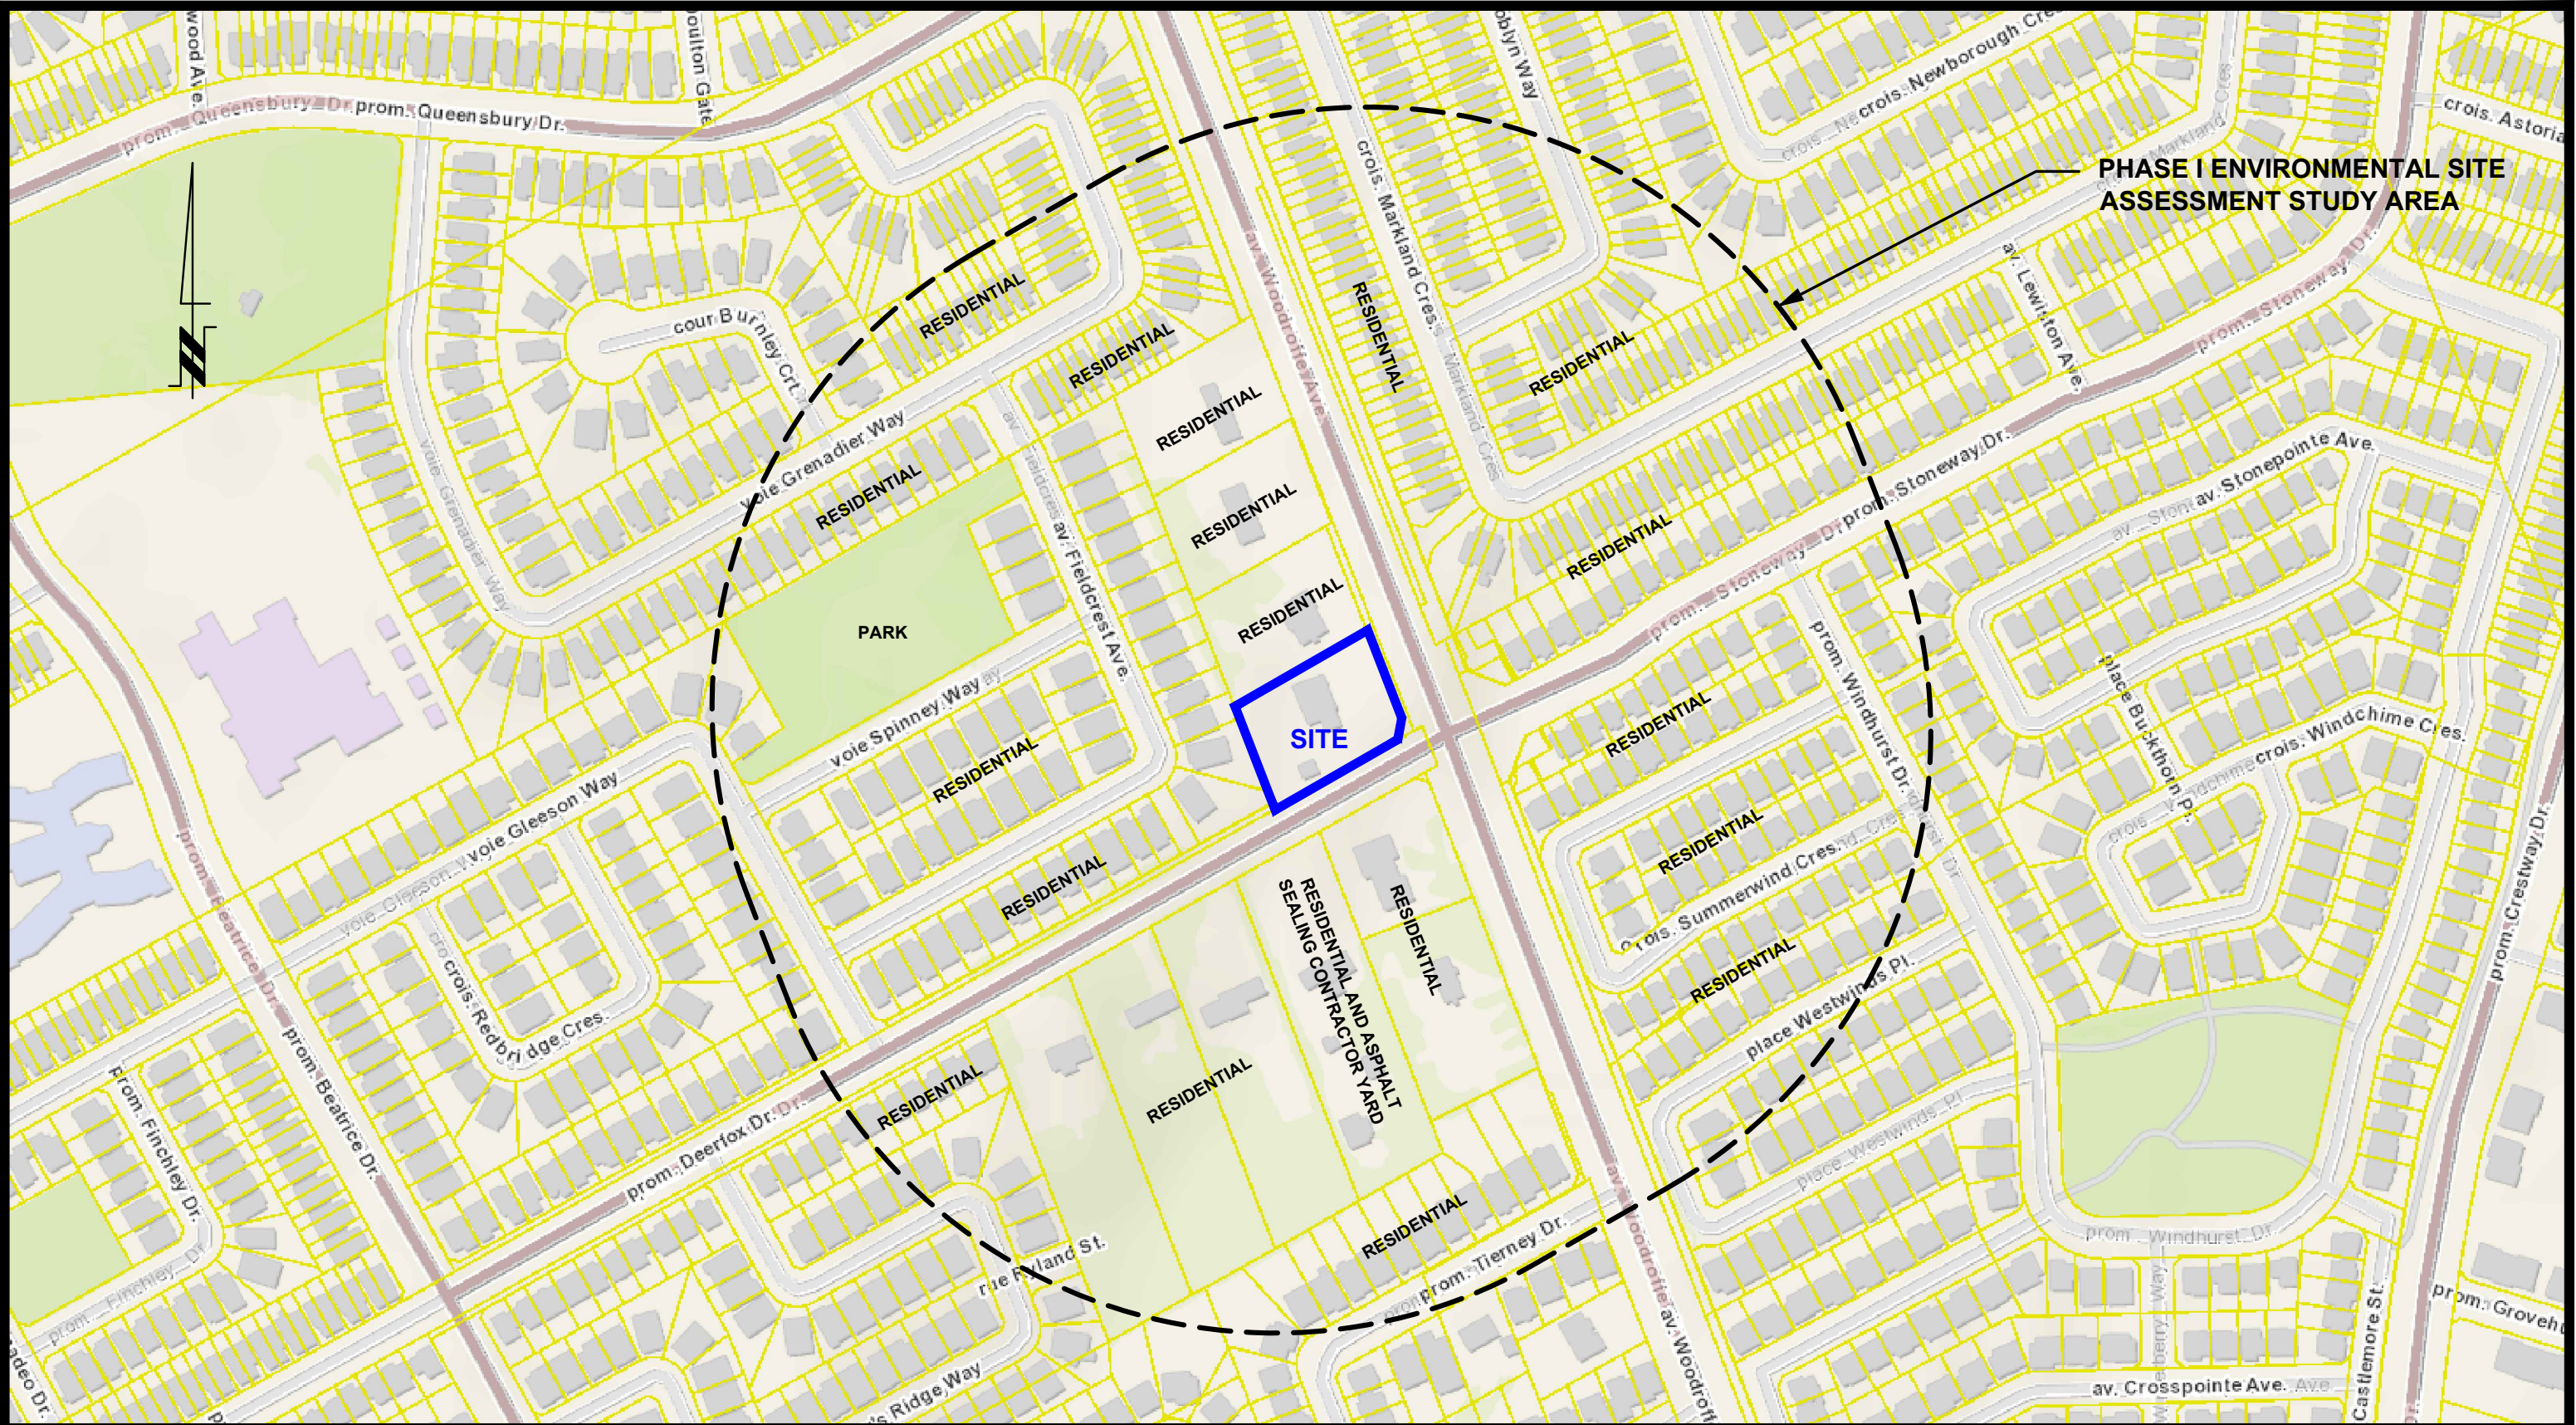
p:\environmental\pe5658\pe5658-2 surrounding land use plan.dwg

An inspection of the neighbouring properties was conducted from publicly accessible roadways at the time of the site inspection. Land use adjacent to the Phase I Property was observed as follows:
