**GEOTECHNICAL REPORT**

2-15 unit 2 BR residences  
Located at  
2345 - 2351 Mer Bleue, Ontario

Prepared for:  
Ziad Zamat

Prepared by:  
Derrick R. Clark, P.Eng.  
EAU Structural & Environnemental Services  
Telephone (613) 869 0523  
[derrick.r.clark@rogers.com](mailto:derrick.r.clark@rogers.com)

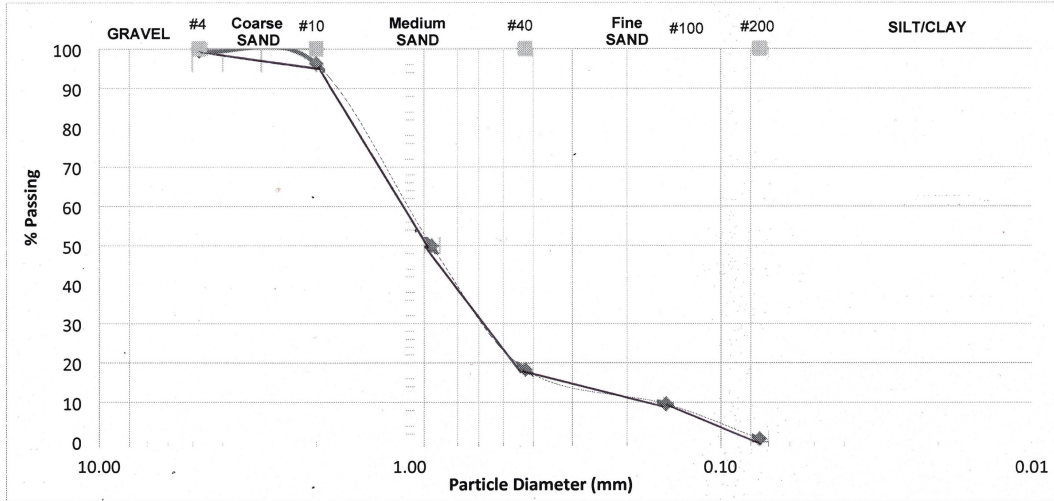
## APPENDIX C – Sieve Analysis

**Grain Size Distribution Curve Results:**

% Gravel:	<u>0</u>
% Sand:	<u>60</u>
% Fines:	<u>10</u>

D <sub>10</sub> :	<u>0.15</u>
D <sub>30</sub> :	<u>0.6</u>
D <sub>60</sub> :	<u>1</u>
D <sub>50</sub> :	<u>0.85</u>

C <sub>u</sub> :	<u>1.67</u>
C <sub>c</sub> :	<u>0.00</u>

Ziad Zarmat                      2345/2351 Mer Bleue  
 date: 19 Nov. 2021  
 description: poorly graded    fine (brown) sand            type SM            20 >T>8 min/cm

The native sand horizon at this site was approximately 300mm thick. The native sand was moist to touch. The native sand was sampled, dried and analysed using the standard drying procedures and standard sieve analysis. The sieve analysis revealed a poorly graded fine sand, type SM, with a poor permeability  $20 > T > 8$  mins/cm. The sand had a moisture content MC of 23%. Because of the recent rain, this explains why the sand was wet to the touch and why MC of 23%. See Appendix C
