## Phase I Environmental Site Assessment

436 Athlone Avenue  
Ottawa, Ontario

October 29, 2021

Report: PE5428-1

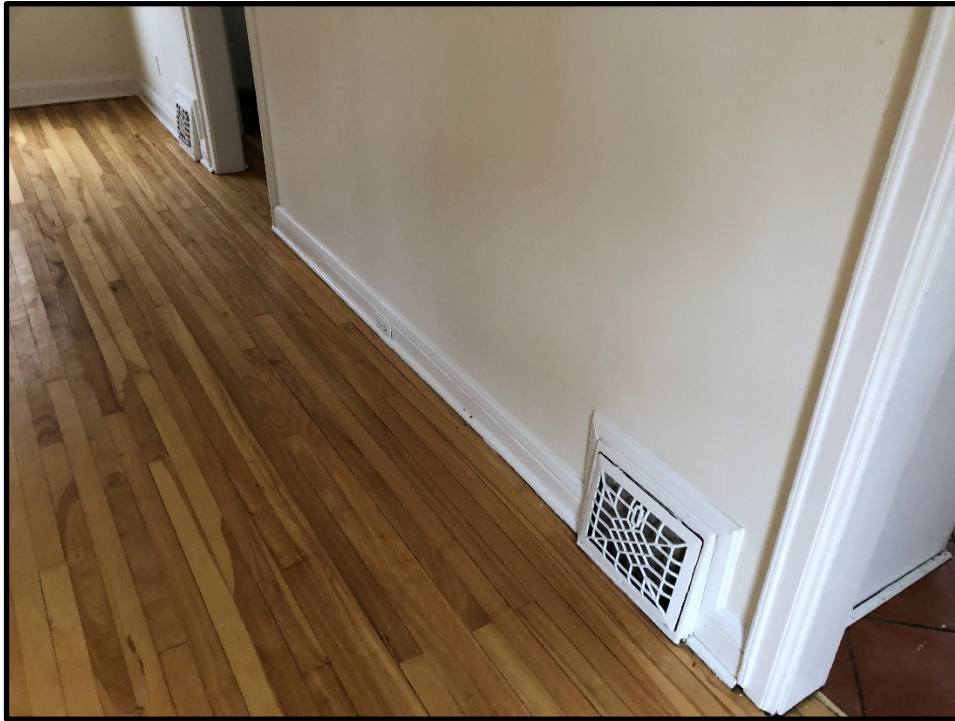
Based on the age of the subject building (pre-1945), asbestos containing building materials may be potentially present within the structure. Potential ACMs observed on-site include the drywall joint compound, plaster, and stipple plaster ceilings. These ACMs were observed to be in good condition at the time of the site inspection and do not represent an immediate concern to the building's occupants.

Based on the age of the subject building, lead-based paints may be present on any original or older painted surfaces. Painted surfaces were generally observed to be in good condition at the time of the site inspection and do not represent an immediate concern.

Photograph 1: Floor and walls of the first-floor living room.

Based on the age of the subject building, asbestos containing building materials (ACMs) may be potentially present within the structures. Potential ACMs observed on-site include the drywall joint compound, plaster, and stipple plaster ceilings. These ACMs were observed to be in good condition at the time of the site inspection and do not represent an immediate concern. A designated substance survey (DSS) of the subject building should be conducted in accordance with Ontario Regulation 278/05, under the Occupational Health and Safety Act, prior to any demolition activities, if one has not already been conducted.

Based on the age of the subject building, lead-based paints may be present on any original or older painted surfaces. The painted surfaces within the subject building were generally observed to be in good condition and do not pose an immediate concern. Major work involving lead-based paint or other lead containing products must be done in accordance with O.Reg. 843, under the Occupational Health and Safety Act.

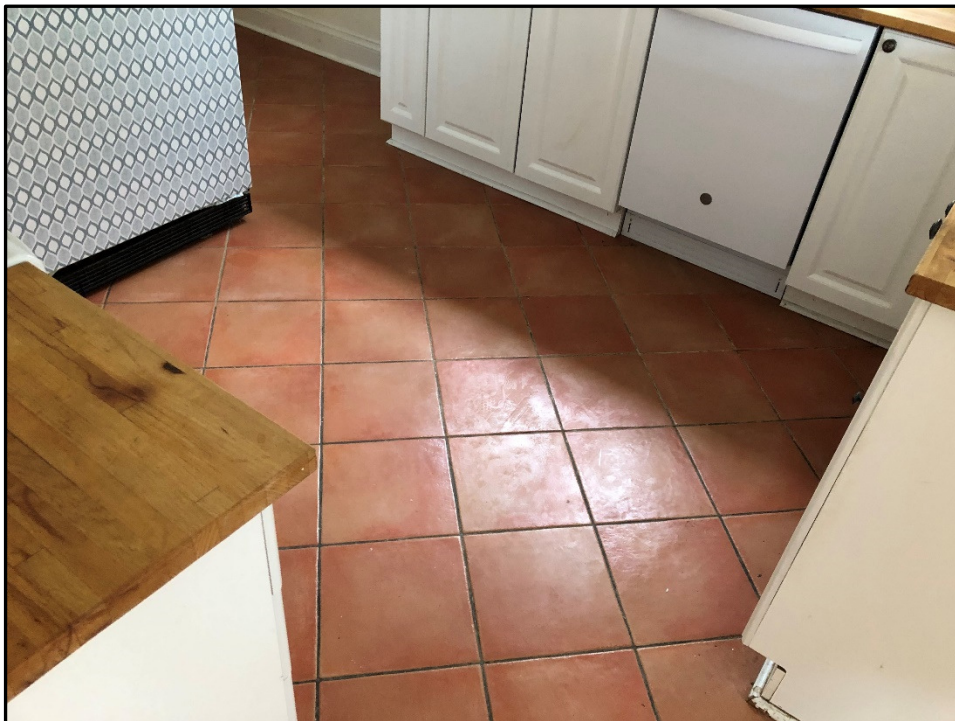
Photograph 2: Ceramic tile flooring in the first-floor kitchen.

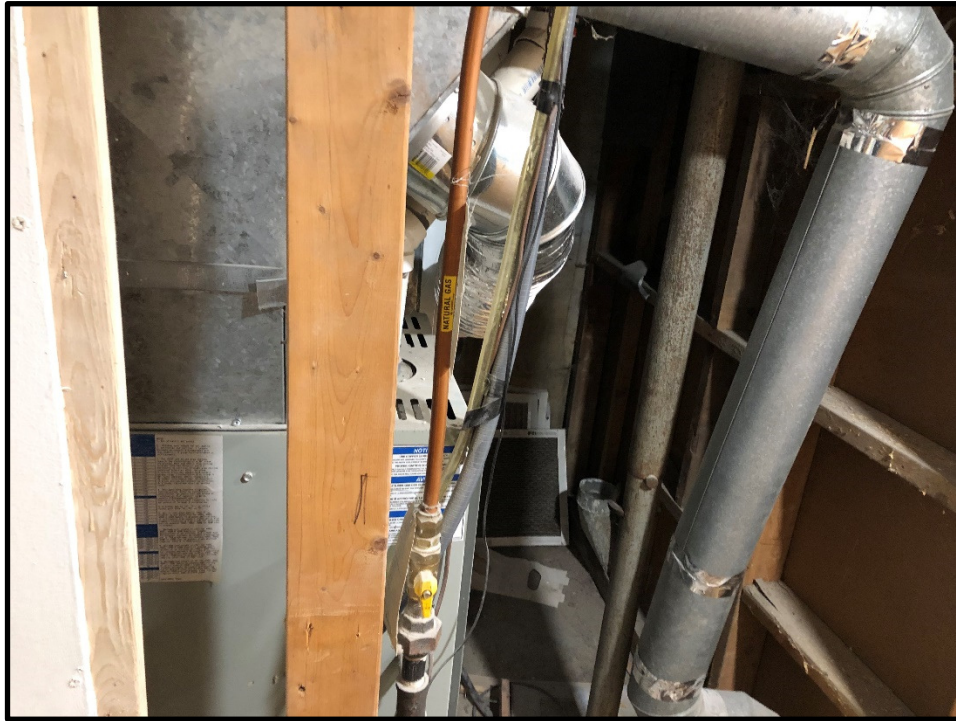
The property is currently occupied with a two-storey residential dwelling, with one basement level. Built sometime prior to the 1940s, the subject building is constructed with a poured concrete foundation and is finished with exterior stucco siding, in addition to a sloped-shingled roof. The subject building is currently heated via a natural gas-fired furnace, located in the basement.

Photograph 3: Natural Gas furnace located in the basement of the property.

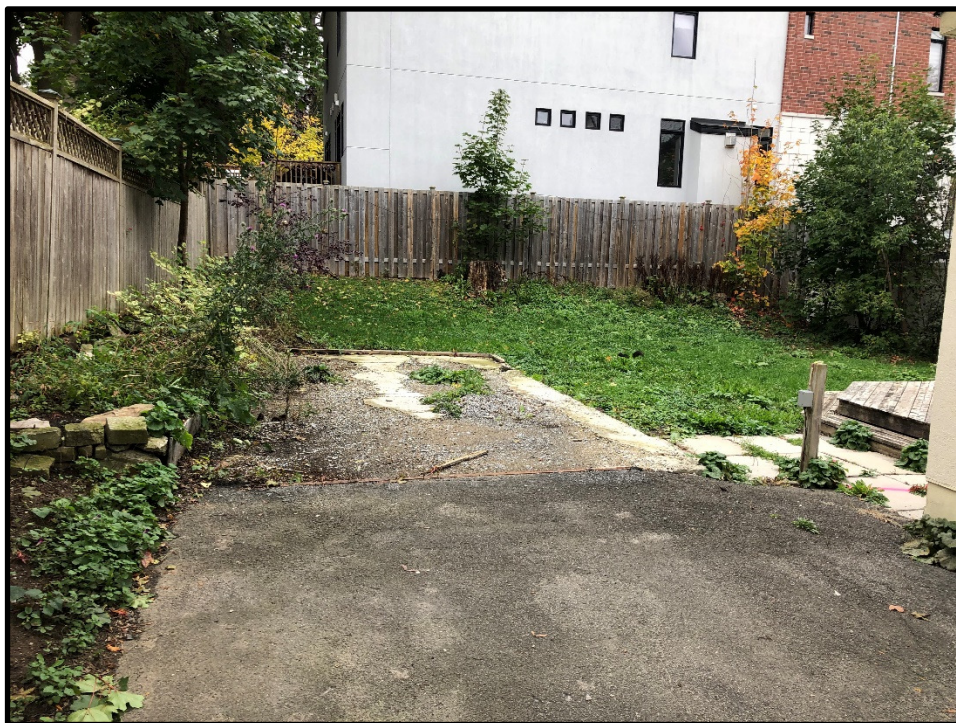
Photograph 4: Previous location of the former garage that was located on the property.

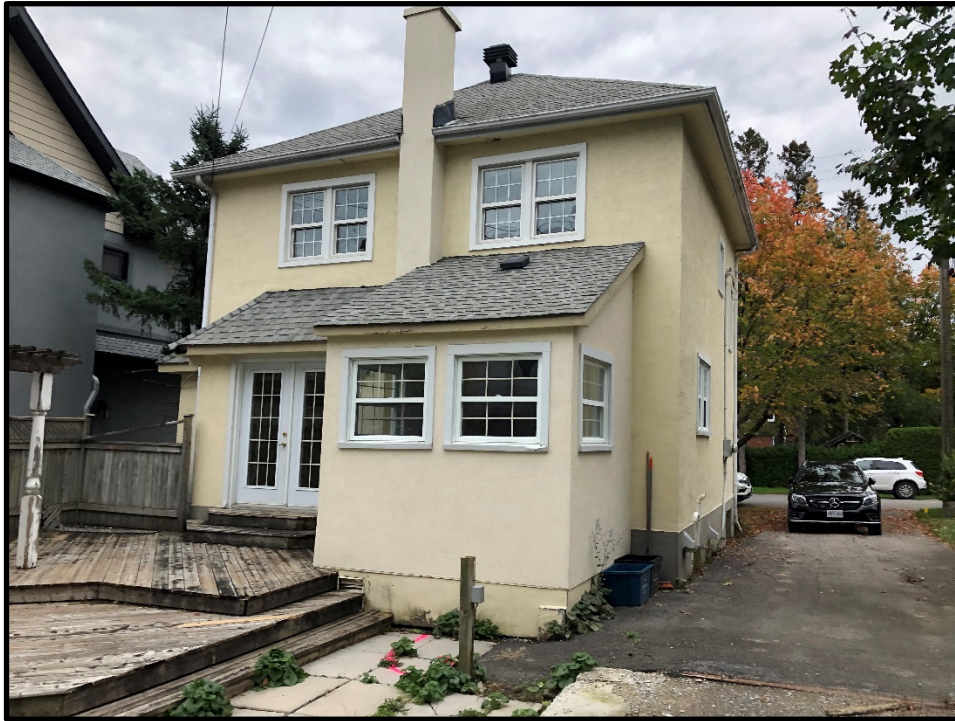
Photograph 5: View of the rear portion of the property looking towards Athlone Avenue.

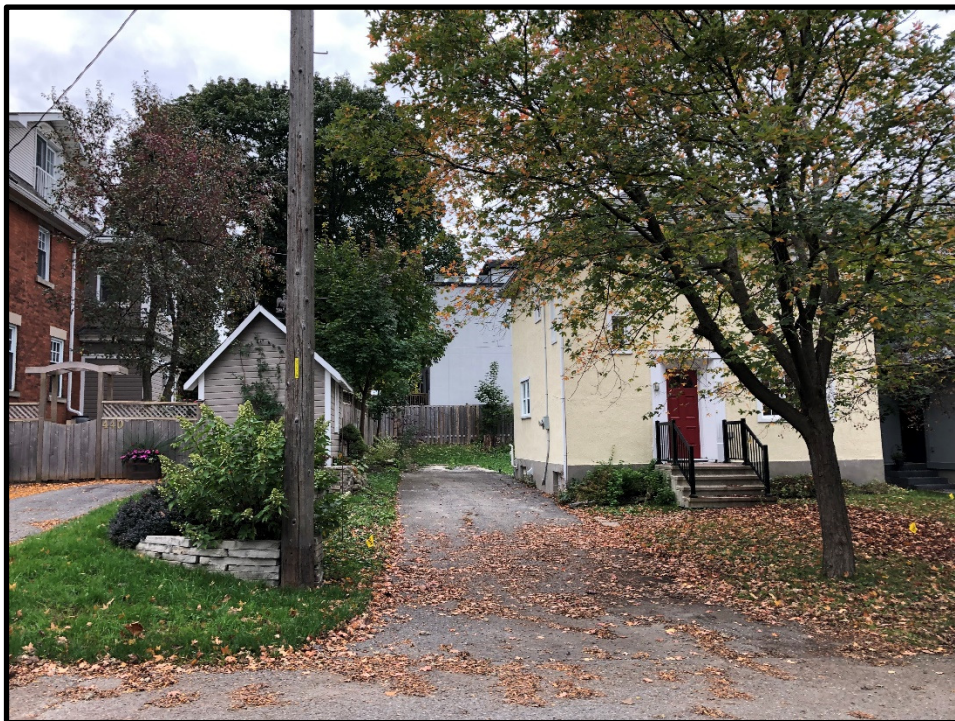
Photograph 6: View of the front portion of the property looking from Athlone Avenue.

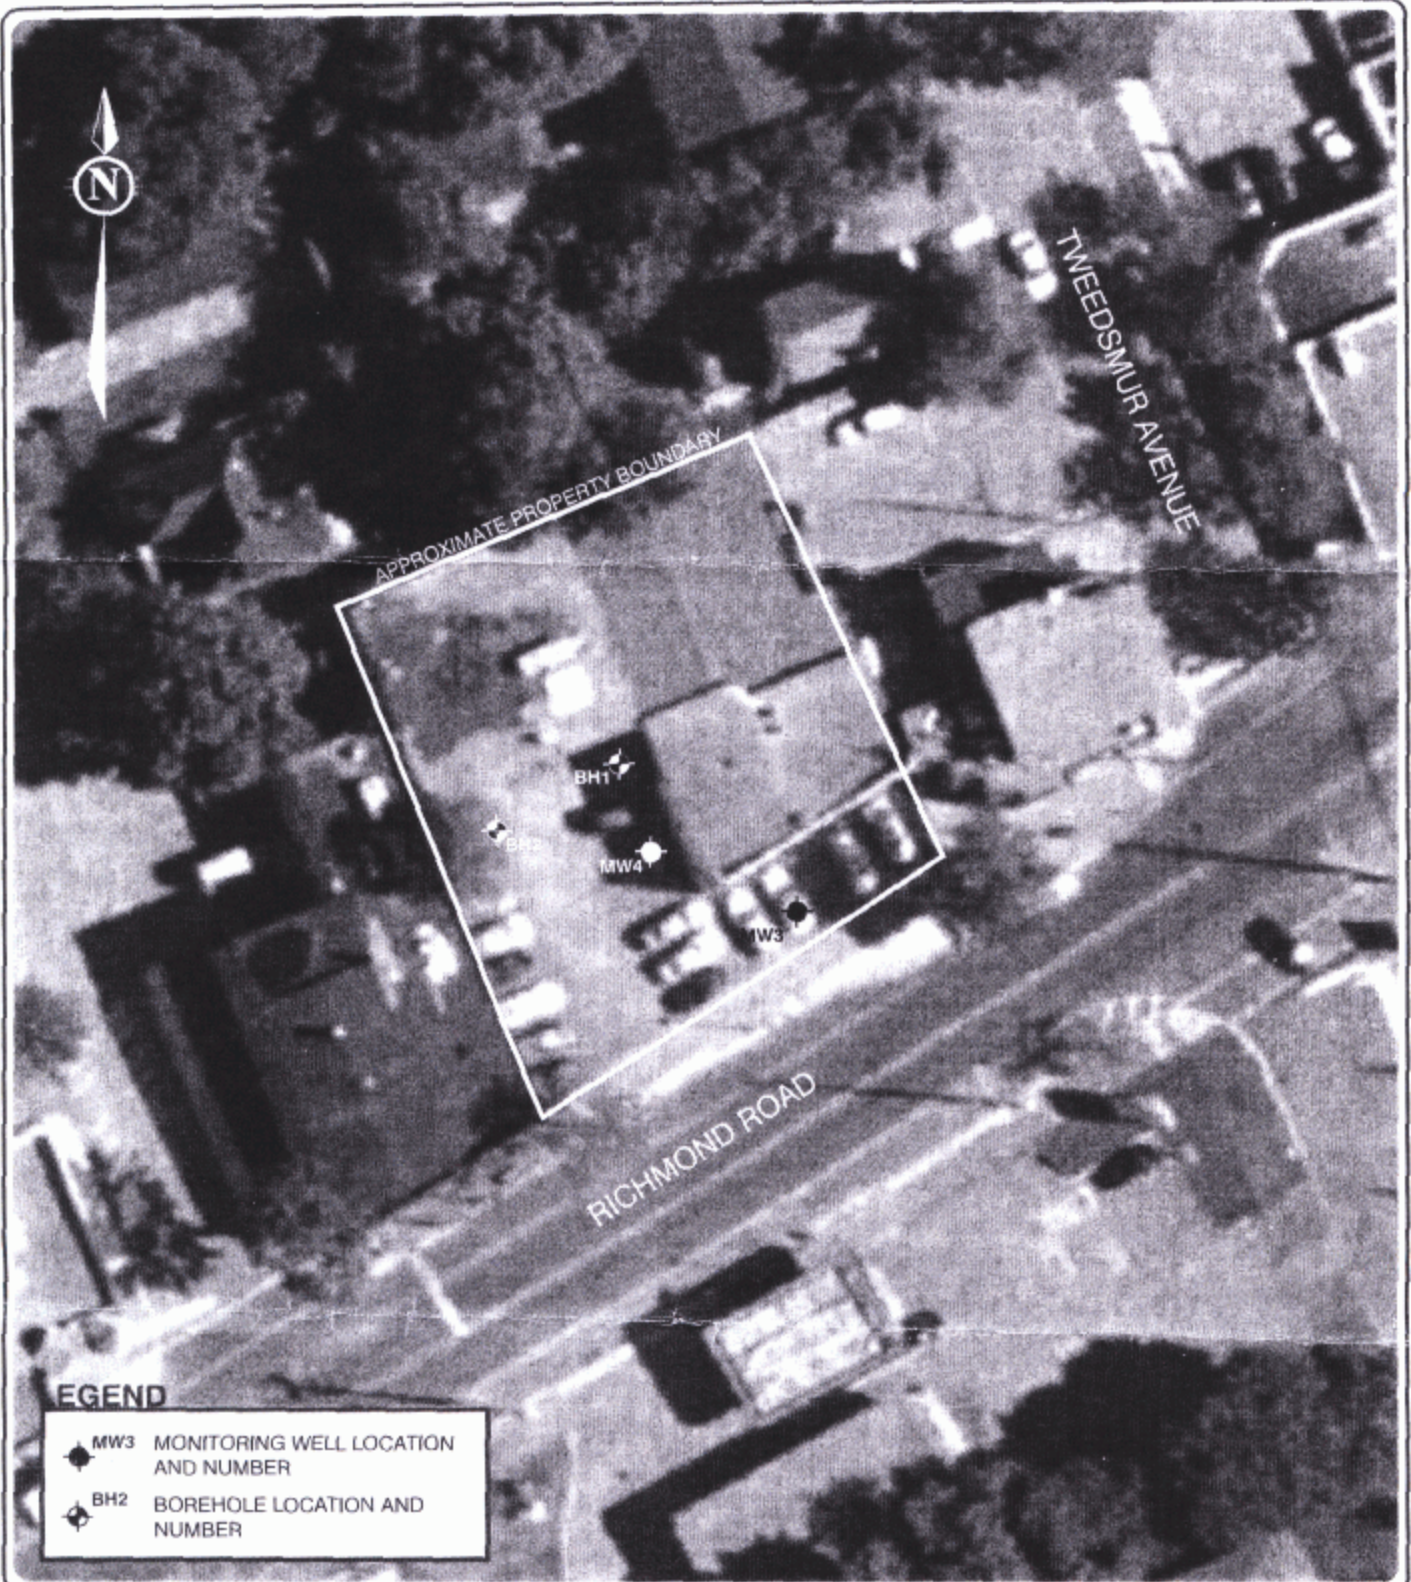
DATE OCT 2008	CLIENT GIBSONS LLP	JOB No. OTEN00019750A
DESIGN CH	CHECKED CTK	SCALE 1:500±
DRAWN RG	TITLE BOREHOLE & MONITORING WELL LOCATION PLAN 255 RICHMOND ROAD, OTTAWA, ON.	FIG 2
