# **Phase Two Environmental Site Assessment**

125 Colonnade Road,  
Ottawa, Ontario

**Access Property  
Development Inc.**

March 31, 2022

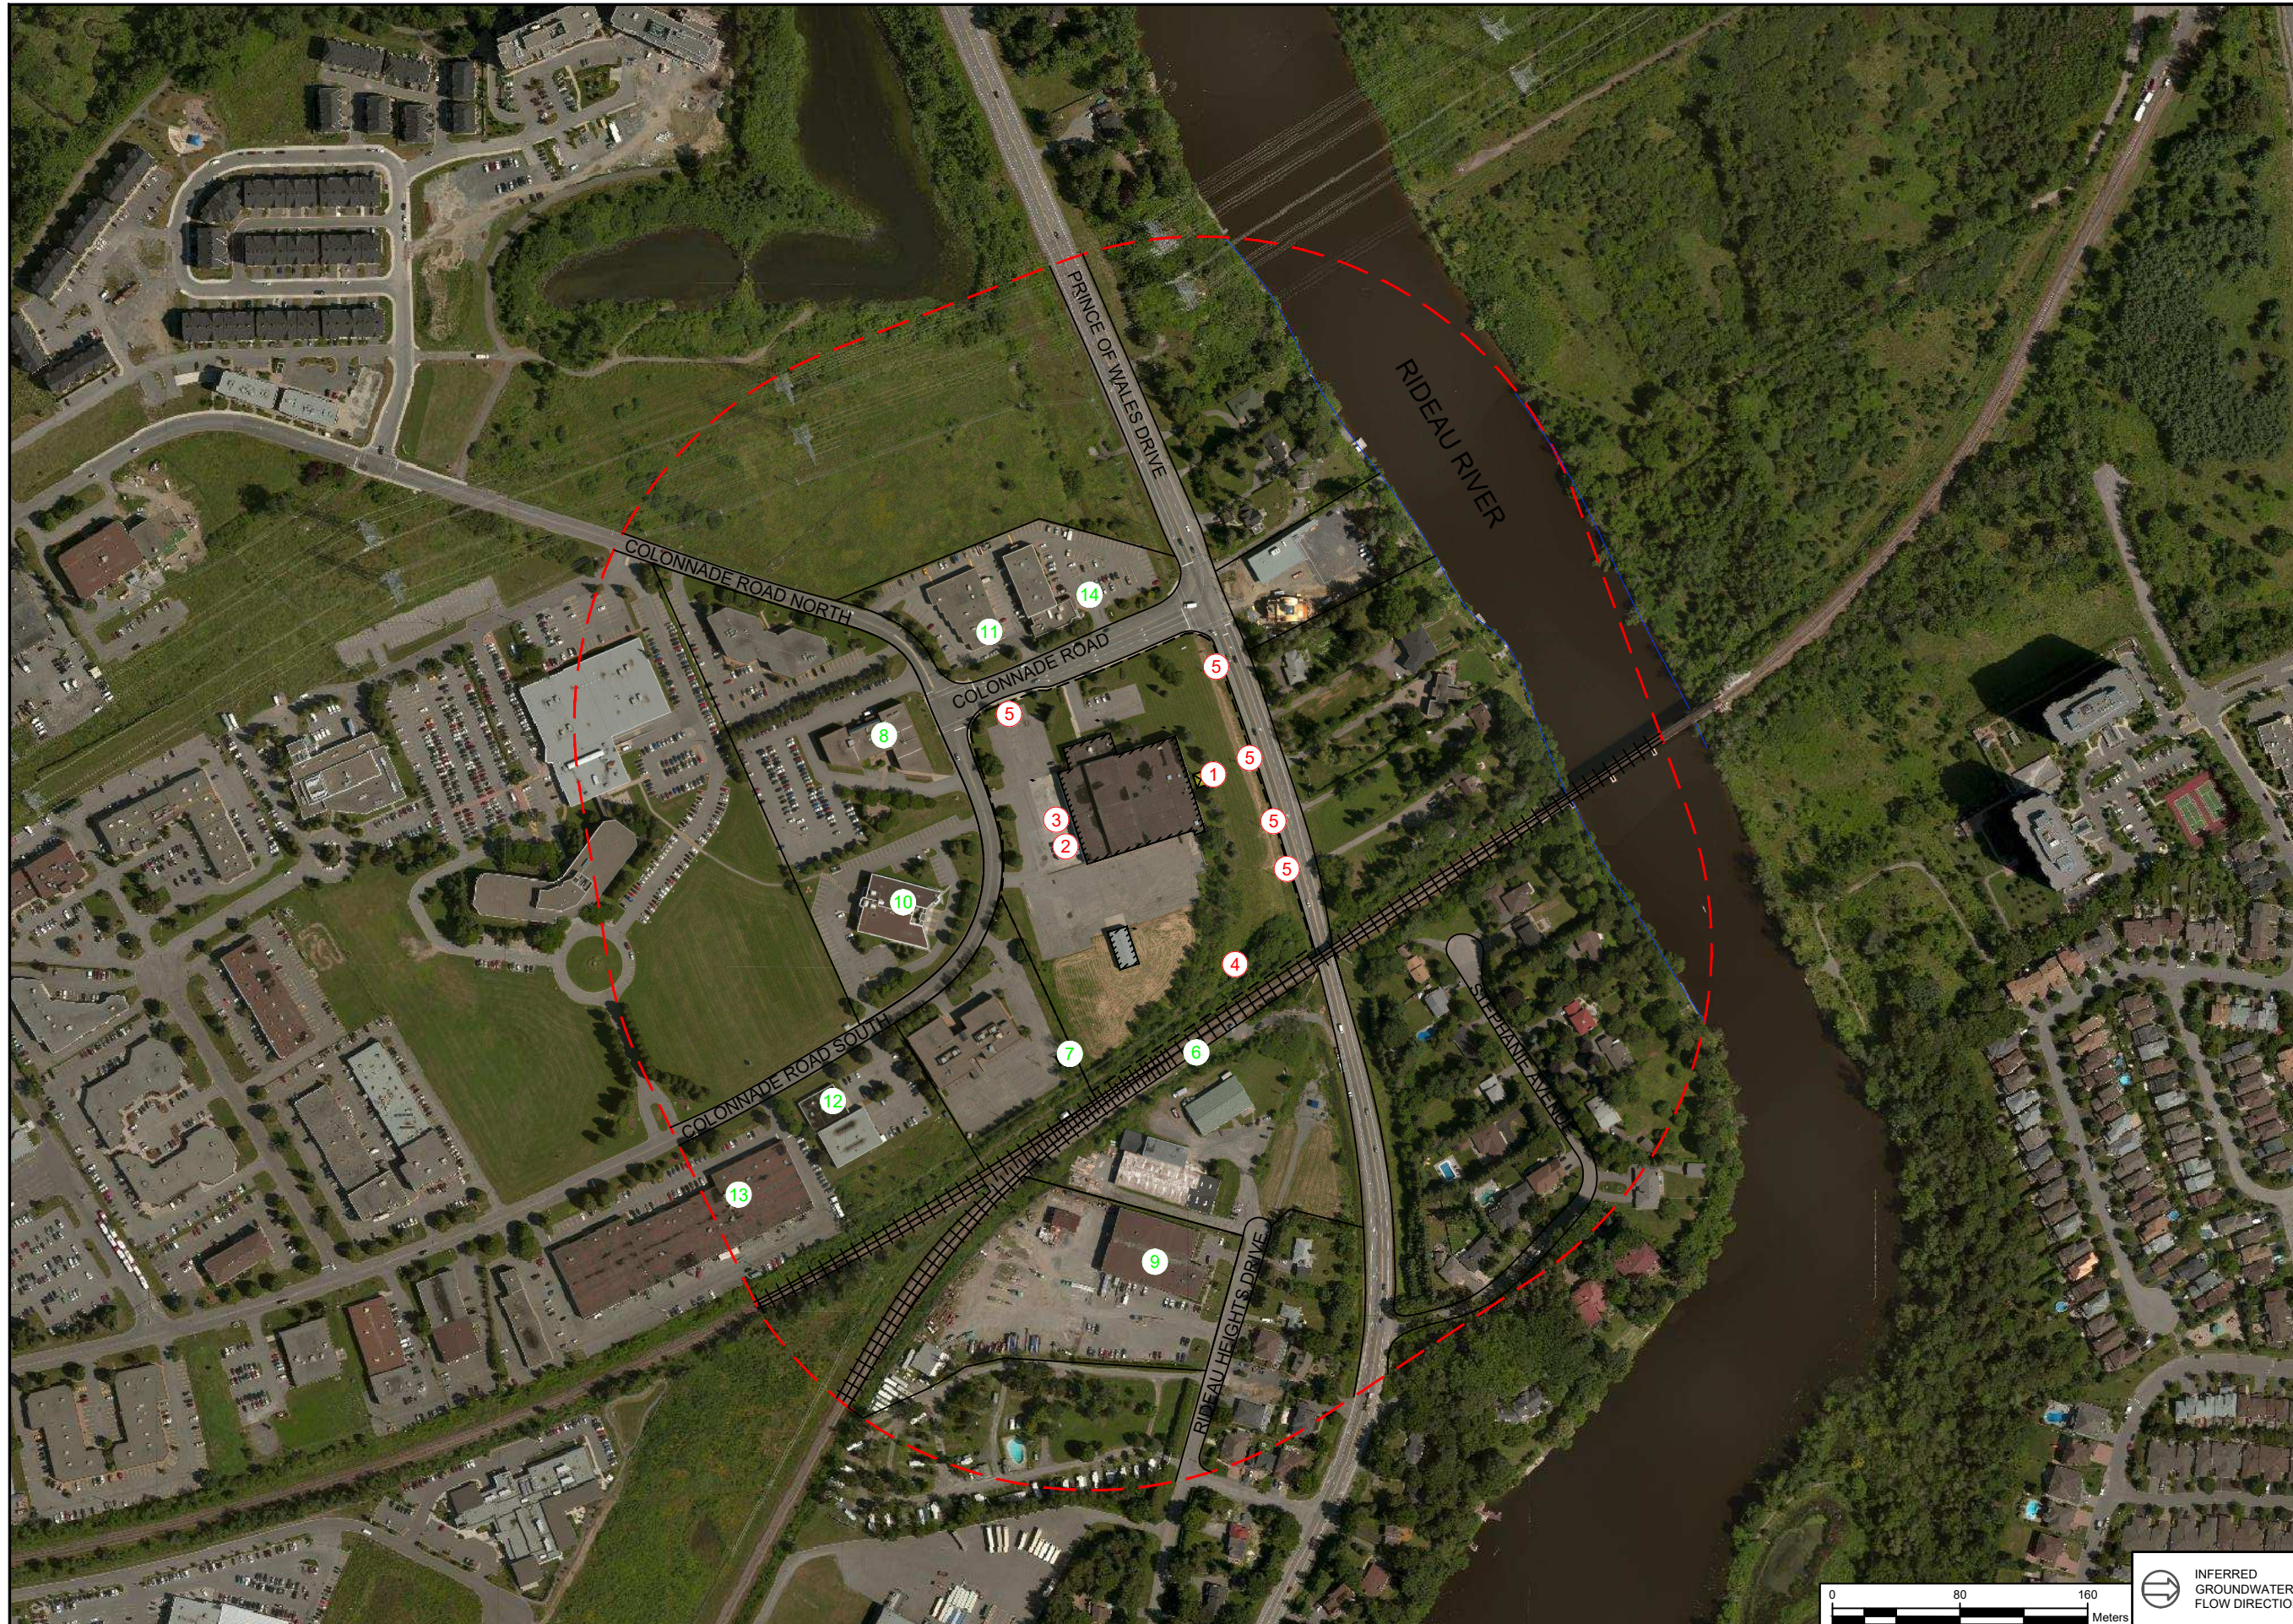
- PCA #1 (Item 18: Electricity Generation, Transformation and Power Stations) – Transformer substation is located east of Site Building A. Oil staining was observed on the concrete slab for the transformer substation located east of Site Building A. The concrete in the area of oil staining was observed to have minor cracking and the oil staining is considered to represent a PCA for the Phase One Property and is considered an APEC.

- PCA #4 (Item 46 – Rail Yards, Tracks and Spurs) - During the Site reconnaissance, Pinchin observed one railway spur line located along the south elevation of the Phase One Property, is a PCA and represents an environmental concern for the Phase One Property that is considered an APEC for the Phase One Property; and
