Phase I-Environmental Site Assessment

50 The Driveway Ottawa, Ontario

Main and Main

Report: PE5340-1

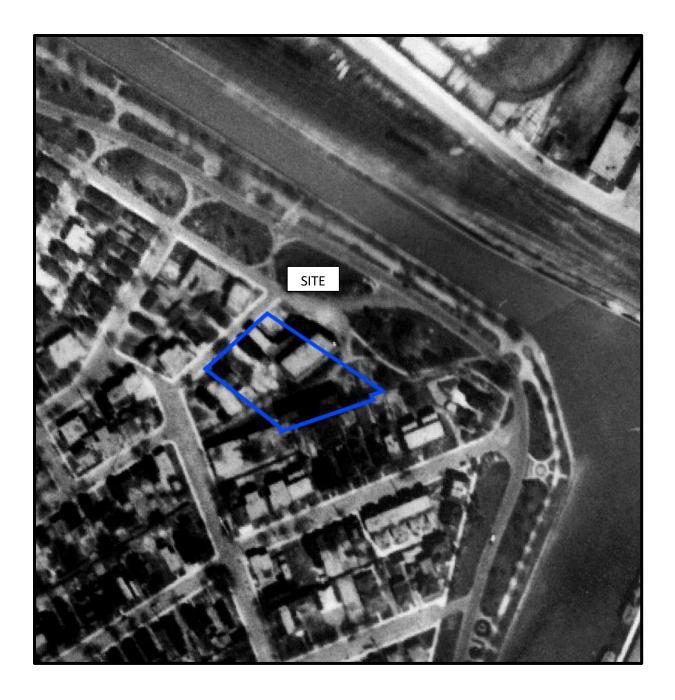
AERIAL PHOTOGRAPH 1928

- 1928 The Phase I ESA Property appears to be occupied by a commercial style building on the eastern half and a residential on the western portion. Neighbouring properties appear to be developed for predominately residential purposes.
- 1956 The Phase I EA Property appears to have been expanded with a northern addition to the warehouse style building, while the neighbouring properties remain unchanged from the previous photograph.
- 1965 The Phase I ESA Property is vacant and under redevelopment. No significant changes are apparent on the surrounding lands.
- 1976 The Phase I ESA Property is occupied by the present-day commercial building, while the neighbouring lands to the north are
