Phase I-Environmental Site Assessment

522 Lower Byron Avenue Ottawa, Ontario

SerCo Realty Group

Report: PE5433-1

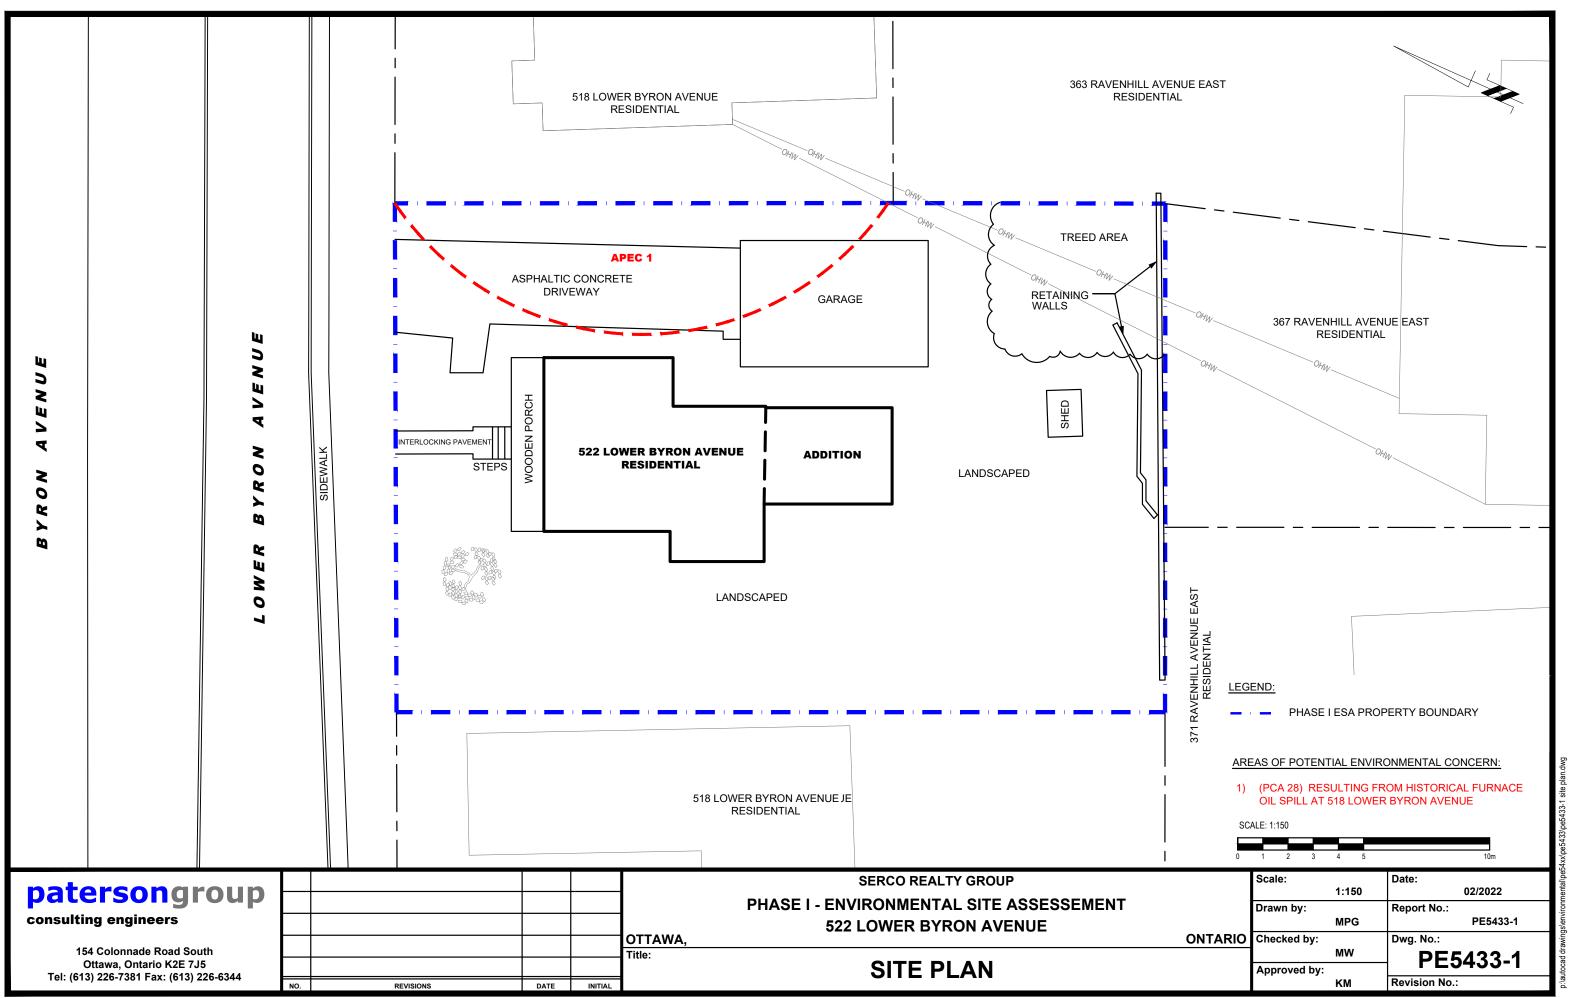
DRAWING PE5433-2 - SITE PLAN

Site drainage consists of infiltration on the landscaped areas of the site with sheet runoff on the paved area to catch basins along Lower Byron Avenue. No standing water or evidence of surficial staining was observed on the exterior of the Phase I ESA Property at the time of the site visit.

No aboveground storage tanks (ASTs) or evidence of underground storage tanks (USTs) or other below ground structures were observed on the subject land at the time of the site visit.

No evidence of recent excavation, fil material, current or former railway or spur lines or unidentified substances were observed on the Phase I Property at the time of the site visit.

The Phase I ESA Property is situated in a municipally serviced area. There were no potable wells observed on the Phase I Property or on other properties within the Phase I Study Area, at the time of the site visit. The above-noted site features are shown on Drawing PE5433-1 - Site Plan.

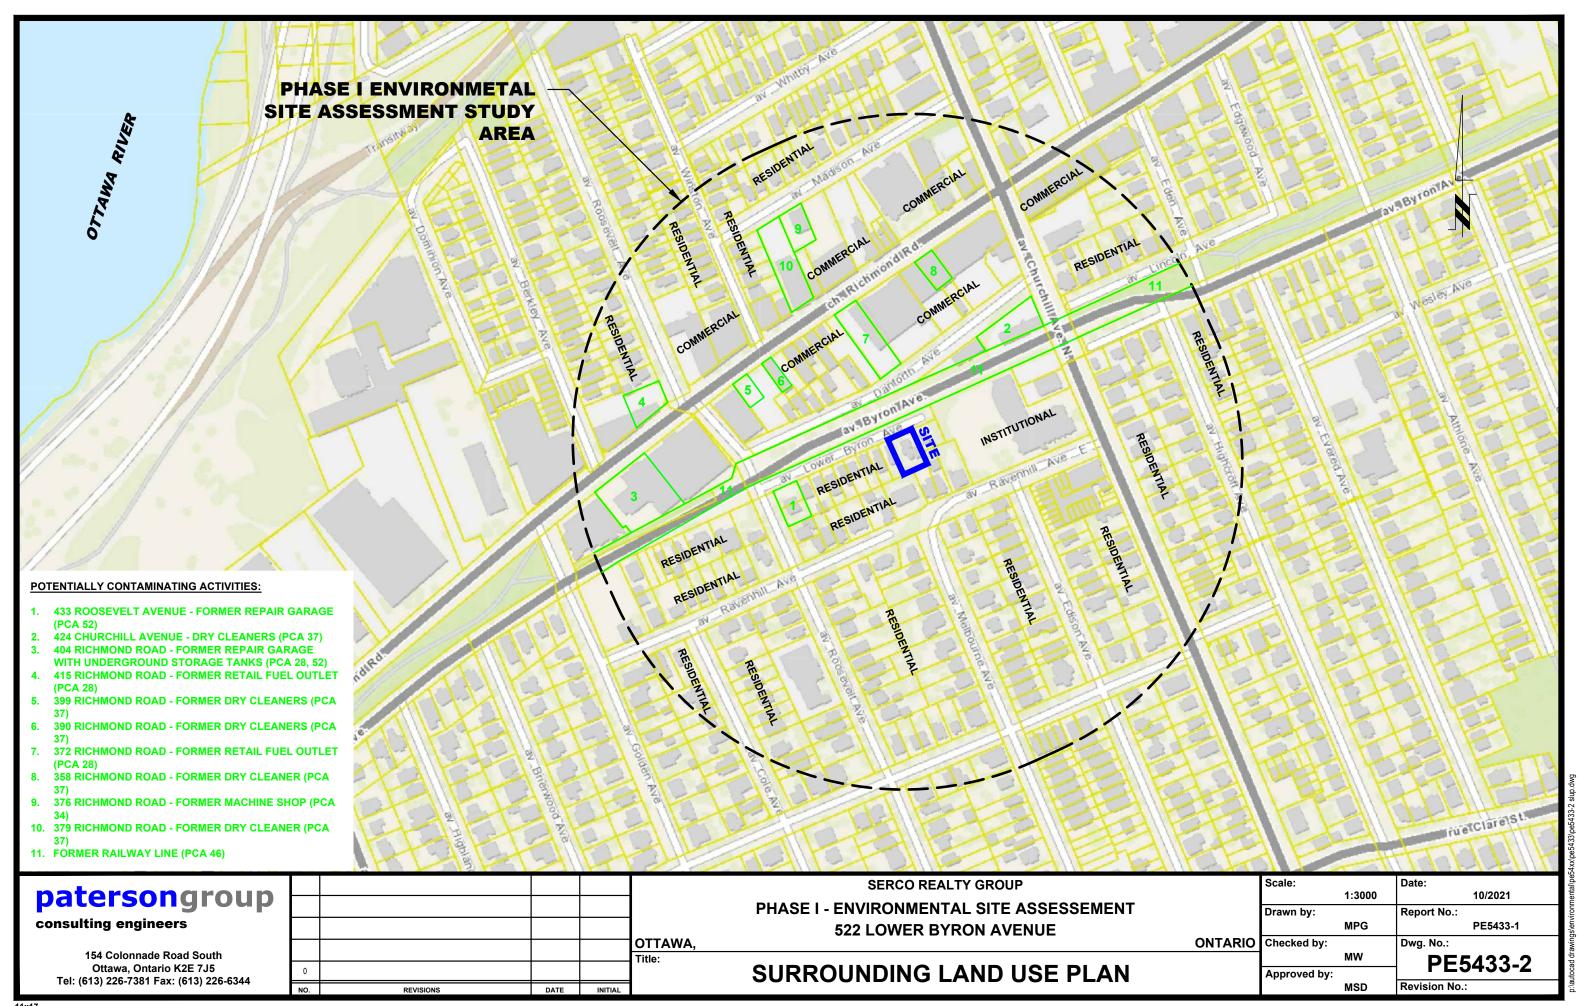
DRAWING PE5433-3 – SURROUNDING LAND USE PLAN

The surrounding lands during the 1947 to 1956 were predominately occupied by residential properties, with some commercial properties along Richmond Road and institutional/community properties. Three (3) off-site PCAs were identified at 433 Roosevelt Avenue (repair garage) approximately 85 m west; 428-430 Richmond Road (garage and 4 USTs) approximately 235 m northwest; and 415 Richmond Road (retail fuel outlet with 4 USTs) approximately 245 m northwest. Based on the separation distances and/or down- or cross-gradient orientation with respect to the Phase I ESA Property, these off-site PCAs are not considered to represent areas of potential environmental concern (APECs) on the Phase I ESA Property. No other off-site PCAs were identified during the review of the FIPs.
