# **Phase I Environmental Site Assessment**

Parking Lot and Vacant Land 716 and 770 Brookfield Road Ottawa, Ontario

Tel: (613) 226-7381 Fax: (613) 226-6344 www.patersongroup.ca October 25, 2017

Report: PE3323-1

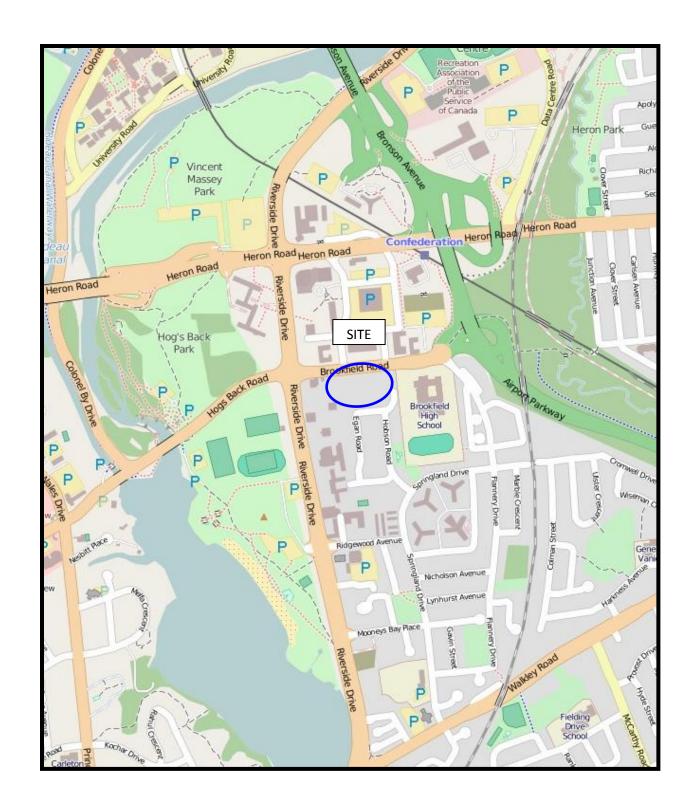
FIGURE 1
KEY PLAN

Road, at the intersection of Brookfield and Hobson Road, in the City of Ottawa, Ontario. The subject site is shown on Figure 1 - Key Plan following the body of

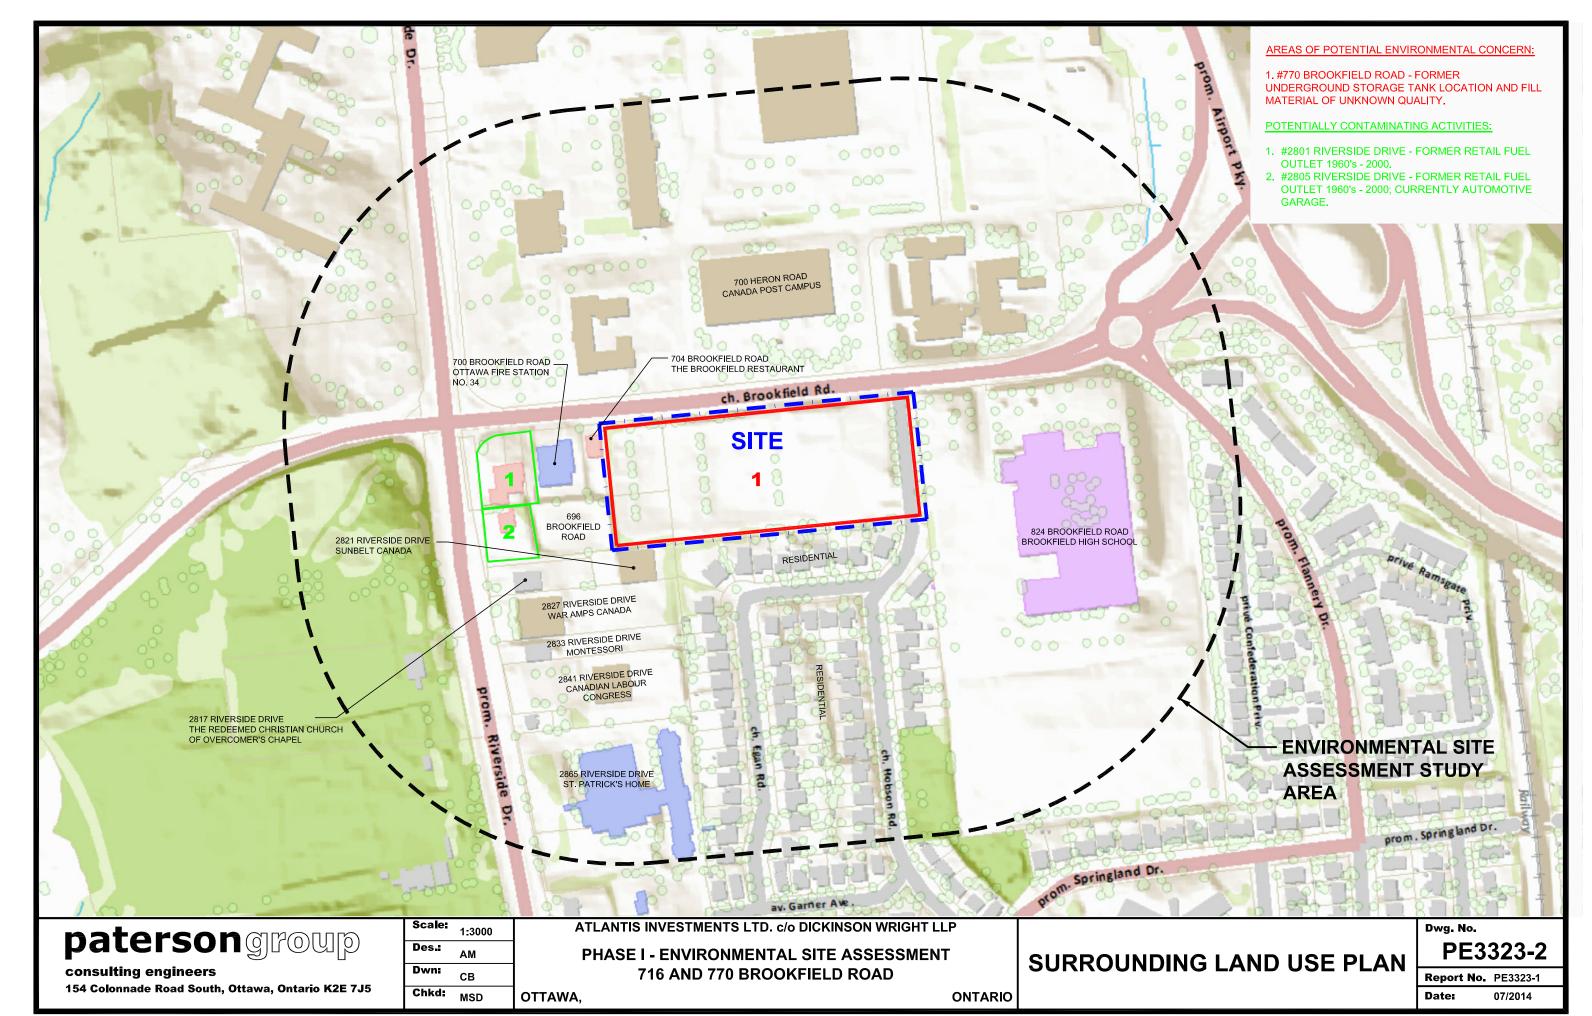
**DRAWING PE3323-2 – SURROUNDING LAND USE PLAN**

Two (2) potentially contaminating activities (PCAs) were identified within the Phase I Study Area in the review of the city directories. However based on the distances of these activities, their locations downgradient from the subject property, and previous works Paterson has conducted in the area, these potentially contaminating activities are not considered to be areas of potential environmental concern. Locations of the PCAs are illustrated in Drawing PE3323-2 Surrounding Land Use Plan.

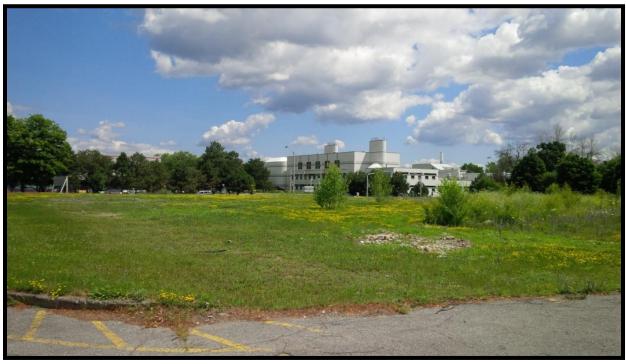
Soil disturbances were observed on the east side of the property, where the former building once stood. Evidence of rubble (concrete, metal and general debris) was visible above the ground surface.

Photograph 1: View of the east side of 770 Brookfield Road. This area was the former location of a multi-storey office building, now a grassy field with exposed rubble. Looking northeast. Office buildings can be seen in the distance.

Based on the results of this Phase I Environmental Site Assessment, in our opinion, additional environmental investigation in the form of a Phase II-Environmental Site Assessment will be required for the property.

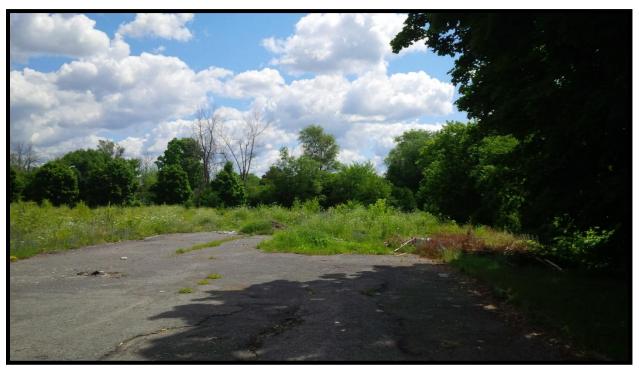
Photograph 2: View of the east side of 770 Brookfield, looking east towards Hobson Road.

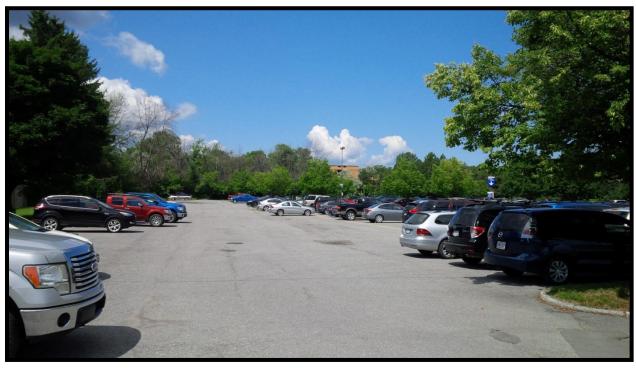
Approximately half of the property (west side) is covered in asphaltic concrete and serves as a paid parking lot, and the other half (east side) is covered in a combination of grass and demolition debris. The site topography appears to slope towards Brookfield Road, while the regional area slopes from east to west. No areas of stained pavement or stressed vegetation were observed on-site.

Photograph 3: View of the paved parking area looking west from the centre of the property, consisting of 770 and 716 Brookfield Road. The treeline in the background of the photograph approximately coincides with the western property line.
