October 12, 2021
File: PE4690-LET.02

Subject: **Phase I – Environmental Site Assessment Update**
4055 Russell Road
Ottawa, Ontario

AVENUE 31 CAPITAL INC.
PHASE I - ENVIRONMENTAL SITE ASSESSMENT UPDATE
4055 RUSSELL ROAD

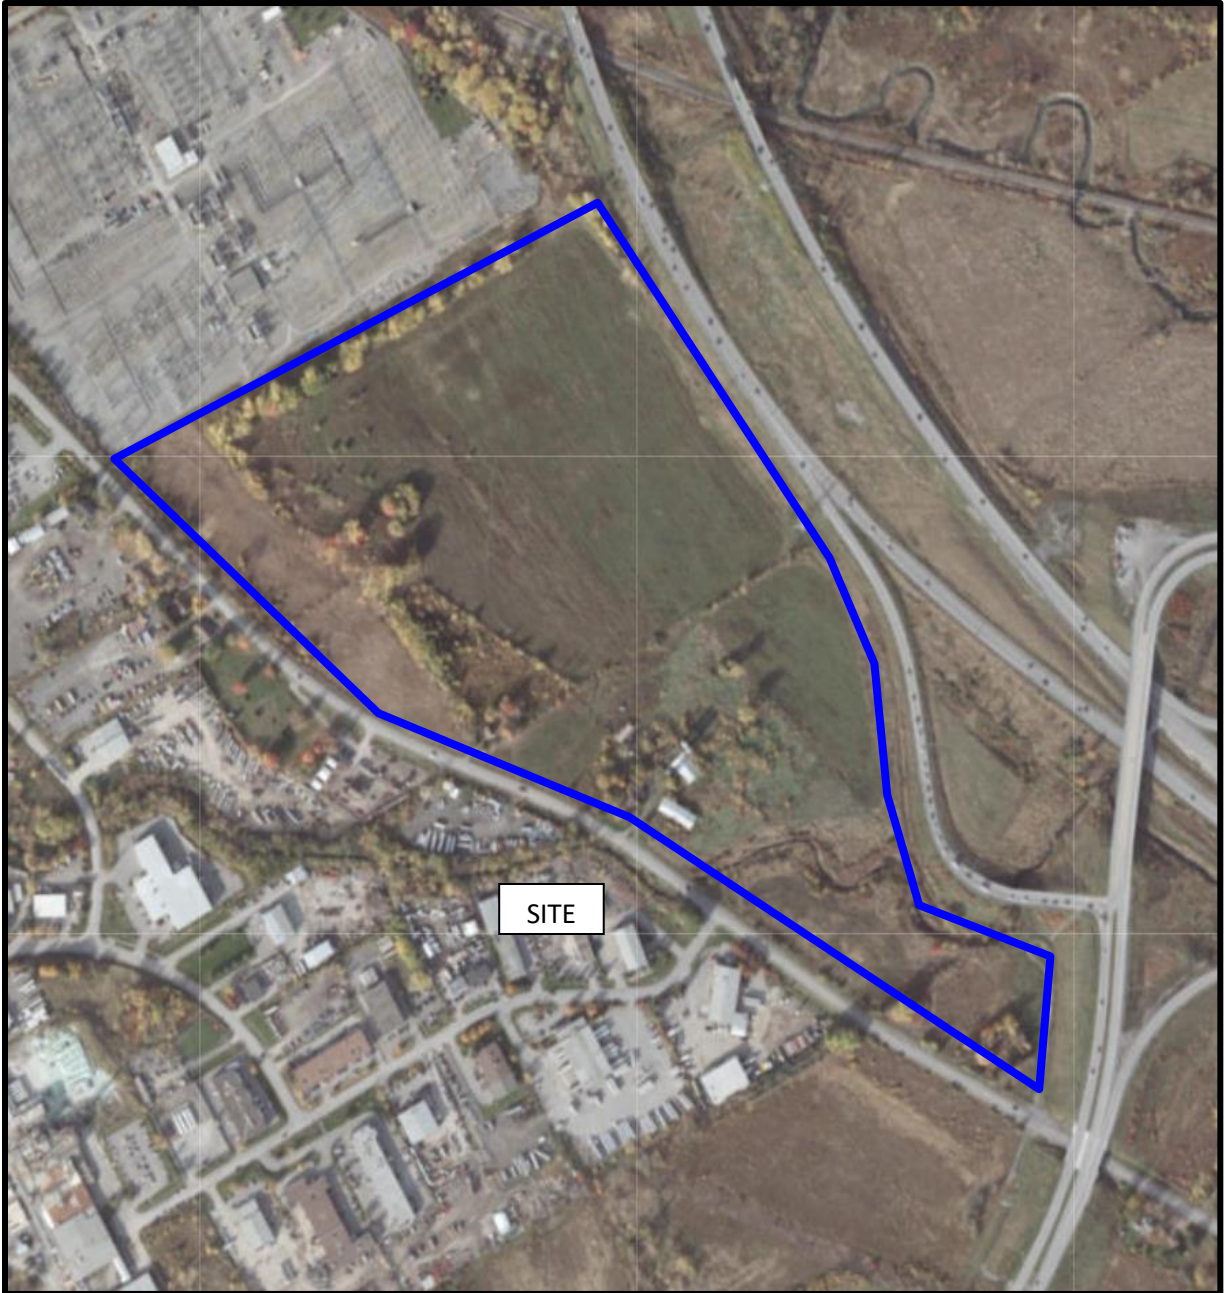
AERIAL PHOTOGRAPH
2019

The most recent photograph reviewed in the 2019 Phase I ESA report was taken in 2017. For this update, a more recent aerial photograph, taken in 2019, was reviewed as part of our assessment. No significant changes were apparent to the subject site during the time period reviewed. A copy of the 2019 aerial photograph has been appended to this letter.
