**Tree Conservation Report for the Proposed Development of  
Site 2 of the National Capital Business Park at 4120 Russell Road,  
Ottawa, Ontario**

**Revised Report**

**March 4, 2021**

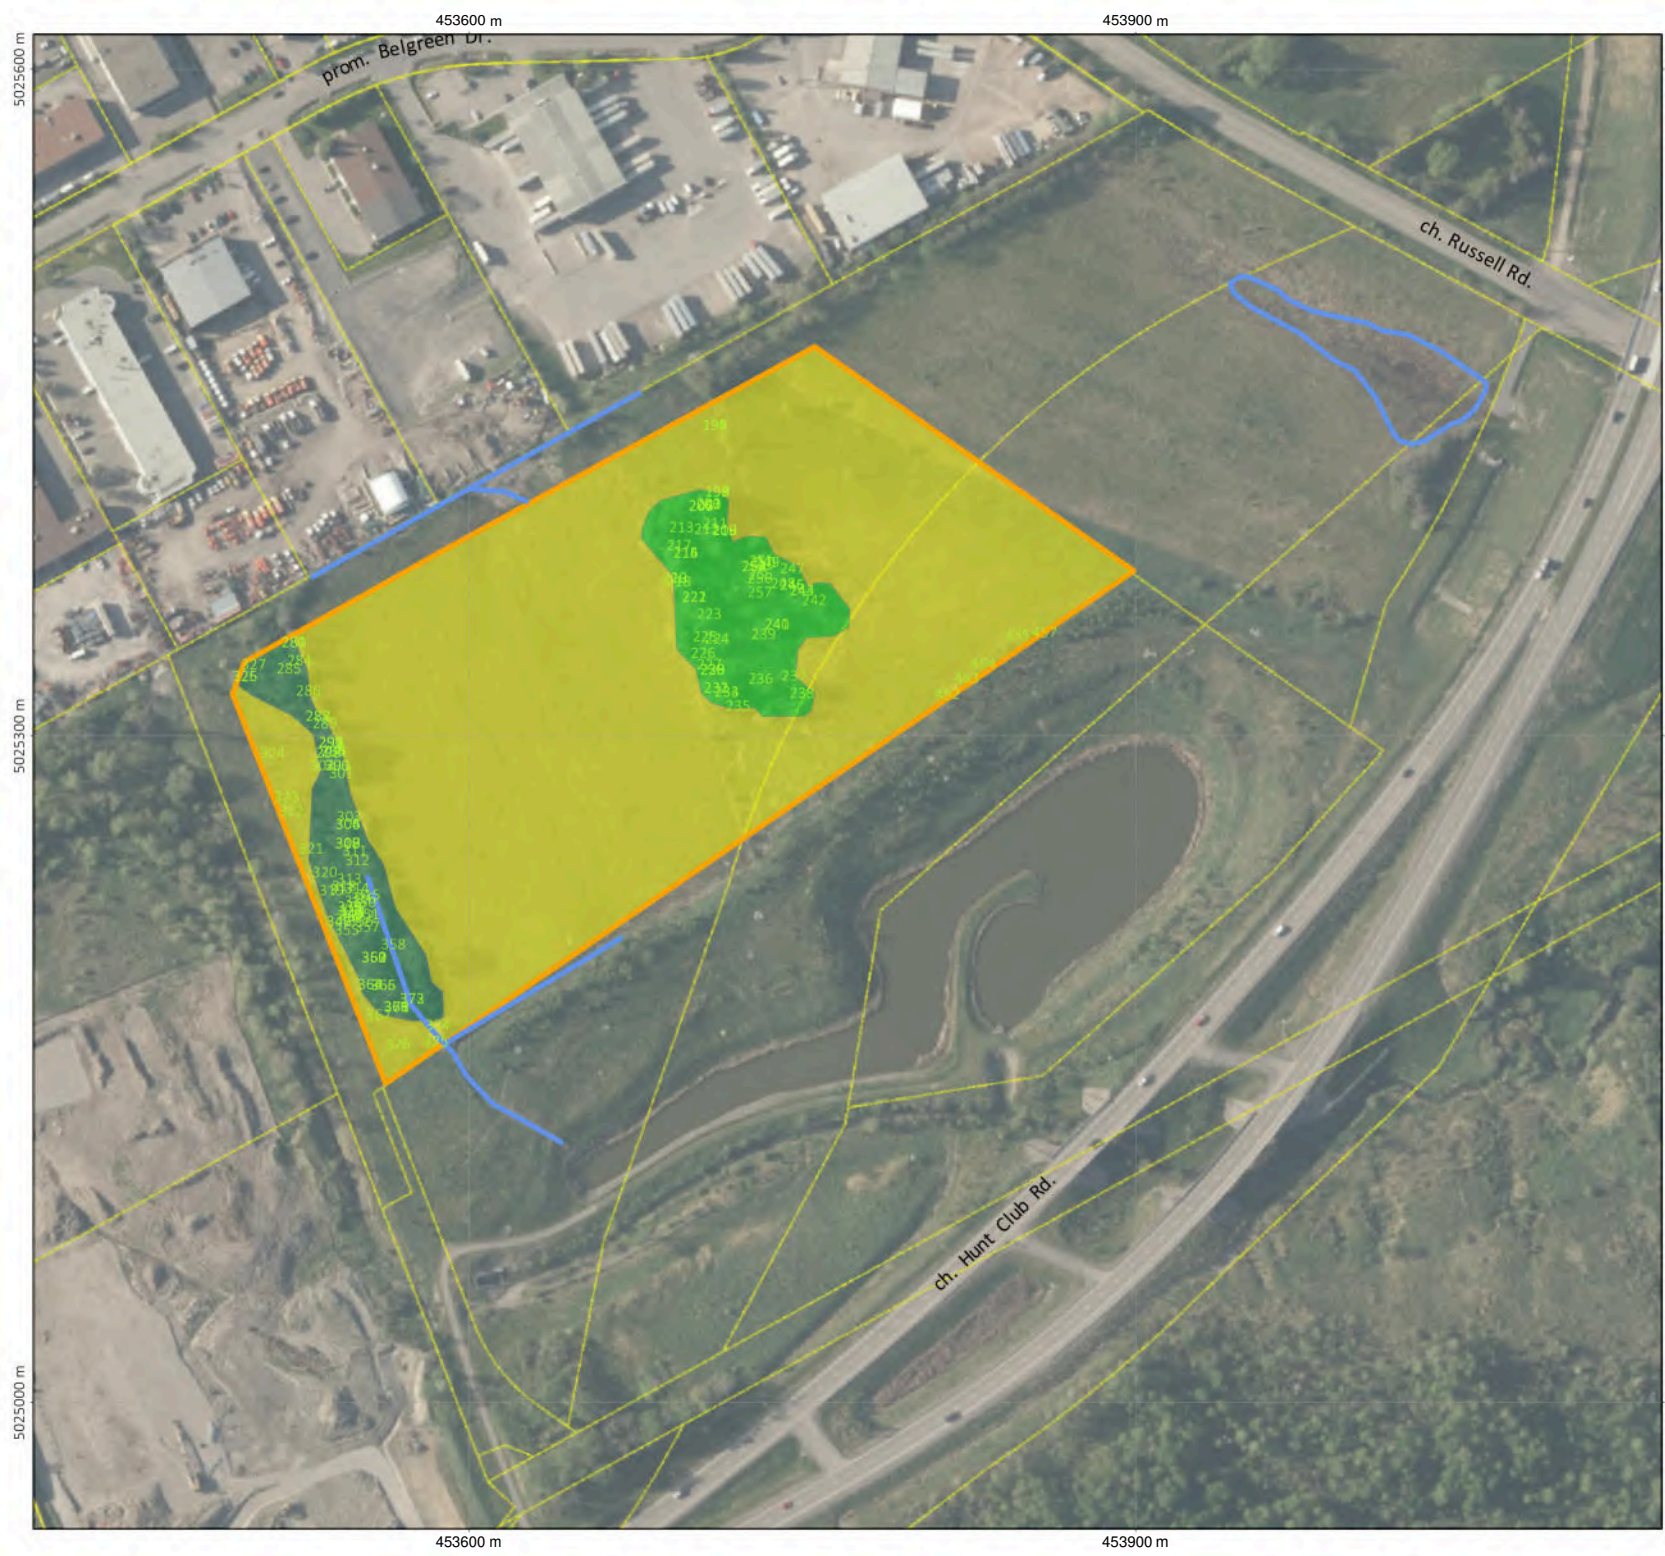
**Figure 2** Map showing existing vegetation and surface water features on Site 2 of the National Capital Business Park

Site 2 contains the following surface water features (Figure 2):

- A small swale within the southern end of the tree hedgerow along the western edge of the site. This surface water feature drains south into the stormwater management pond south of the site. This swale contained very shallow (<10 cm) standing water during the spring freshet and then dried shortly after.
- A small swale along the southwestern edge of the site that drains into the above swale. This swale similarly did not contain surface water after the spring freshet.
- A shallow depression in the centre of the site (surrounded by a cluster of mainly Manitoba Maples) resulting from a building foundation that was once here. This feature held water in the spring and summer but was not connected to other drainage features.
