# **Phase II Environmental Site Assessment**

150 and 160 Laurier Avenue  
Ottawa, Ontario

Prepared for JADCO Corporation

Report: PE4822-2  
October 25, 2022

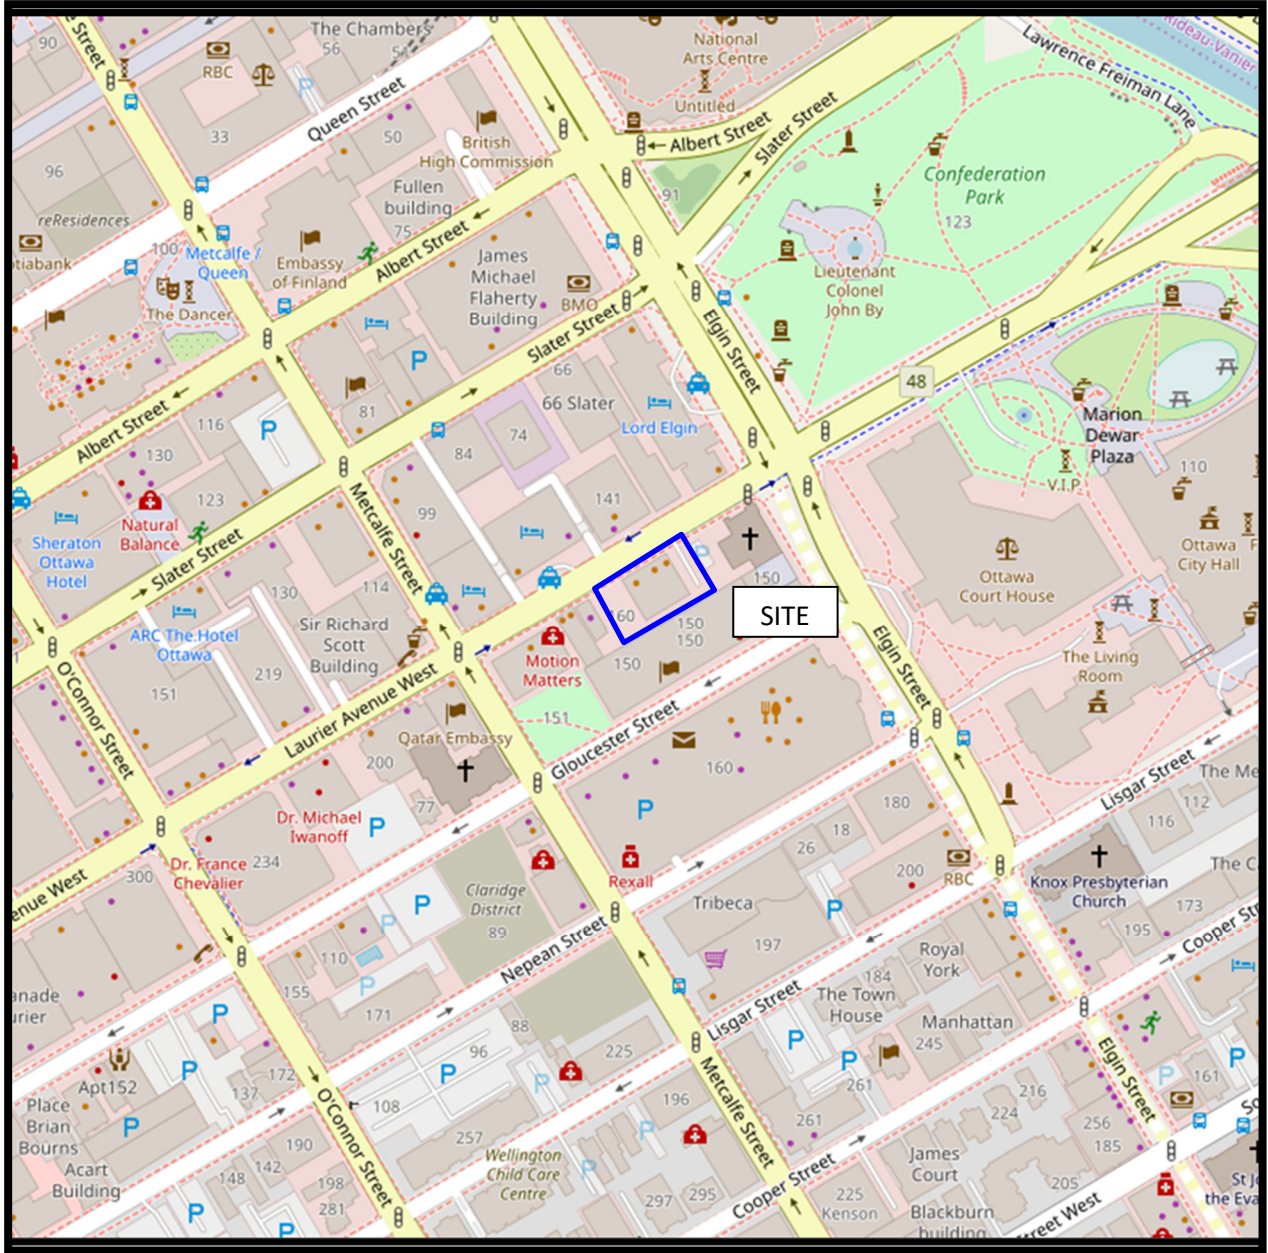
**FIGURE 1**  
**KEY PLAN**

#161 LAURIER AVENUE WEST  
COMMERCIAL OFFICE BUILDING

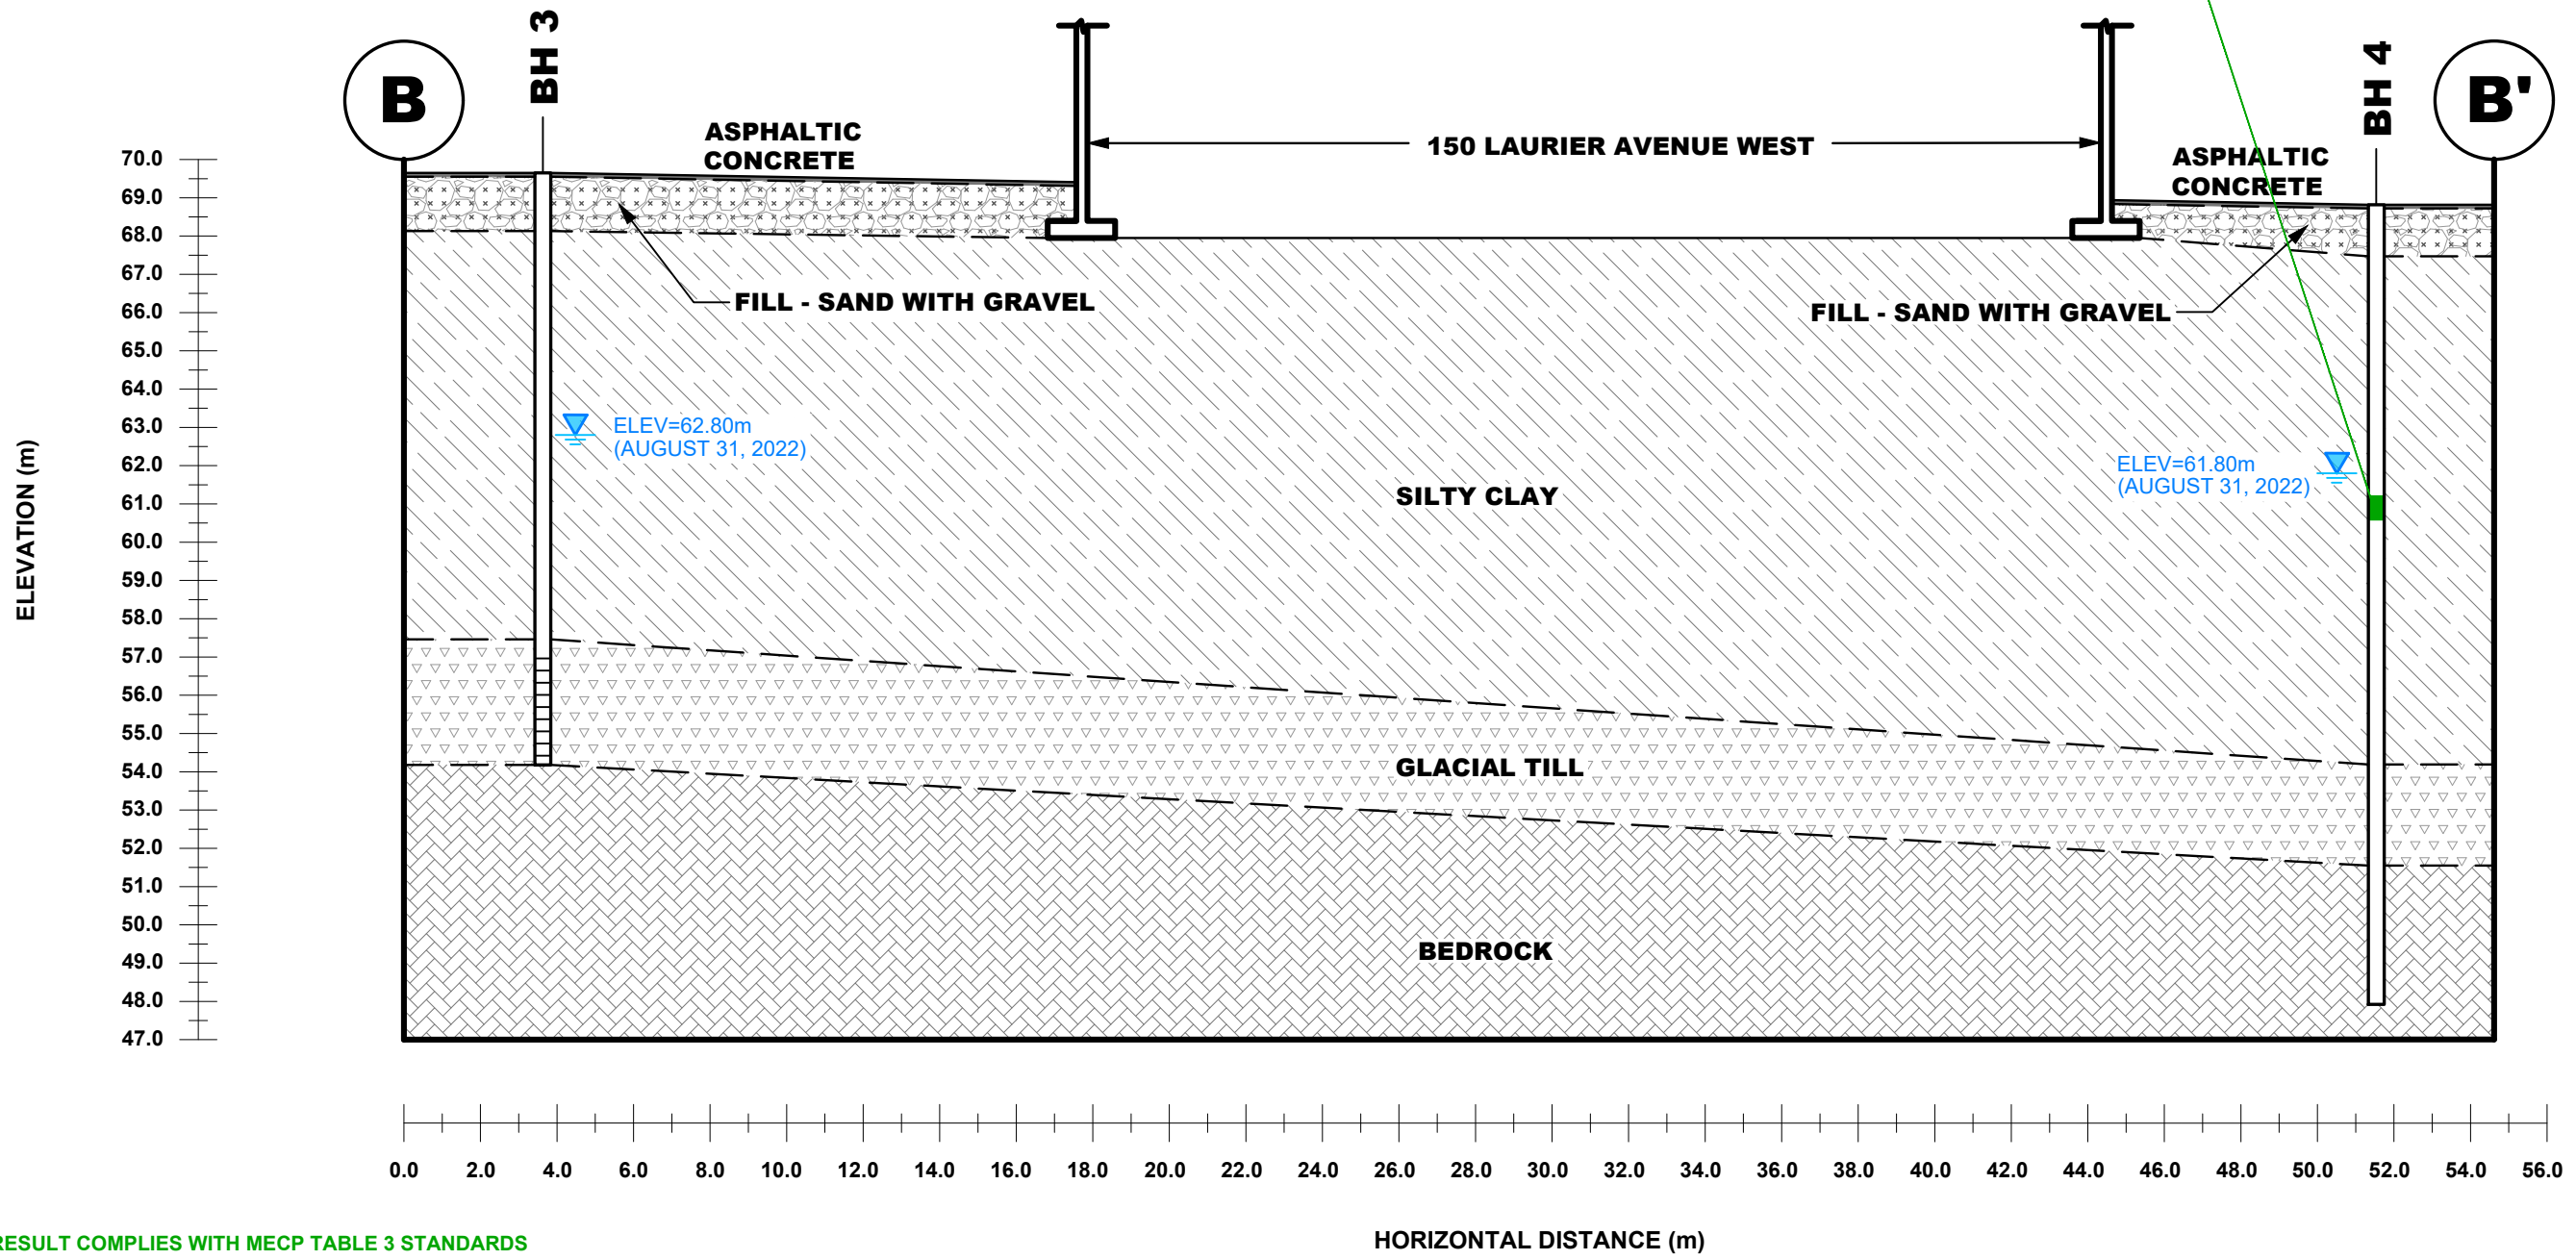
JADCO CORPORATION  
**PHASE II - ENVIRONMENTAL SITE ASSESSMENT**  
 150 AND 160 LAURIER AVENUE WEST  
 OTTAWA, ONTARIO  
**CROSS SECTION B-B' - SOIL**  
 (PCBs, VOCs, PHCs)

BH4-SS8	7.62-8.23m	15-JAN-2020
PCBs comply with the MECP Table 3 Standards		
BH4-SS8	7.62-8.23m	15-JAN-2020
VOCs and PHCs comply with the MECP Table 3 Standards
