Phase II – Environmental Site Assessment

1649 Montreal Road & 741 Blair Road
Ottawa, Ontario

October 30, 2020

Report: PE5061-2

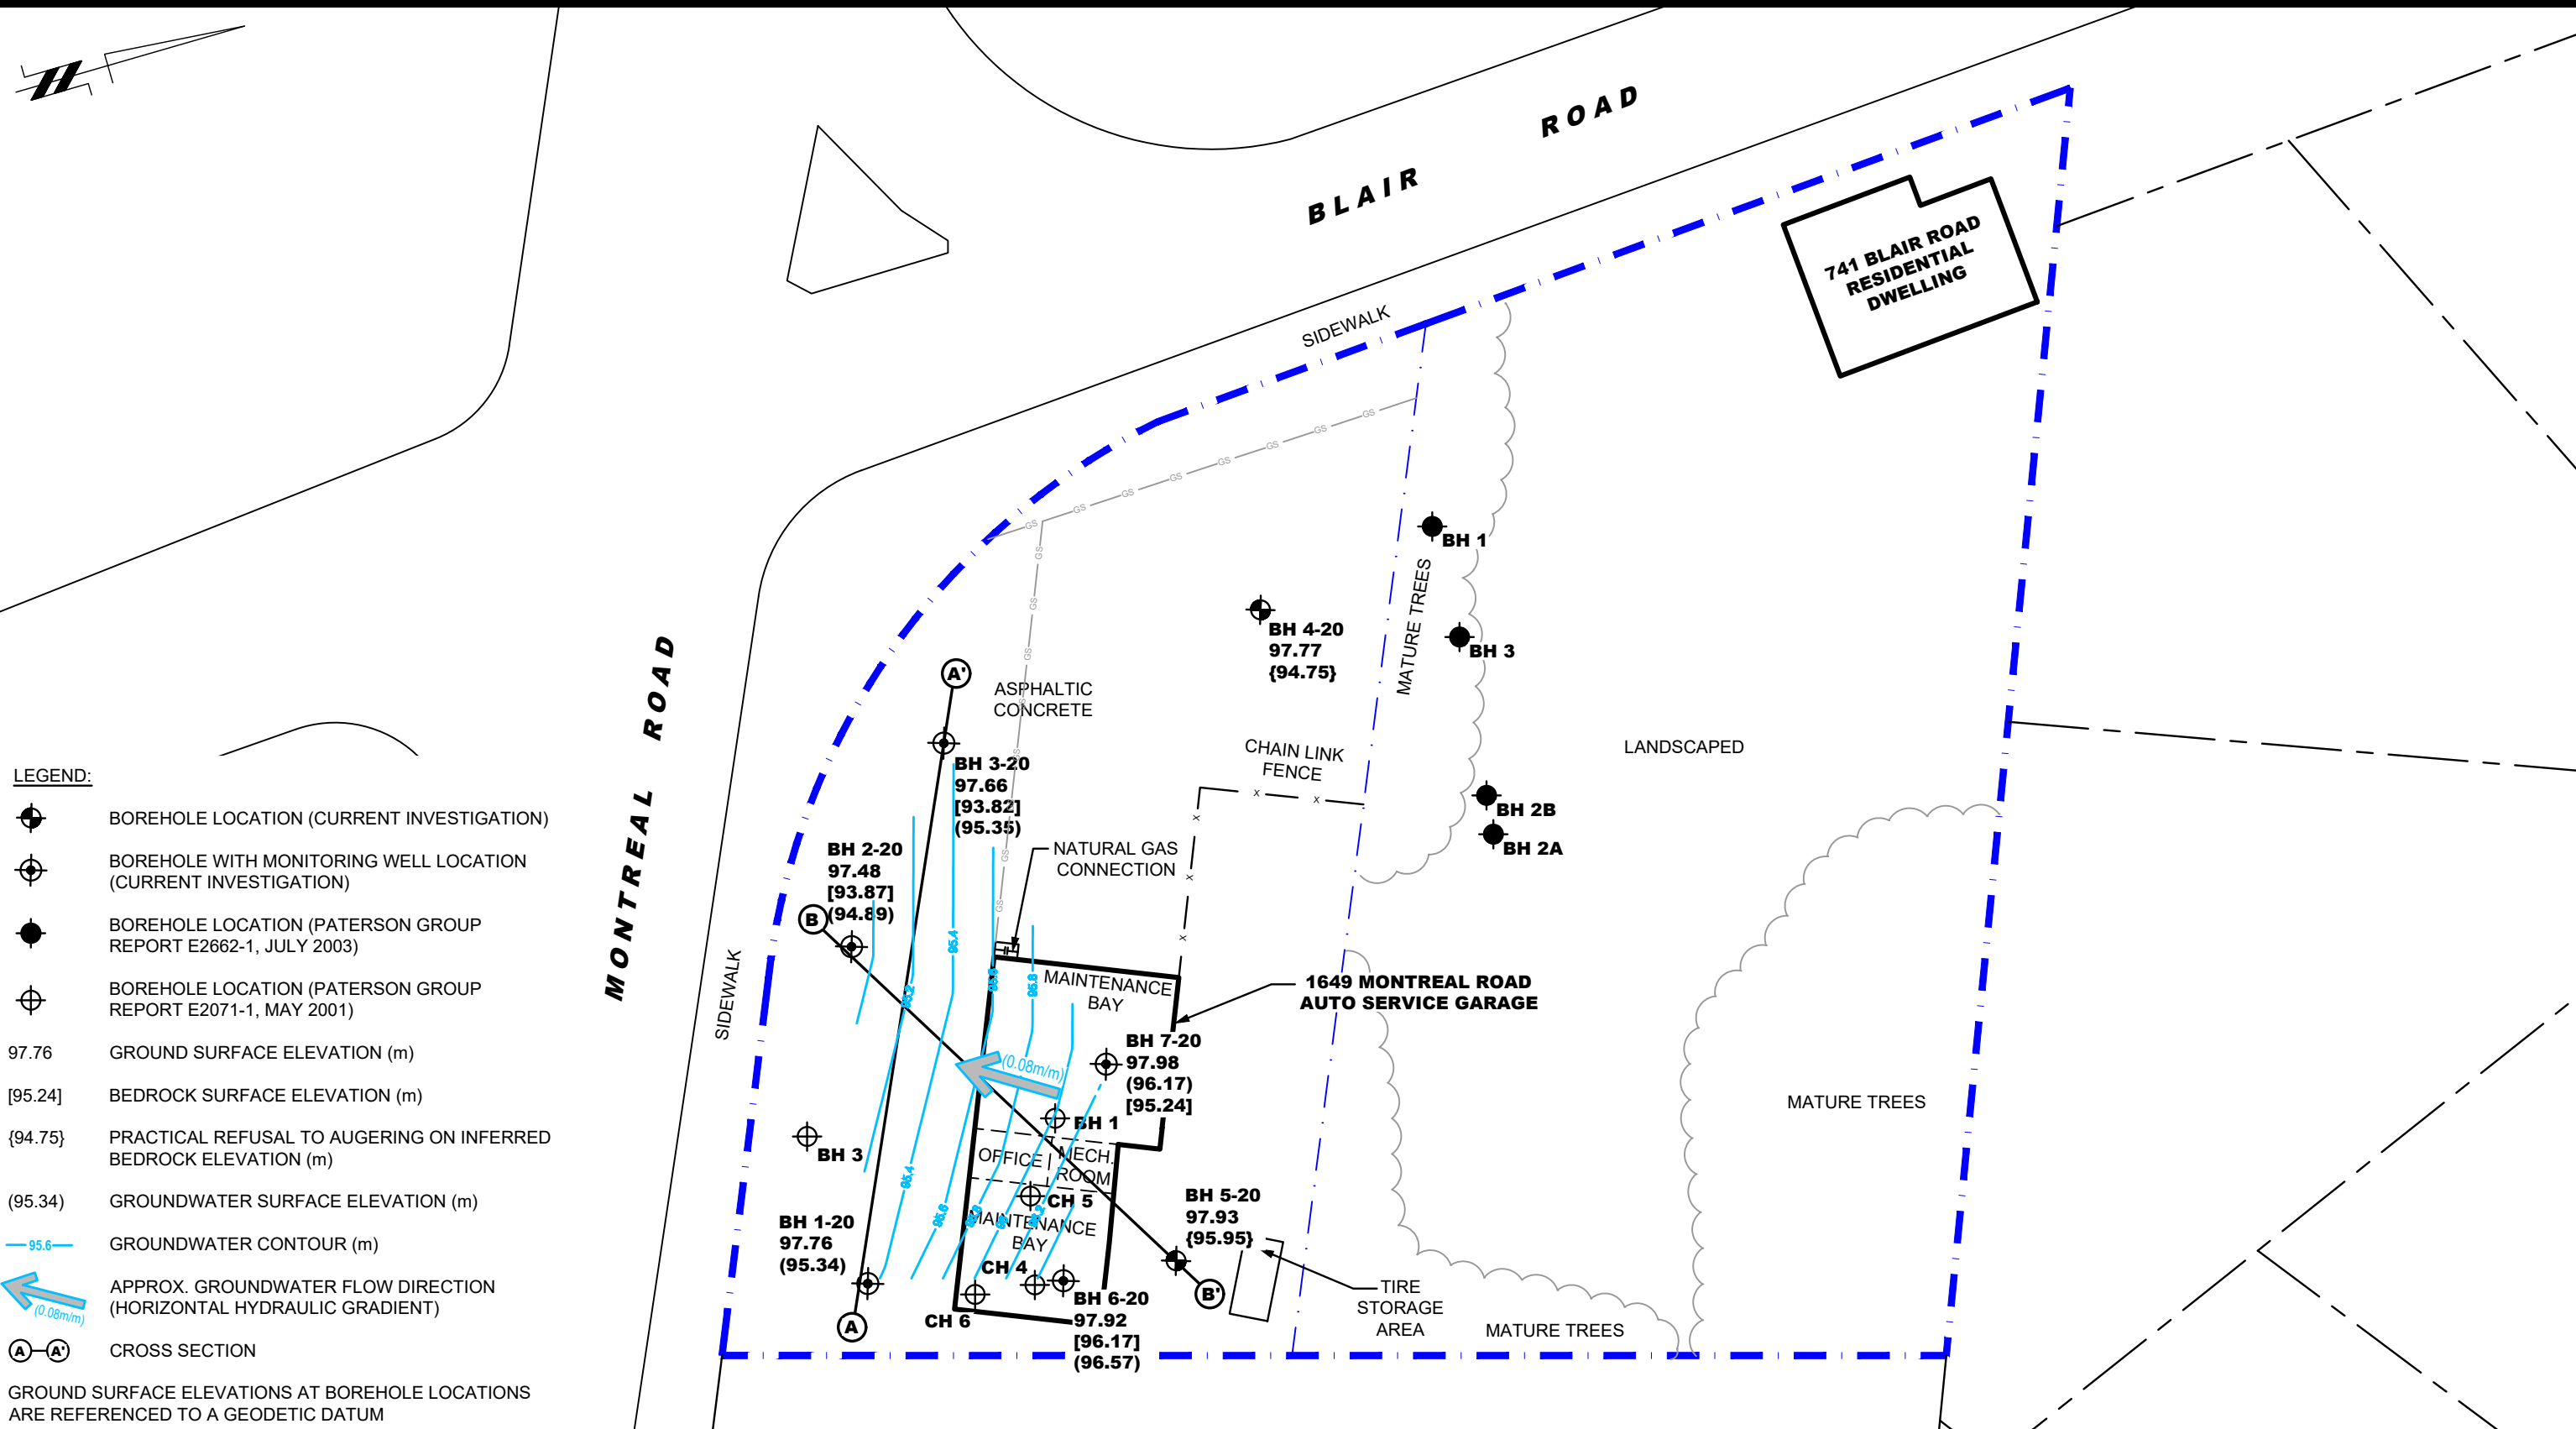
Drawing PE5061-3 – Test Hole Location Plan

The subsurface investigation for this assessment was conducted on October 15, 16, and 21, 2020. The field program consisted of drilling seven (7) boreholes on the subject site (BH1-BH7), of which five (5) were instrumented with groundwater monitoring wells (BH1, BH2, BH3, BH6, and BH7). The boreholes were advanced to depths ranging from approximately 1.98 m to 6.48 m below ground surface and terminated on or within the bedrock.

- BOREHOLE LOCATION (CURRENT INVESTIGATION)
- BOREHOLE WITH MONITORING WELL LOCATION (CURRENT INVESTIGATION)
- BOREHOLE LOCATION (PATERSON GROUP REPORT E2662-1, JULY 2003)
- BOREHOLE LOCATION (PATERSON GROUP REPORT E2071-1, MAY 2001)
- 97.76 GROUND SURFACE ELEVATION (m)
- [95.24] BEDROCK SURFACE ELEVATION (m)
- {94.75} PRACTICAL REFUSAL TO AUGERING ON INFERRED BEDROCK ELEVATION (m)
- (95.34) GROUNDWATER SURFACE ELEVATION (m)
- 95.6— GROUNDWATER CONTOUR (m)
- APPROX. GROUNDWATER FLOW DIRECTION (HORIZONTAL HYDRAULIC GRADIENT)
- (A)—(A') CROSS SECTION

Refer to Drawing PE5061-3 – Test Hole Location Plan, appended to this report, for the location of all boreholes drilled on the subject site.

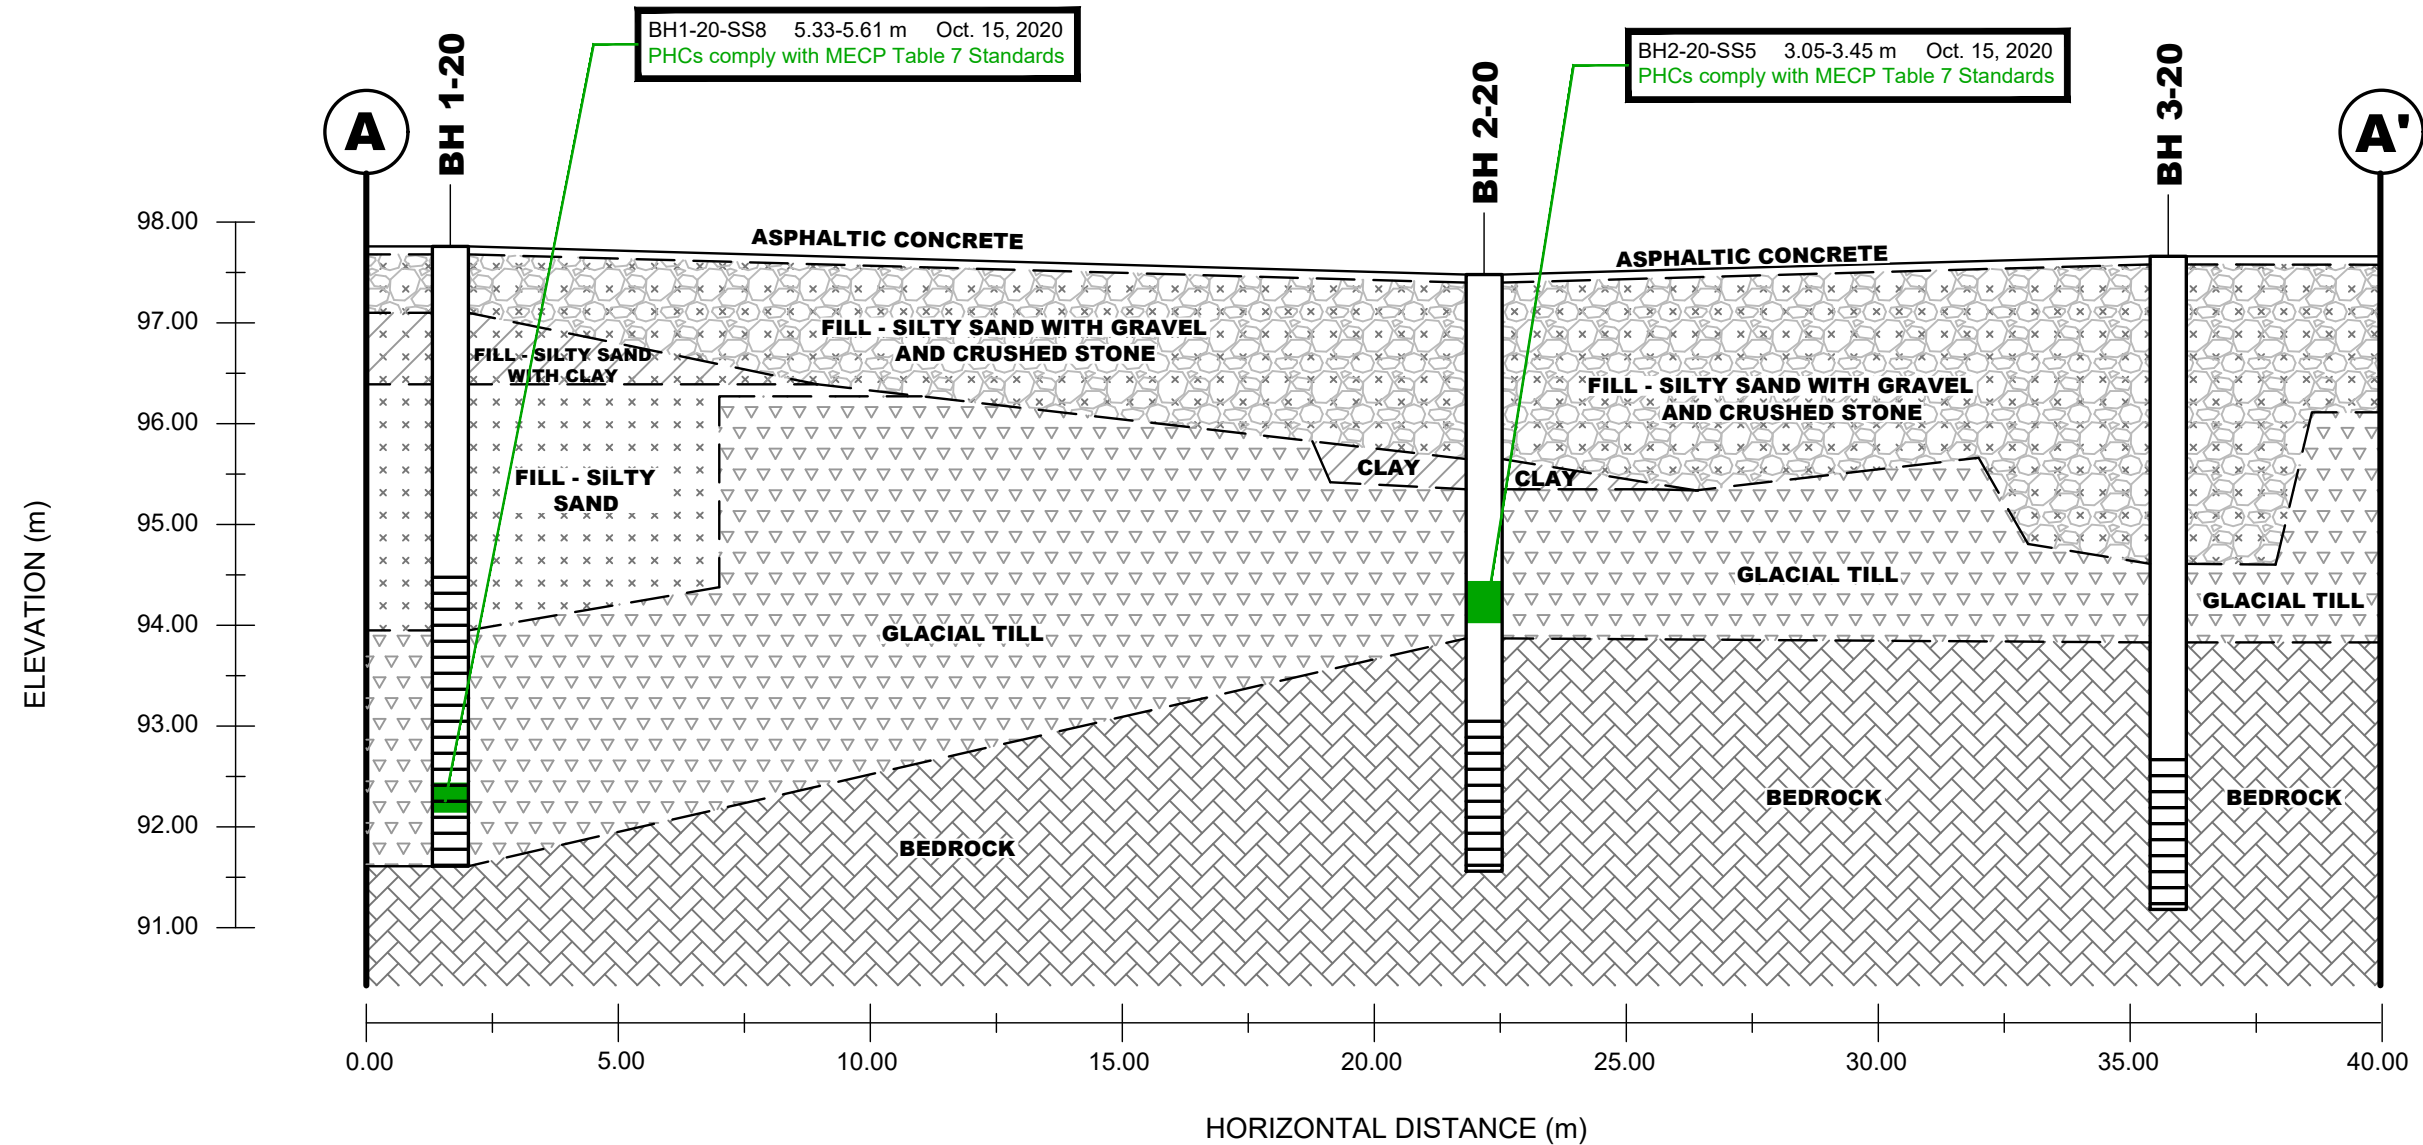
SOIL RESULT COMPLIES WITH MECP TABLE 7 STANDARDS

SOIL RESULT EXCEEDS MECP TABLE 7 STANDARDS

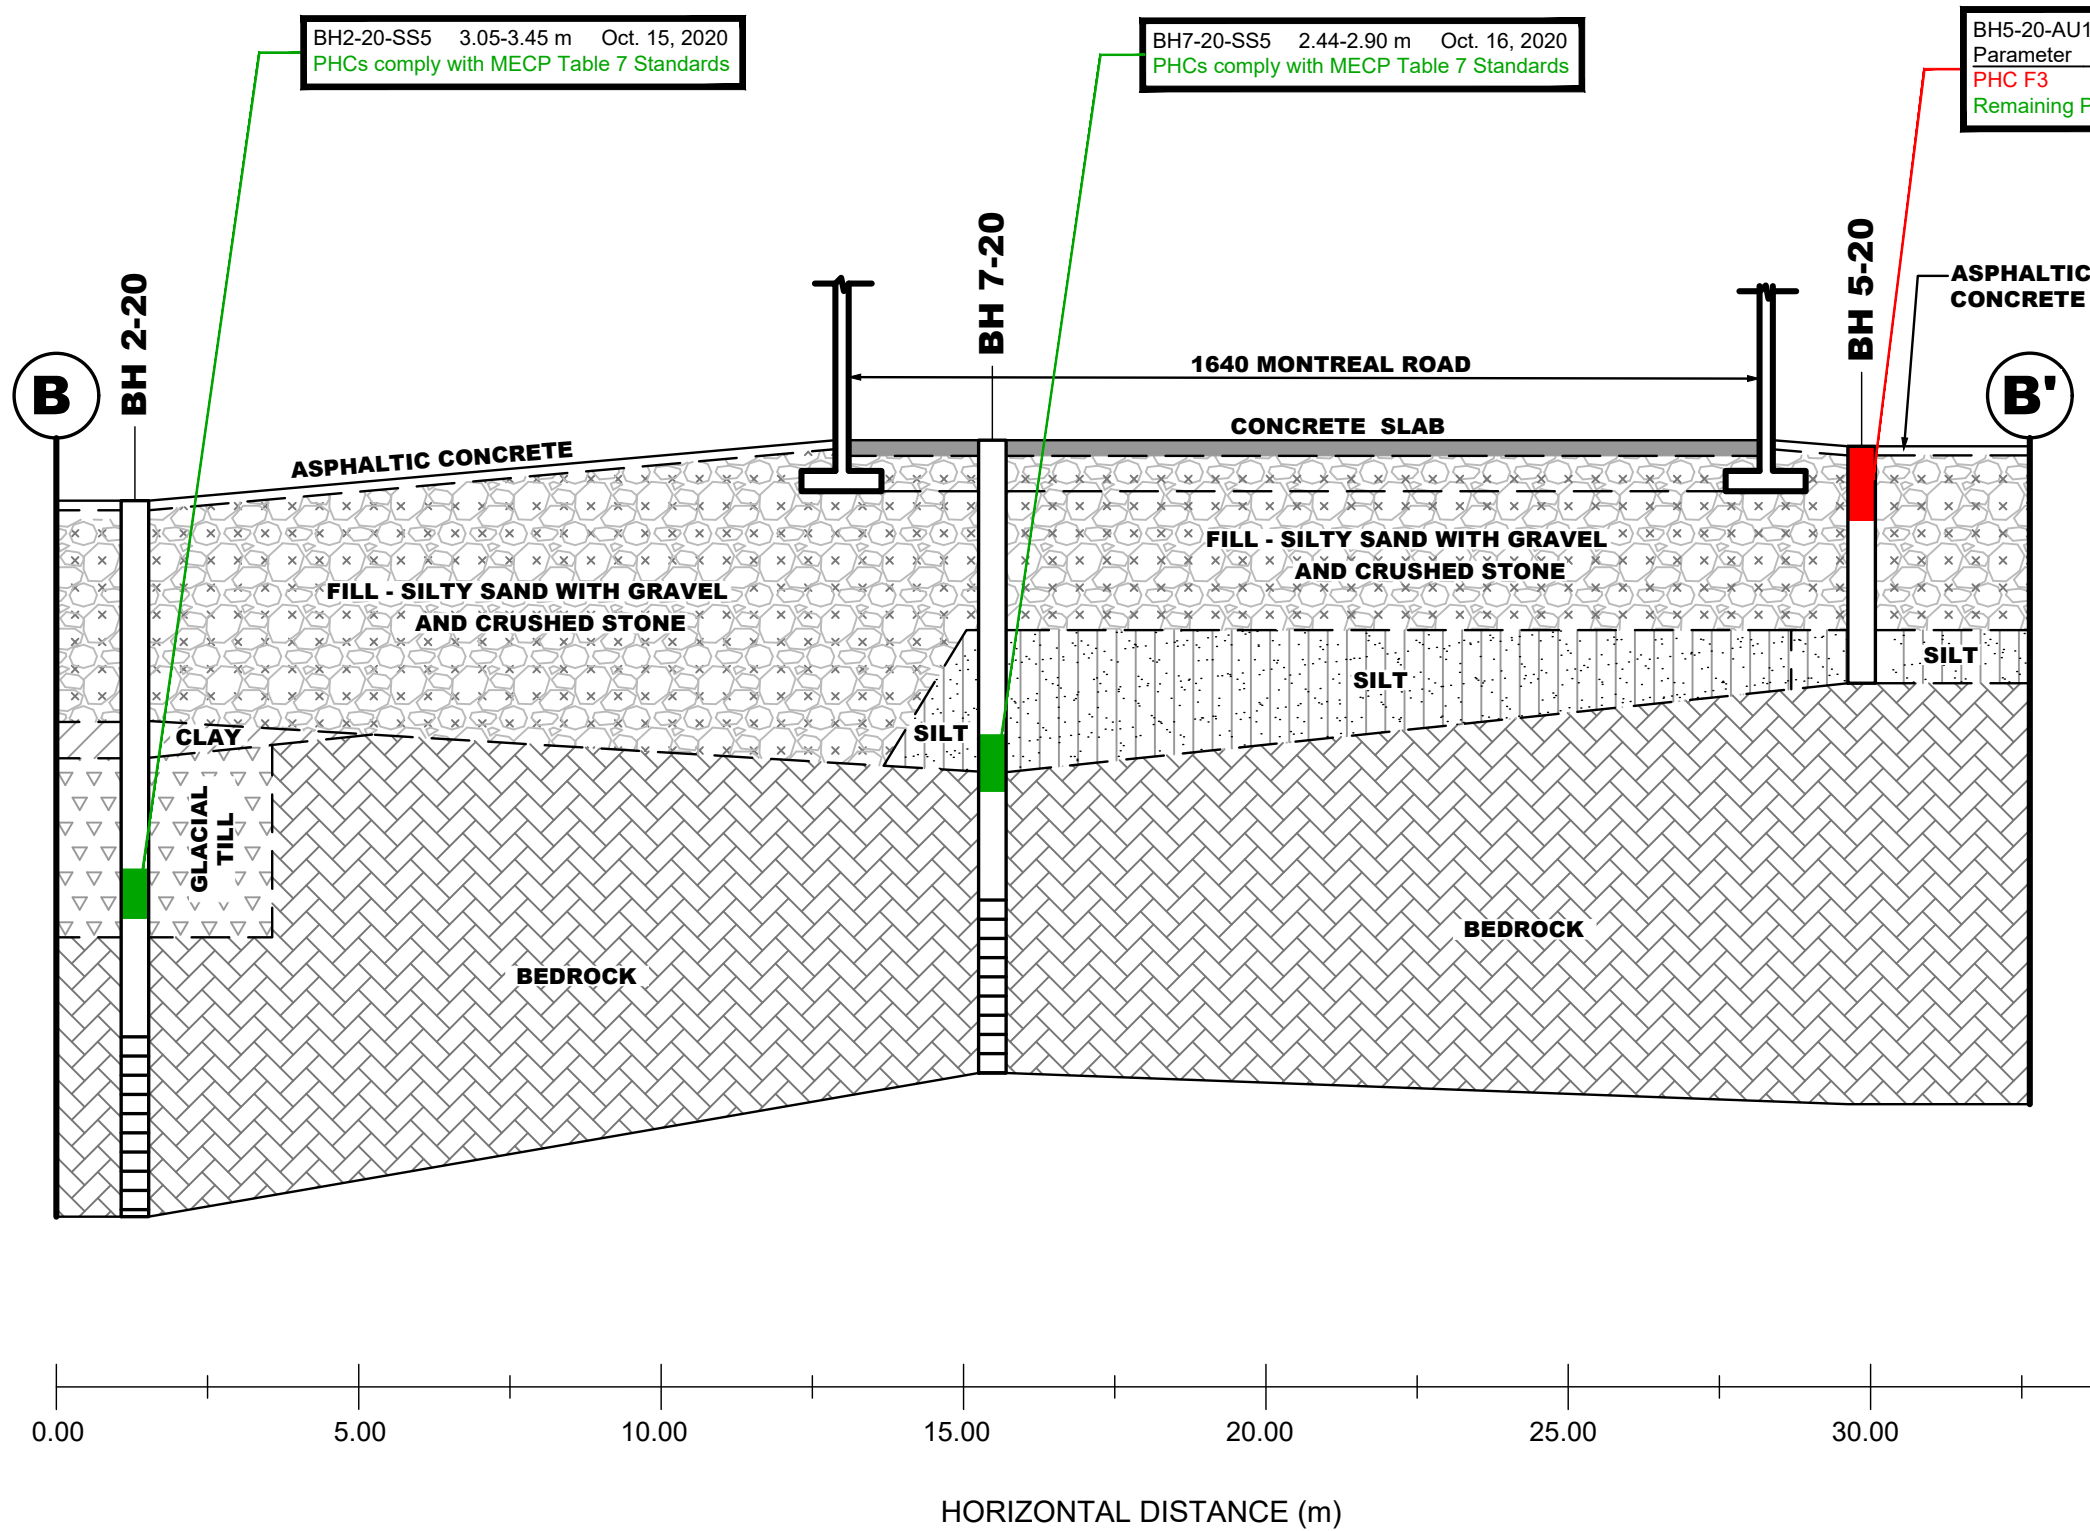
BH2-20-SS5 3.05-3.45 m Oct. 15, 2020
PHCs comply with MECP Table 7 Standards

BH7-20-SS5 2.44-2.90 m Oct. 16, 2020
PHCs comply with MECP Table 7 Standards

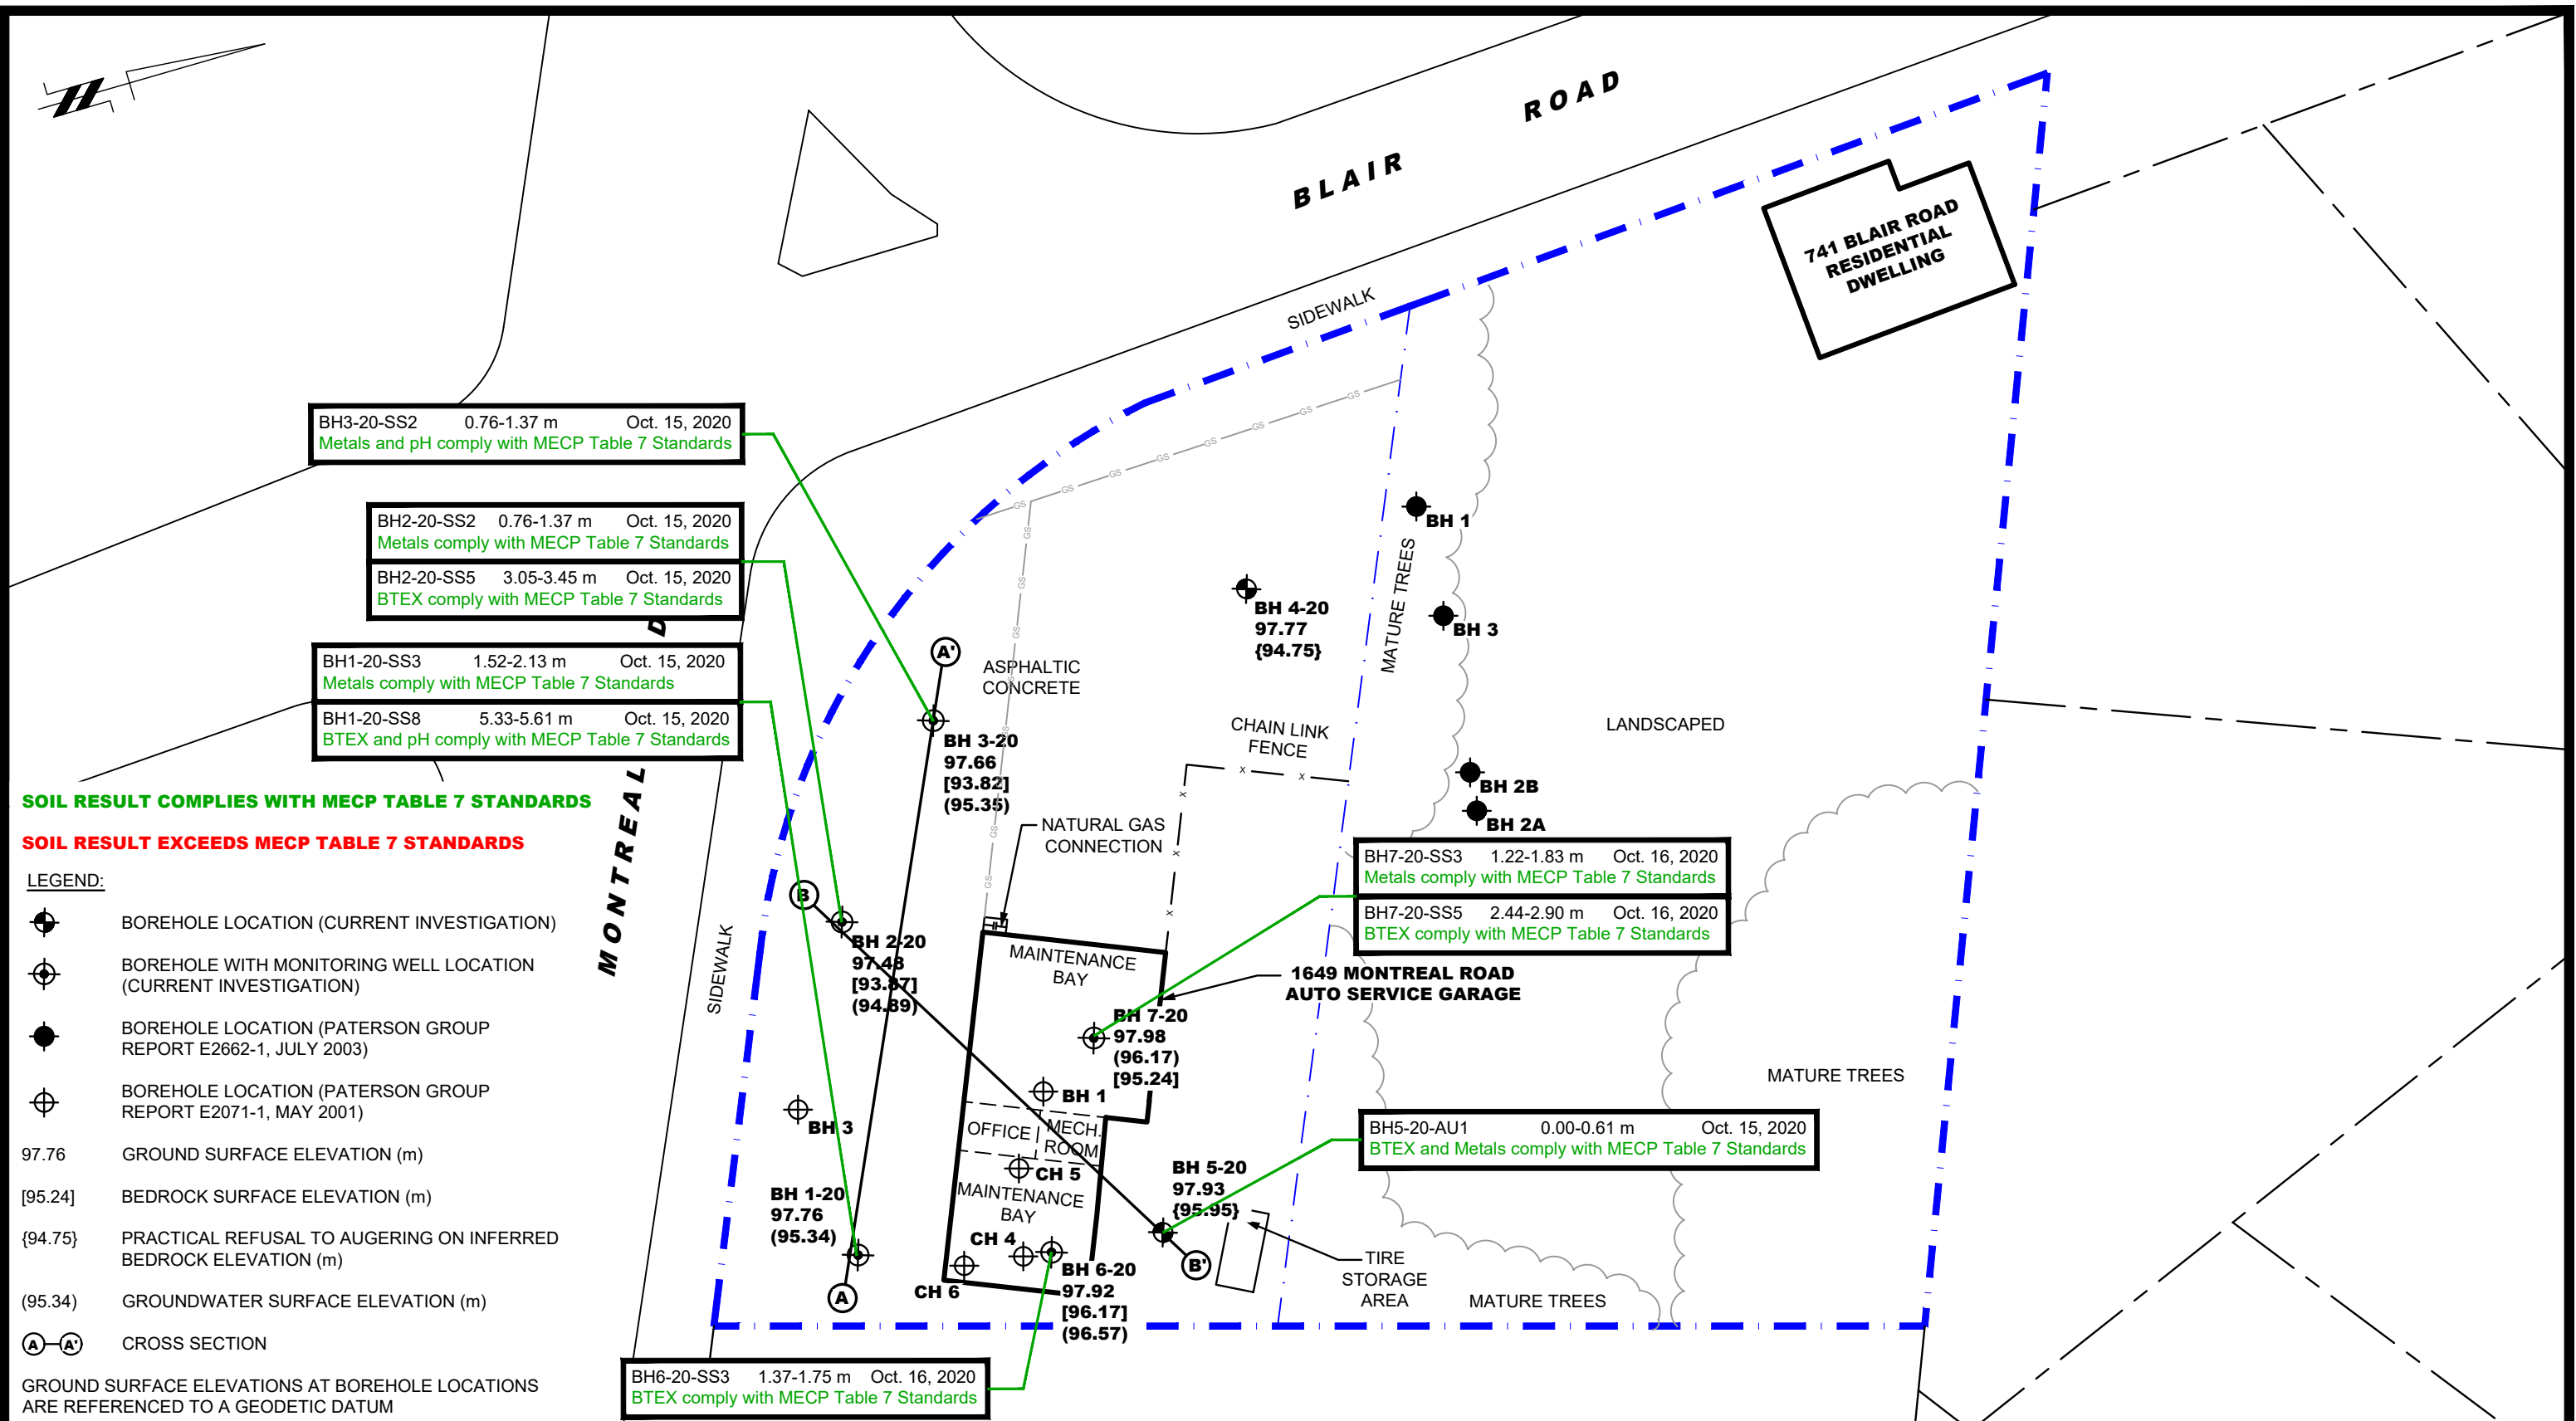
Drawing PE5061-5 – Analytical Testing Plan – Soil (BTEX, Metals, pH)

BH3-20-SS2 0.76-1.37 m Oct. 15, 2020
Metals and pH comply with MECP Table 7 Standards

BH2-20-SS2 0.76-1.37 m Oct. 15, 2020
Metals comply with MECP Table 7 Standards

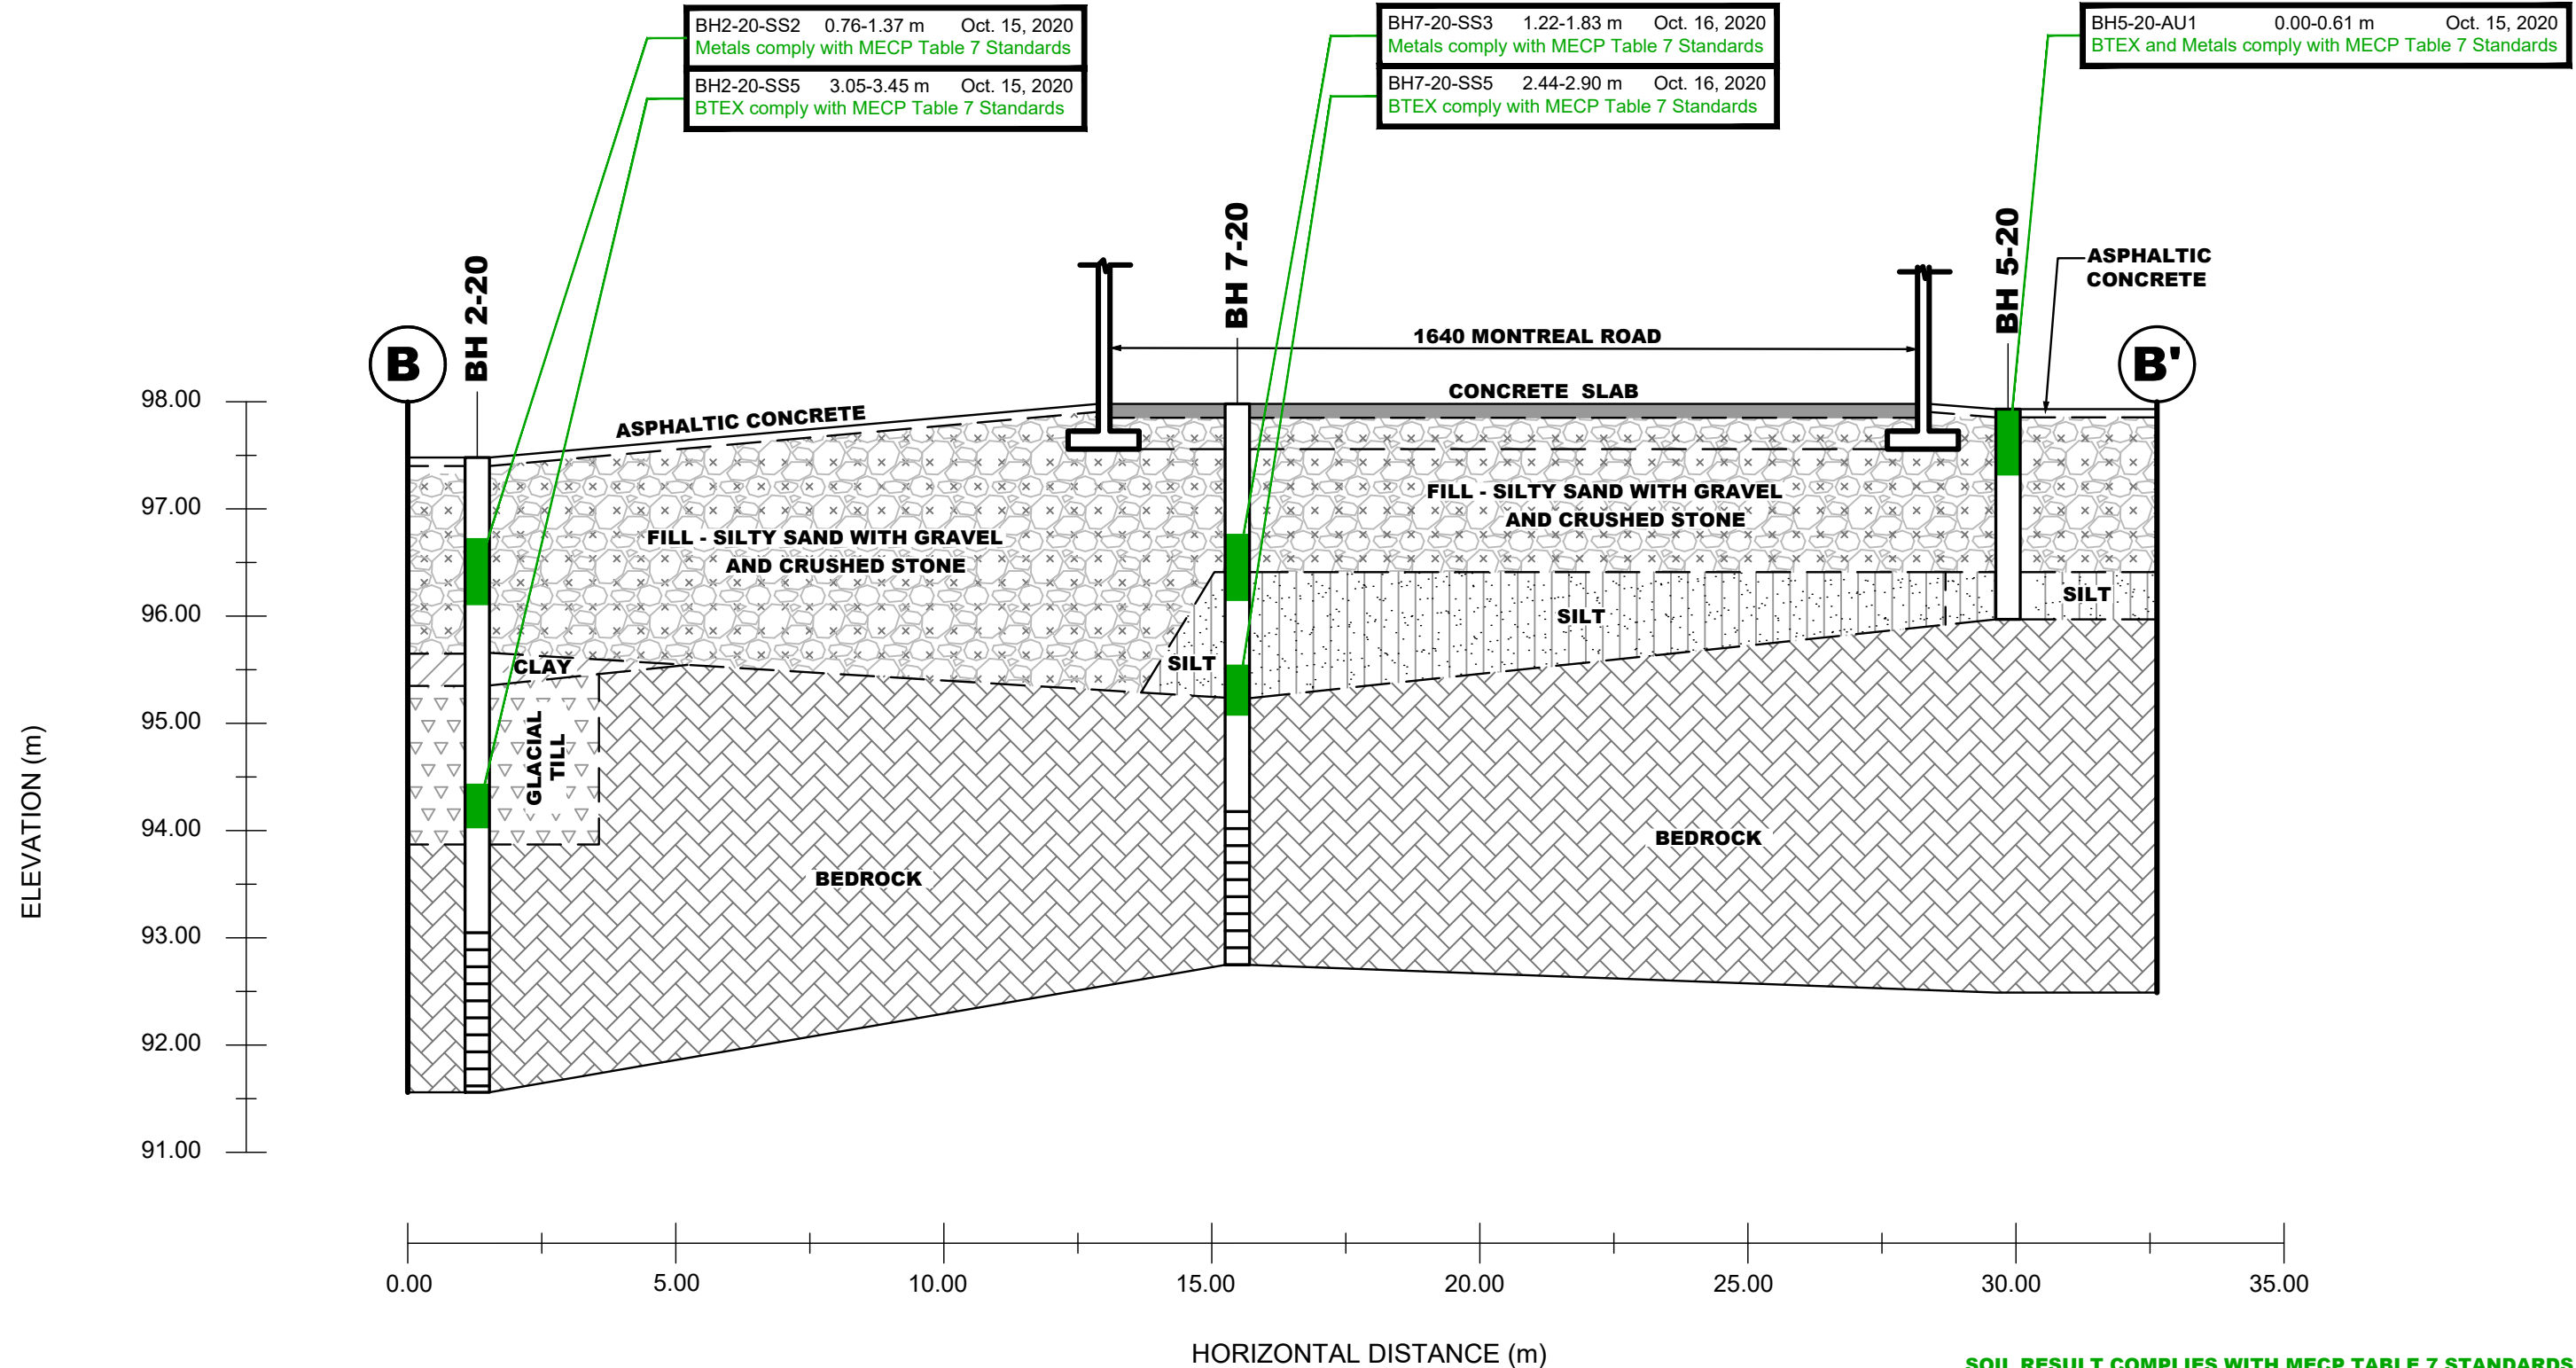
BH2-20-SS2 0.76-1.37 m Oct. 15, 2020
Metals comply with MECP Table 7 Standards

BH2-20-SS5 3.05-3.45 m Oct. 15, 2020
BTEX comply with MECP Table 7 Standards

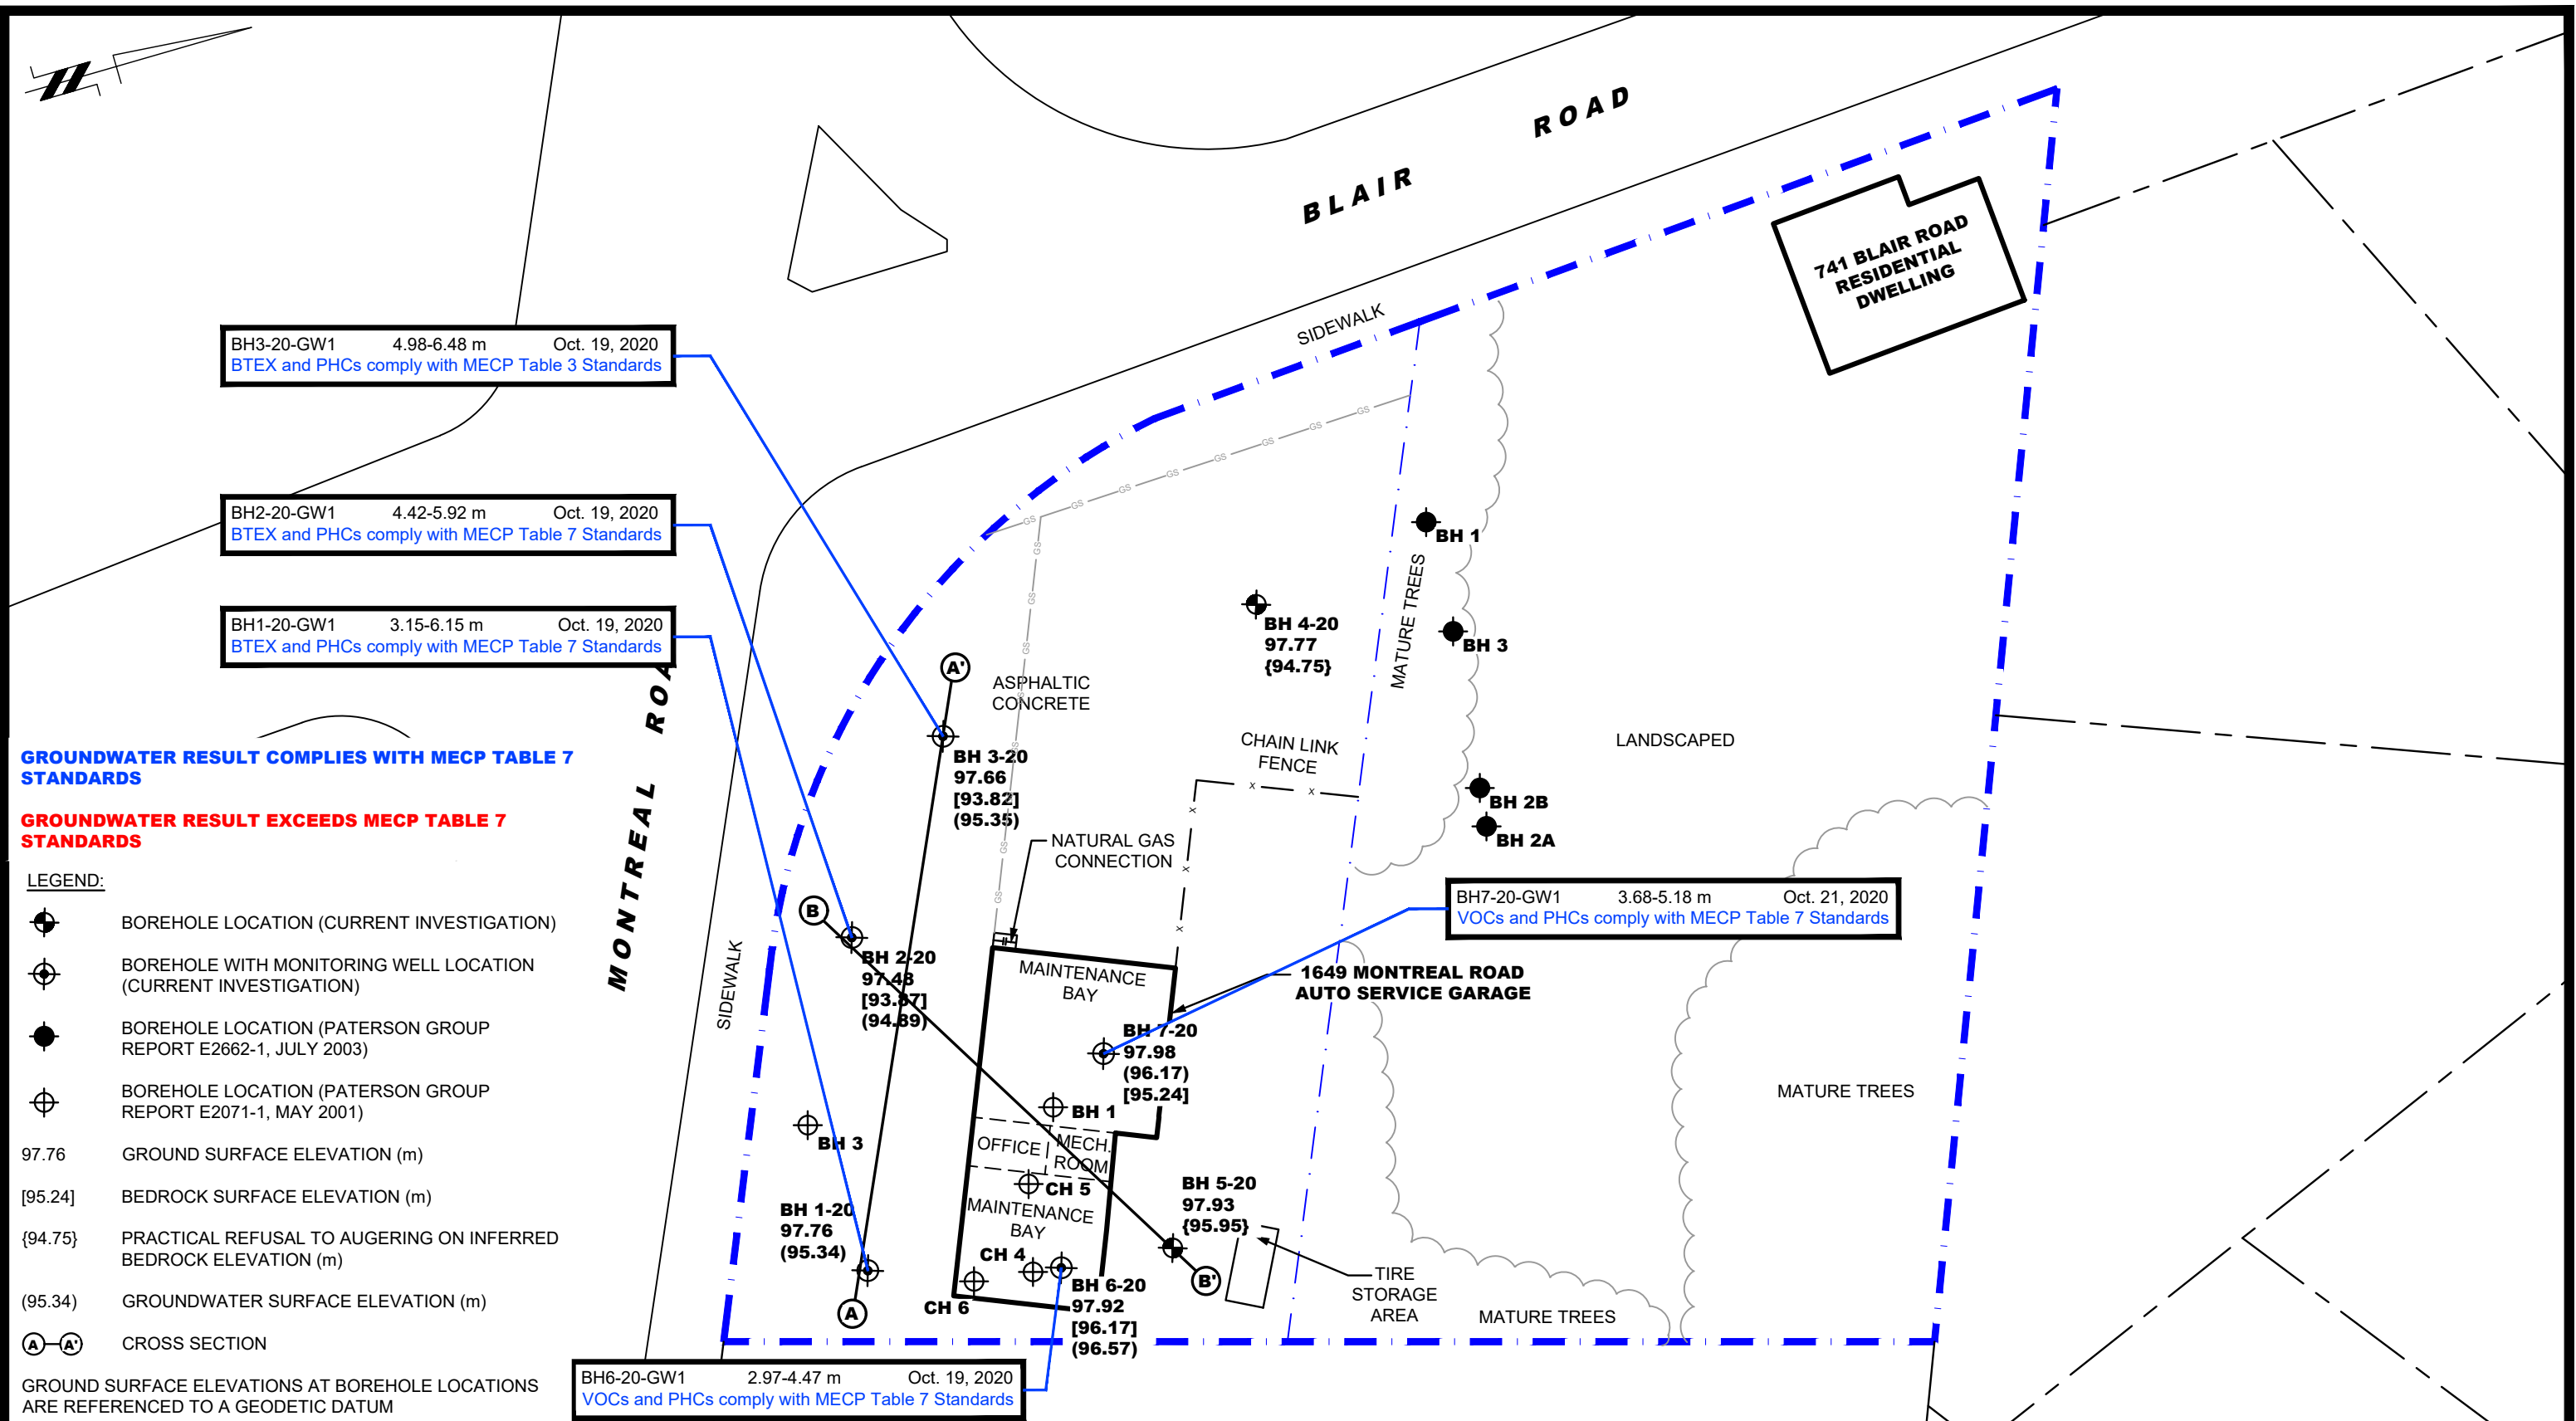
Drawing PE5061-6 – Analytical Testing Plan – Groundwater (BTEX, VOCs, PHCs)

BH3-20-GW1 4.98-6.48 m Oct. 19, 2020
 BTEX and PHCs comply with MECP Table 3 Standards

BH2-20-GW1 4.42-5.92 m Oct. 19, 2020
 BTEX and PHCs comply with MECP Table 7 Standards

The concentration of chloroform detected in groundwater sample BH6-20-GW1 is marginally in excess of the selected MECP Table 7 residential standards. This exceedance is inferred to be a result of municipal water used during the rock coring process and is expected to dissipate in the near future. It is recommended that additional groundwater sampling be conducted at BH6 to confirm the dissipation of the chloroform.
