Phase II – Environmental Site Assessment

1649 Montreal Road & 741 Blair Road
Ottawa, Ontario

October 30, 2020

Report: PE5061-2

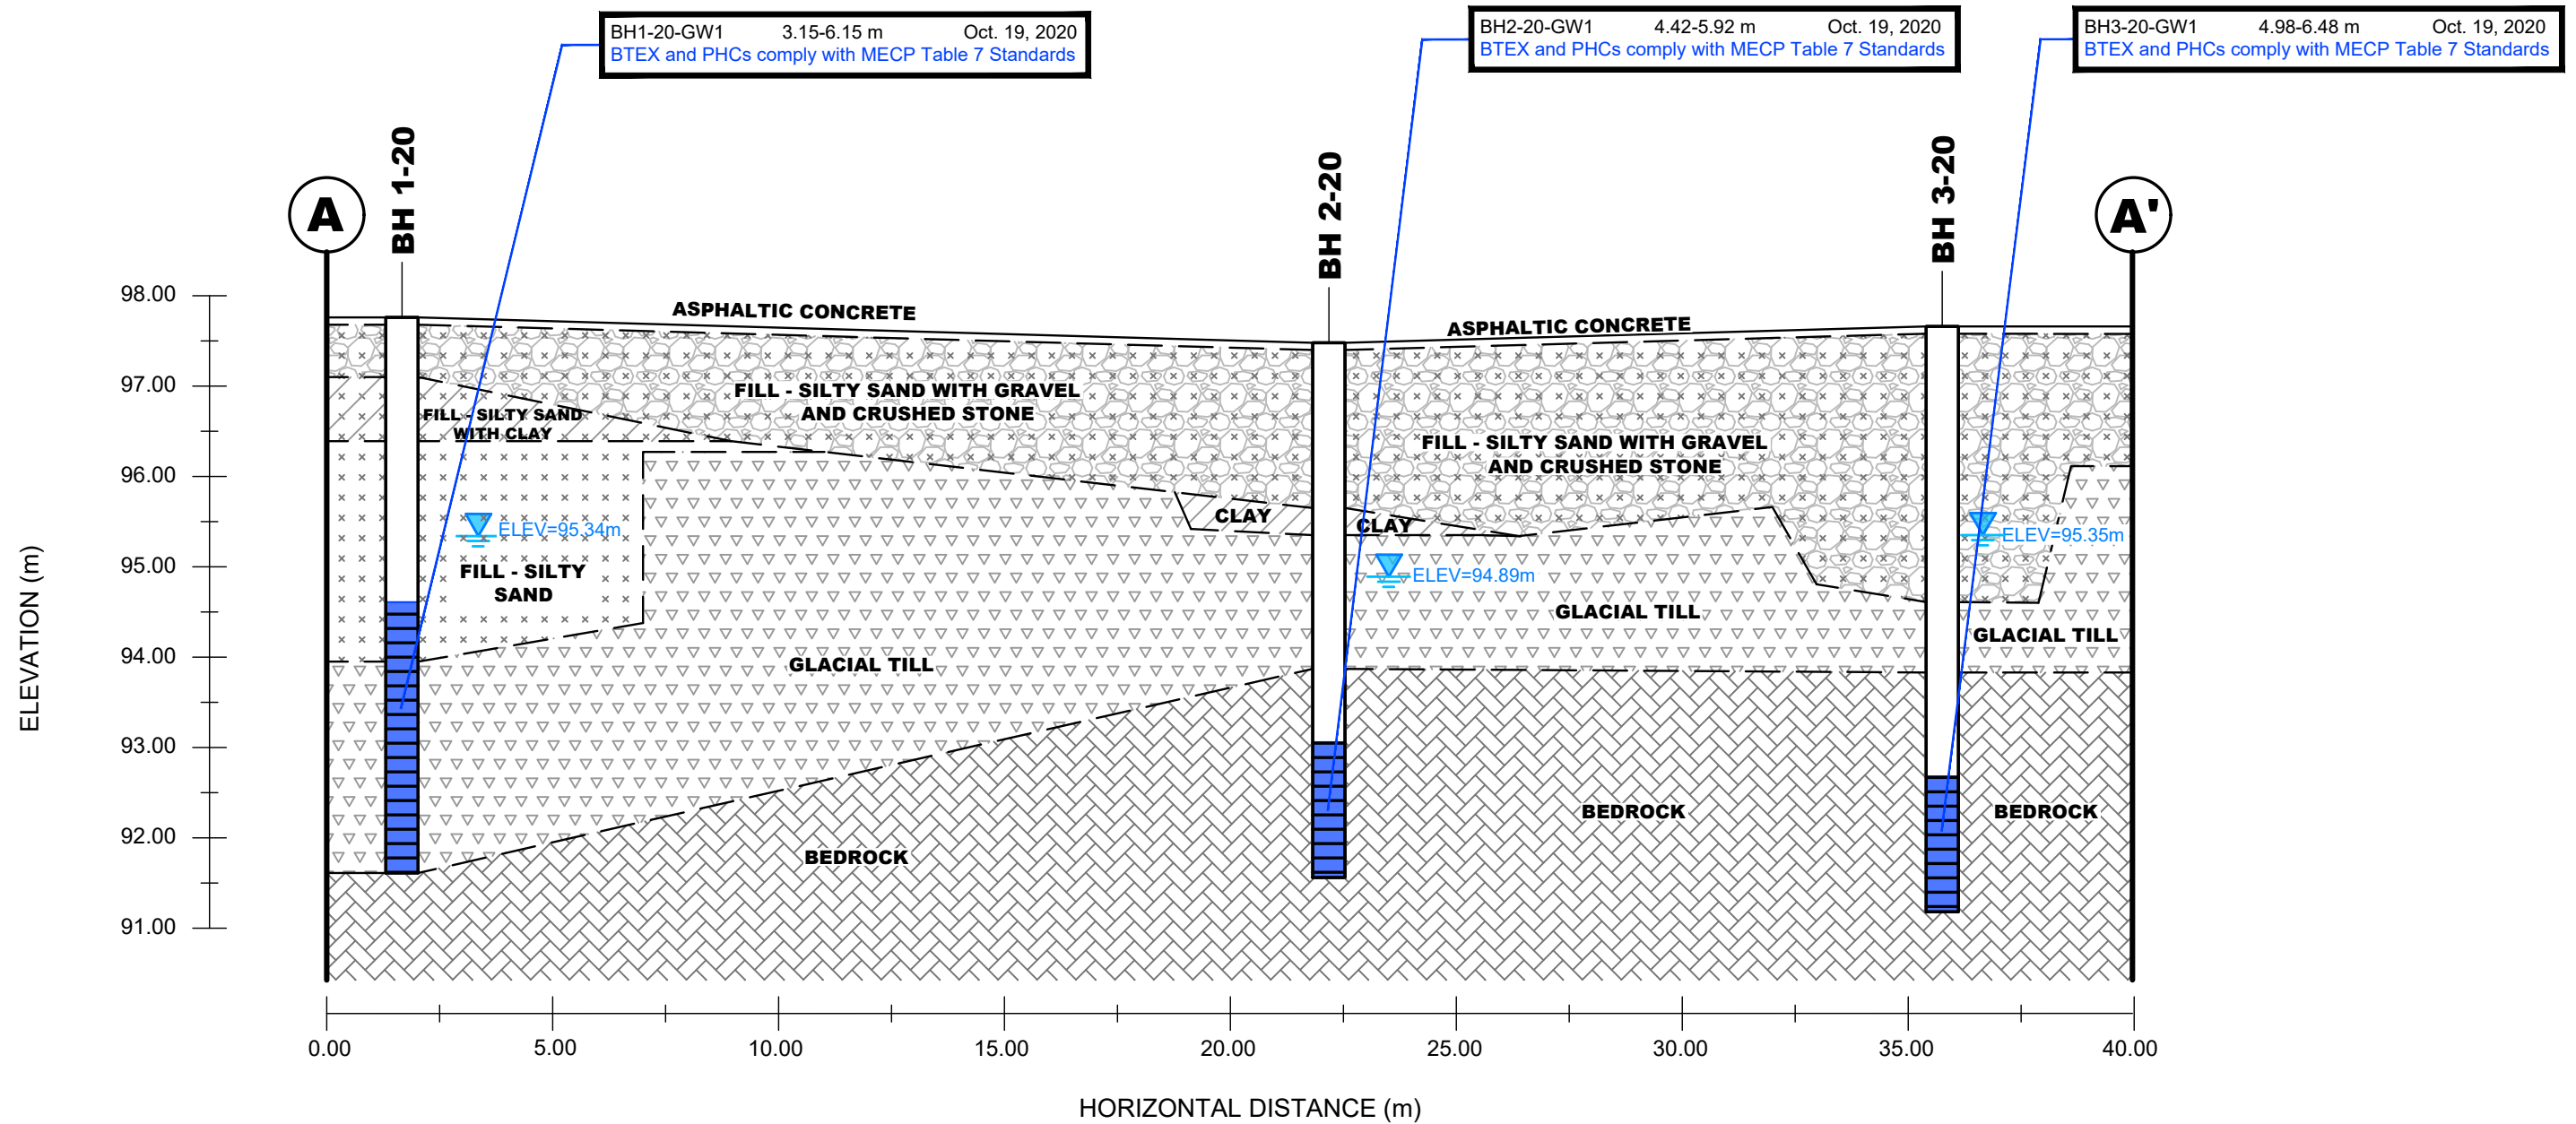
| Checked by: | NS | Dwg. No.: | PE5061-6A |

GROUNDWATER RESULT COMPLIES WITH MECP TABLE 7 STANDARDS

GROUNDWATER RESULT EXCEEDS MECP TABLE 7 STANDARDS

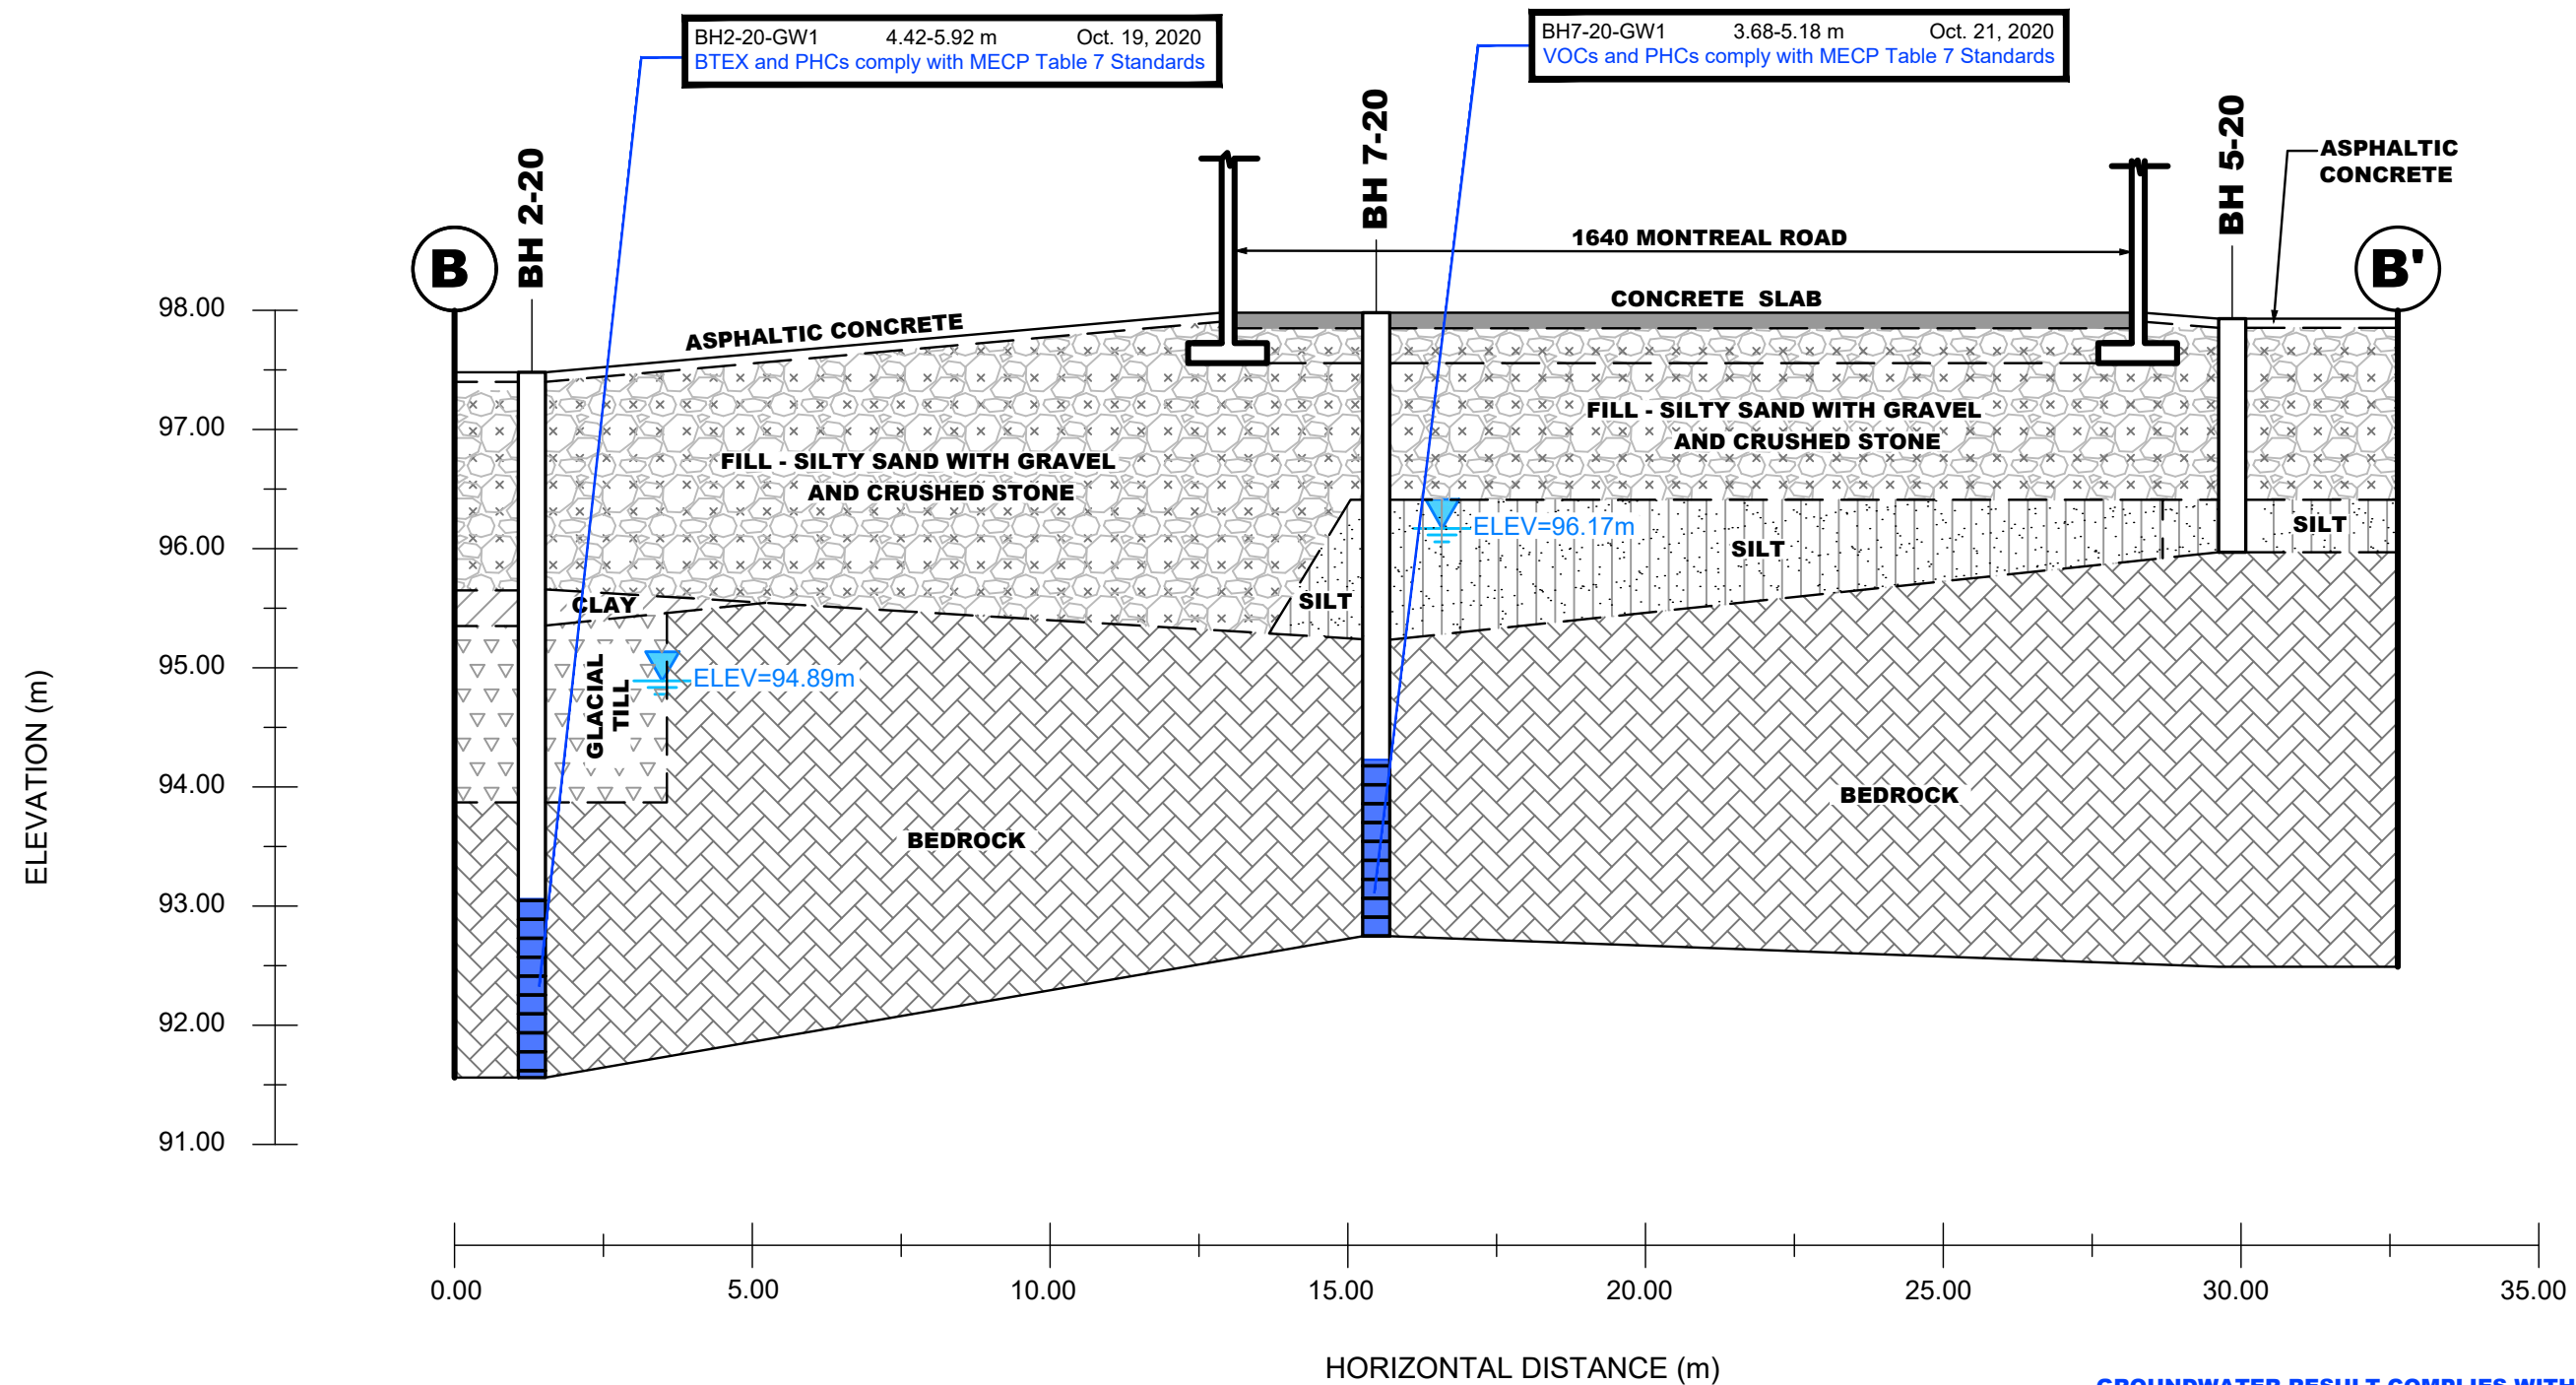
GROUNDWATER RESULT COMPLIES WITH MECP TABLE 7 STANDARDS
GROUNDWATER RESULT EXCEEDS MECP TABLE 7 STANDARDS

The concentration of chloroform detected in groundwater sample BH6-20-GW1 is marginally in excess of the selected MECP Table 7 residential standards. This exceedance is inferred to be a result of municipal water used during the rock coring process and is expected to dissipate in the near future. It is recommended that additional groundwater sampling be conducted at BH6 to confirm the dissipation of the chloroform.

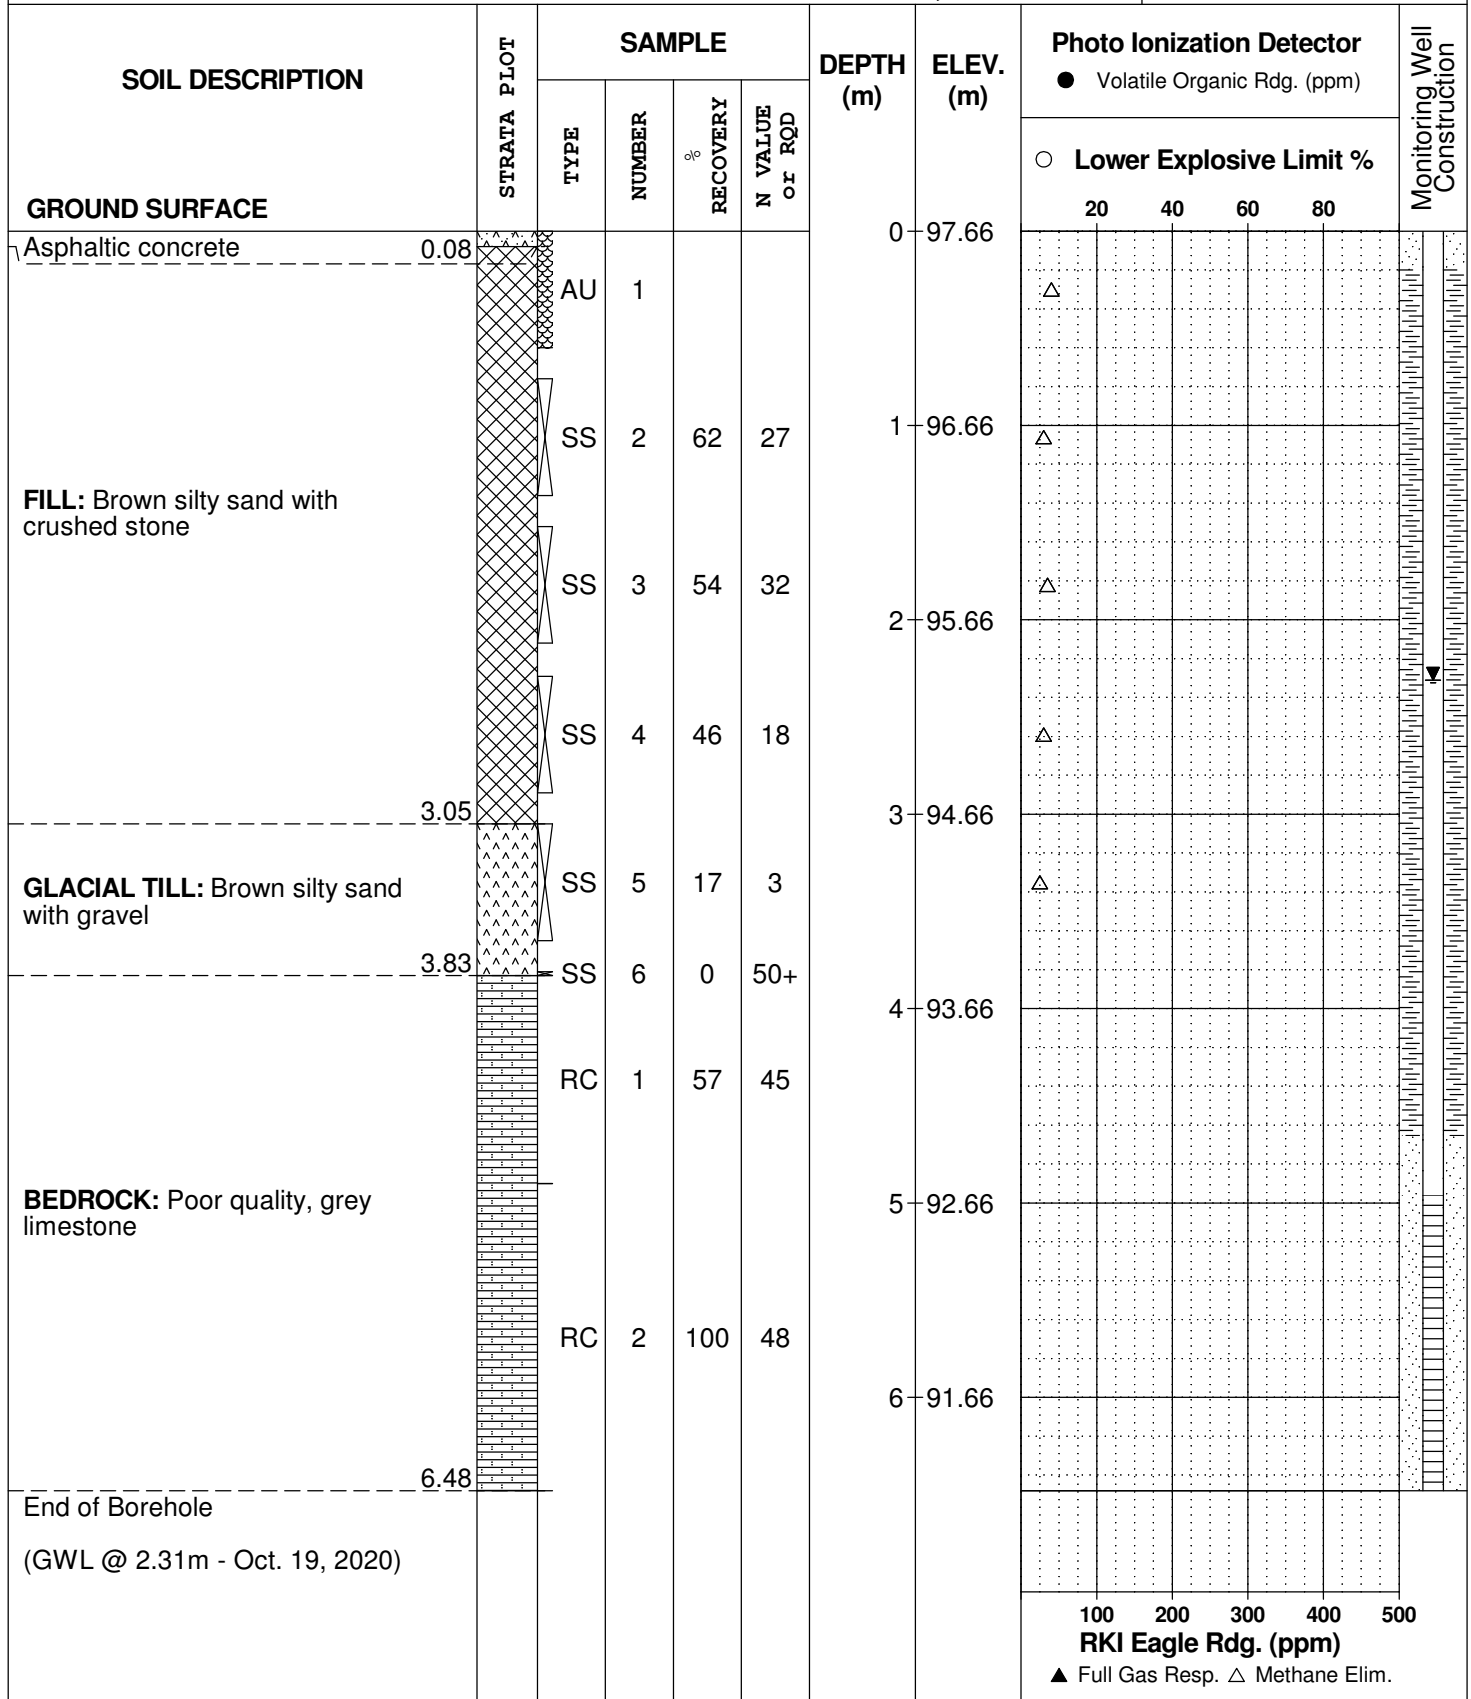
HOLE NO. **BH 3-20**

SOIL PROFILE AND TEST DATA
