Phase One Environmental Site Assessment 112 Montreal Road, Ottawa, Ontario

Phase One Environmental Site Assessment

OTT-00214936-CO

2022-04-04

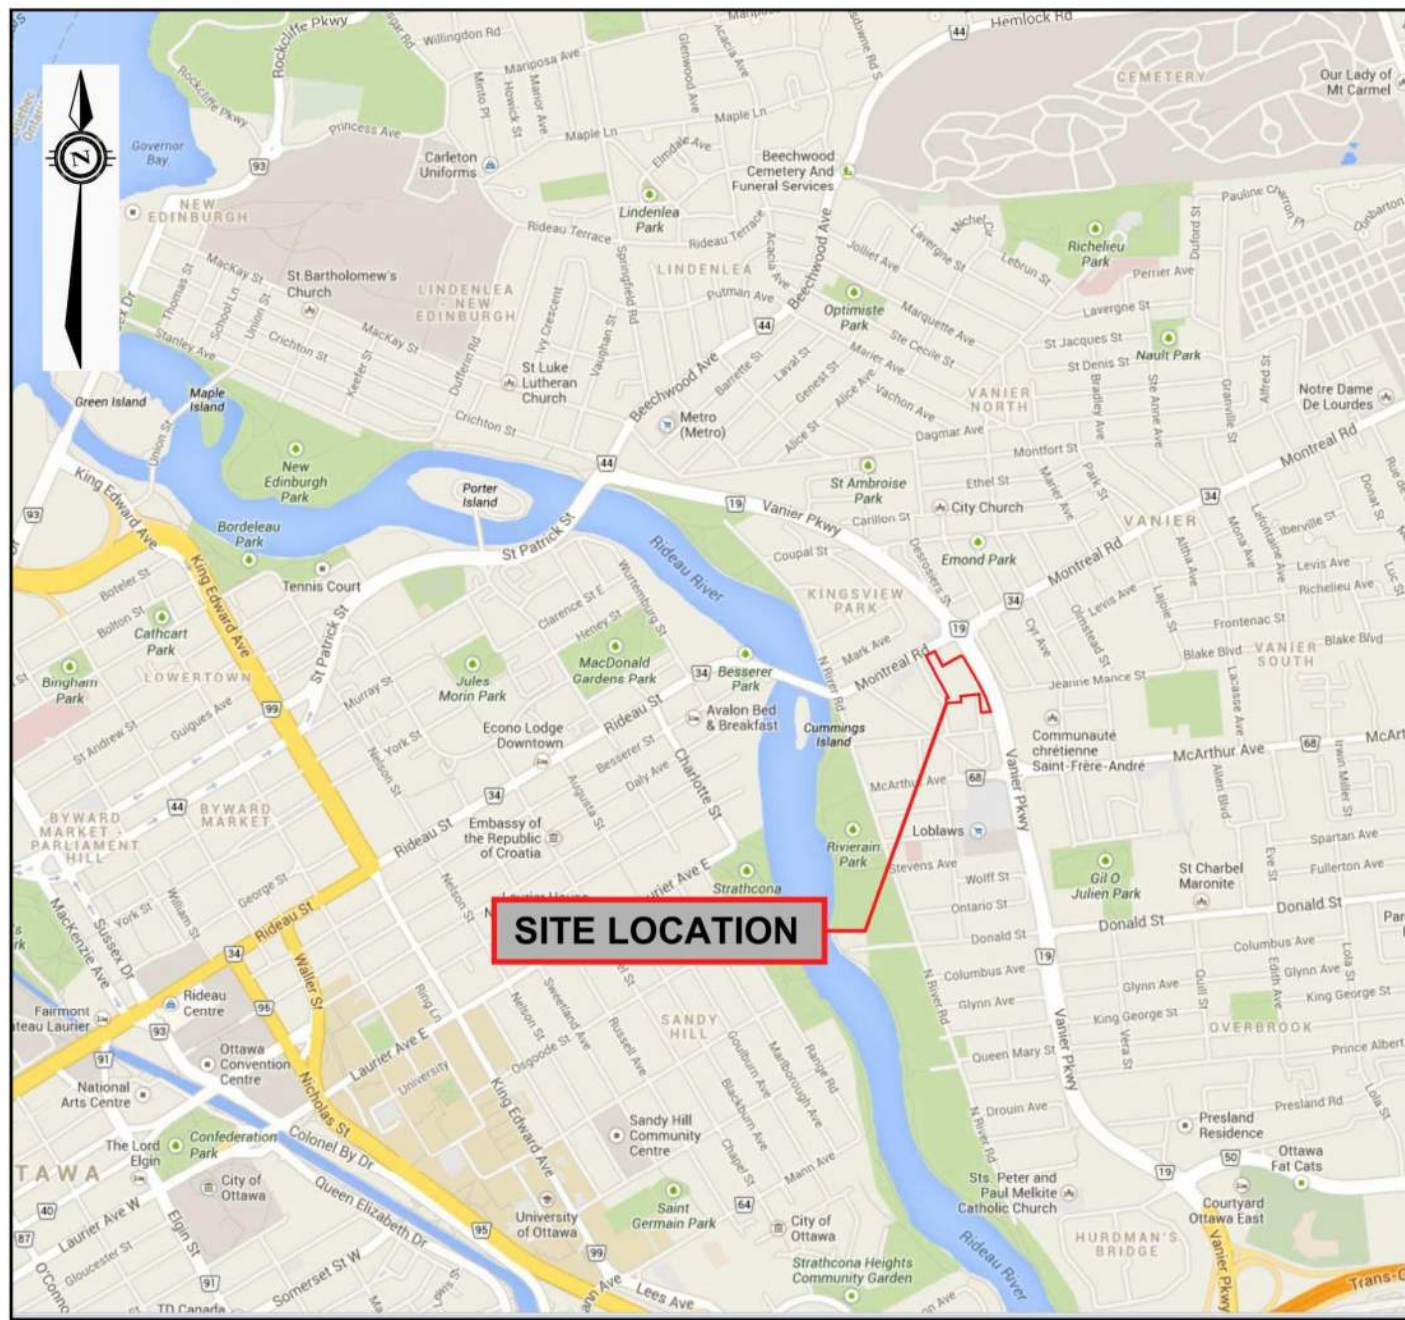
DATE APRIL 2023	CLIENT: 2705460 ONTARIO INCORPORATED	project no. OTT-00214936-C0
DESIGN LW	CHECKED MM	scale 1:20,000
DRAWN BY AS	TITLE: SITE LOCATION PLAN 112 MONTREAL ROAD, OTTAWA, ONTARIO	FIG 1

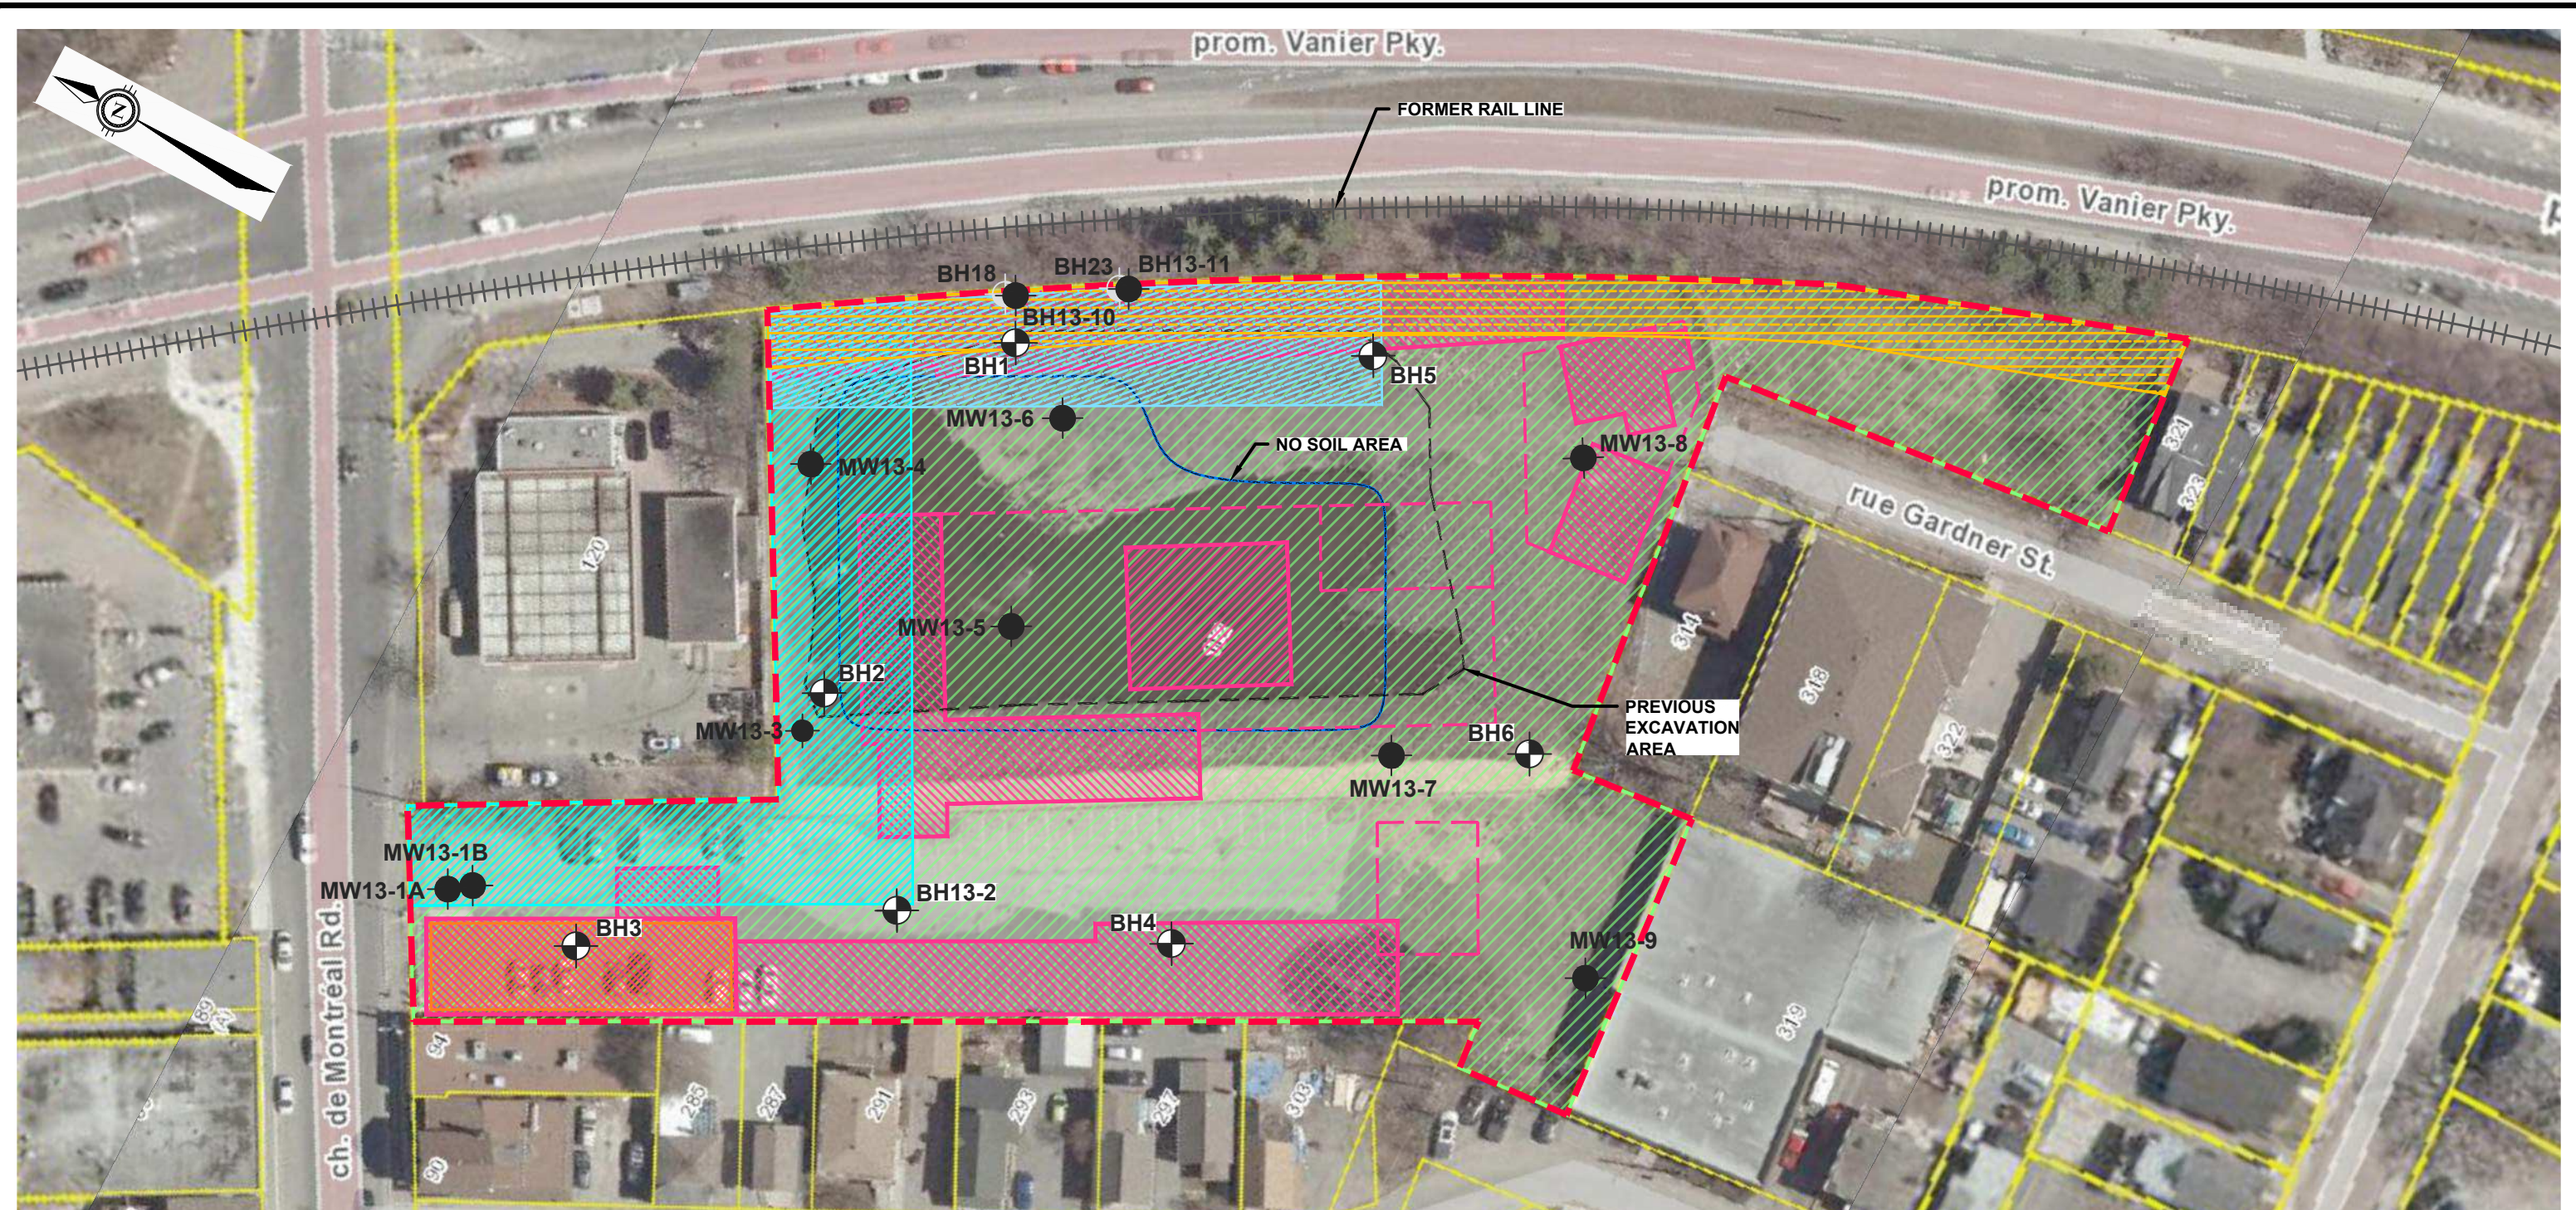
PROPERTY BOUNDARY
	BH1 BOREHOLE / MONITORING WELL NO. & LOCATION (EXP, 2022)
	MW13-1A MONITORING WELL NO. & LOCATION (EXP, 2013)
	FORMER BUILDINGS (Removed 2017-2018)
	FORMER BUILDINGS (Removed ~70-90ties)

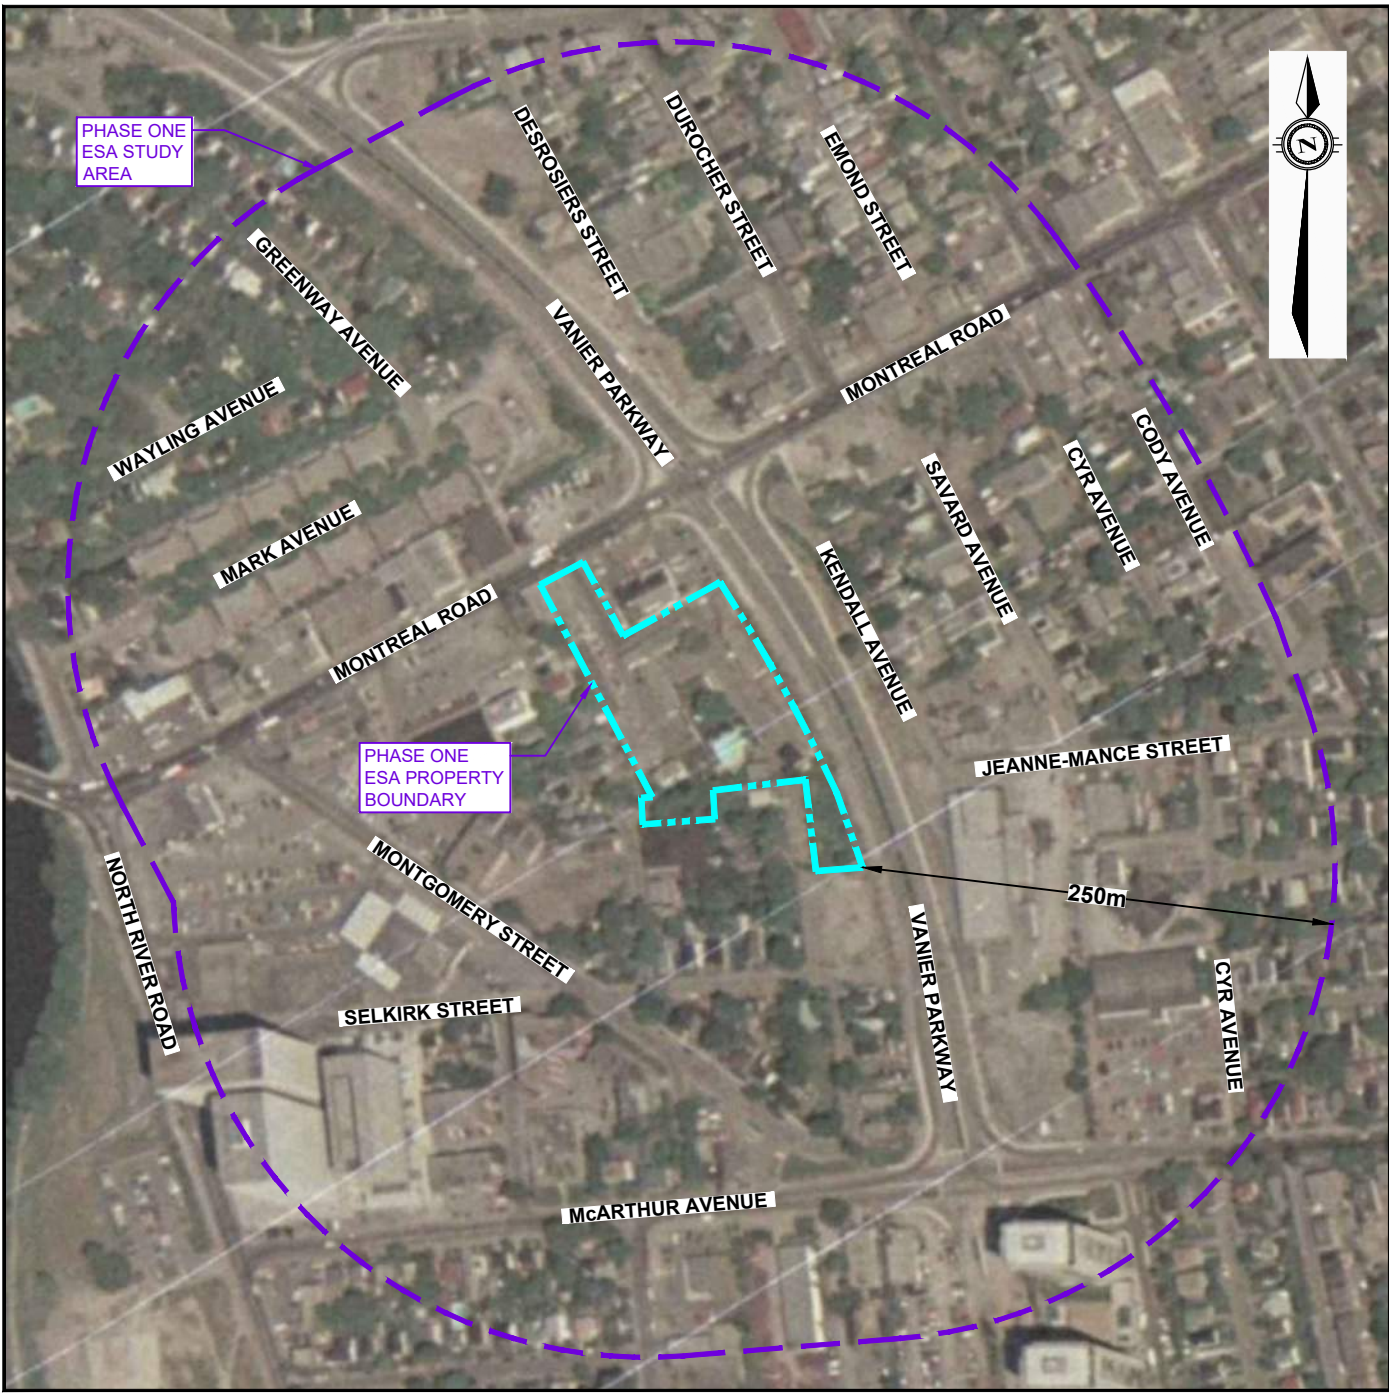
DATE APRIL 2023		CLIENT: 2705460 ONTARIO INCORPORATED		project no. OTT-00214936-C0
DESIGN LW	CHECKED MM	PHASE ONE ENVIRONMENTAL SITE ASSESSMENT (ESA)		scale 1:4,000
DRAWN BY PG / AS		TITLE: 1976 AERIAL PHOTOGRAPH 112 MONTREAL ROAD, OTTAWA, ONTARIO		FIG F-5

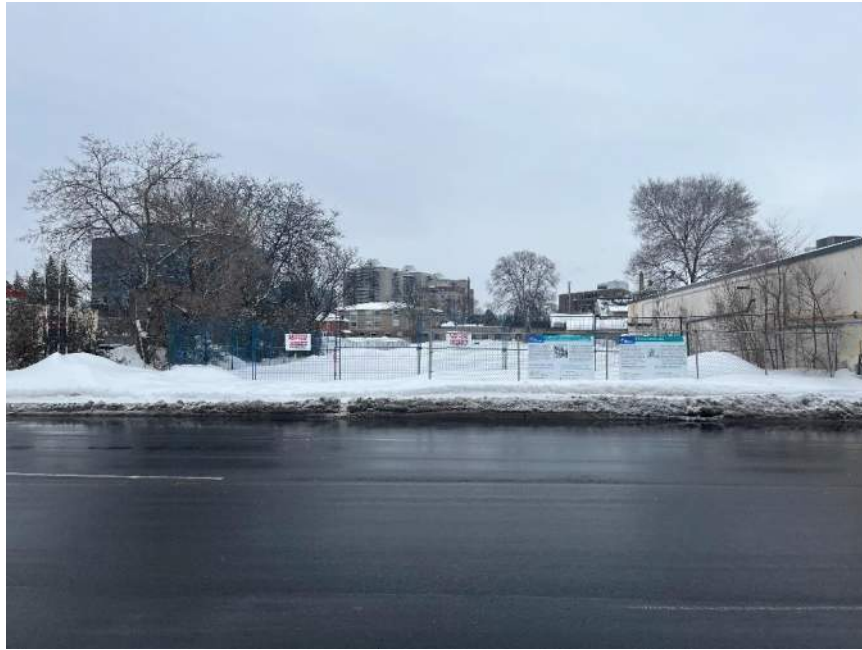
Photograph No. 1

View of the north part of the Phase One property, looking south.

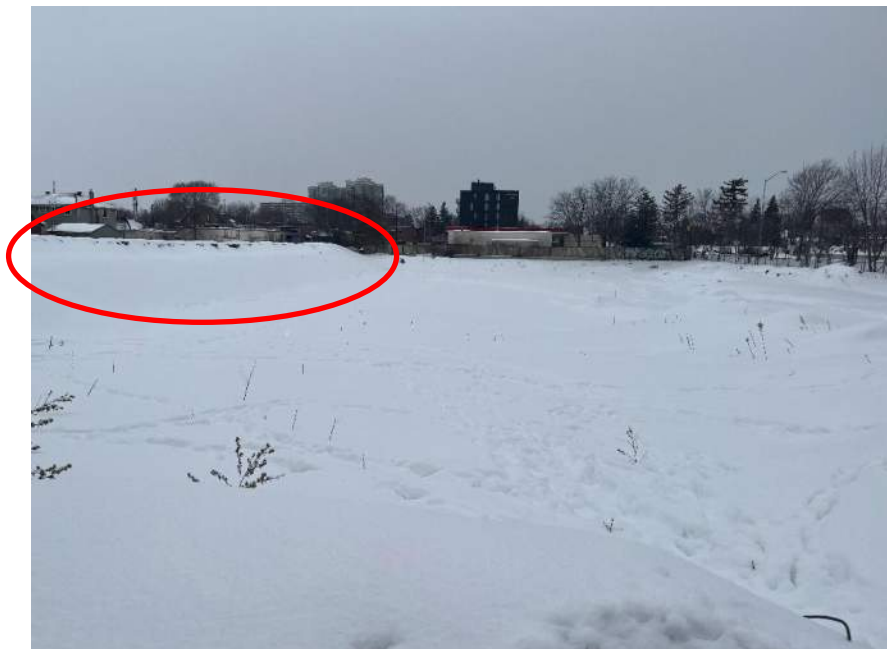
Photograph No. 2

View of the south part of the Phase One property, looking north. The berm is located on the left side of the photo.

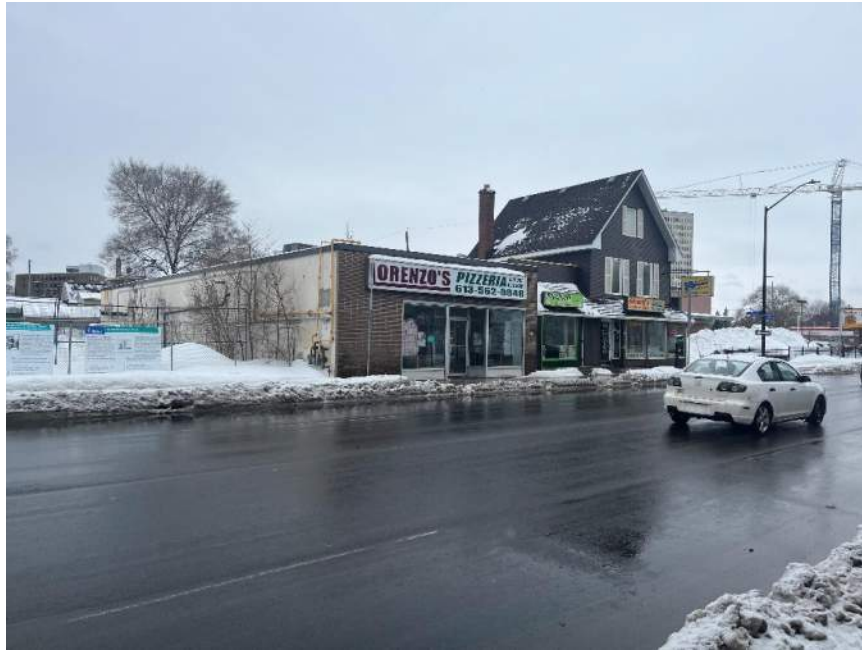
Photograph No. 3

View of the commercial properties to the west of the Phase One property along Montreal Road.

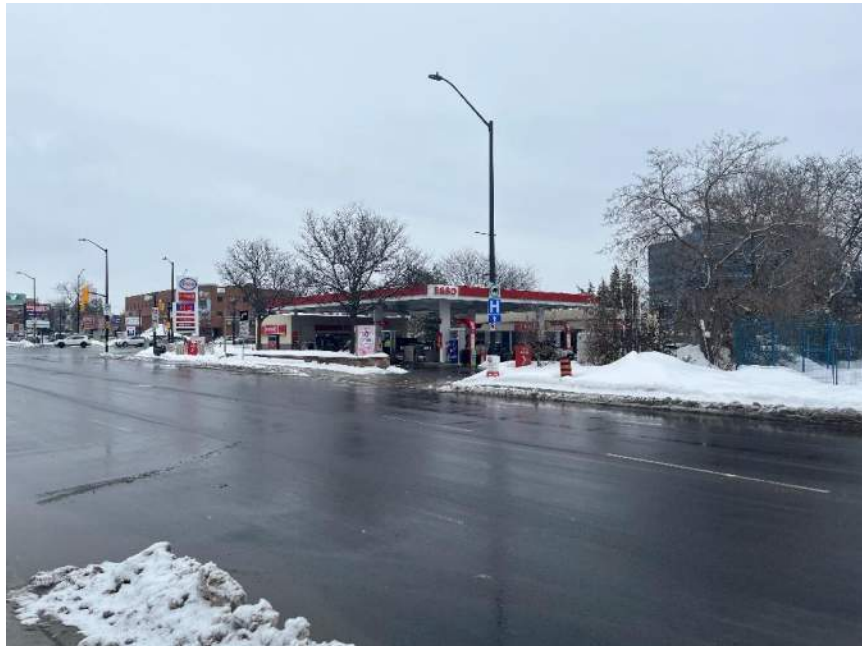
Photograph No. 4

View of the gas station to the east of the Phase One property along Montreal Road.
