**Hydrogeological Investigation &
Terrain Analysis
Proposed Commercial Building
4 Campbell Reid Court
Ottawa, Ontario**

December 22, 2022
Project: 65103.01

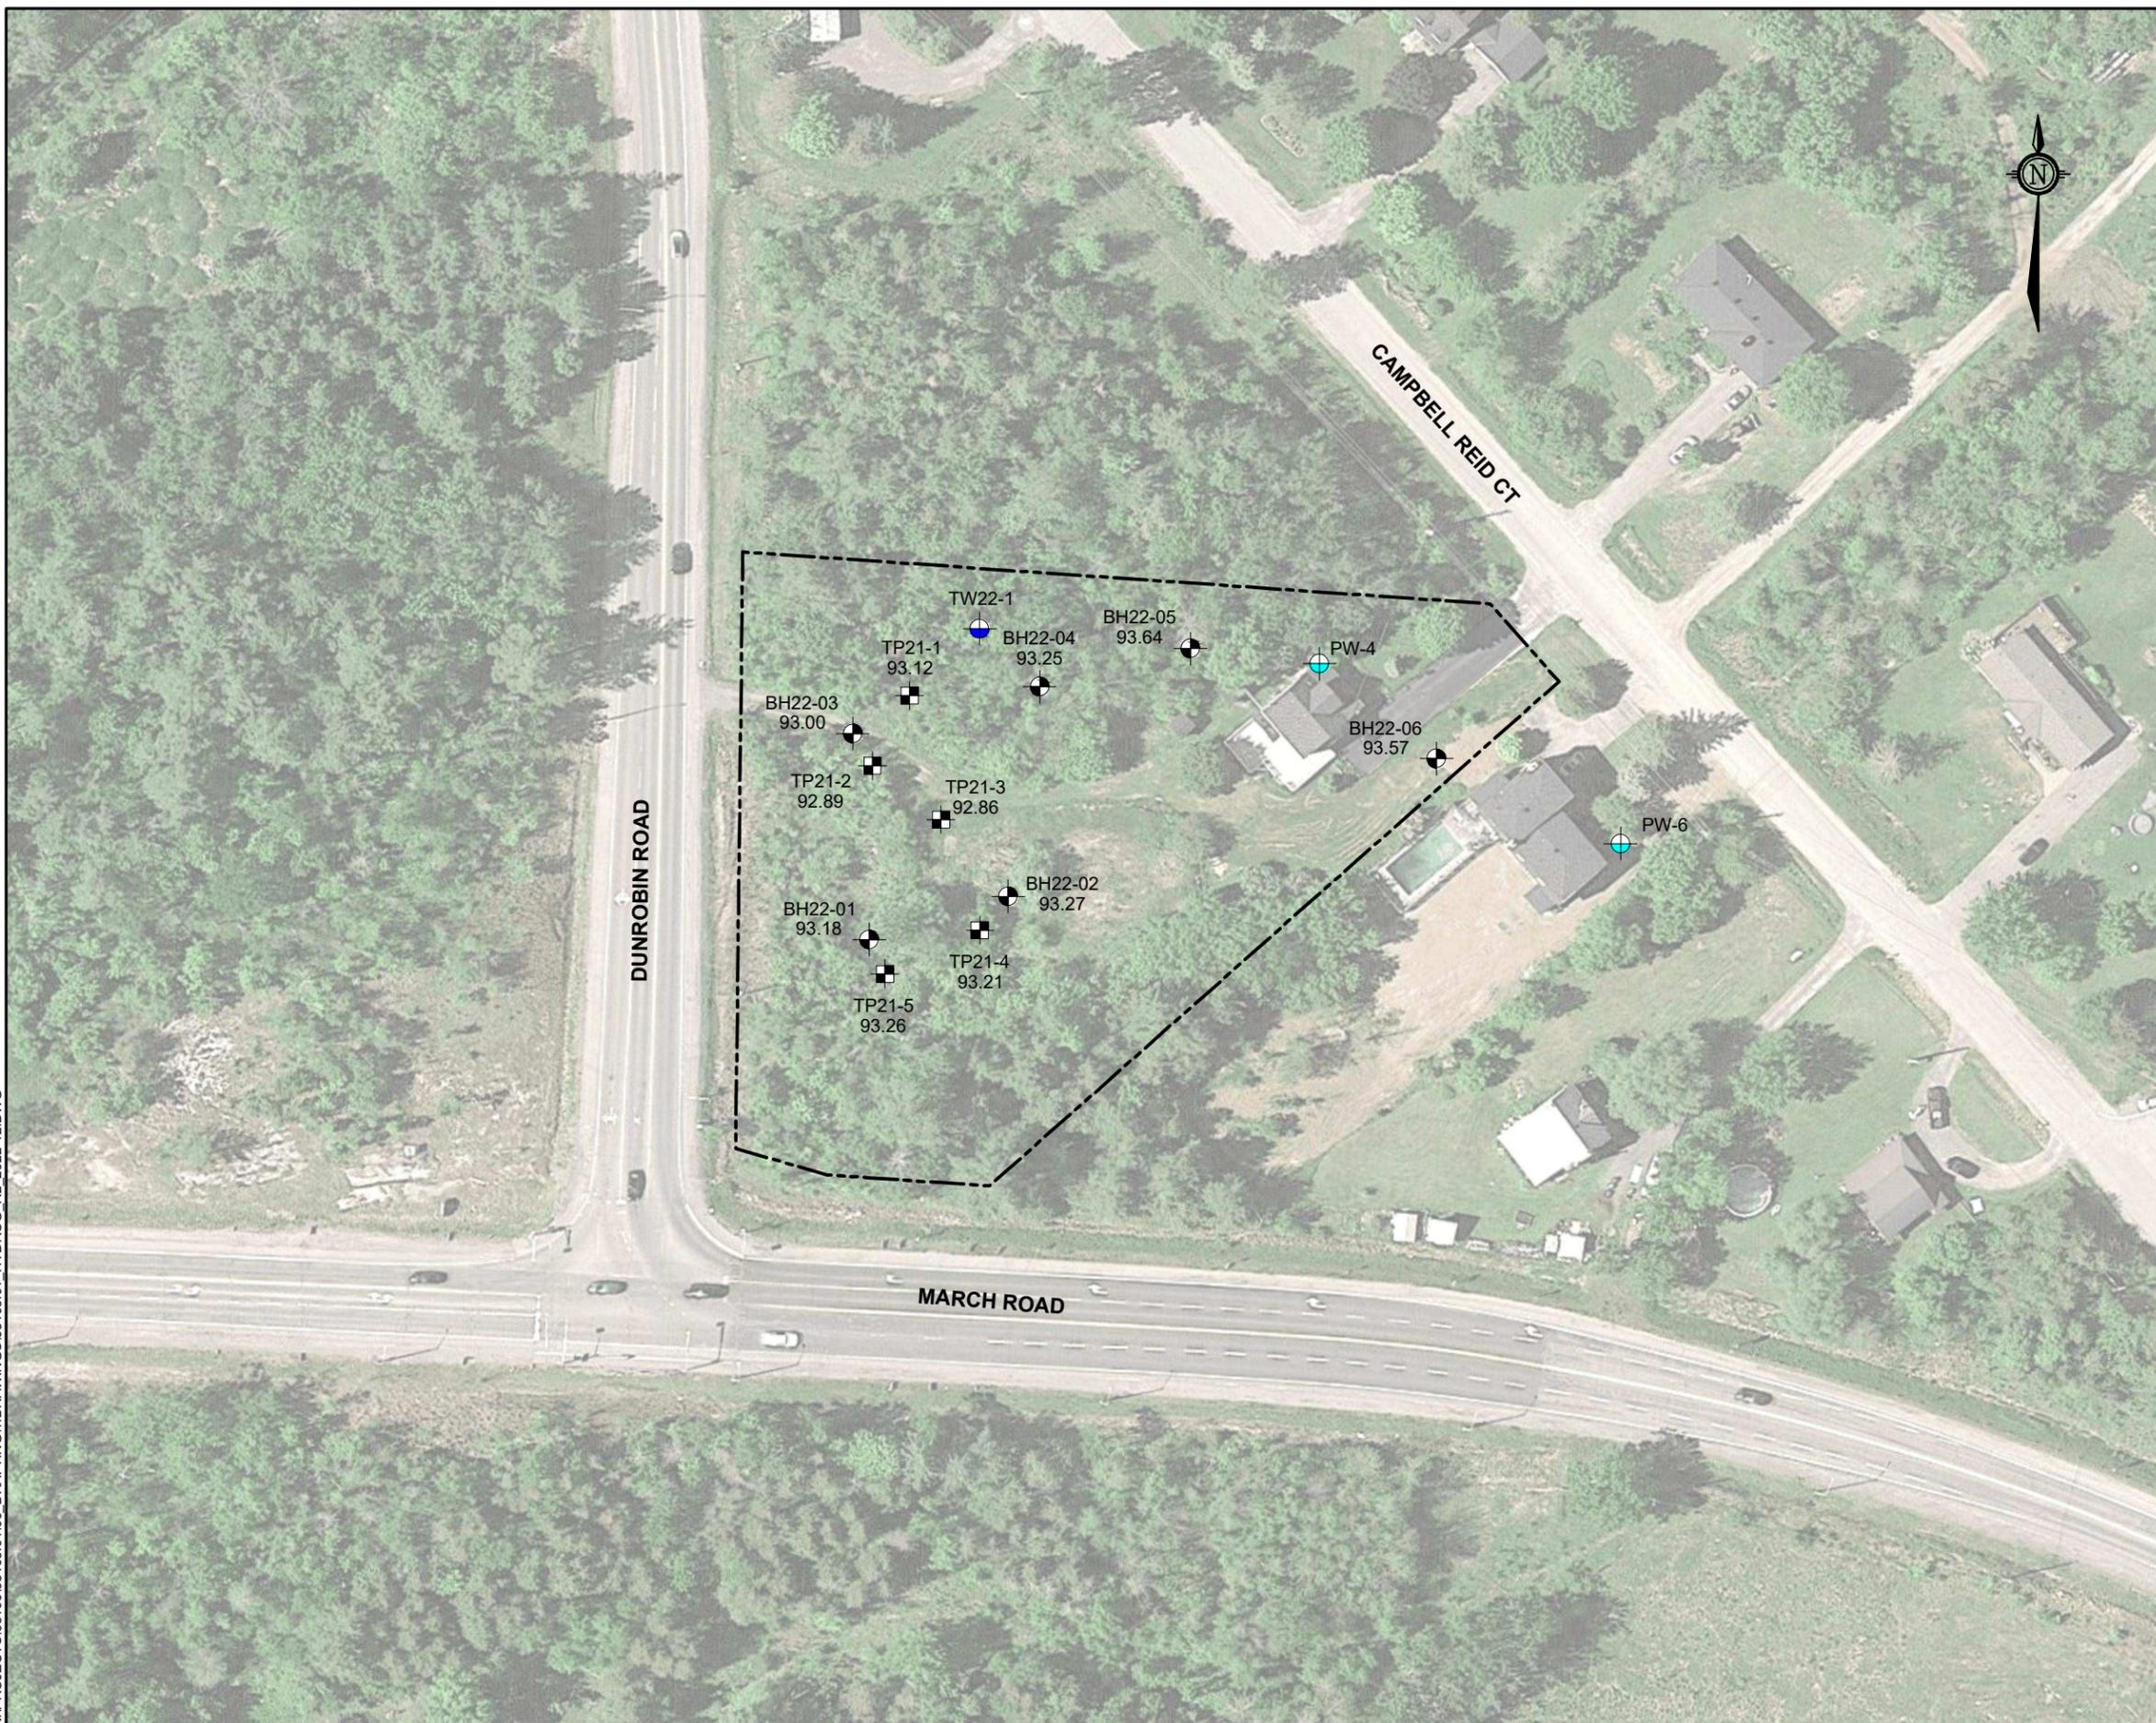
Date	DECEMBER, 2022	Rev.	2	FIGURE 1
------	----------------	------	---	-----------------

BH/ TP/ TW/ PW # → BOREHOLE/ TEST PIT/ TEST WELL/ PRIVATE WELL ID
 XX.XX → GROUND SURFACE ELEVATION, IN METRES GEODETIC DATUM

GEMTEC Consulting Engineers and Scientists Limited (GEMTEC) was retained to carry out a hydrogeological investigation and terrain analysis in support of a proposed commercial building to be located at 4 Campbell Reid Court in Ottawa, Ontario. The site location is provided in Figure 1, which is located following the text of this report.

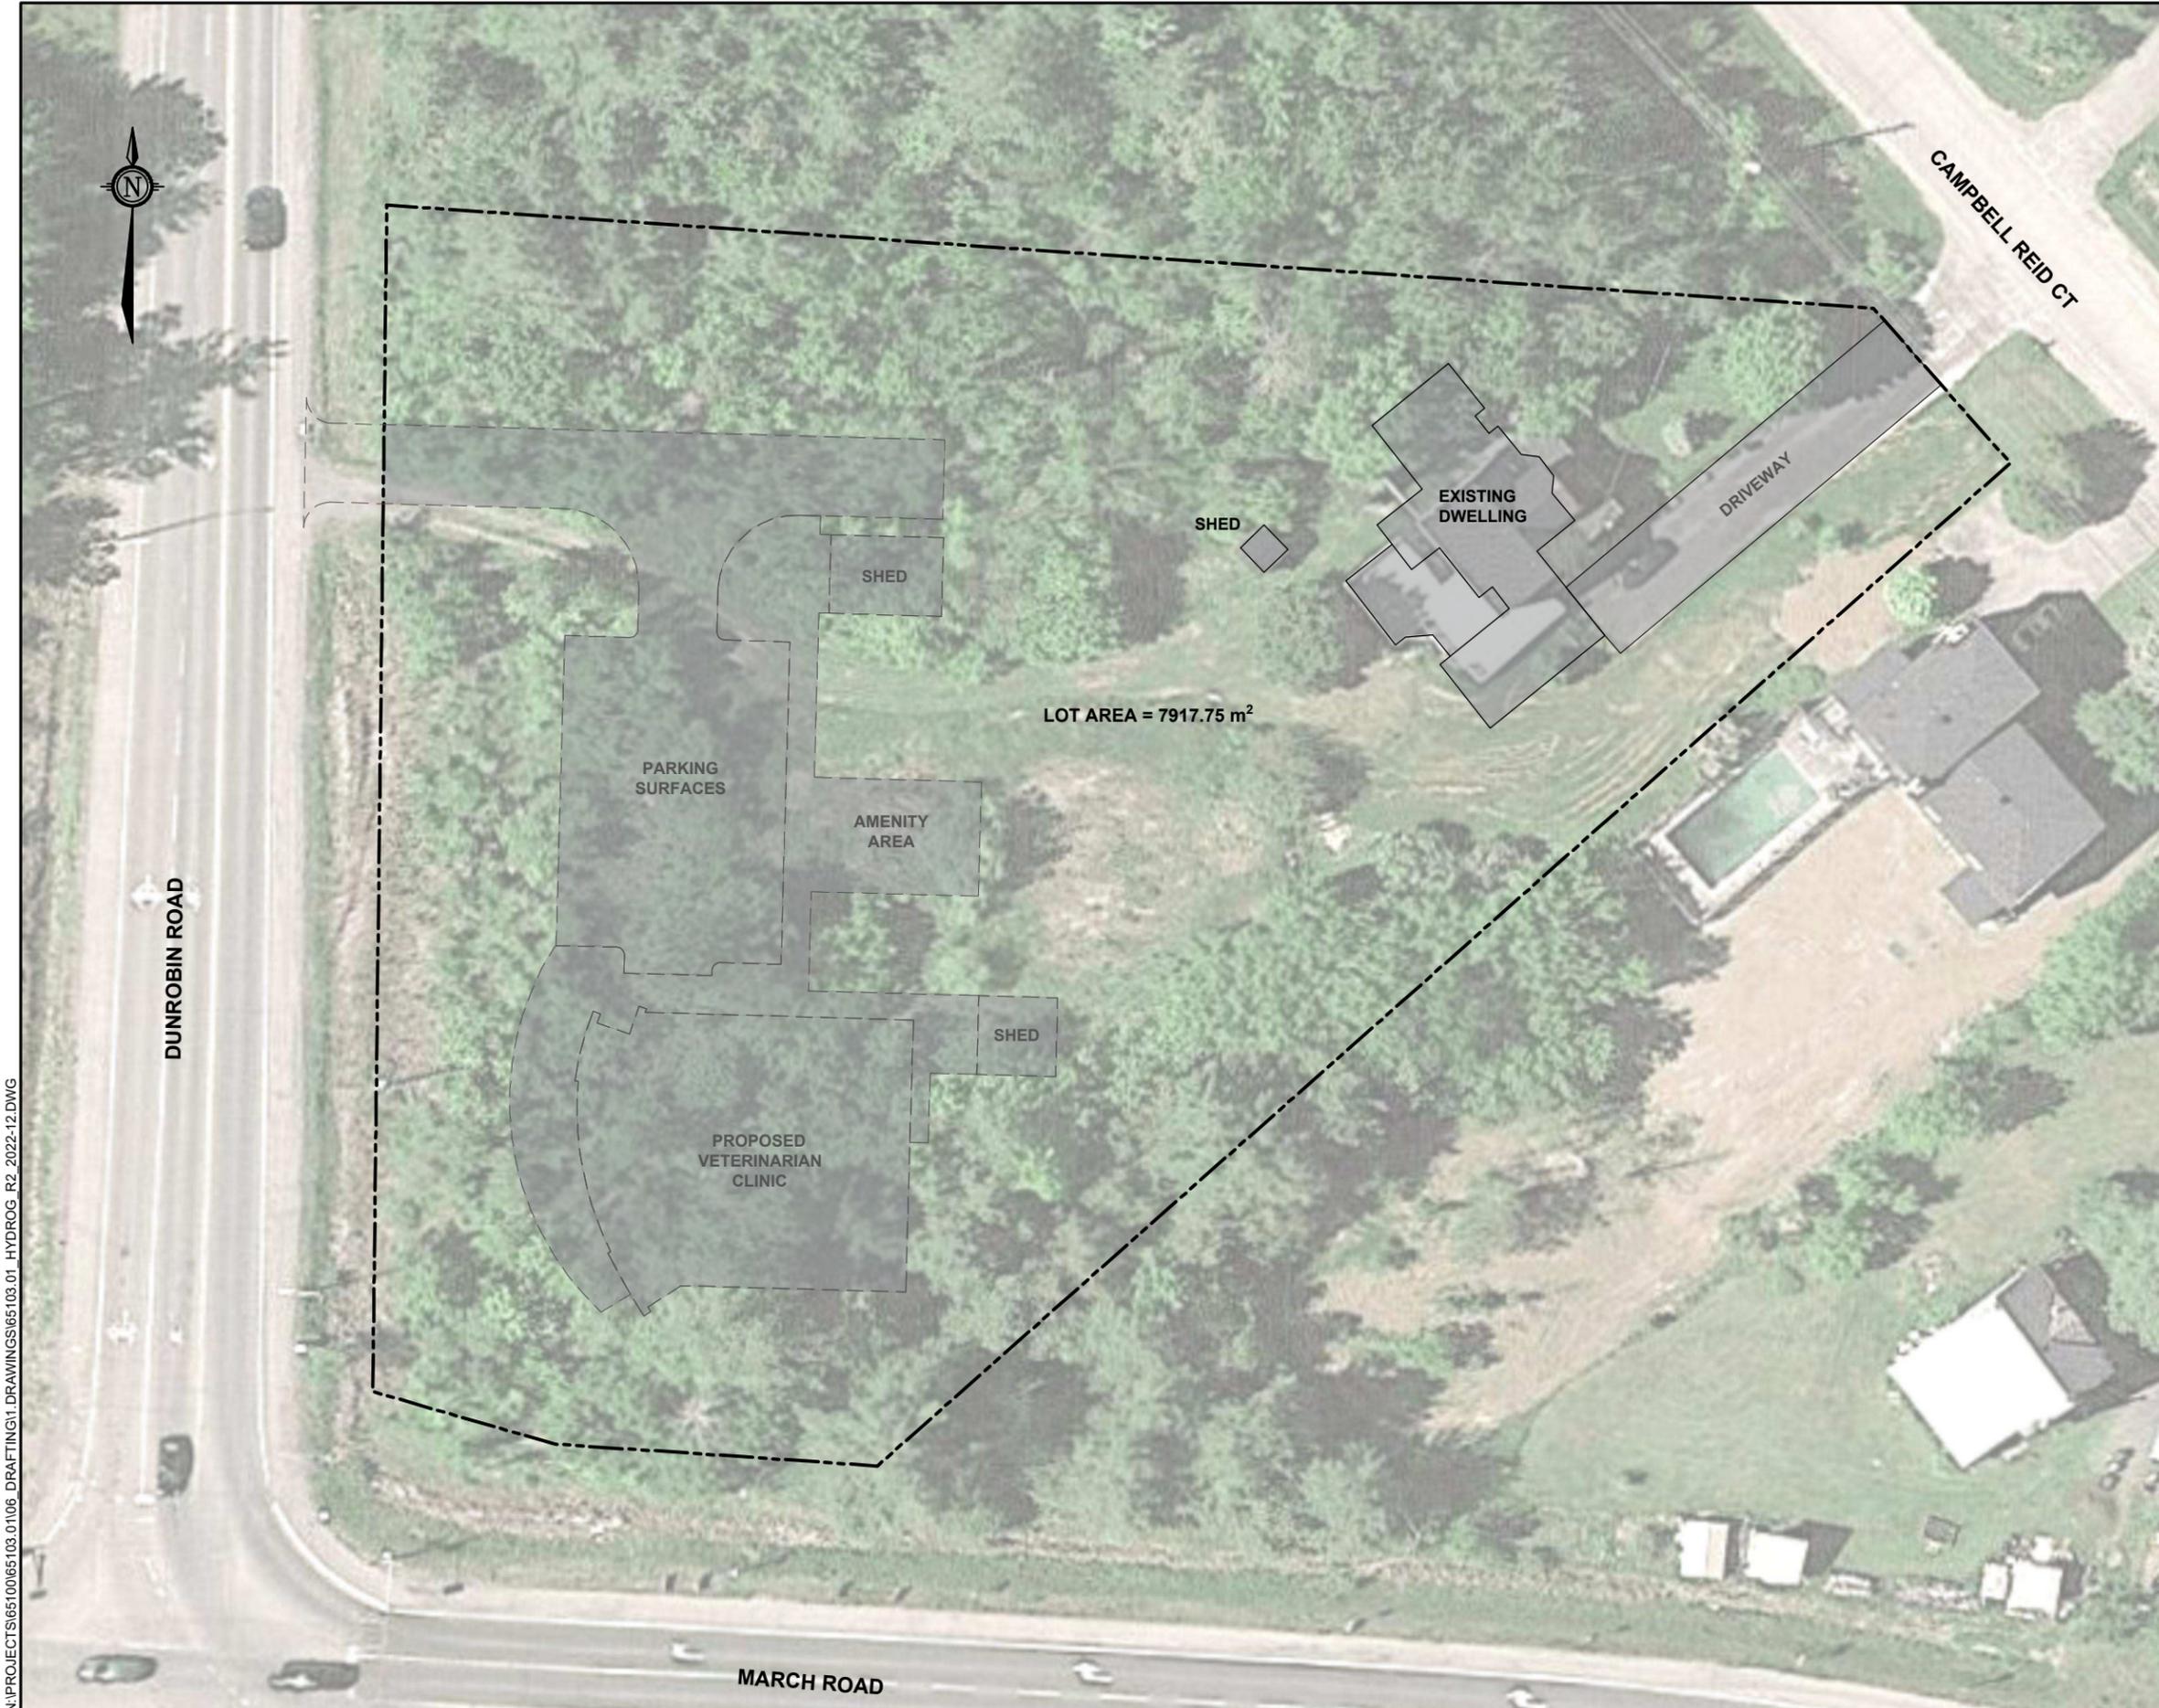
Date	Rev.	FIGURE 3
DECEMBER, 2022	2

- APPROXIMATE PROPERTY BOUNDARY
- STUDY AREA
(250m RADIUS FROM THE PROPERTY BOUNDARY)
- HARD SURFACES = 2302.89 m²
(29% OF LOT AREA)
