# Phase One Environmental Site Assessment 4 Campbell Reid Court

Ottawa, Ontario

May 31, 2023

Project: 65013.01

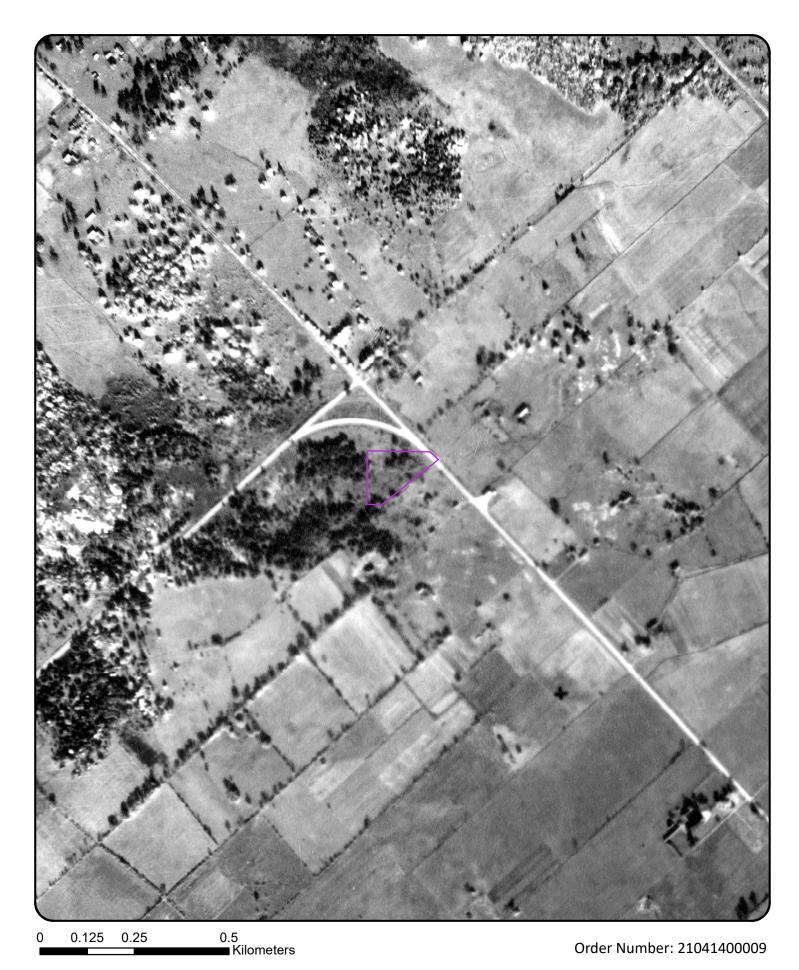
Year: 1945 Source: NAPL Map Scale: 1: 10000

Date	Photograph Number	Observations
1945	National Air Photo Library - NAPL	Although, the photo resolution is poor, the subject property appears to be vacant and covered with vegetation.
1954	National Air Photo Library - NAPL	No significant changes observed from the 1945 aerial photograph.
1965	GeoOttawa – Publically Available	No significant changes observed from the 1954 aerial photograph.
1976	GeoOttawa – Publically Available	No significant changes observed from the 1965 aerial photograph.
1984	National Air Photo Library - NAPL	A residential building appears to be present on the subject property with the western portion of the property covered with vegetation.
1991	GeoOttawa – Publically Available	No significant changes observed from the 1984 aerial photograph.
2002	GeoOttawa – Publically Available	The western portion of the subject property appears to be covered with fill material
2005	GeoOttawa – Publically Available	No significant changes observed from the 2002 aerial photograph.

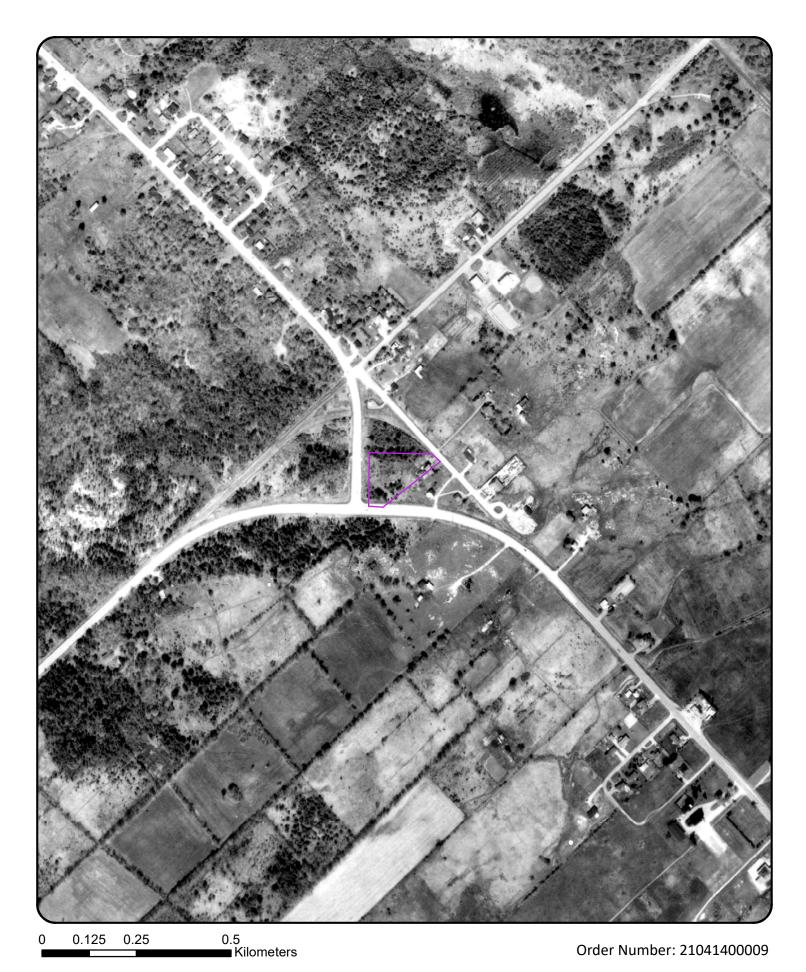
Year: 1984 Source: NAPL Map Scale: 1: 10000

Based on the review of selected historical aerial photographs, the subject property appears to be vacant up until sometime in 1984. Based on the historical development of the subject property (anticipated sometime between 1976 and 1984), fill of unknown quality has likely been imported to the property in the past, *PCA #30. Importation of Fill Material of Unknown Quality.* In addition, as per testimonial evidence from Mr. Olender, the western portion of the subject property was used as a storage site for fill material. No significant changes are observed for the subject property since 1984 except for a fire incident that reportedly took place sometime in 2018/2019. Response from the City of Ottawa received October 21, 2021, did not indicate the use of firefighting foam or fire suppression. The northern portion of the residential building, on the subject property, appears to be damaged in the aerial photograph from 2019. The land parcels to the north of the subject property were vacant until sometime in 1984 as well. Several land parcels were developed and later occupied by residential buildings, which appear in the aerial photographs between 1984 and 2005. Since 2005, no significant changes have been observed for the study area.

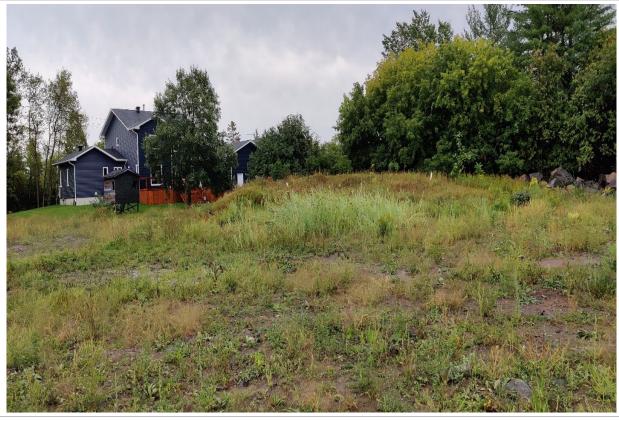
Photograph Plate I2: Anticipated fill material on the subject property.

Through a review of aerial photographs, the subject property has had an on-site building (initial site development observed sometime after 1984) and therefore fill of unknown quality has likely been imported on-site in the past. Based on GEMTEC's geotechnical report titled "Geotechnical Investigation Proposed Commercial Building 4 Campbell Reid Court Ottawa Ontario" dated July 12, 2021, the site is covered with a superficial layer of fill material, which was encountered at all test pits locations advanced during the geotechnical investigation. The fill material was variable across the site but can generally be described as dark brown/grey gravelly sandy silt with organics, rootlets, roots, cobbles, boulders, and construction debris. In addition, as per testimonial evidence from Mr. Olender, the western portion of the subject property was used as a storage site for fill material. The associated contaminants of potential concern are PAHs, M&I, PHCs F1-F4, and VOCs in soil and groundwater. This APEC is present across the property. PCA#30 - Importation of Fill Material of Unknown Quality.

No stockpiled fill materials were observed on the subject property during the site reconnaissance. However, based on GEMTEC's geotechnical report titled "Geotechnical Investigation Proposed Commercial Building 4 Campbell Reid Court Ottawa Ontario" dated July 12, 2021, the site is covered with a superficial layer of fill material, which was encountered at all test pits locations advanced during the geotechnical investigation. The fill material was variable across the site but can generally be described as dark brown/grey gravelly sandy silt with organics, rootlets, roots, cobbles, boulders, and construction debris. In addition, fill material is anticipated to be present on the subject property based on historical development of the subject property and study area, and, as per testimonial evidence from Mr. Olender, the western portion of the subject property was used as a storage site for fill material in the past. PCA#30 - Importation of Fill Material of Unknown Quality.

GEMTEC concludes that there is a potential for soil and groundwater contamination at the subject property. As such, completion of a Phase Two ESA to investigate soil and groundwater quality on the subject property is recommended.
