Tree Conservation Report

2625 Sheffield Road, Ottawa, Ontario

60648725

October 2022

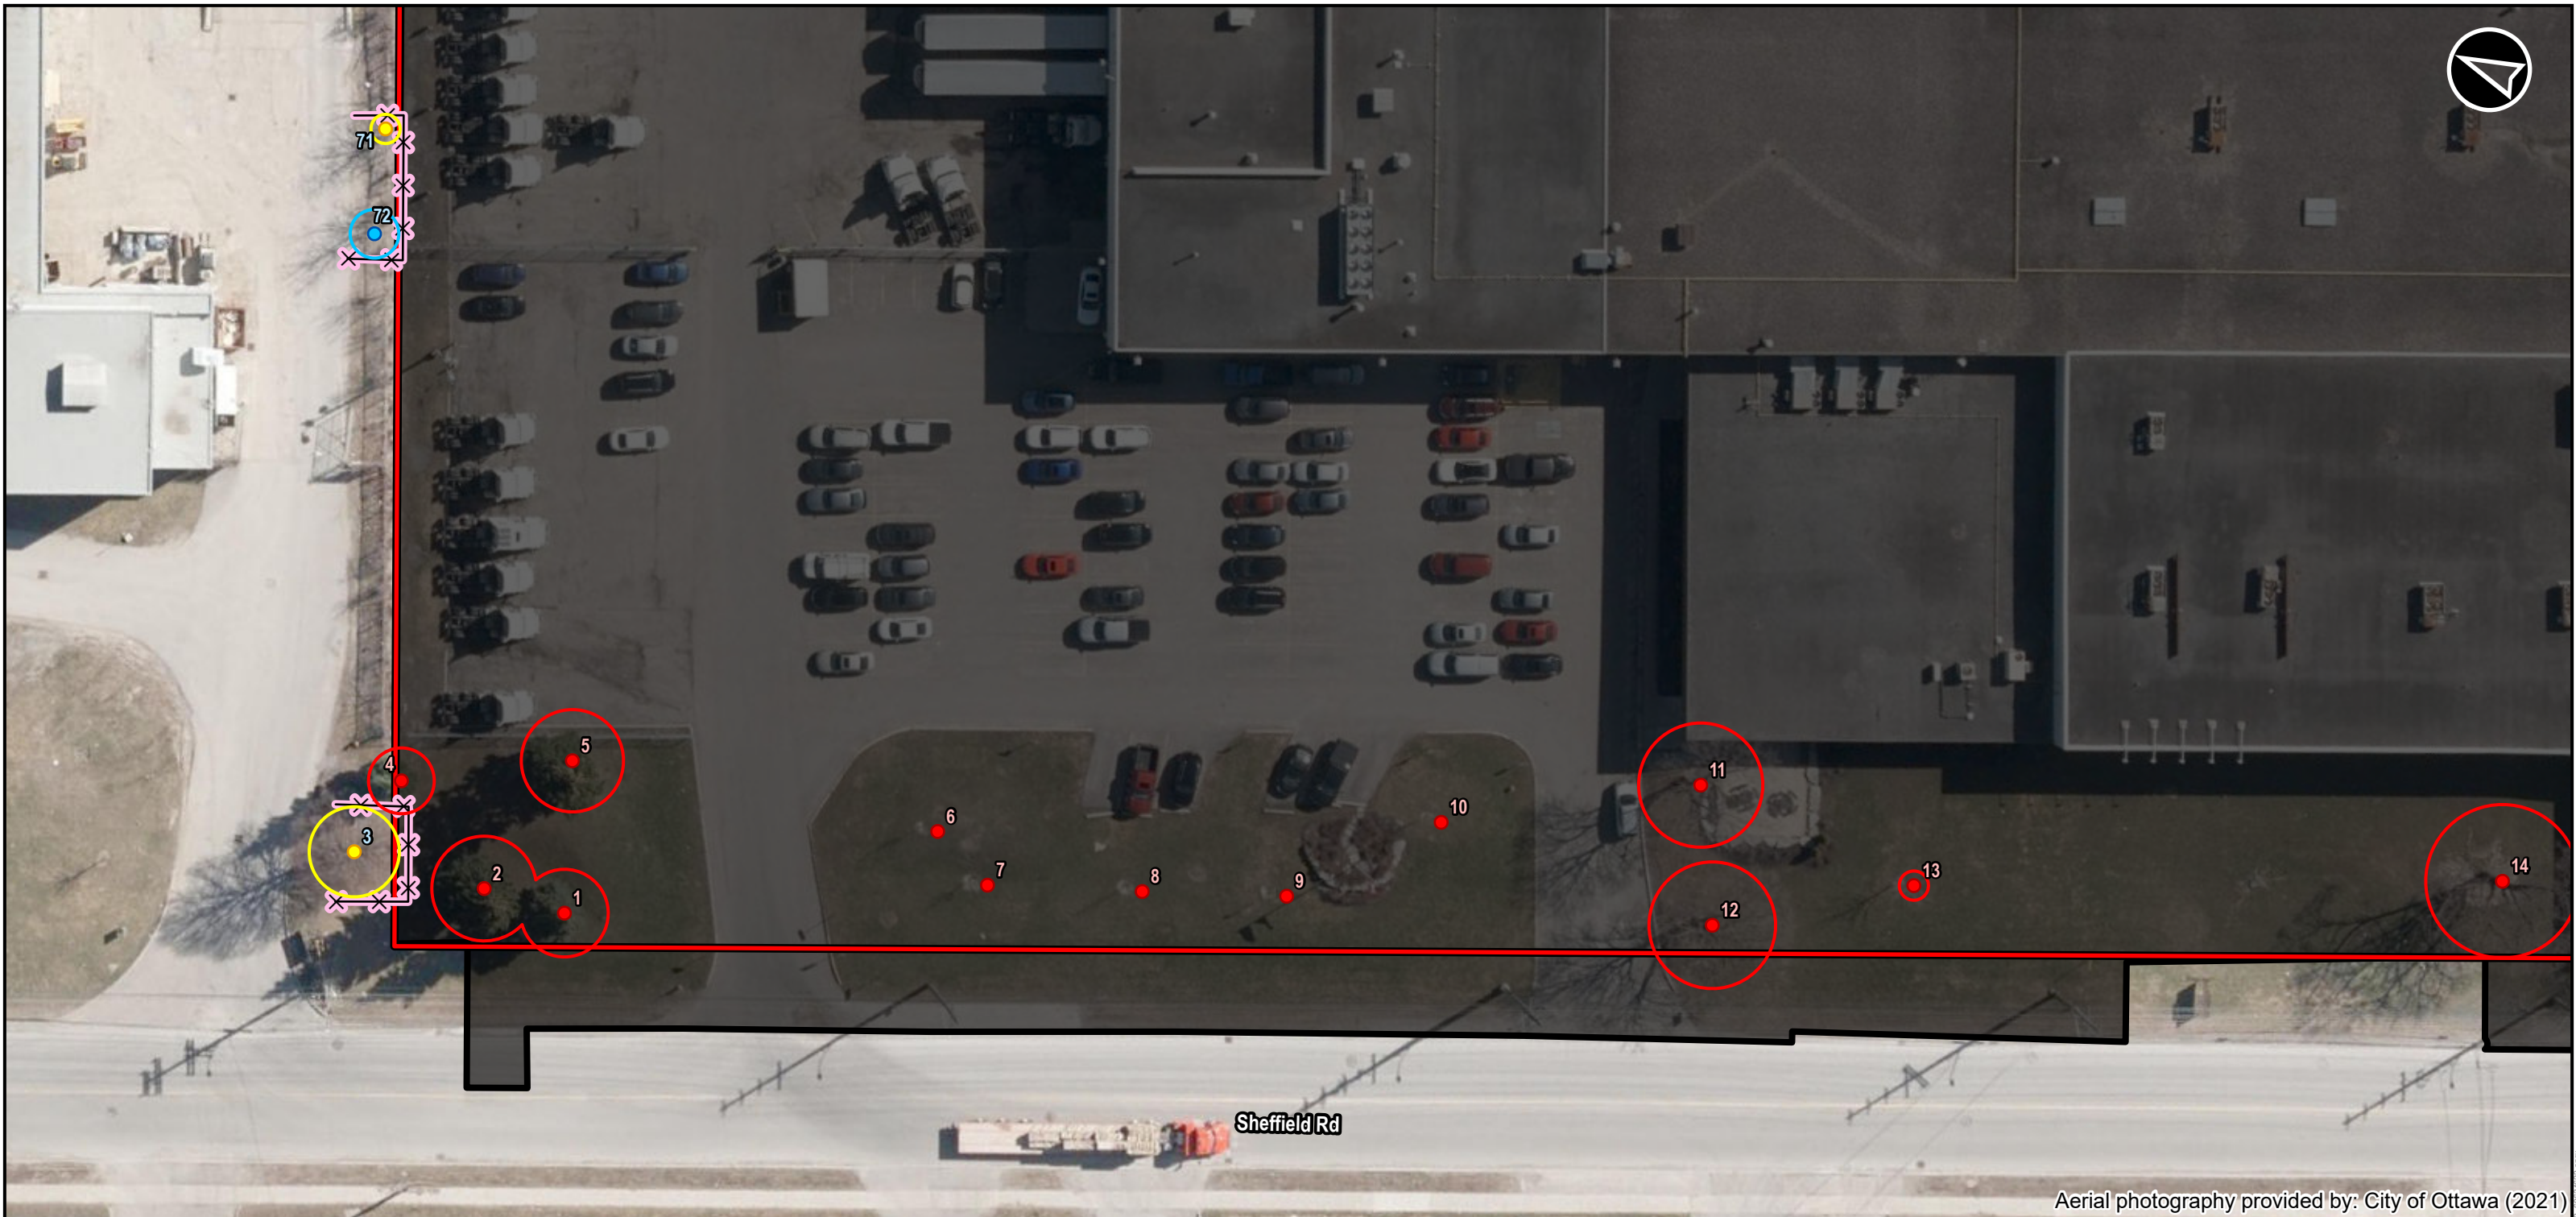
Tree Inventory and Preservation Plan

Table 4 summarizes the removal and preservation recommendations for trees within and outside the Tree Inventory Study Area; **Appendix B** indicates each tree’s recommended action and illustrates the CRZs for all trees that are recommended for protection and retention.

Tree protection fencing must be installed prior to initiation of the work. Tree protection fencing shall be installed to protect trees recommended for protection with injury, protection with minor injury, or protection (i.e., where trees that are being retained are within or 2 m outside the Buffer Area). The installation of tree protection fencing will reduce the potential for negative impacts including soil and root compaction as well as the potential for mechanical damage to trunks or branches. Lastly, it is recommended that any necessary pruning be conducted prior to construction by a Certified Arborist or trained professional with adequate arboricultural experience, in order to ensure that trees marked for preservation do not experience unnecessary stress or damage.
