REPORT ON

**PHASE I  
ENVIRONMENTAL SITE ASSESSMENT  
3904 MARCH ROAD, WEST CARLETON-MARCH WARD  
CITY OF OTTAWA, ONTARIO**

Dog World Bedrock Kennels  
3904 March Road  
Carp, Ontario  
K0A 1L0

DATE: April 5, 2022

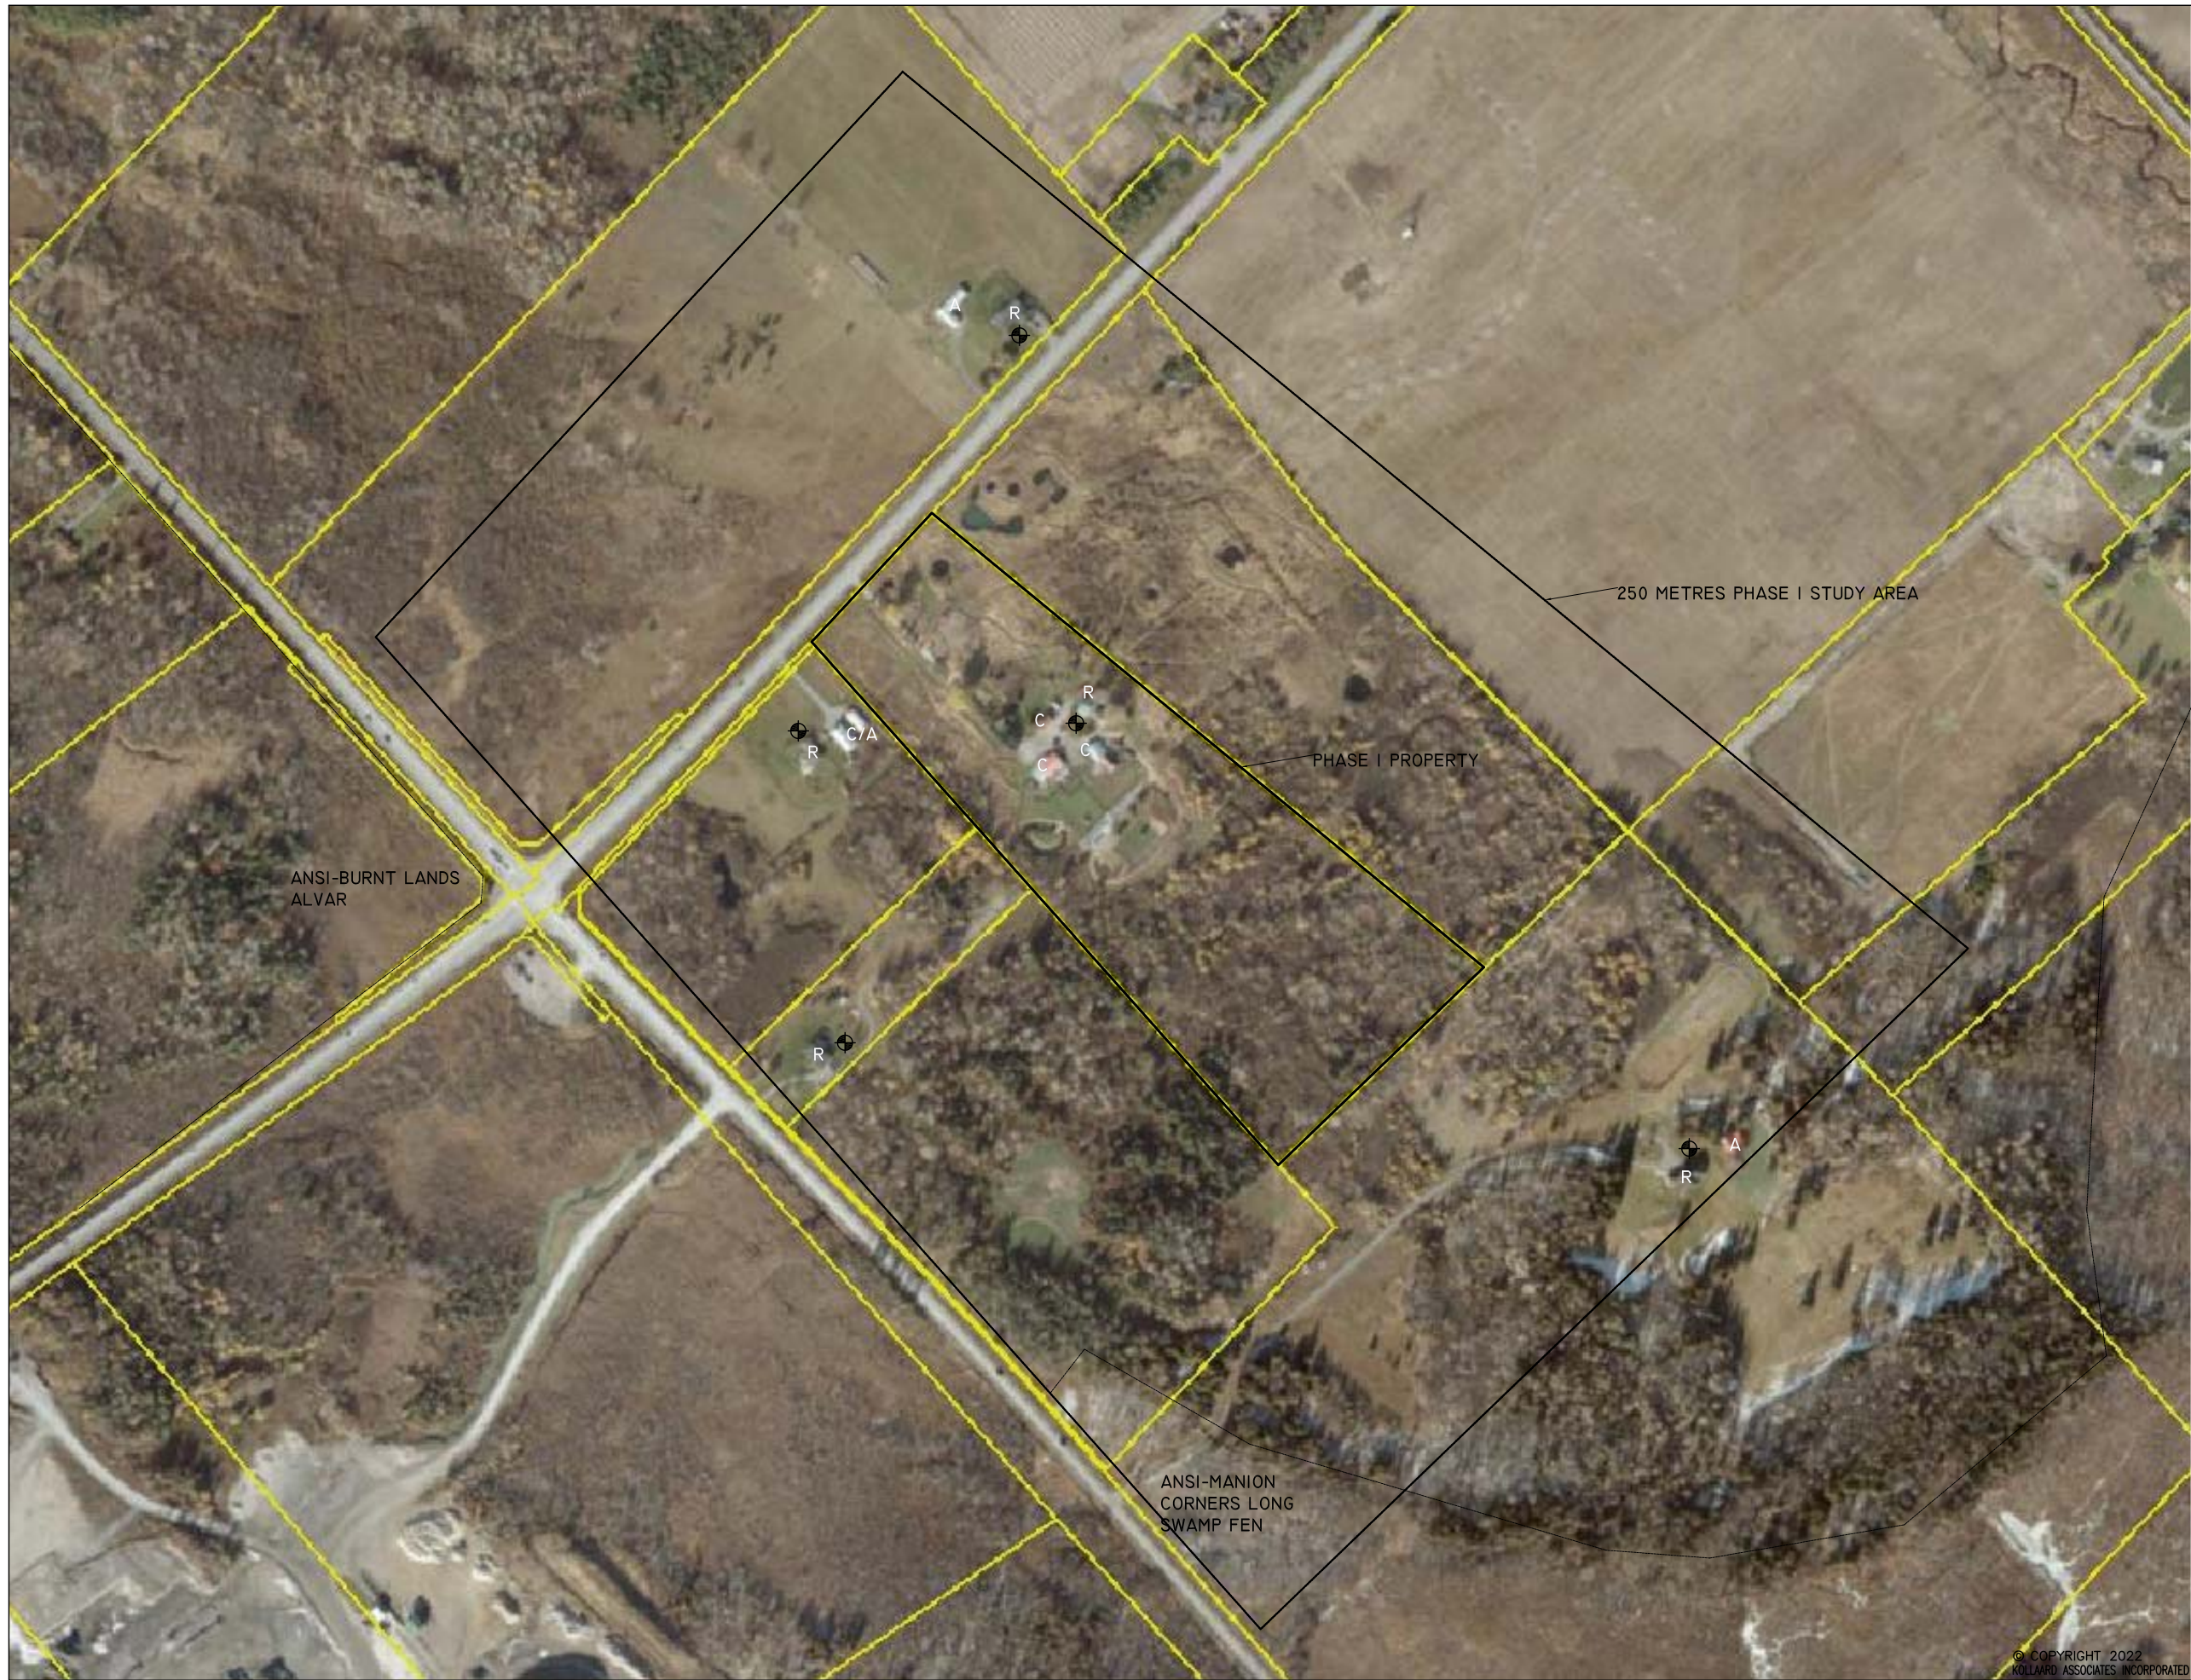
DRAWING NUMBER:  
FIGURE 2

The Phase I ESA Conceptual Model provided as Figure 2 identifies the PCAs (identified in Sections 7.2 and 7.3, if applicable) at the site and within the Phase I Study Area (250 metres) as well as surface features, such as buildings, roads and property uses for adjacent properties. The Phase I study area and all of the activities and historical property uses are described within maps provided.

There are no current or historical activities that have been identified within 250 metres of the subject site that could be considered Potentially Contaminating Activities within the Phase One Study Area (see Conceptual Site Model, Figure 2). There were no PCAs on the subject property. Therefore there are no APECs on the subject site.

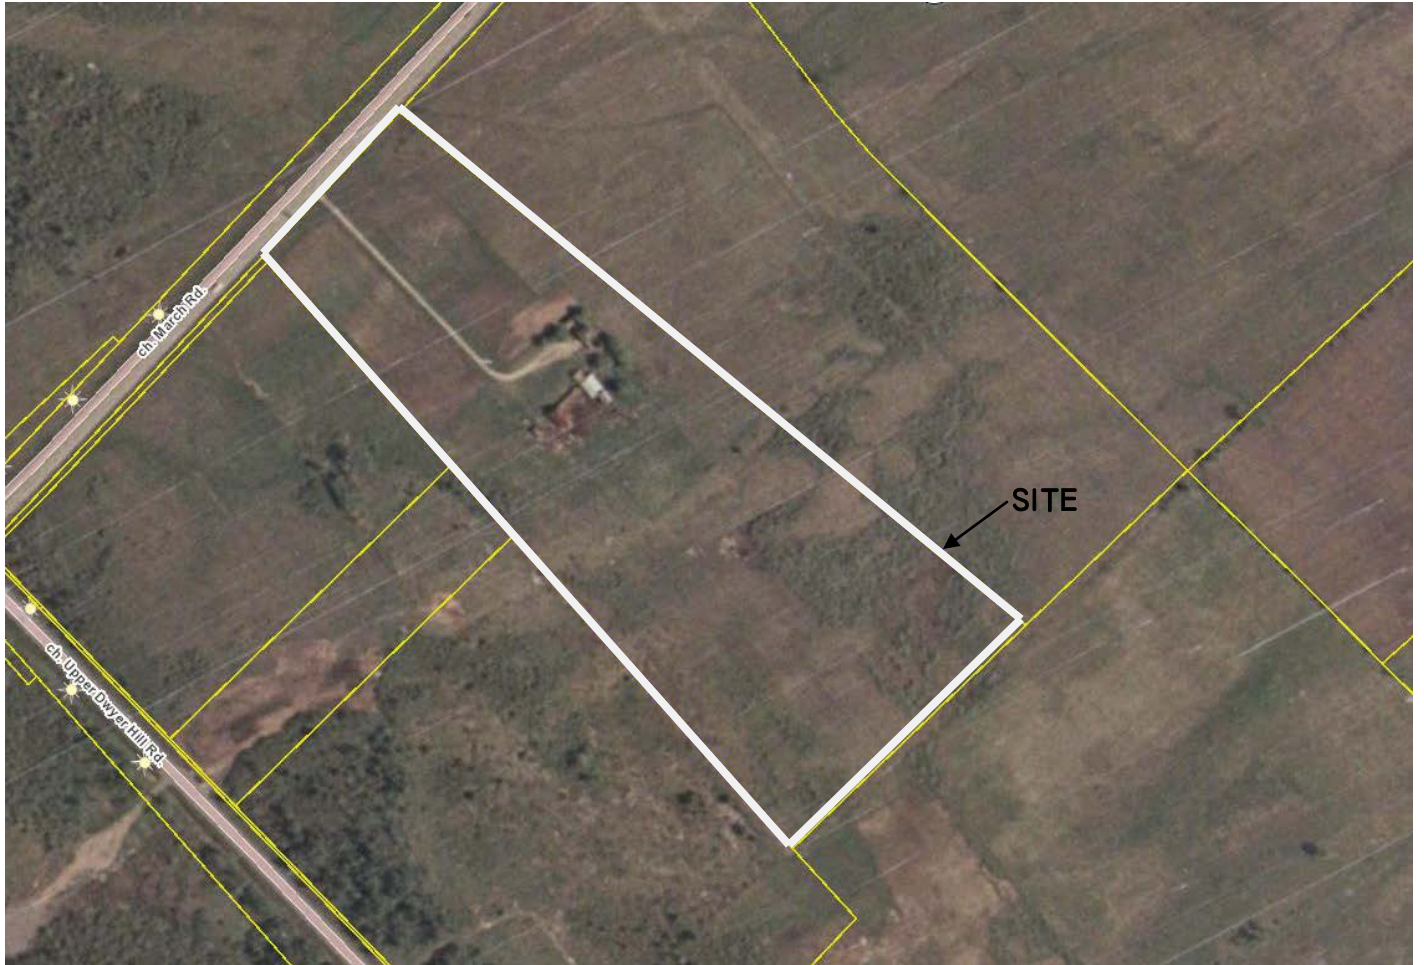
<b>Date</b>	<b>Observations</b>
1976	The site was observed to consist of vacant farmland. Single family dwellings and farms were observed to exist to the west, east and south of Renaud Road.

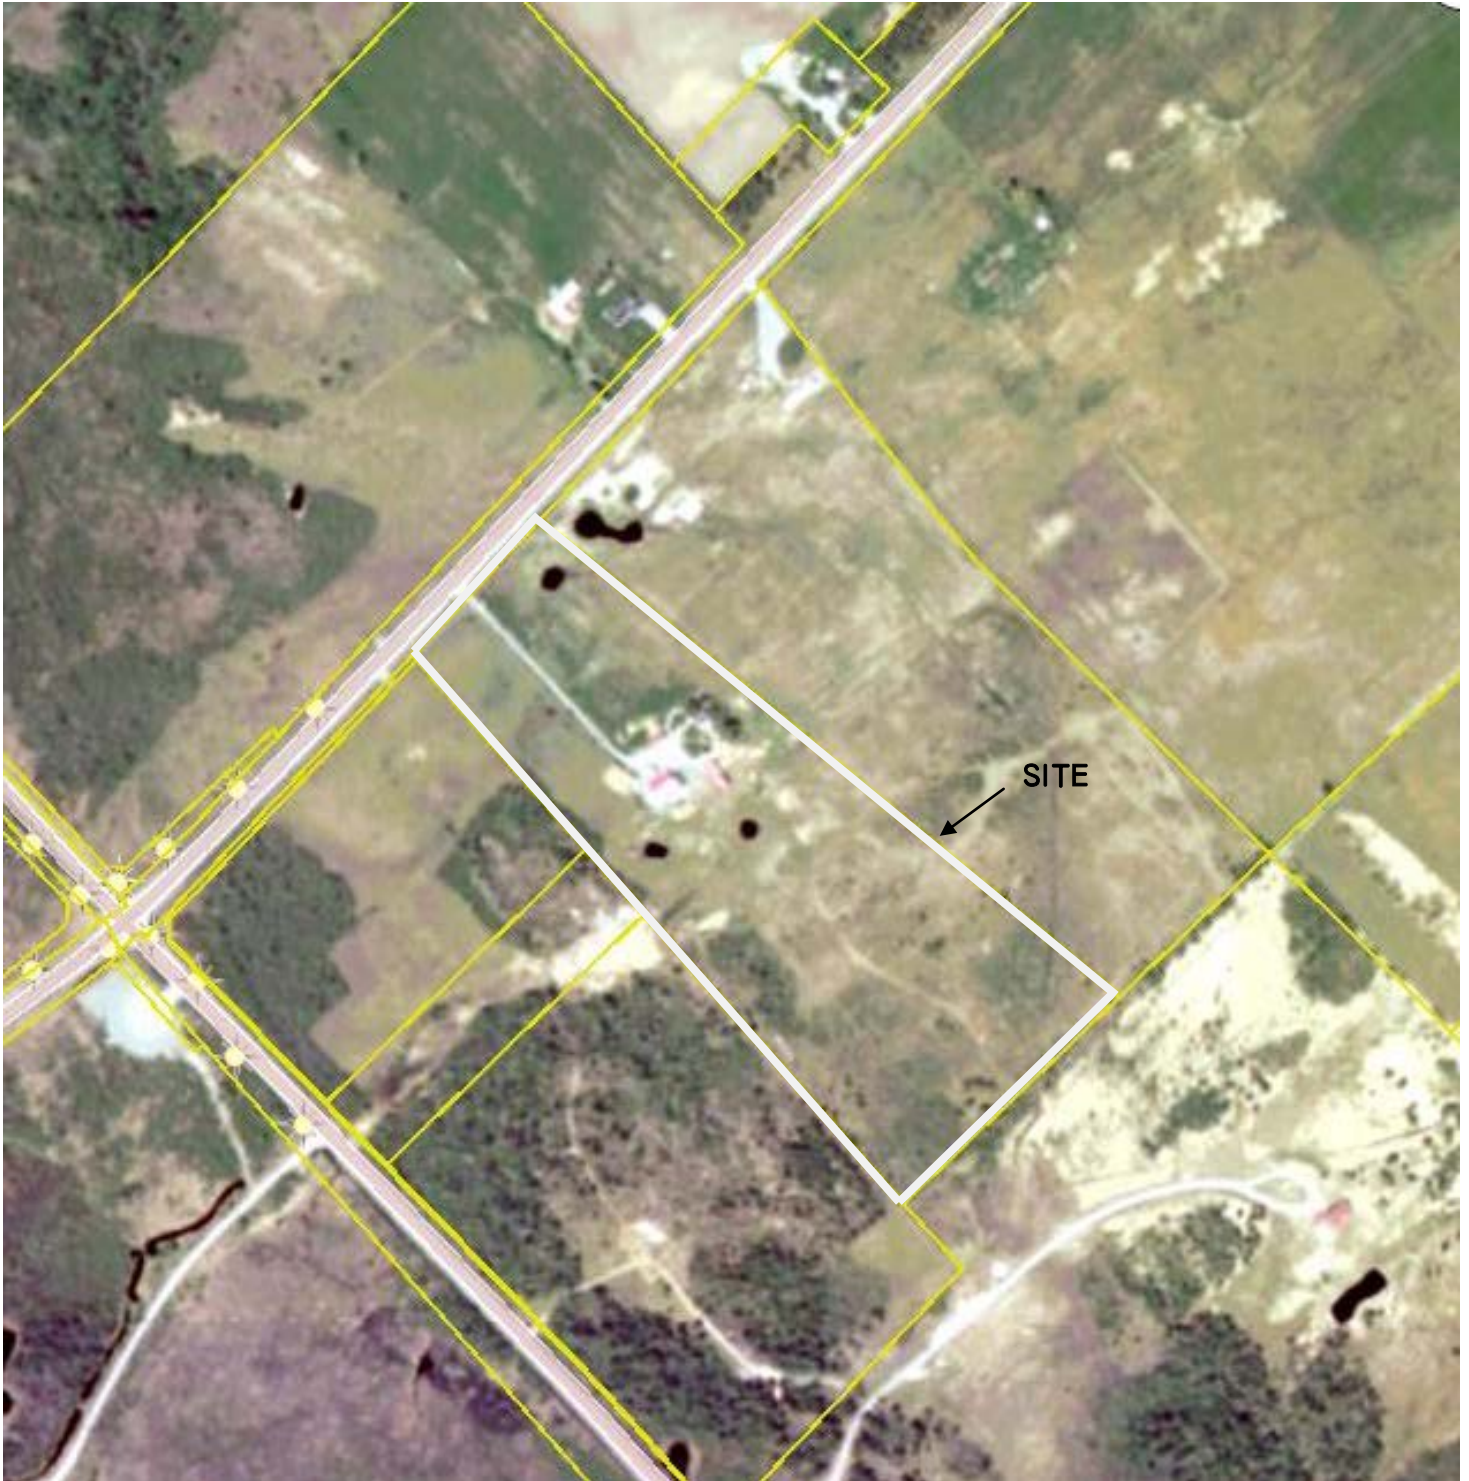
1999	A single family dwelling was observed to have been constructed at the site. Other residential development has occurred east and west of the site. A farm remains on the south side of Renaud Road. No other significant changes are evident on the subject site or adjacent properties.
2005	No significant changes are evident on the subject site or adjacent properties.
2014	All of the trees have been cleared north of the site. The site appears to be under construction as several fill piles and heavy equipment are observed in the air photograph. No significant changes are evident on the subject site or adjacent properties.
2019	No significant changes are evident on the subject site. Some dwelling construction has occurred in the subdivision constructed north of the subject site. No other significant changes are evident on the adjacent properties.

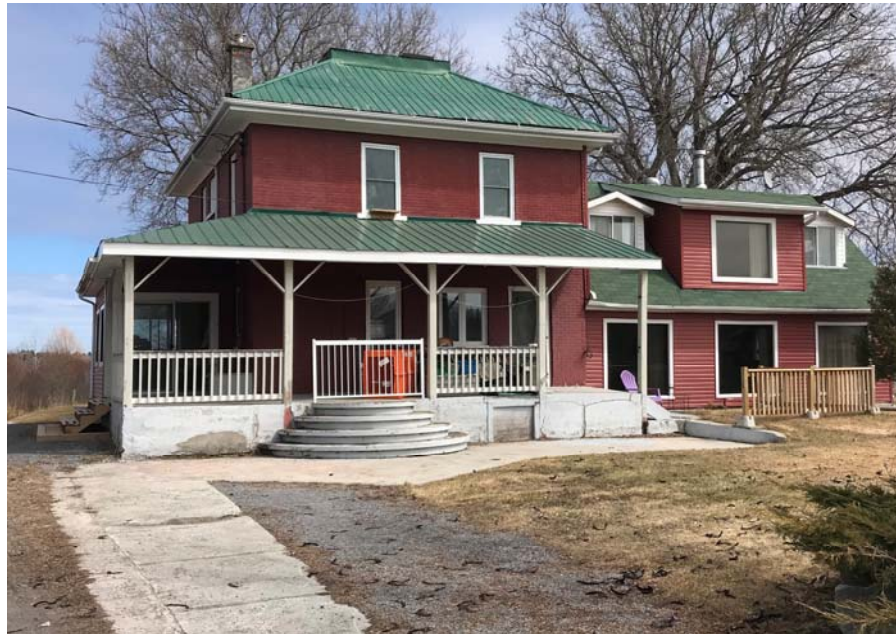
The site is currently occupied by a single storey dwelling. Building construction is described as wooden framed, rubble foundation with brick cladding. The addition is understood to be constructed with no basement.

**East facing, front view of house**

Based on the age of the dwelling at the site, there is a potential for ACMs to be contained within the building materials. Prior to any future demolition, it is recommended that a Designated Substances Survey (DSS) be carried out to identify and test building materials to ensure proper handling and disposal measures are carried out.

Due to the age of the building at the site, there is a potential for UFFI to be present. A Designated Substances Survey should be carried out prior to any renovations or demolition to ensure proper handling/disposal of any building materials that contain hazardous materials.

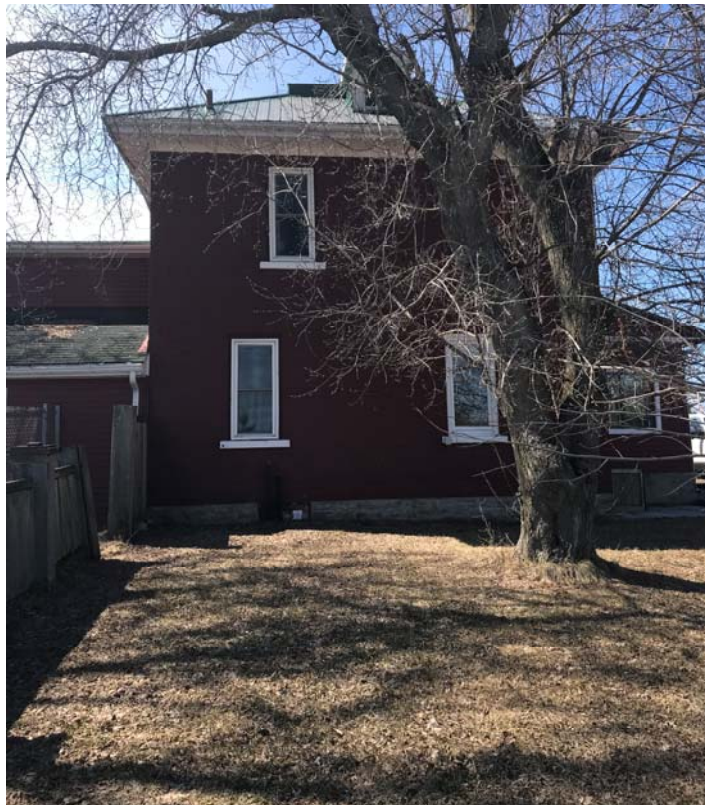
The fill and vent pipes for the AST were located on the east side of the building around the exterior of the foundation.

**View of east side yard of dwelling, vent and fill pipes observed for AST in basement**

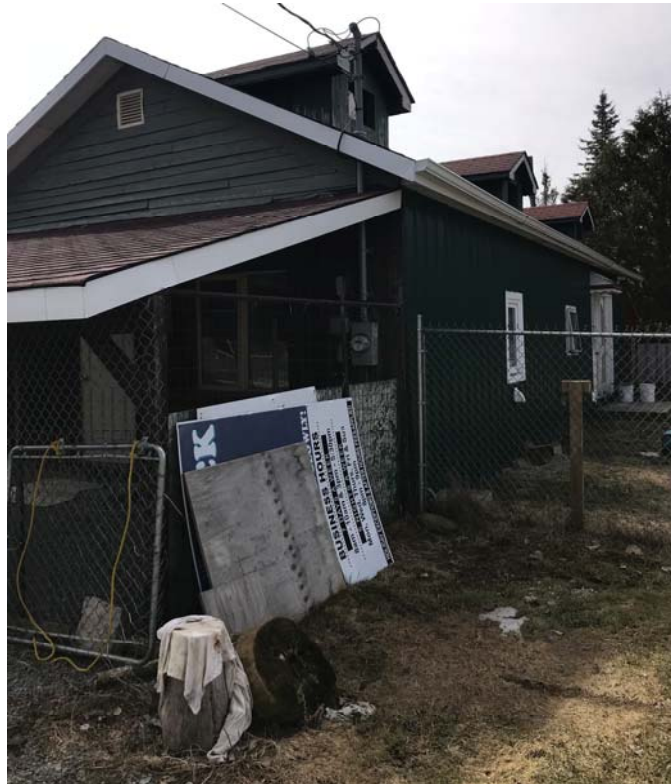
**Shop building (laundry and tool shed)**

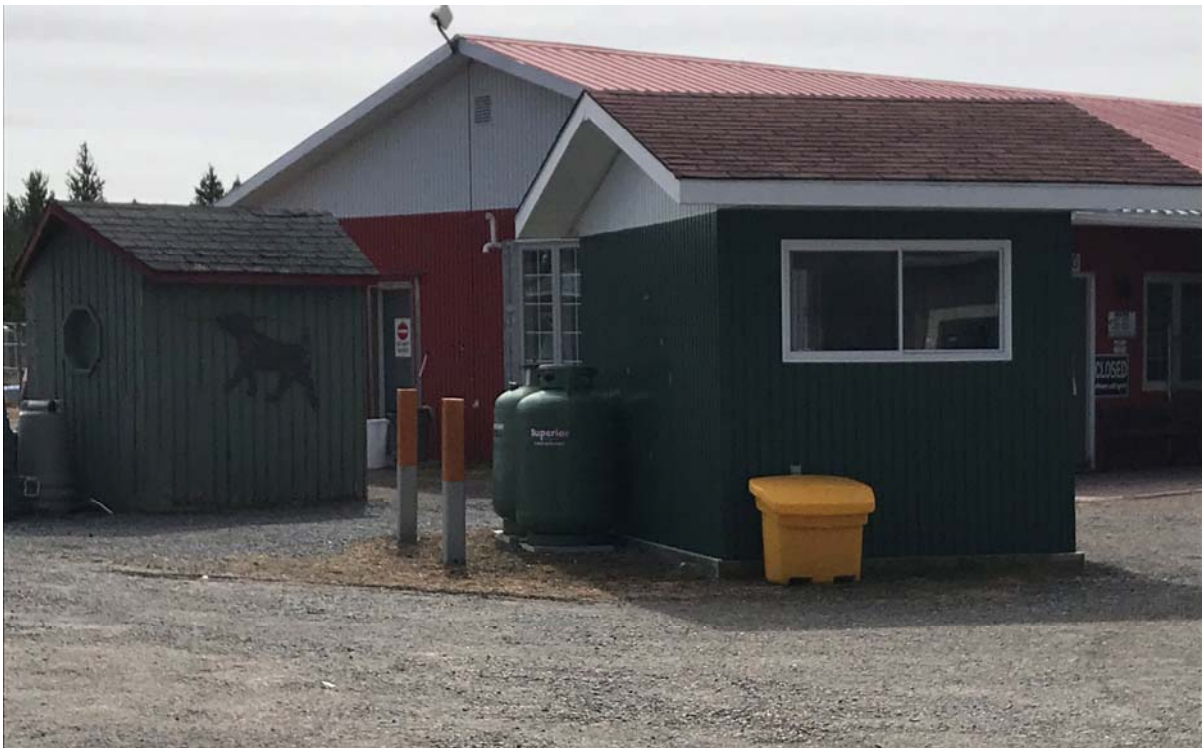
**Kennel building with two sheds in foreground**

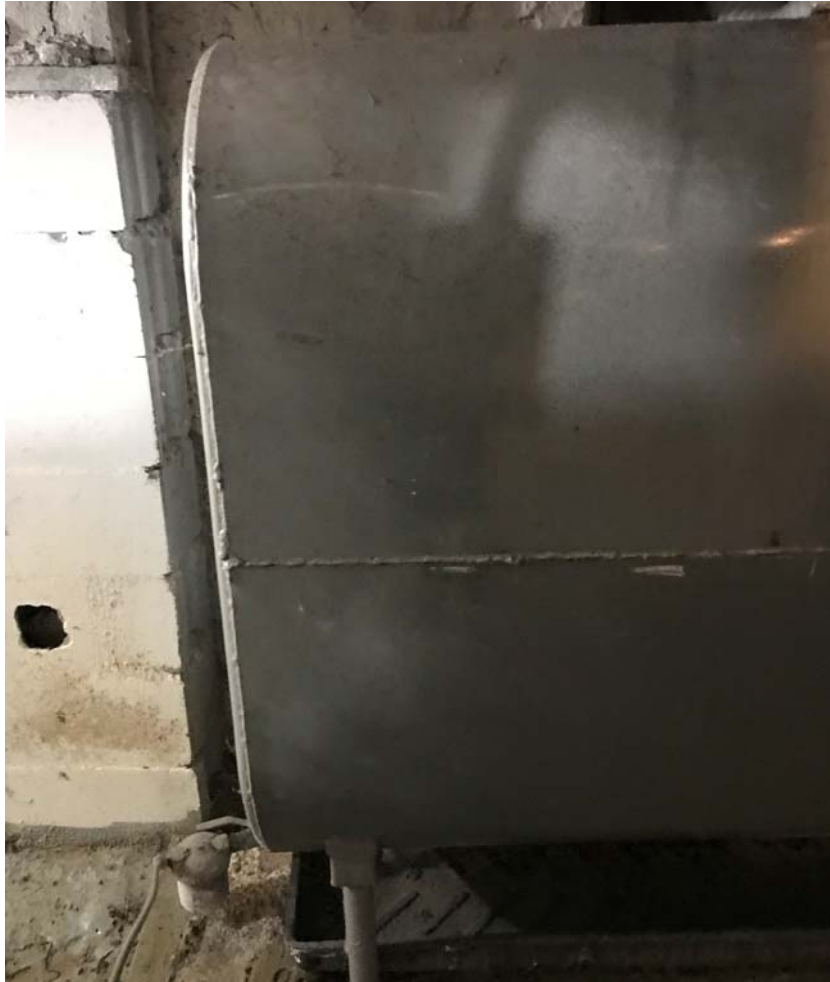
The dwelling at the site is serviced using an above ground fuel storage tank which was observed within the basement of the dwelling at the site. No staining or odours were detected within the basement. The AST is located on a poured concrete floor and was observed to be in fair condition. A drip tray (secondary containment) observed below the AST was clean, with no evidence of spillage. The lines from the storage tank to the furnace were observed to be on the floor. The furnace itself was observed. There was no evidence of spills and the floor underneath and adjacent to the AST, lines and furnace was intact, with no major cracks observed. Based on a review of the Ecolog ERIS report for the site and site area, no reports of any spills were documented for the site.

**Furnace oil AST in basement**

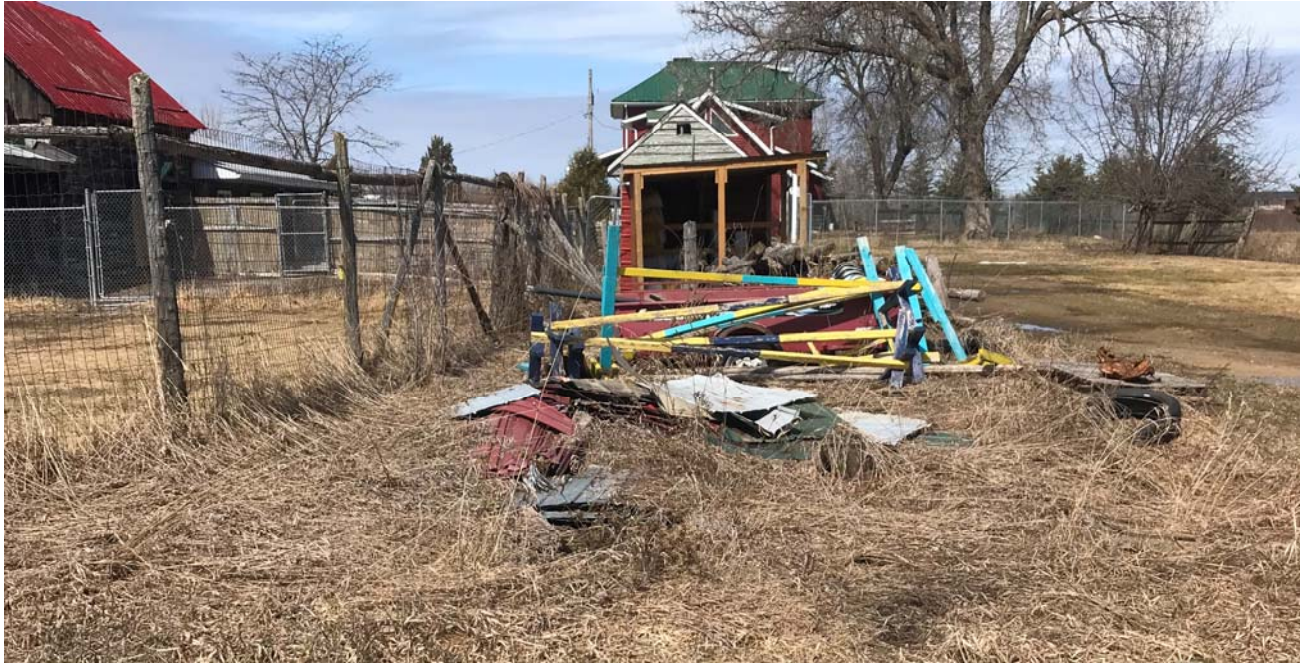
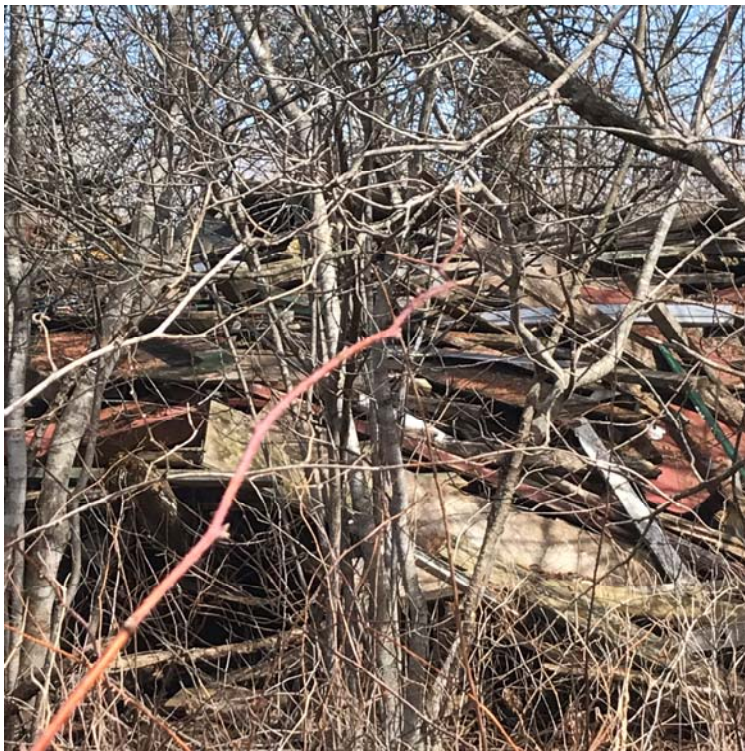
Some exterior storage of old equipment was observed consisting of wood, metal, tin and/or rubber tires in a couple of areas on the south and east sides of the developed portion of the site.

**Debris Piles present on property at time of site visit (April 2020)**
