## Phase Two Environmental Site Assessment 266 and 268 Carruthers Avenue, Ottawa, Ontario

McCormick Park Developments Incorporated

OTT-22009213-C0

2022-10-03

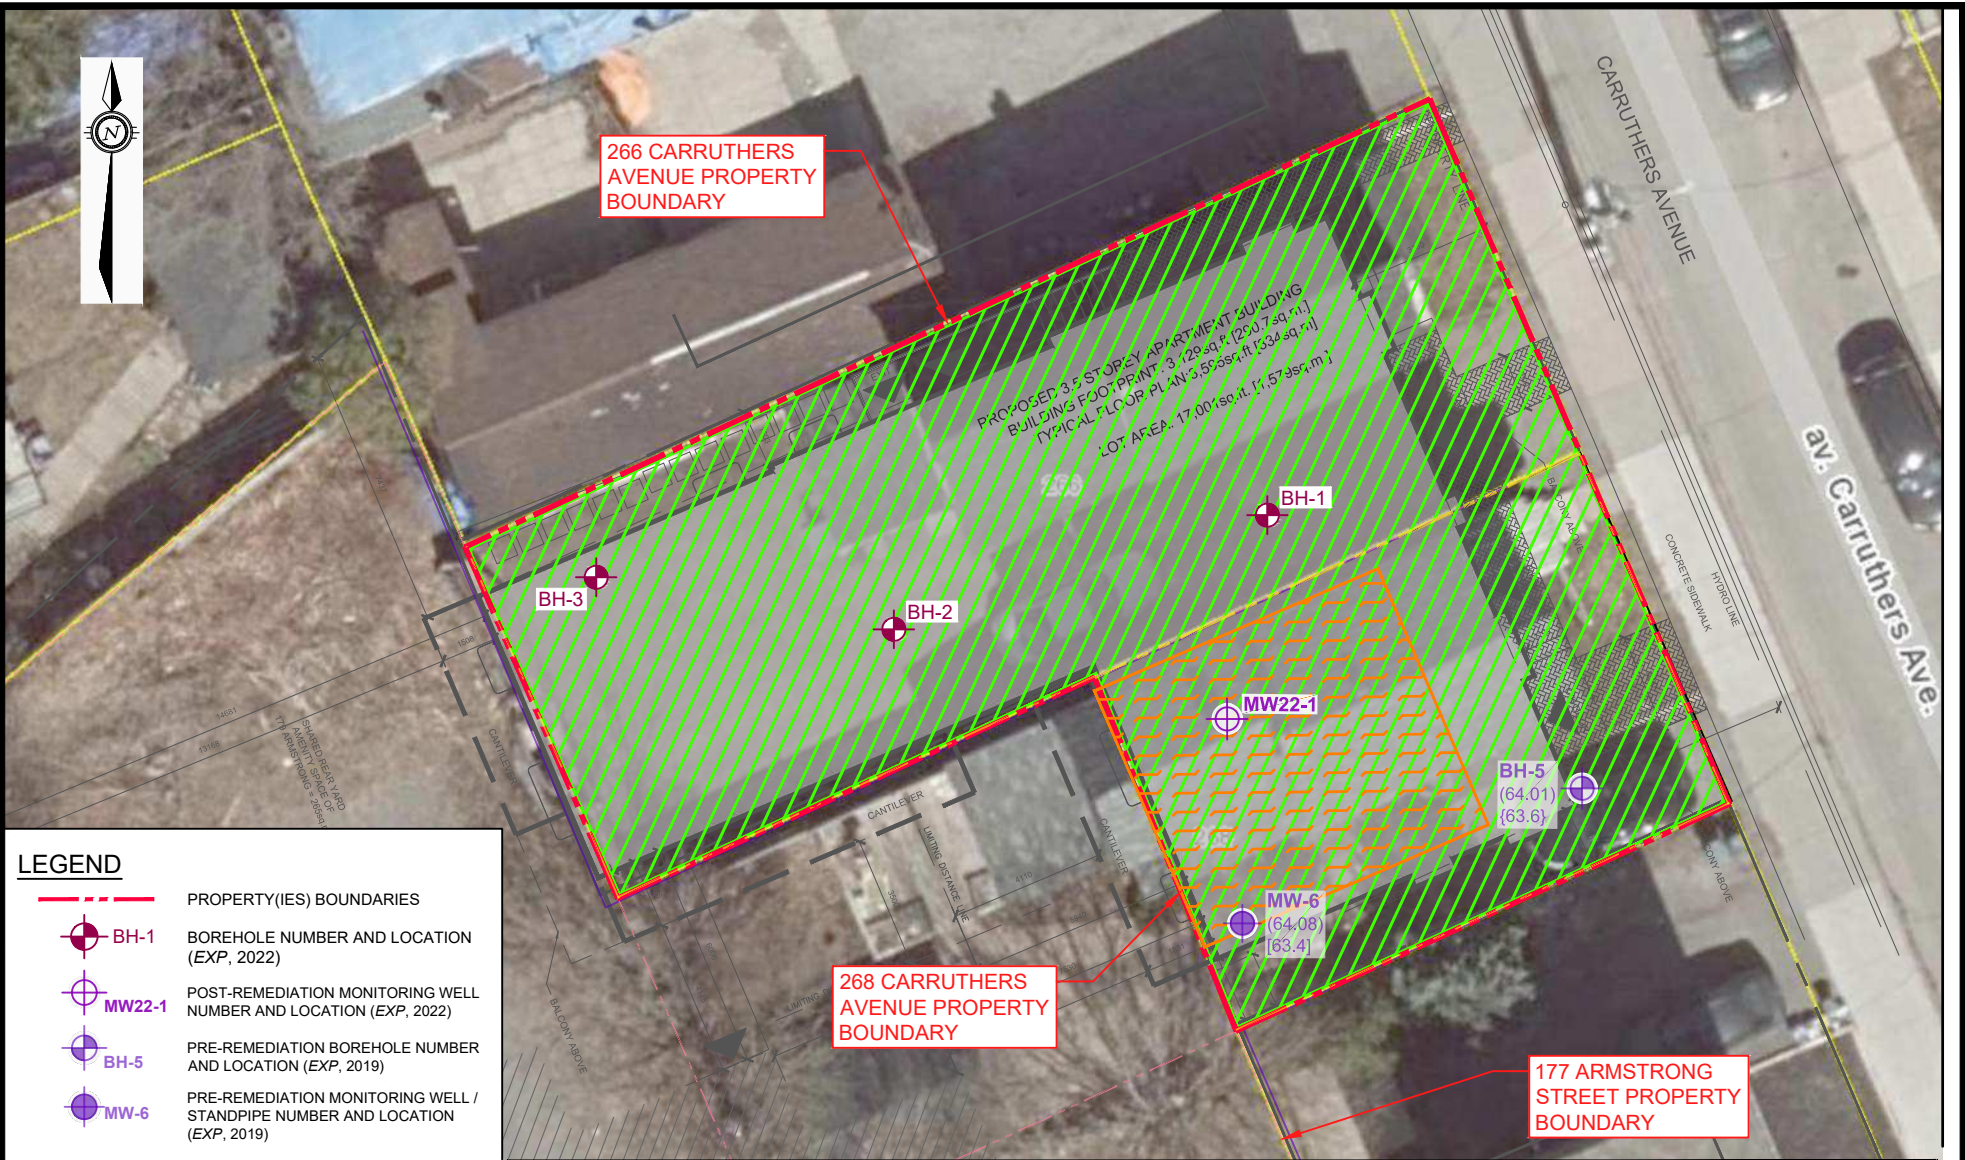
DATE SEPTEMBER 2022		<b>PHASE TWO ENVIRONMENTAL SITE ASSESSMENT (ESA)</b> 266 AND 268 CARRUTHERS AVENUE, OTTAWA, ONTARIO TITLE:	project no. OTT-22009213-C0
DESIGN M.M.	CHECKED C.H.		scale 1:4000
DRAWN BY MZG / AS		<b>PHASE TWO STUDY AREA</b>	
		<b>FIG 2</b>

The Phase Two study area and PCA is provided as Figure 2 in Appendix A. The locations of the APEC that may be affected by the PCA are shown on Figure 4 in Appendix A.

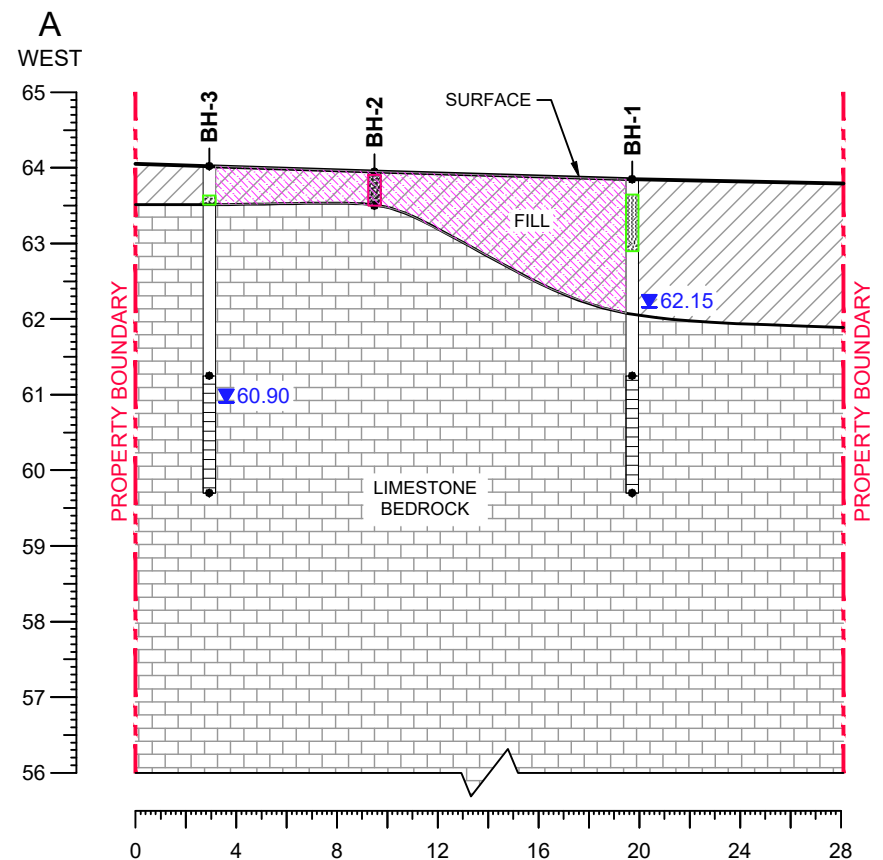
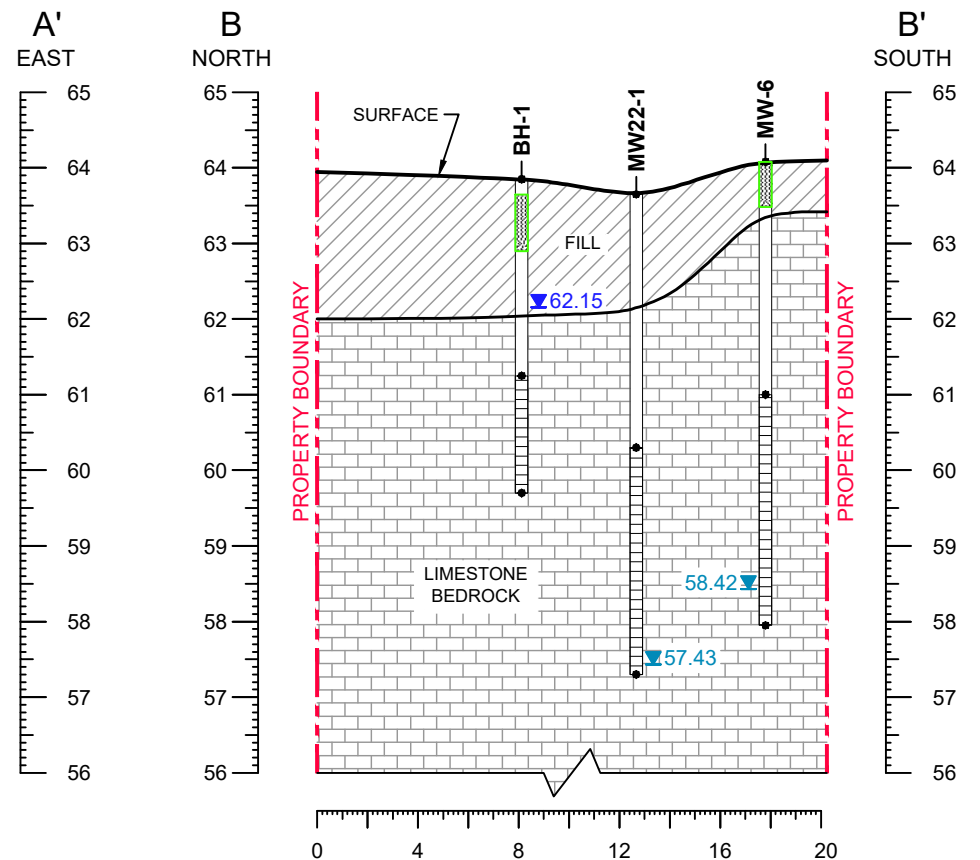
**CROSS SECTION A-A'**

**CROSS SECTION B-B'**

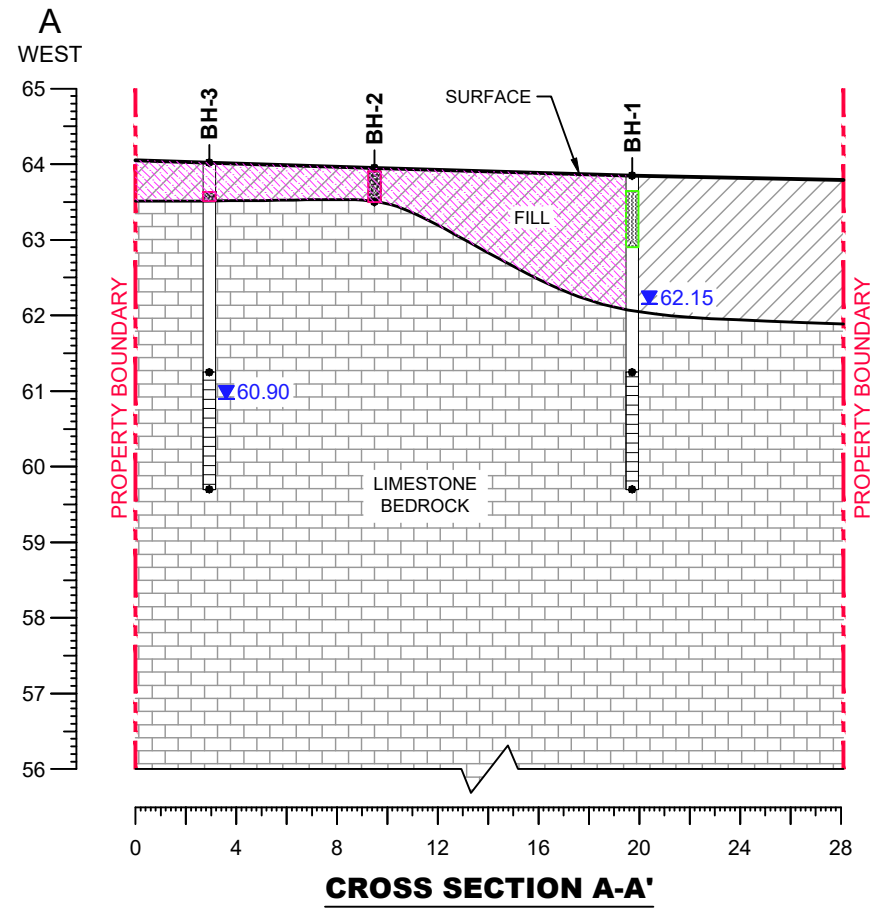
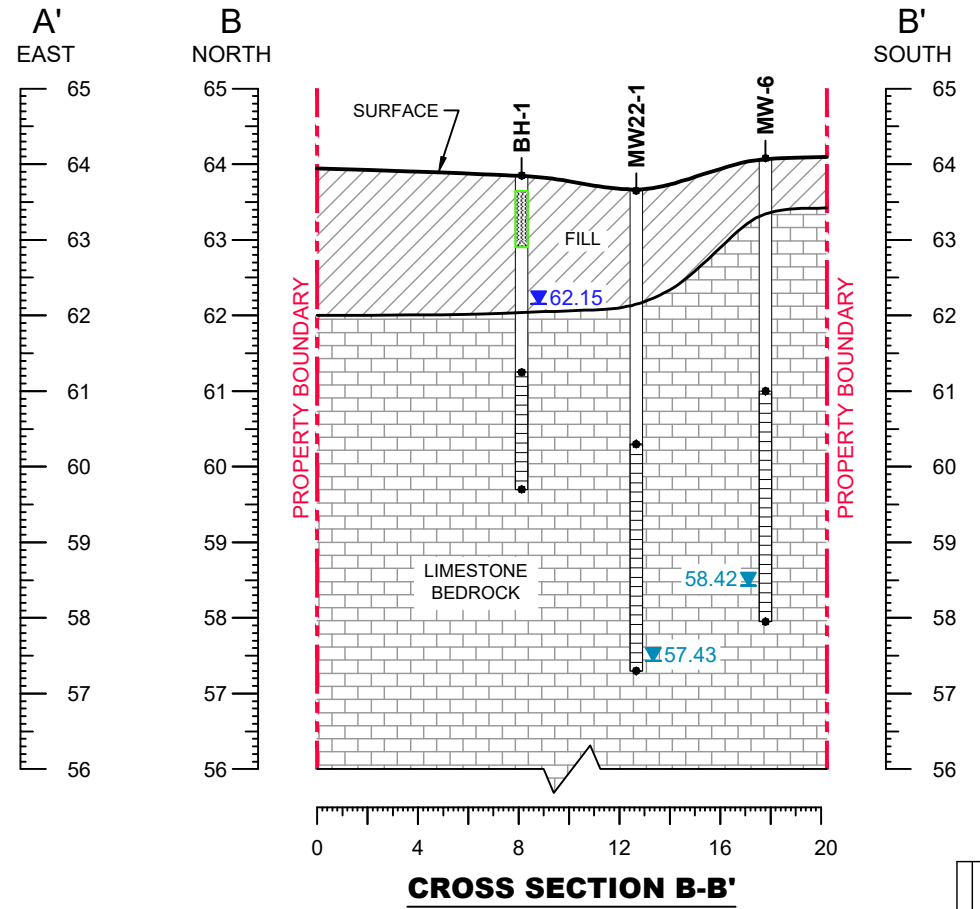
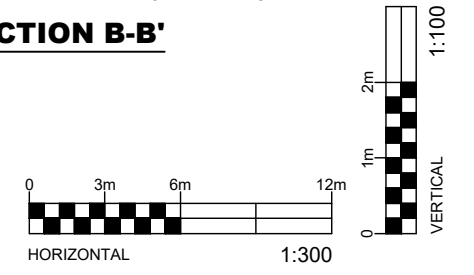
DATE SEPTEMBER 2022		TITLE: <b>CROSS SECTION A-A' &amp; B-B'</b> <b>ANALYTICAL RESULTS - METALS</b>	project no. OTT-22009213-CO
DESIGN MM	CHECKED CH		scale HORZ. 1:300 / VERT. 1:100
DRAWN BY AS			<b>FIG 10</b>

- LEGEND**
- PROPERTY (IES) BOUNDARIES
  - ▼ GROUNDWATER LEVEL SEPTEMBER 19, 2019
  - ▼ GROUNDWATER LEVEL (2022)
  - SOIL QUALITY MEETS MECP TABLE 7 SCS
  - SOIL QUALITY EXCEEDS MECP TABLE 7 SCS

ESTIMATED AREA OF IMPACTED SOIL

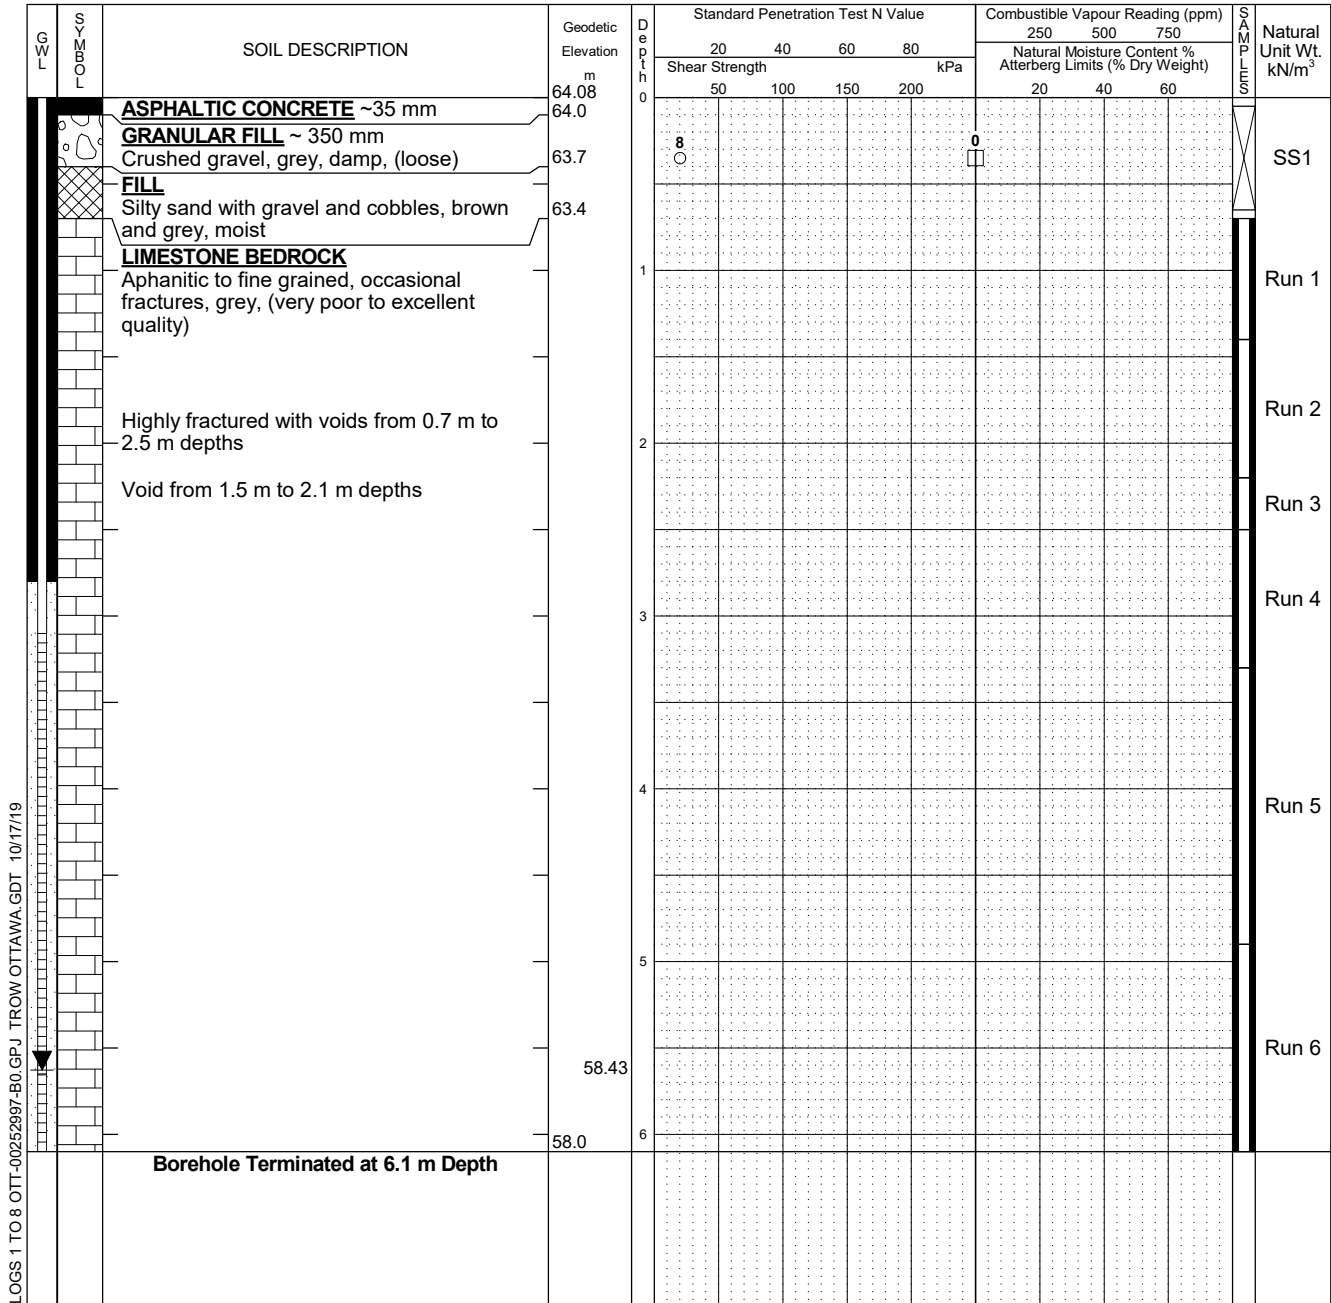
LOG OF BOREHOLE BOREHOLE LOGS 1 TO 8 OTT-00252997-B0.GPJ TROW/OTTAWA.GDT 10/17/19

- NOTES:
- Borehole data requires interpretation by EXP before use by others
  - A 32 mm diameter monitoring well with screened section installed as shown.
  - Field work supervised by an EXP representative.
  - See Notes on Sample Descriptions
  - Log to be read with EXP Report OTT-00252997-B0

EXP staff continuously monitored the drilling activities to log the stratigraphy observed from the recovered samples, to record the depth of the samples, and to record total depths of borings. Field observations are documented on the borehole logs provided in Appendix D.
