Phase I – Environmental Site Assessment

140 Lusk Street
Ottawa, Ontario

April 12, 2022

Report: PE5694-1

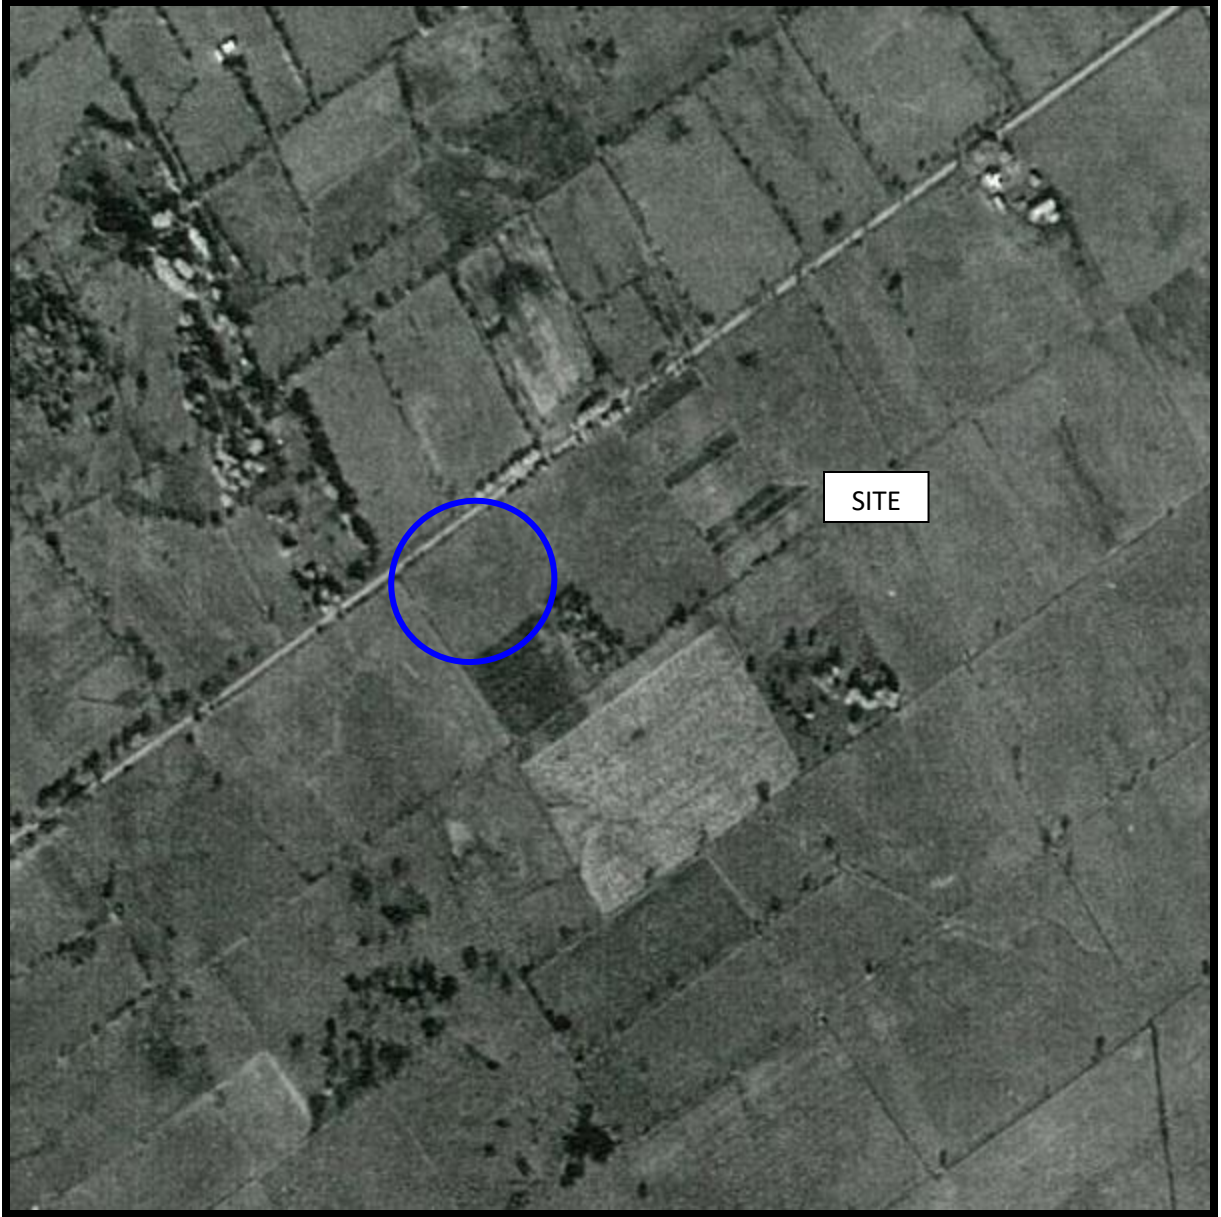
AERIAL PHOTOGRAPH
1945

| 1945 | The subject and surrounding properties appear to be vacant and used for agricultural purposes. A treed area is present to the southeast of the site. Fallowfield Road is present to the north of the site. |

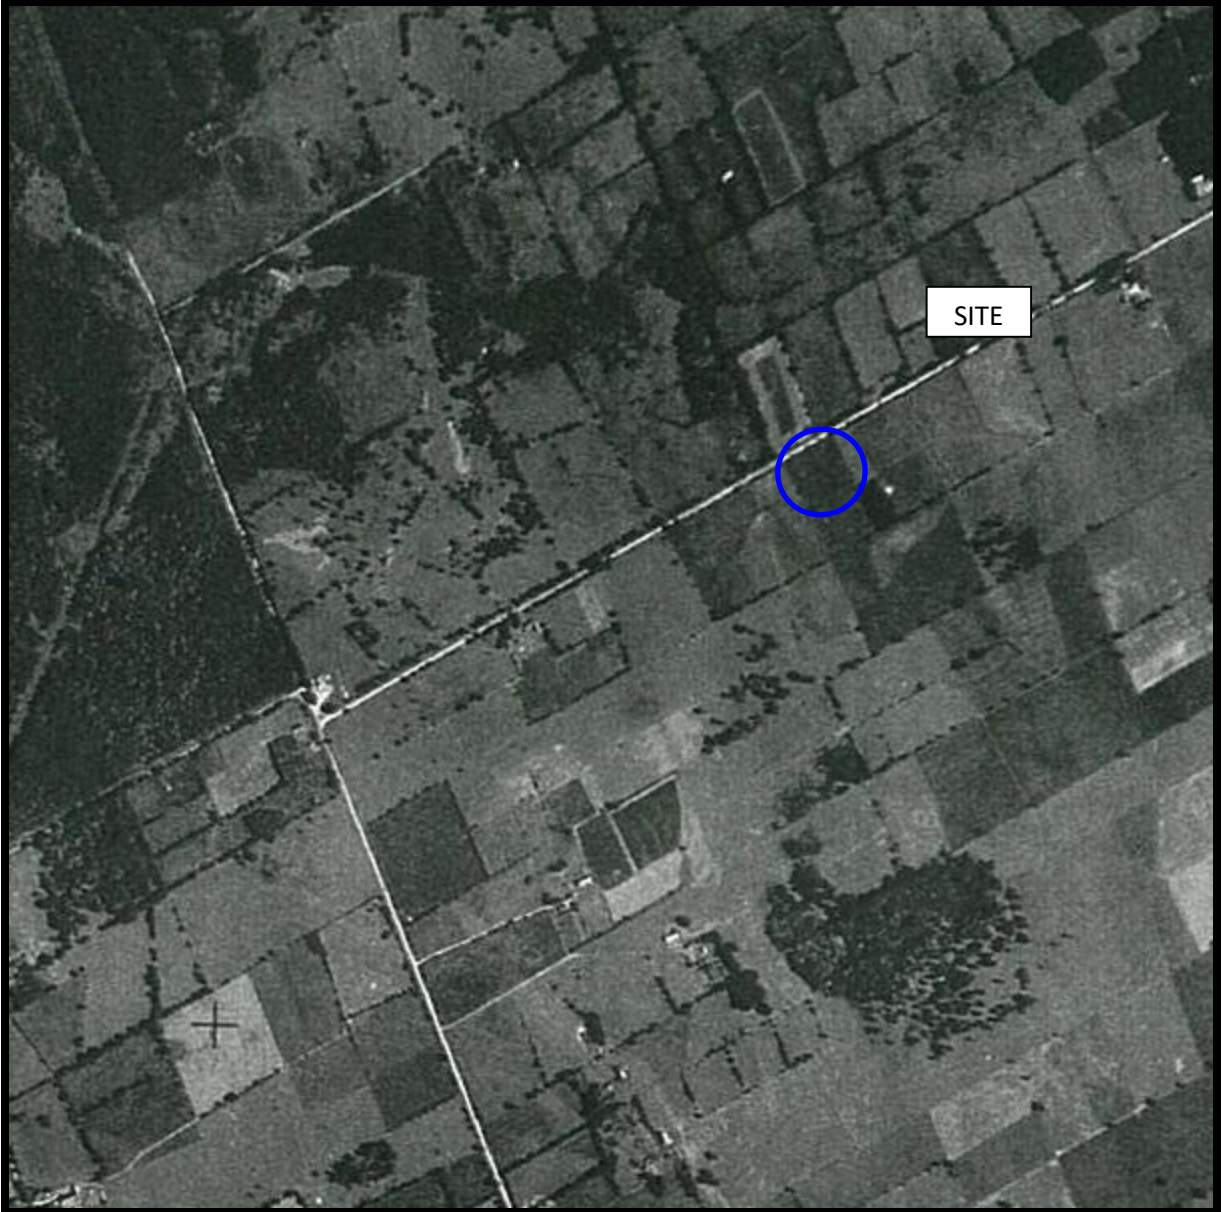
AERIAL PHOTOGRAPH
1955

| 1955 | No significant changes have been made to the subject site or neighbouring properties. |

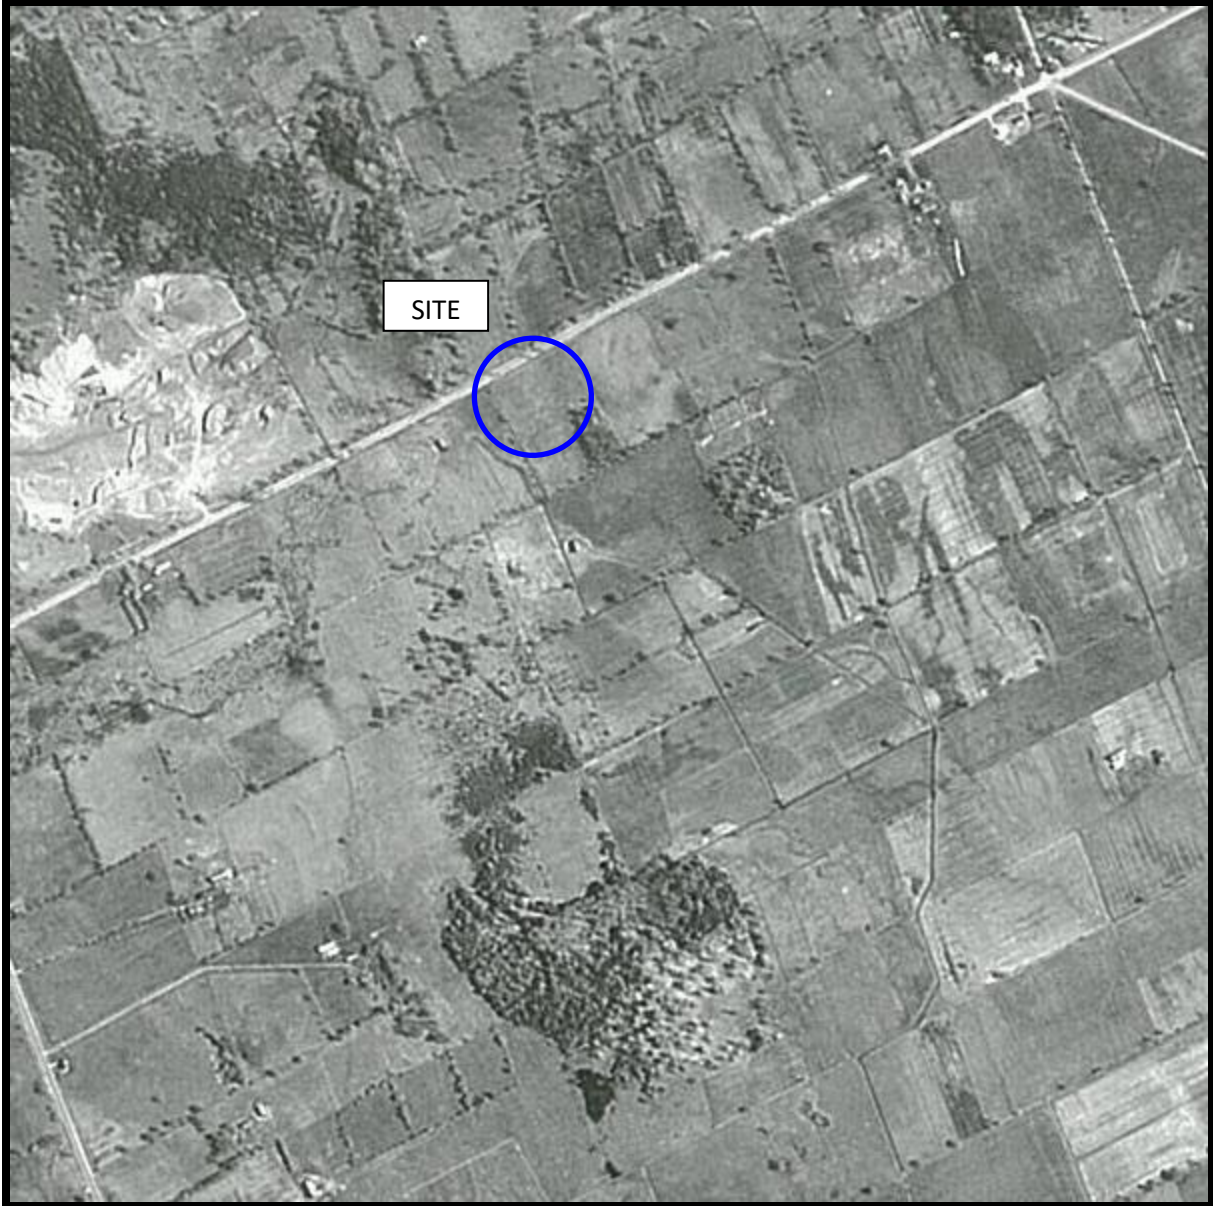
AERIAL PHOTOGRAPH
1963

| 1963 | No significant changes have been made to the subject site or neighbouring properties. |

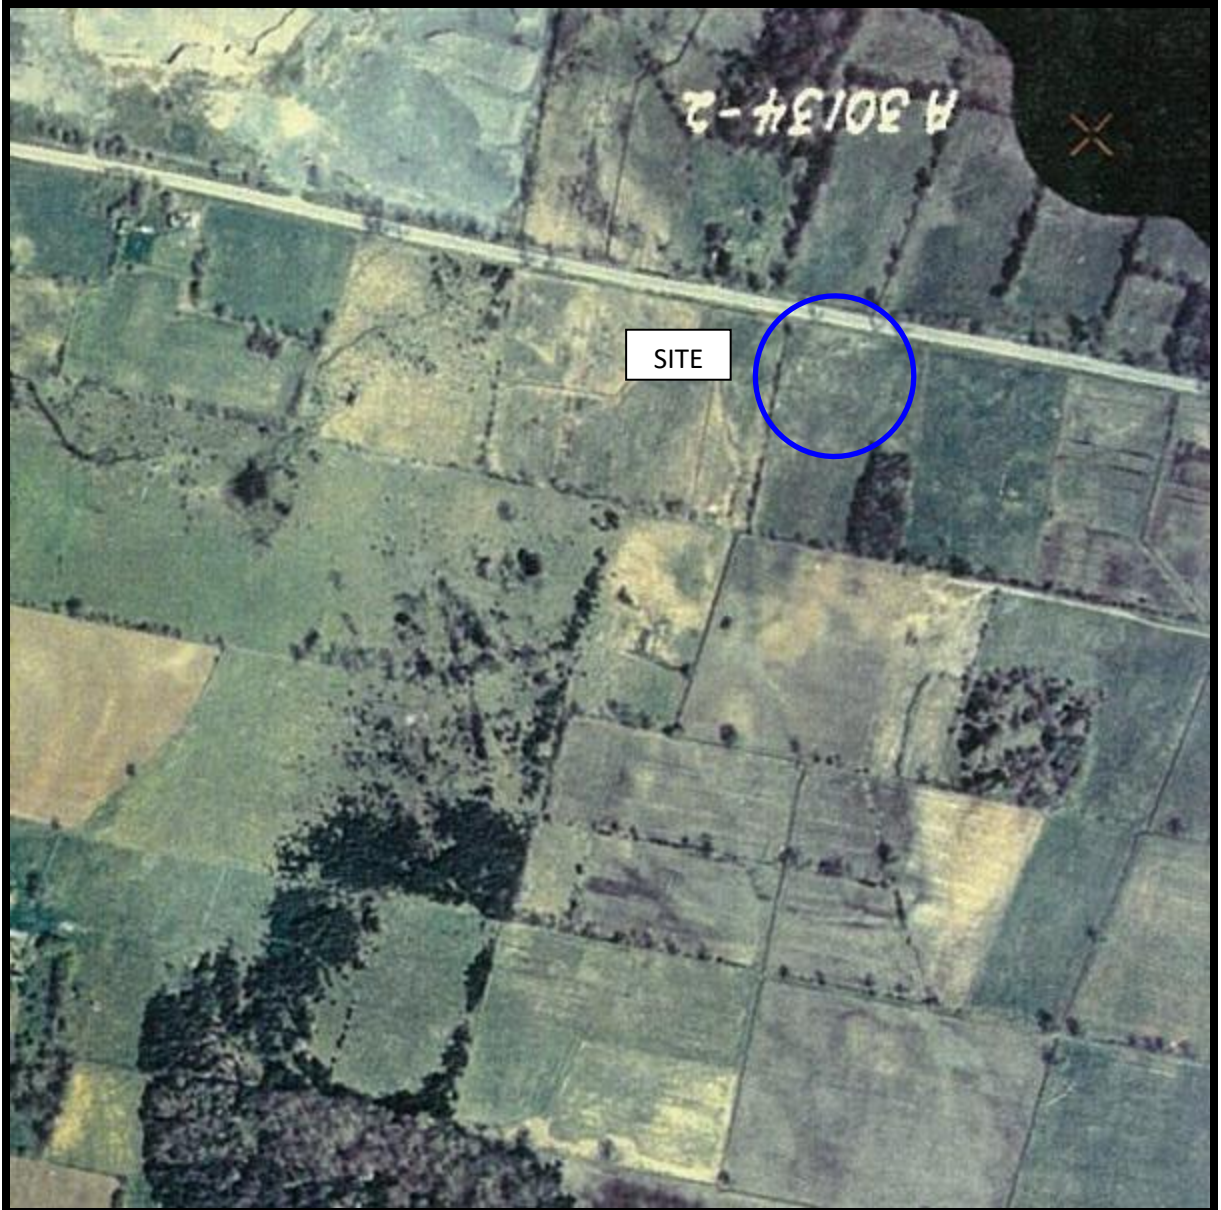
AERIAL PHOTOGRAPH
1968

| 1968 | No significant changes have been made to the subject site or neighbouring properties. |

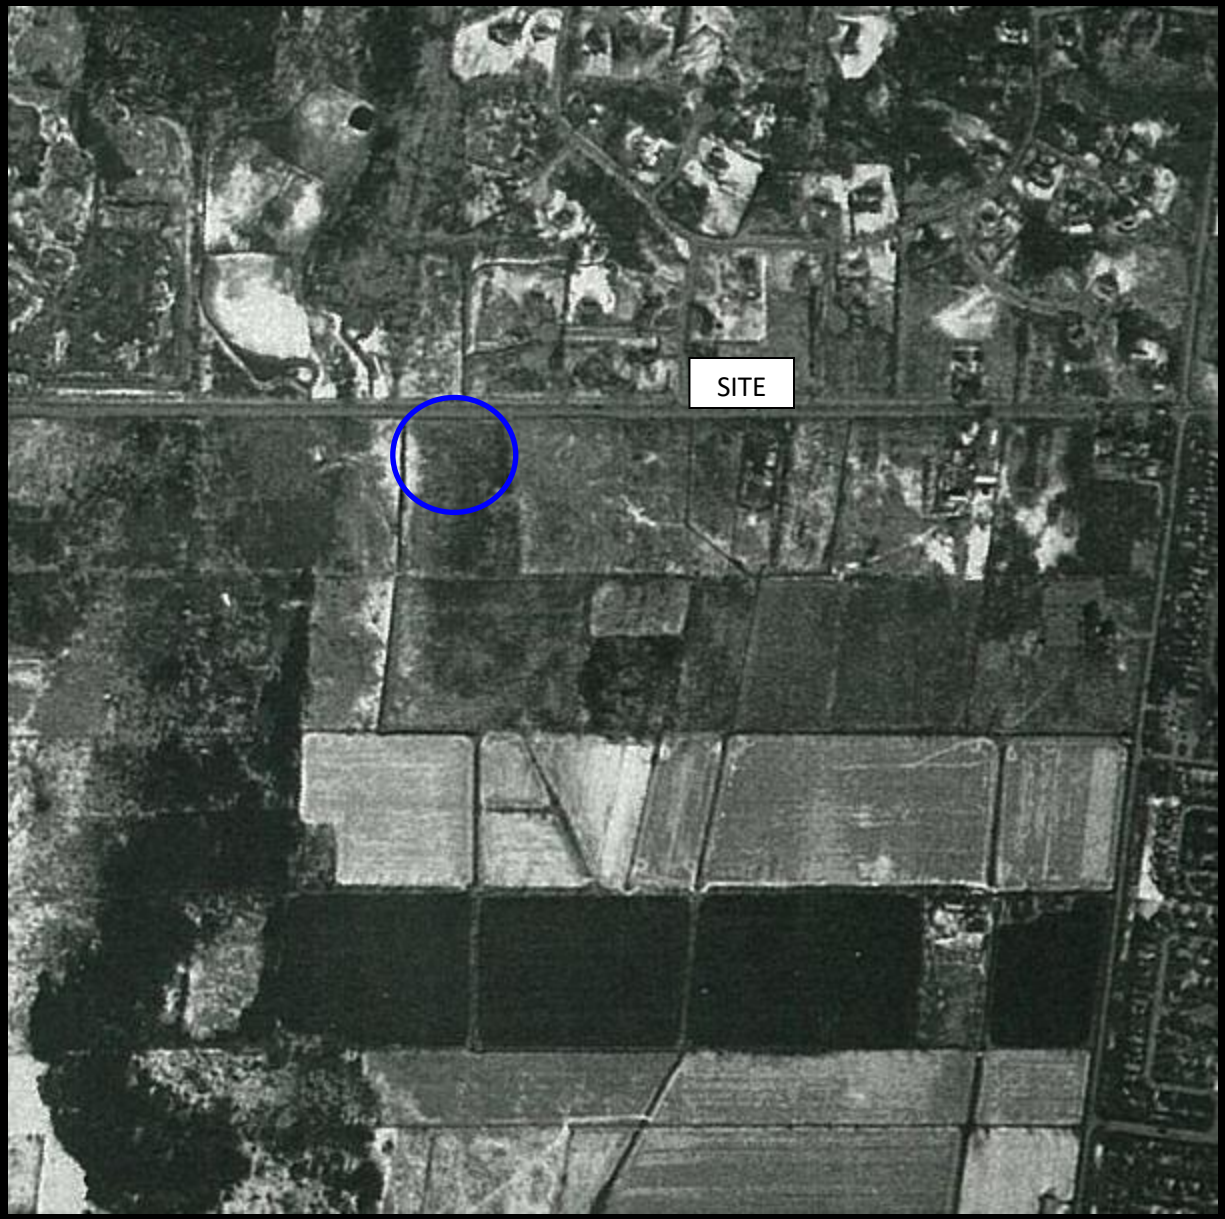
AERIAL PHOTOGRAPH
1988

| 1988 | Residential development is apparent to the north of Fallowfield Road and further east of the site. No significant changes have been made to the subject site or neighbouring properties to the south and west. |

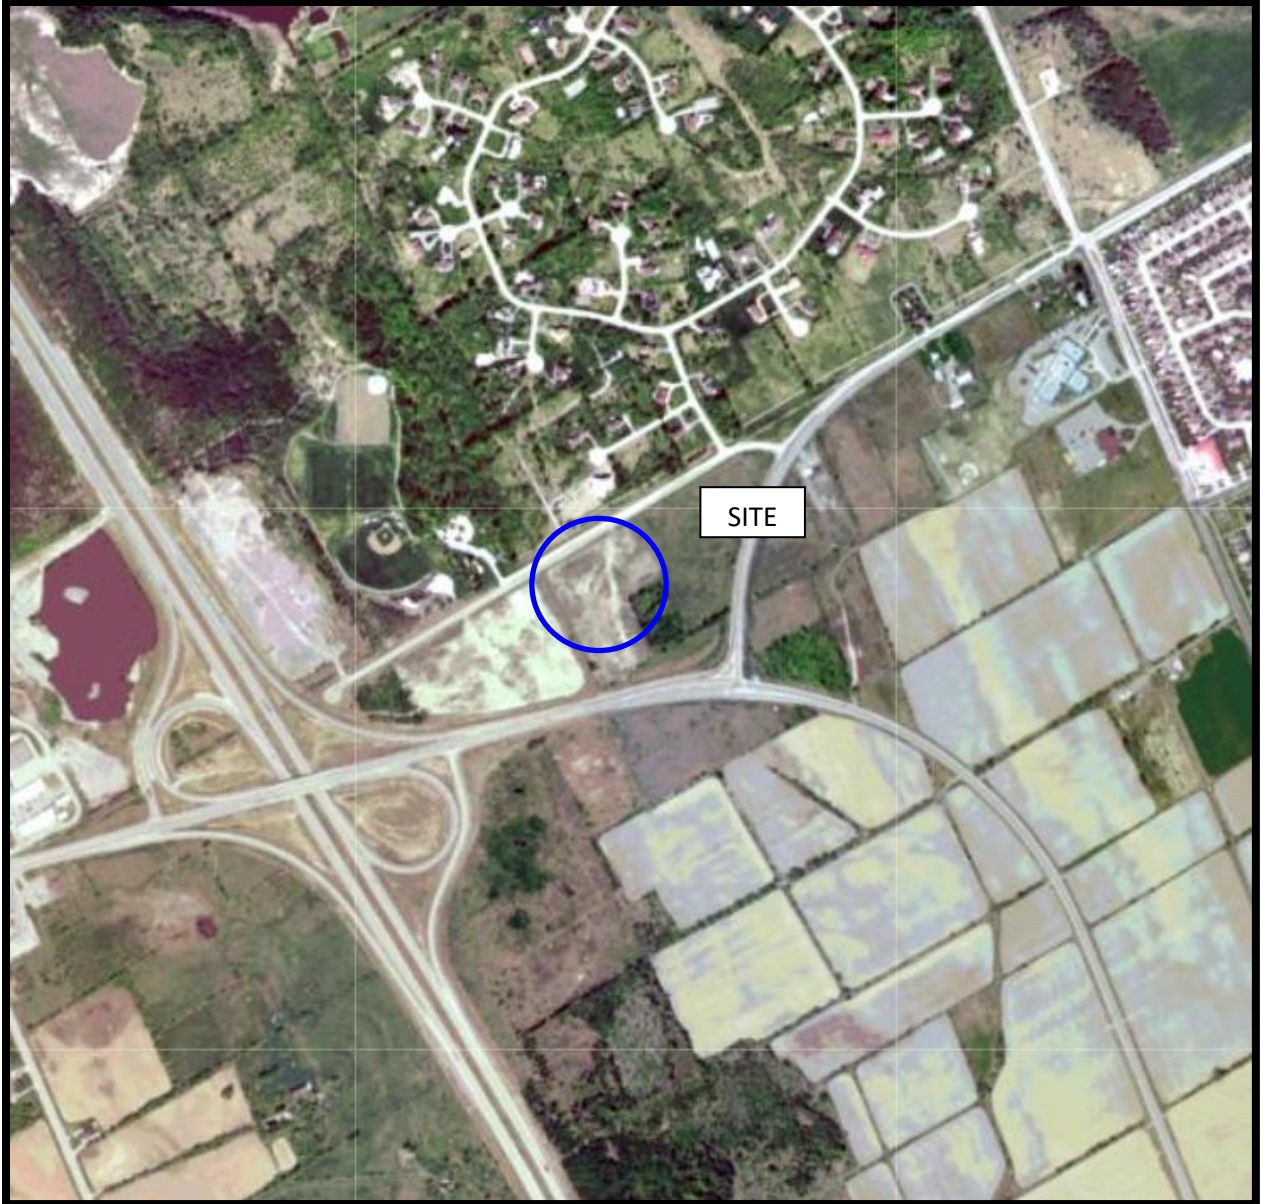
AERIAL PHOTOGRAPH
1999

| 1999 | Highway 416 was constructed further to the west of the subject site which resulted in the realignment of Fallowfield Road and Strandherd Drive. O'Keefe Drive is now present to the north of the subject site. Fill material has been placed on the subject site and the adjacent properties to the east, south and west. Additional residential development to the north has been constructed. |

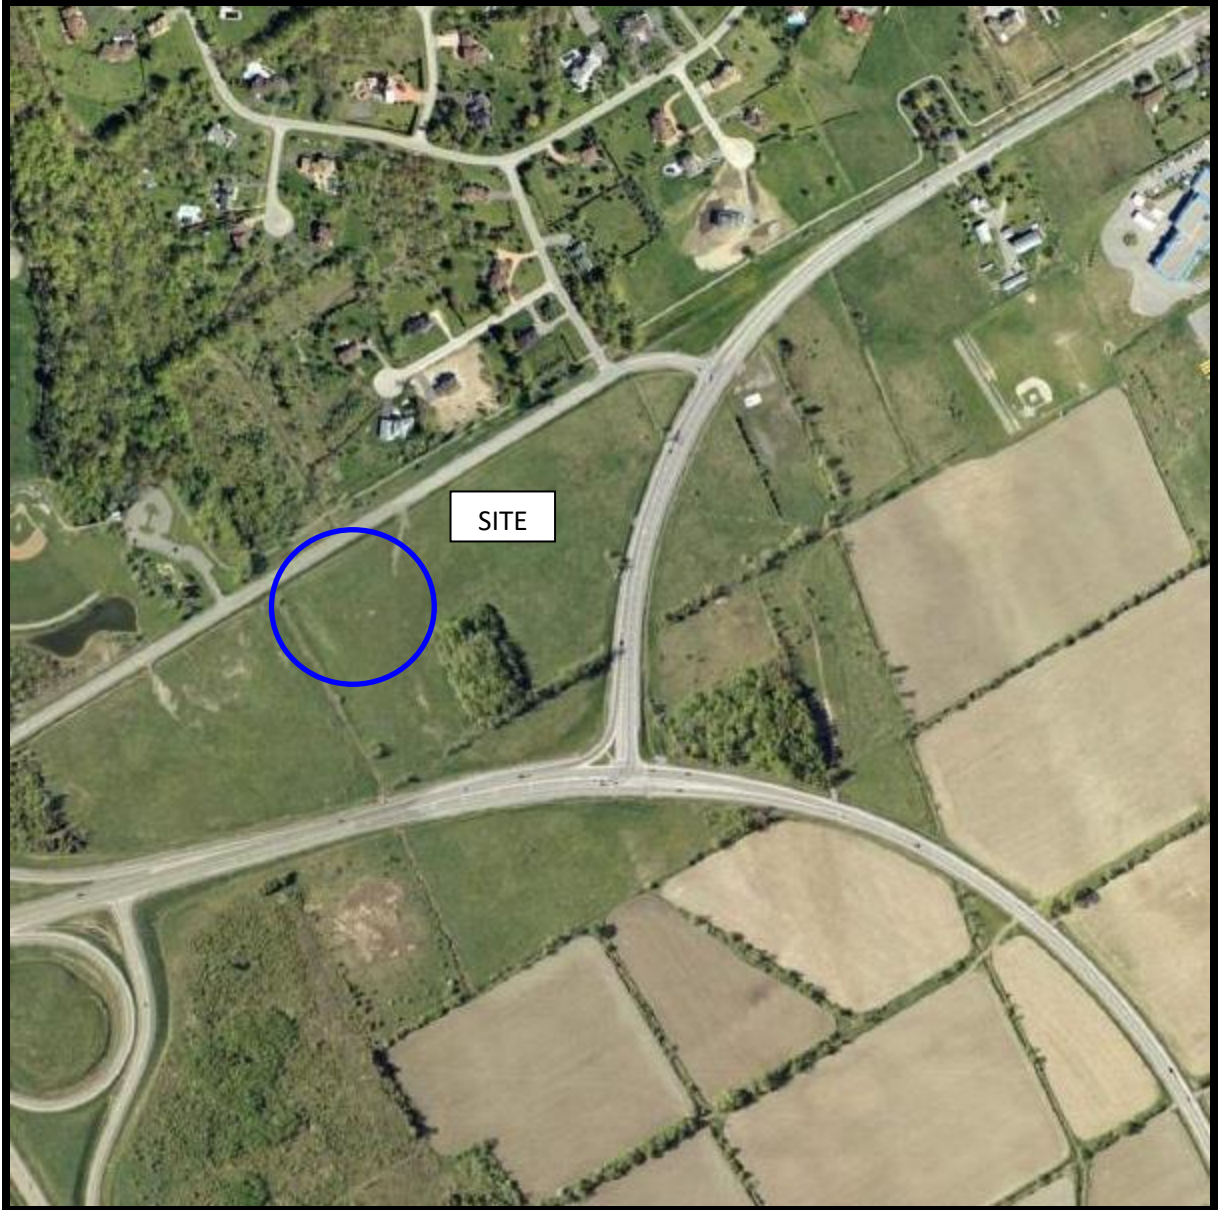
AERIAL PHOTOGRAPH
2002

| 2002 | Increased residential development is apparent to the north of O'Keefe Drive. The subject site appears vacant grassland. No significant changes have been made to the neighbouring properties. |

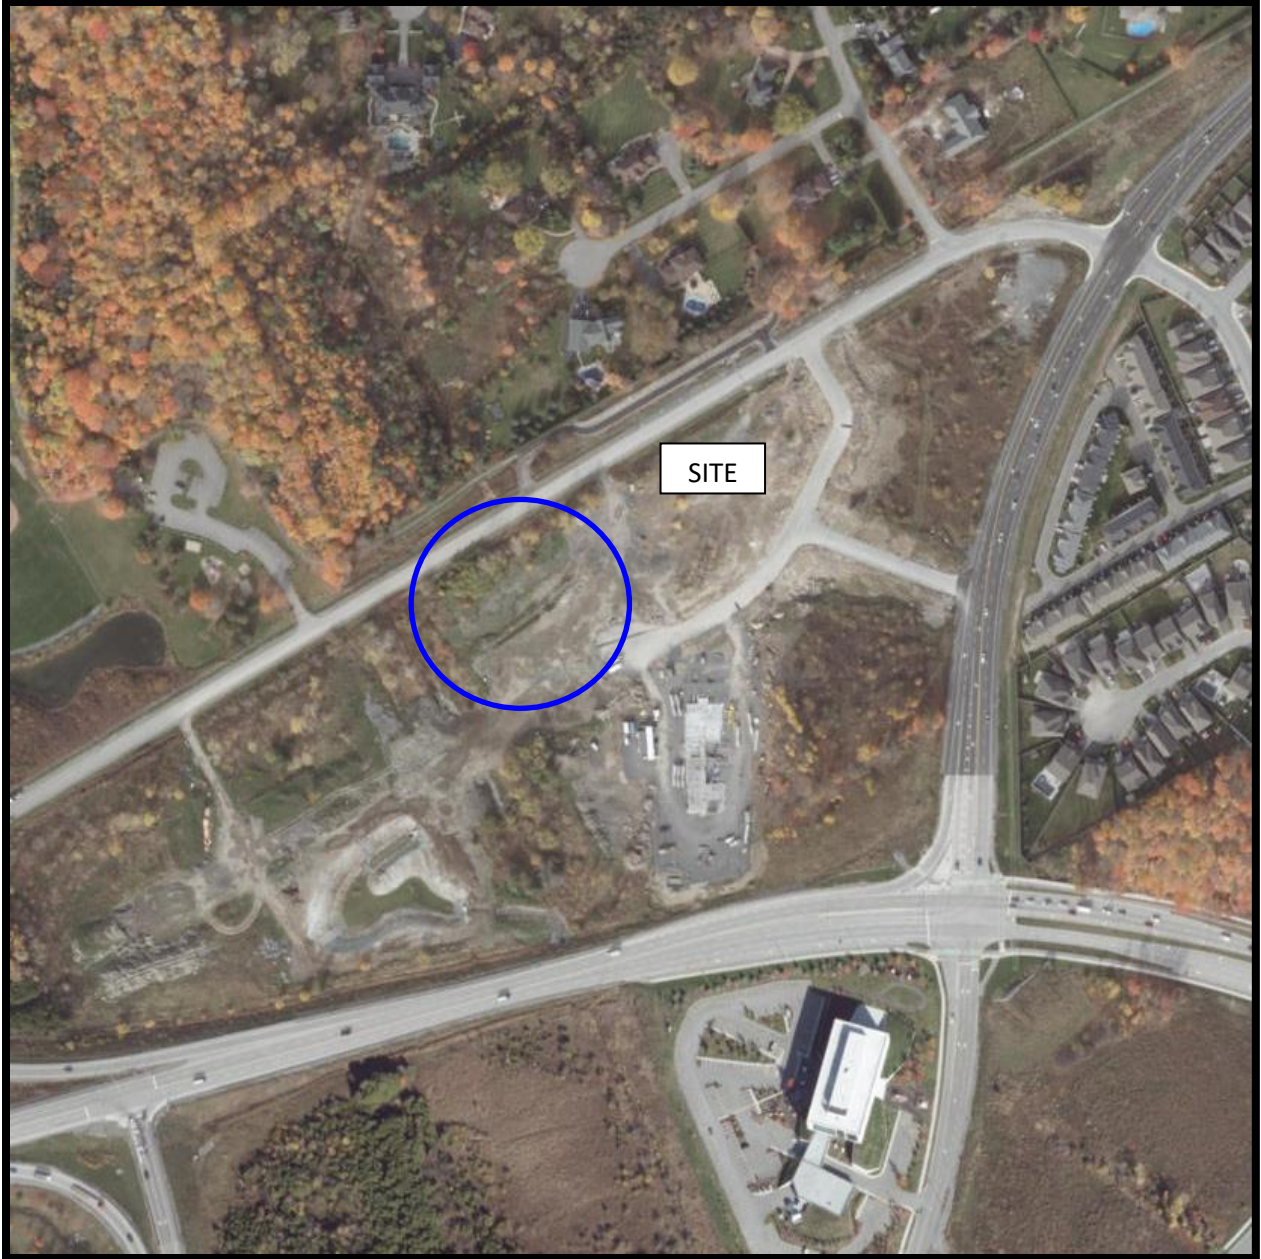
AERIAL PHOTOGRAPH
2019

2019 (City of Ottawa) Additional fill placement has occurred on site. Lusk Street is now present, while a commercial building is under construction to the southeast. A stormwater management pond appears to have been constructed to the southwest of the subject site. Residential development has been constructed further to the east and a commercial building has been constructed further to the south.

Based on the findings of the Phase I - ESA, the subject site has received a significant quantity of imported fill material of unknown quality. It is recommended that a fill quality assessment be conducted for the subject site to assess the quality of the fill and determine any impact on future site development.
