July 31, 2023

Project No. 22572533

ADDENDUM TO THE SCOPED ENVIRONMENTAL IMPACT ASSESSMENT AND TREE CONSERVATION REPORT FOR THE PROPOSED DEVELOPMENT OF 405 HUNTMAR DRIVE, OTTAWA, ON

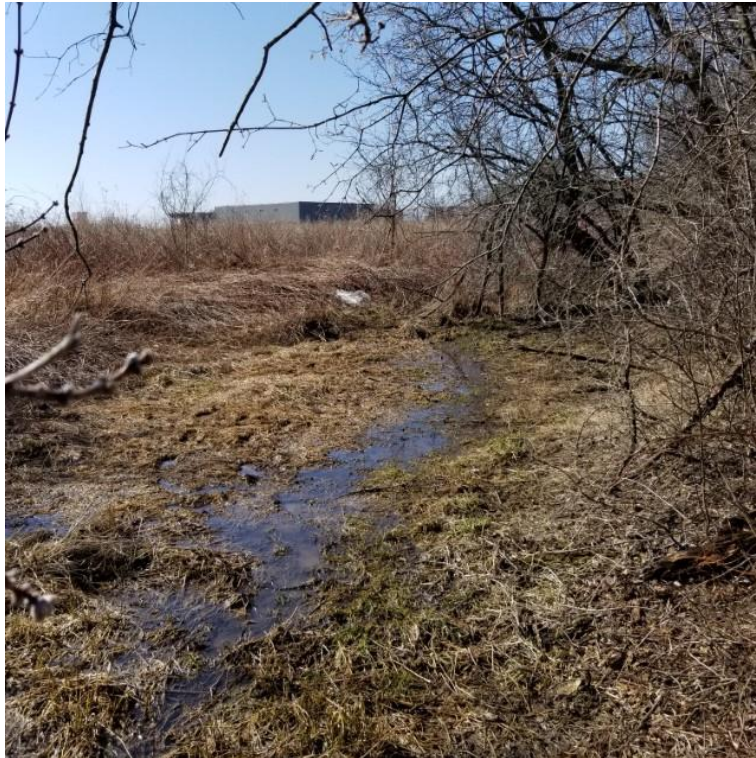
Photo 1: Headwater Drainage Feature April 2023

The mapped feature was evident during the April 13 field survey through the presence of standing water, however; the feature was seen to be dry during the May 24 and June 19 field survey, indicating it is ephemeral and likely the result of snow melt accumulating in this area (Attachment A; Photos 1 and 2). The feature was seen to overlap the Site in the form of a small swale running parallel to and within the hedgerow (see Figure 1) then extending north of the Site and eventually connecting to the roadside ditch along Huntmar Drive. An assessment of the feature, where present on the Site, was completed in accordance with the Guidelines (TRCA and CVC 2014), the results of which are presented in Table 1. No fish sampling was completed as the feature was dry during the appropriate window for sampling.

Based on the results of the additional field surveys and analysis presented in this letter, the feature is not fish habitat, but it is a headwater drainage feature. As noted in Section 3.1, the management recommendation per the Guidelines is to maintain the terrestrial linkage function of this feature, however; this feature is the southern tip of the headwater drainage feature and so offers no terrestrial connection between two natural areas. The proposed development will remove the on-Site portion of this feature (Map 2), but as noted, it does not perform any linkage function so no impacts to the identified functions of this feature are anticipated. No further consideration of this feature is warranted. No updates to the original conclusions of the Scoped EIS and TCR are required.

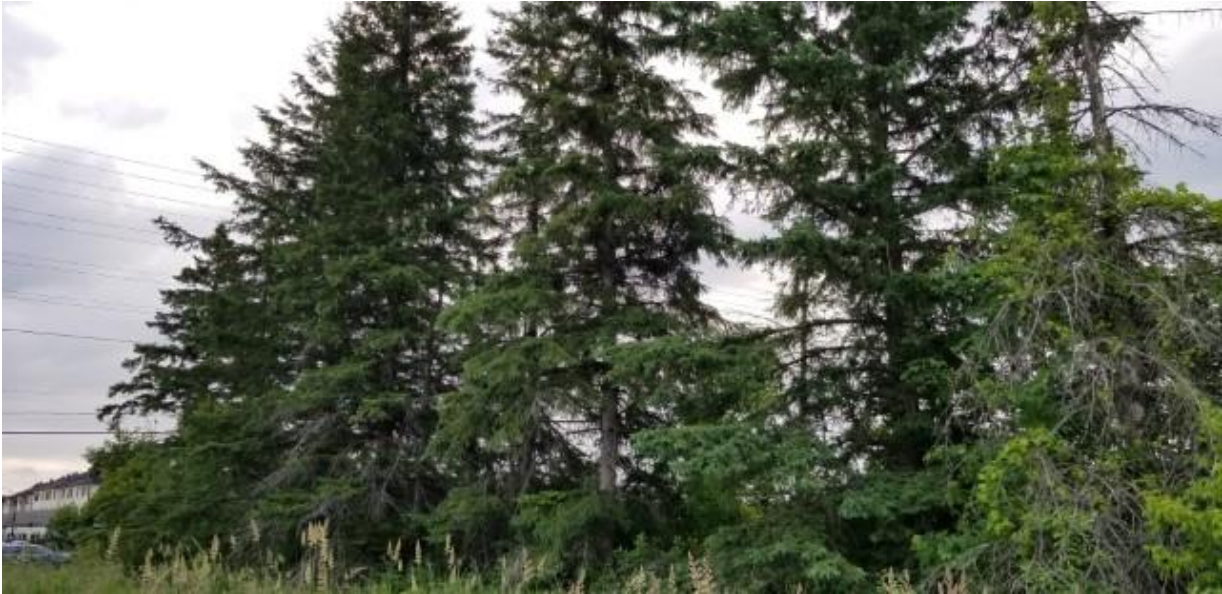
Photo 3: Tree Grouping 1

- Grouping 1 consisted of nine white spruce trees, all in good condition. These trees appear to have been planted, given their similar ages and linear arrangement. Diameter-at-breast-height (DBH) of these trees ranged from 15 to 32 cm.
- Grouping 2 consisted of approximately 40 stems of immature hybrid poplars, 25% of which were less than 10 cm DBH. The remaining trees were between 10 and 14 cm DBH, and all were in good condition.
- Grouping 3 was a cultural thicket with scattered mature trees including approximately six Manitoba maple (*Acer negundo*) in fair-to-poor condition ranging from 12 – 58 cm DBH, approximately three black cherry (*Prunus serotina*) in good-to-fair condition ranging from 26 – 31 cm DBH, and apple (*Malus sylvestris*) in fair condition ranging from 18 -38 cm DBH.

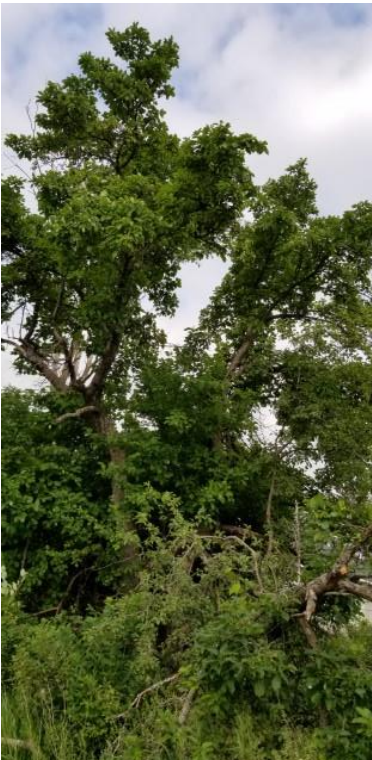
Photo 6: Tree 1

- Tree 1 was a large, two-stemmed apple with a DBH of 36 and 42 cm in fair condition.
- Tree 2 was a mature, healthy white elm (*Ulmus americana*) with two stems of 48 and 54 cm DBH.
- Tree 3 was a large Manitoba maple with a DBH of 68 cm in poor condition (half dead and covered in wild grape [*Vitis riparia*] vines).

The proposed impacts to tree cover are illustrated on Map 2. The proposed development will remove the majority of the existing tree cover on the Site (approximately 45 trees >10 cm DBH), with the exception of the eastern end of Tree Grouping 3, and the northern hedgerow containing Trees 1 and 2 (Map 2). The proposed tree removal will be compensated for by the proposed planting of 149 trees on the Site, which exceeds the number of trees >10 cm DBH proposed for removal. This will result in a net gain of tree cover at the Site. The impact of the tree removal from a natural heritage functions standpoint were assessed as part of the preliminary Scoped EIS and TCR, as well as within this Addendum. No updates to the original conclusions of the Scoped EIS and TCR are required.

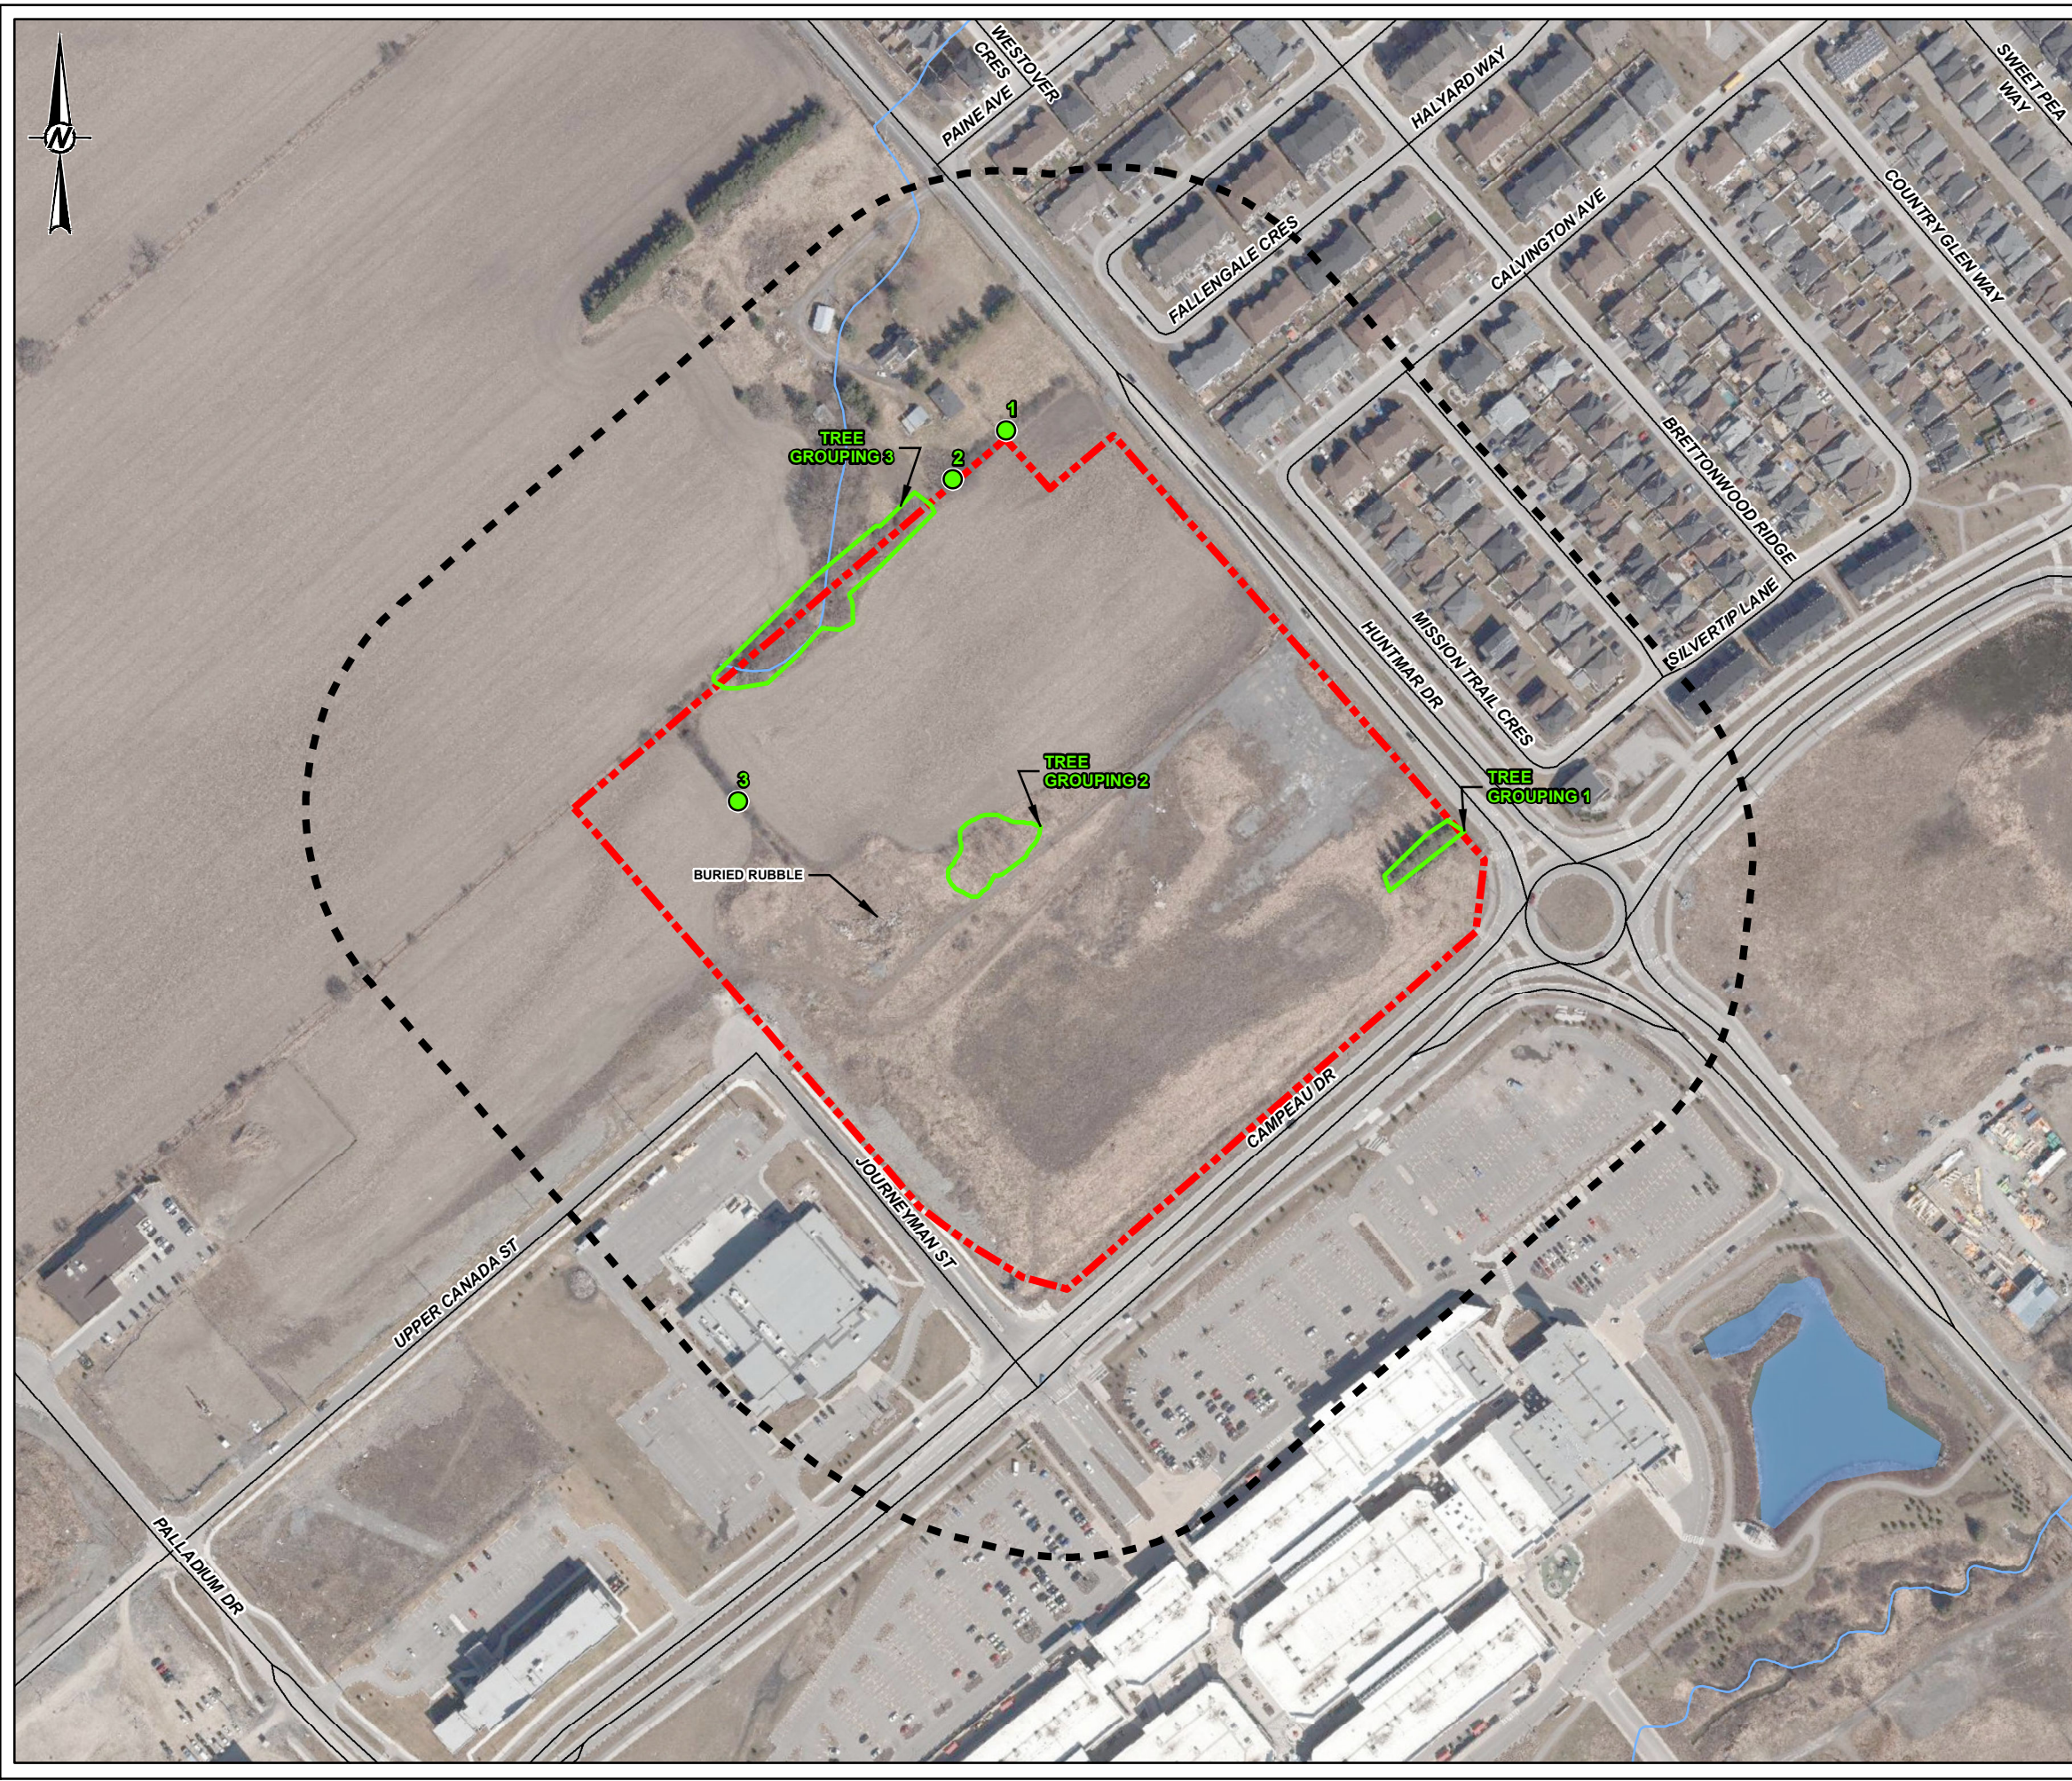
TITLE
EXISTING TREE COVER

Tree cover on the Site was divided into three main groupings, as well as three individual trees (Map 1; Photos 3-8) as detailed below:
