October 12, 2023

Project No. CA-GLD-22572533 Rev.2

UPDATED ADDENDUM TO THE SCOPED ENVIRONMENTAL IMPACT ASSESSMENT AND TREE CONSERVATION REPORT FOR THE PROPOSED DEVELOPMENT OF 405 HUNTMAR DRIVE, OTTAWA, ON

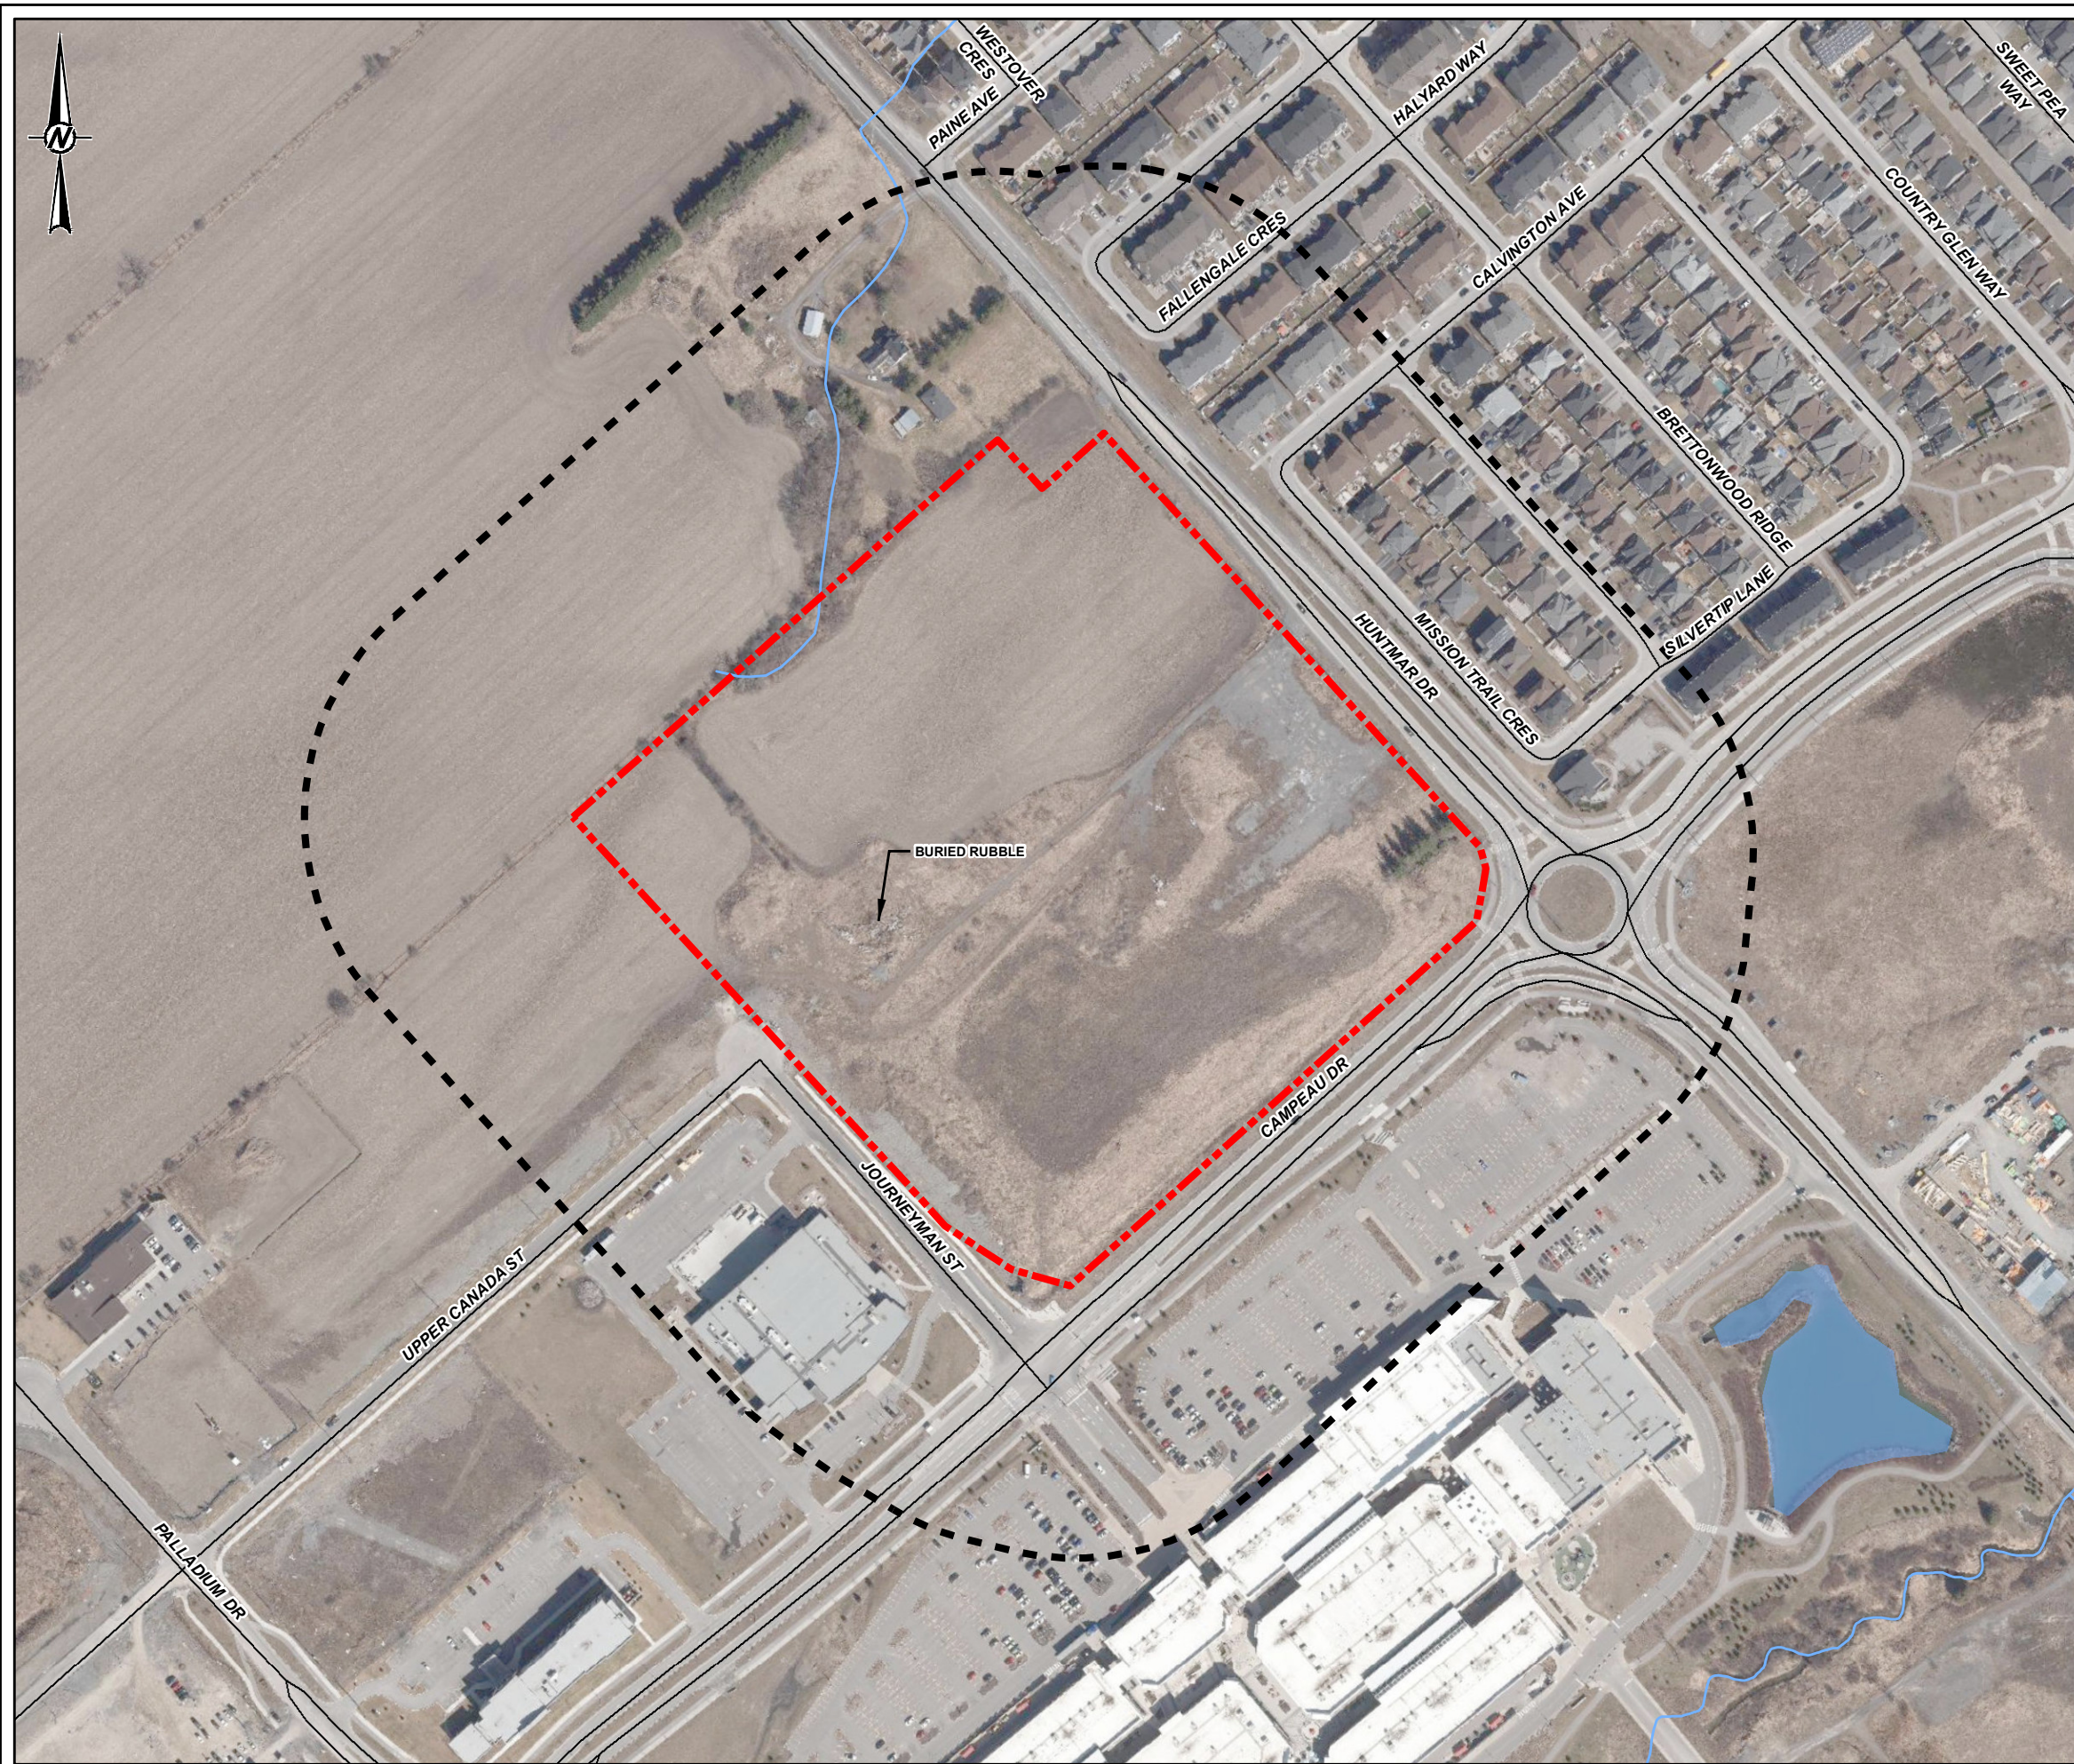
PROJECT No. 22572533 CONTROL 0002 REV. 0 FIGURE 1

WSP Canada Inc. (WSP; formerly Golder Associates Ltd.) was retained by RF Kanata LP I. to conduct environmental studies for a Scoped Environmental Impact Statement (EIS) and Tree Conservation Report (TCR) for the proposed commercial development at 405 Huntmar Drive, Ottawa, Ontario (The Site; Figure 1). A preliminary Scoped EIS and TCR was prepared and submitted to the City of Ottawa in December 2022 (WSP 2022), with the recommendation that, following additional study, an addendum be prepared to confirm or update the findings of the preliminary Scoped EIS and TCR. This letter is intended to act as that addendum.

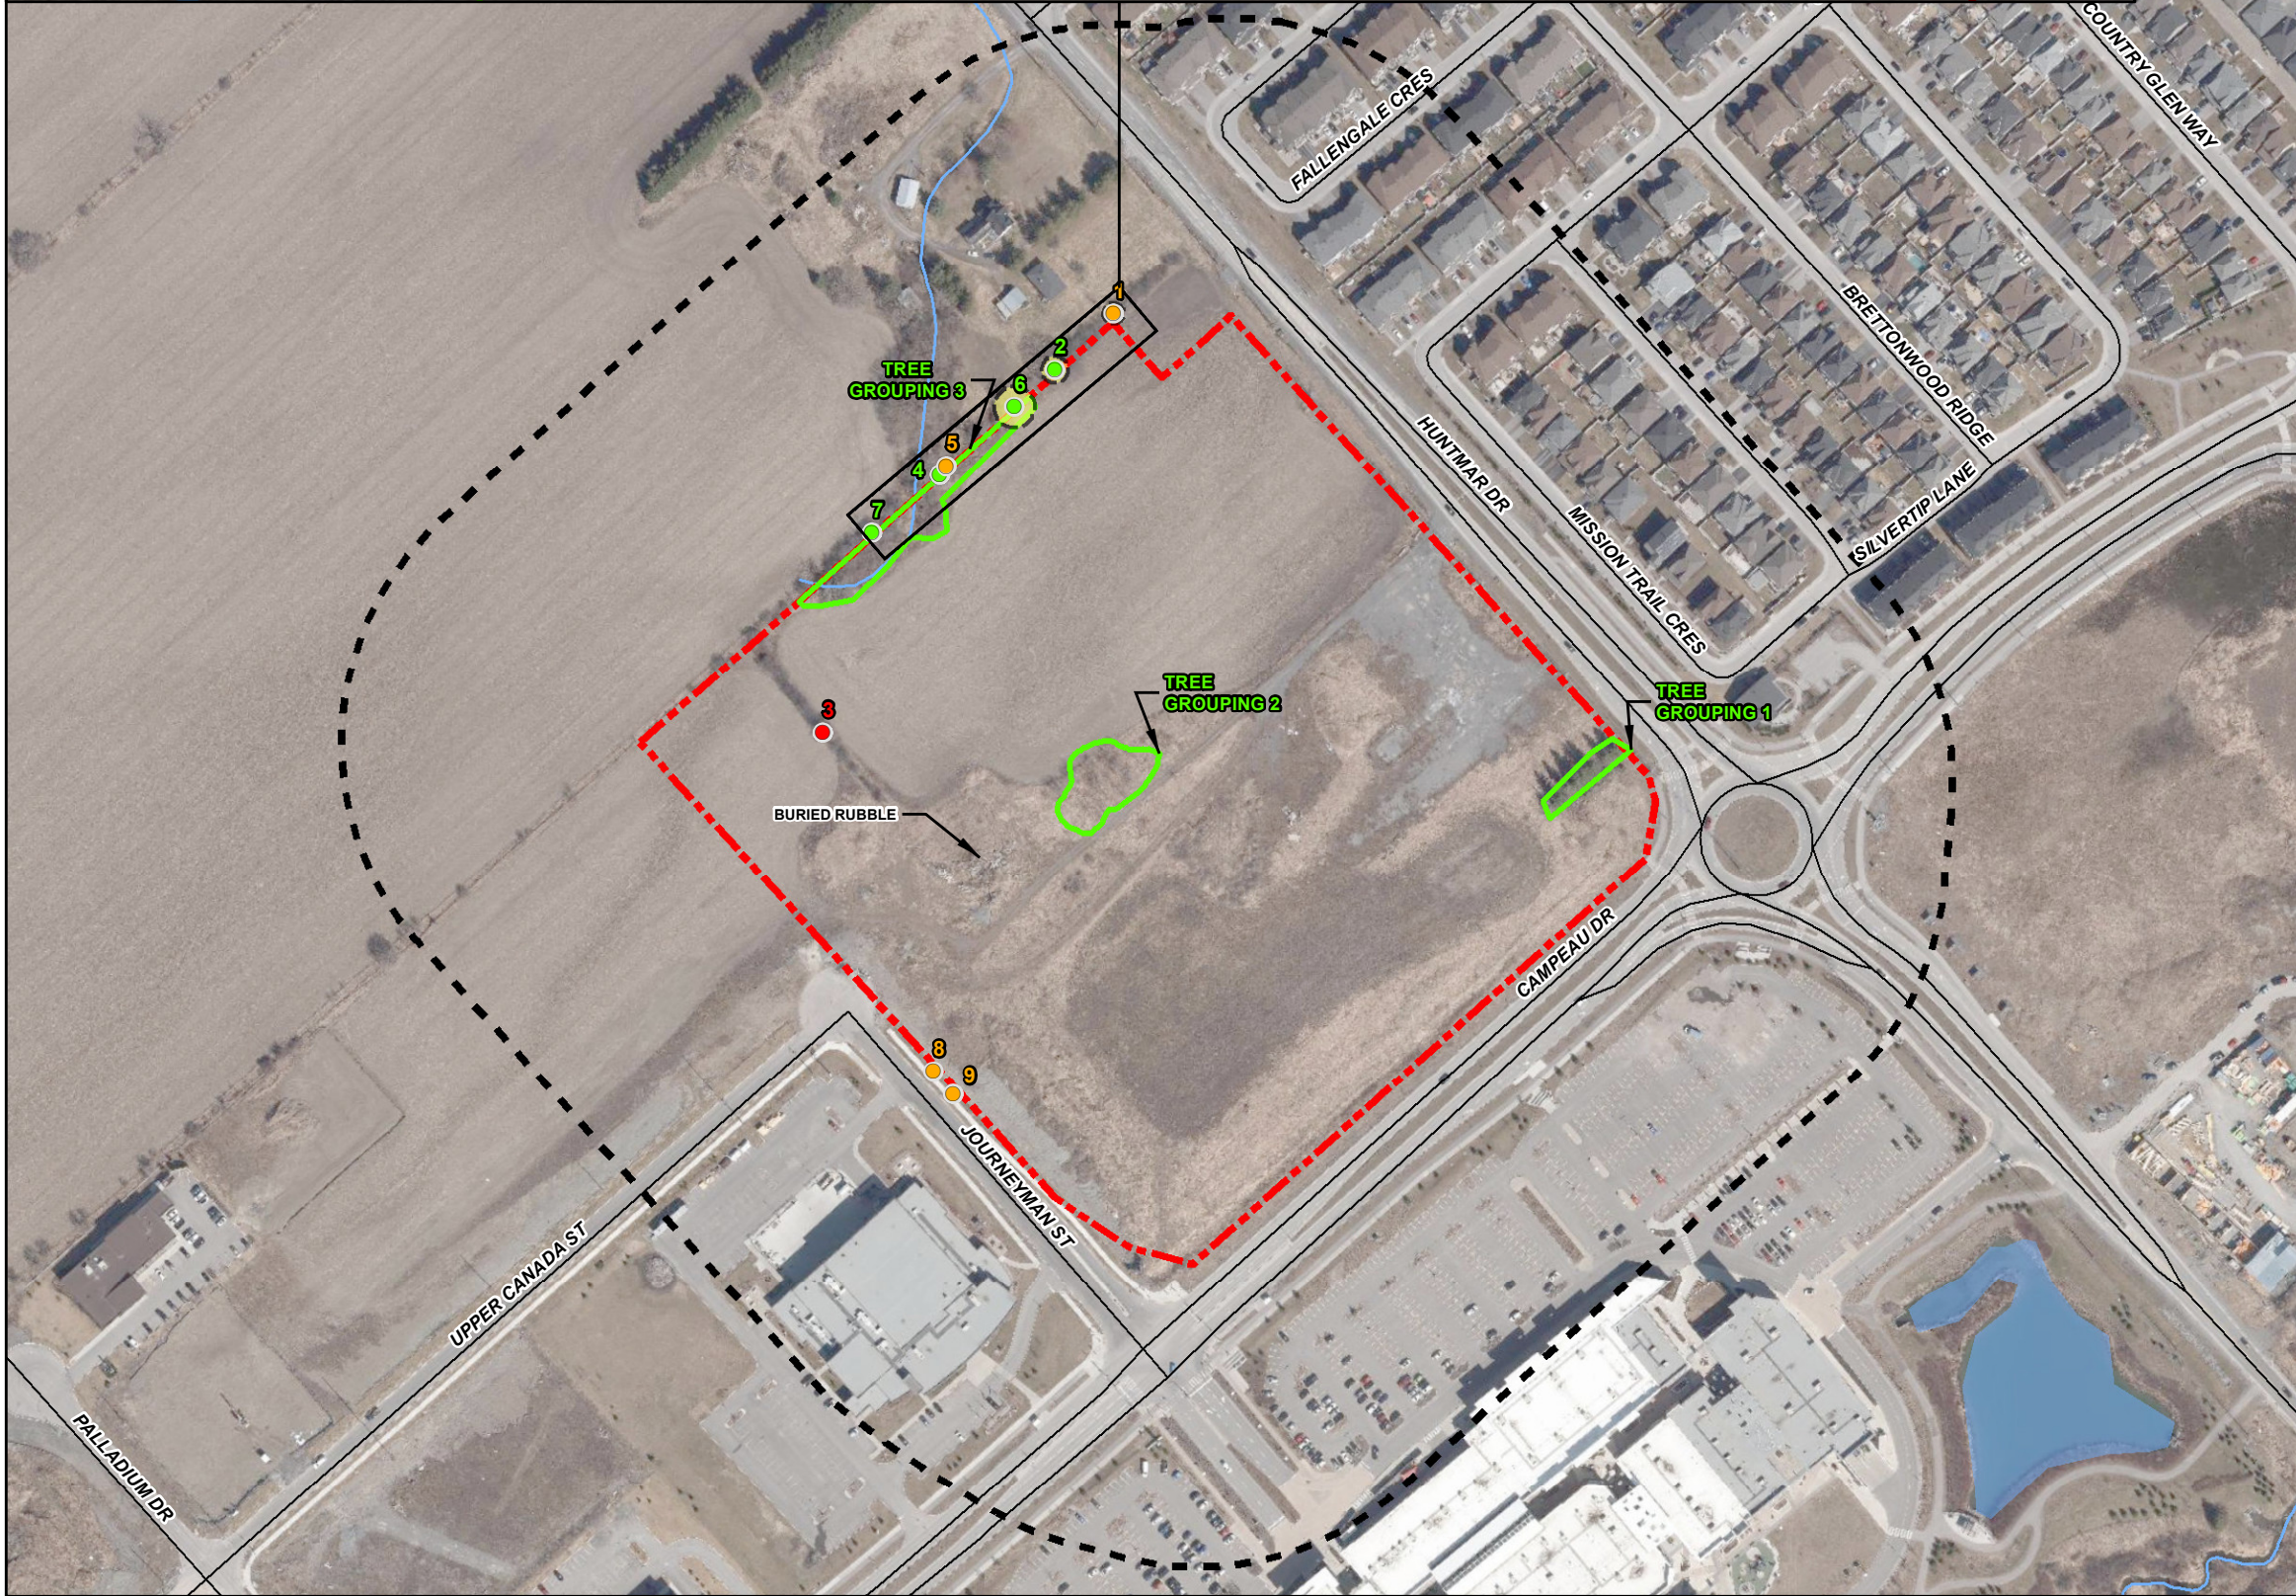
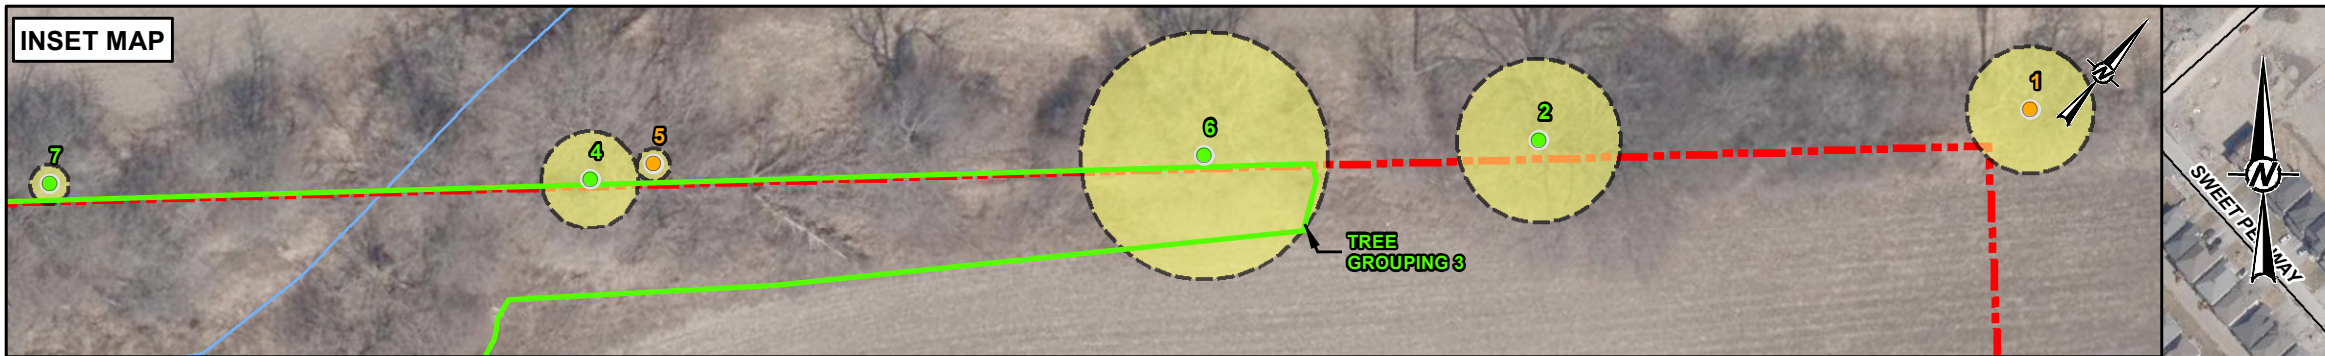
PROJECT No. 22572533 CONTROL 0002 REV. 0 MAP 1

Tree cover on the Site was divided into three main groupings, as well as several individual trees (Map 1; Photos 3-8) as detailed in Tables 2, 3 and 4 below:

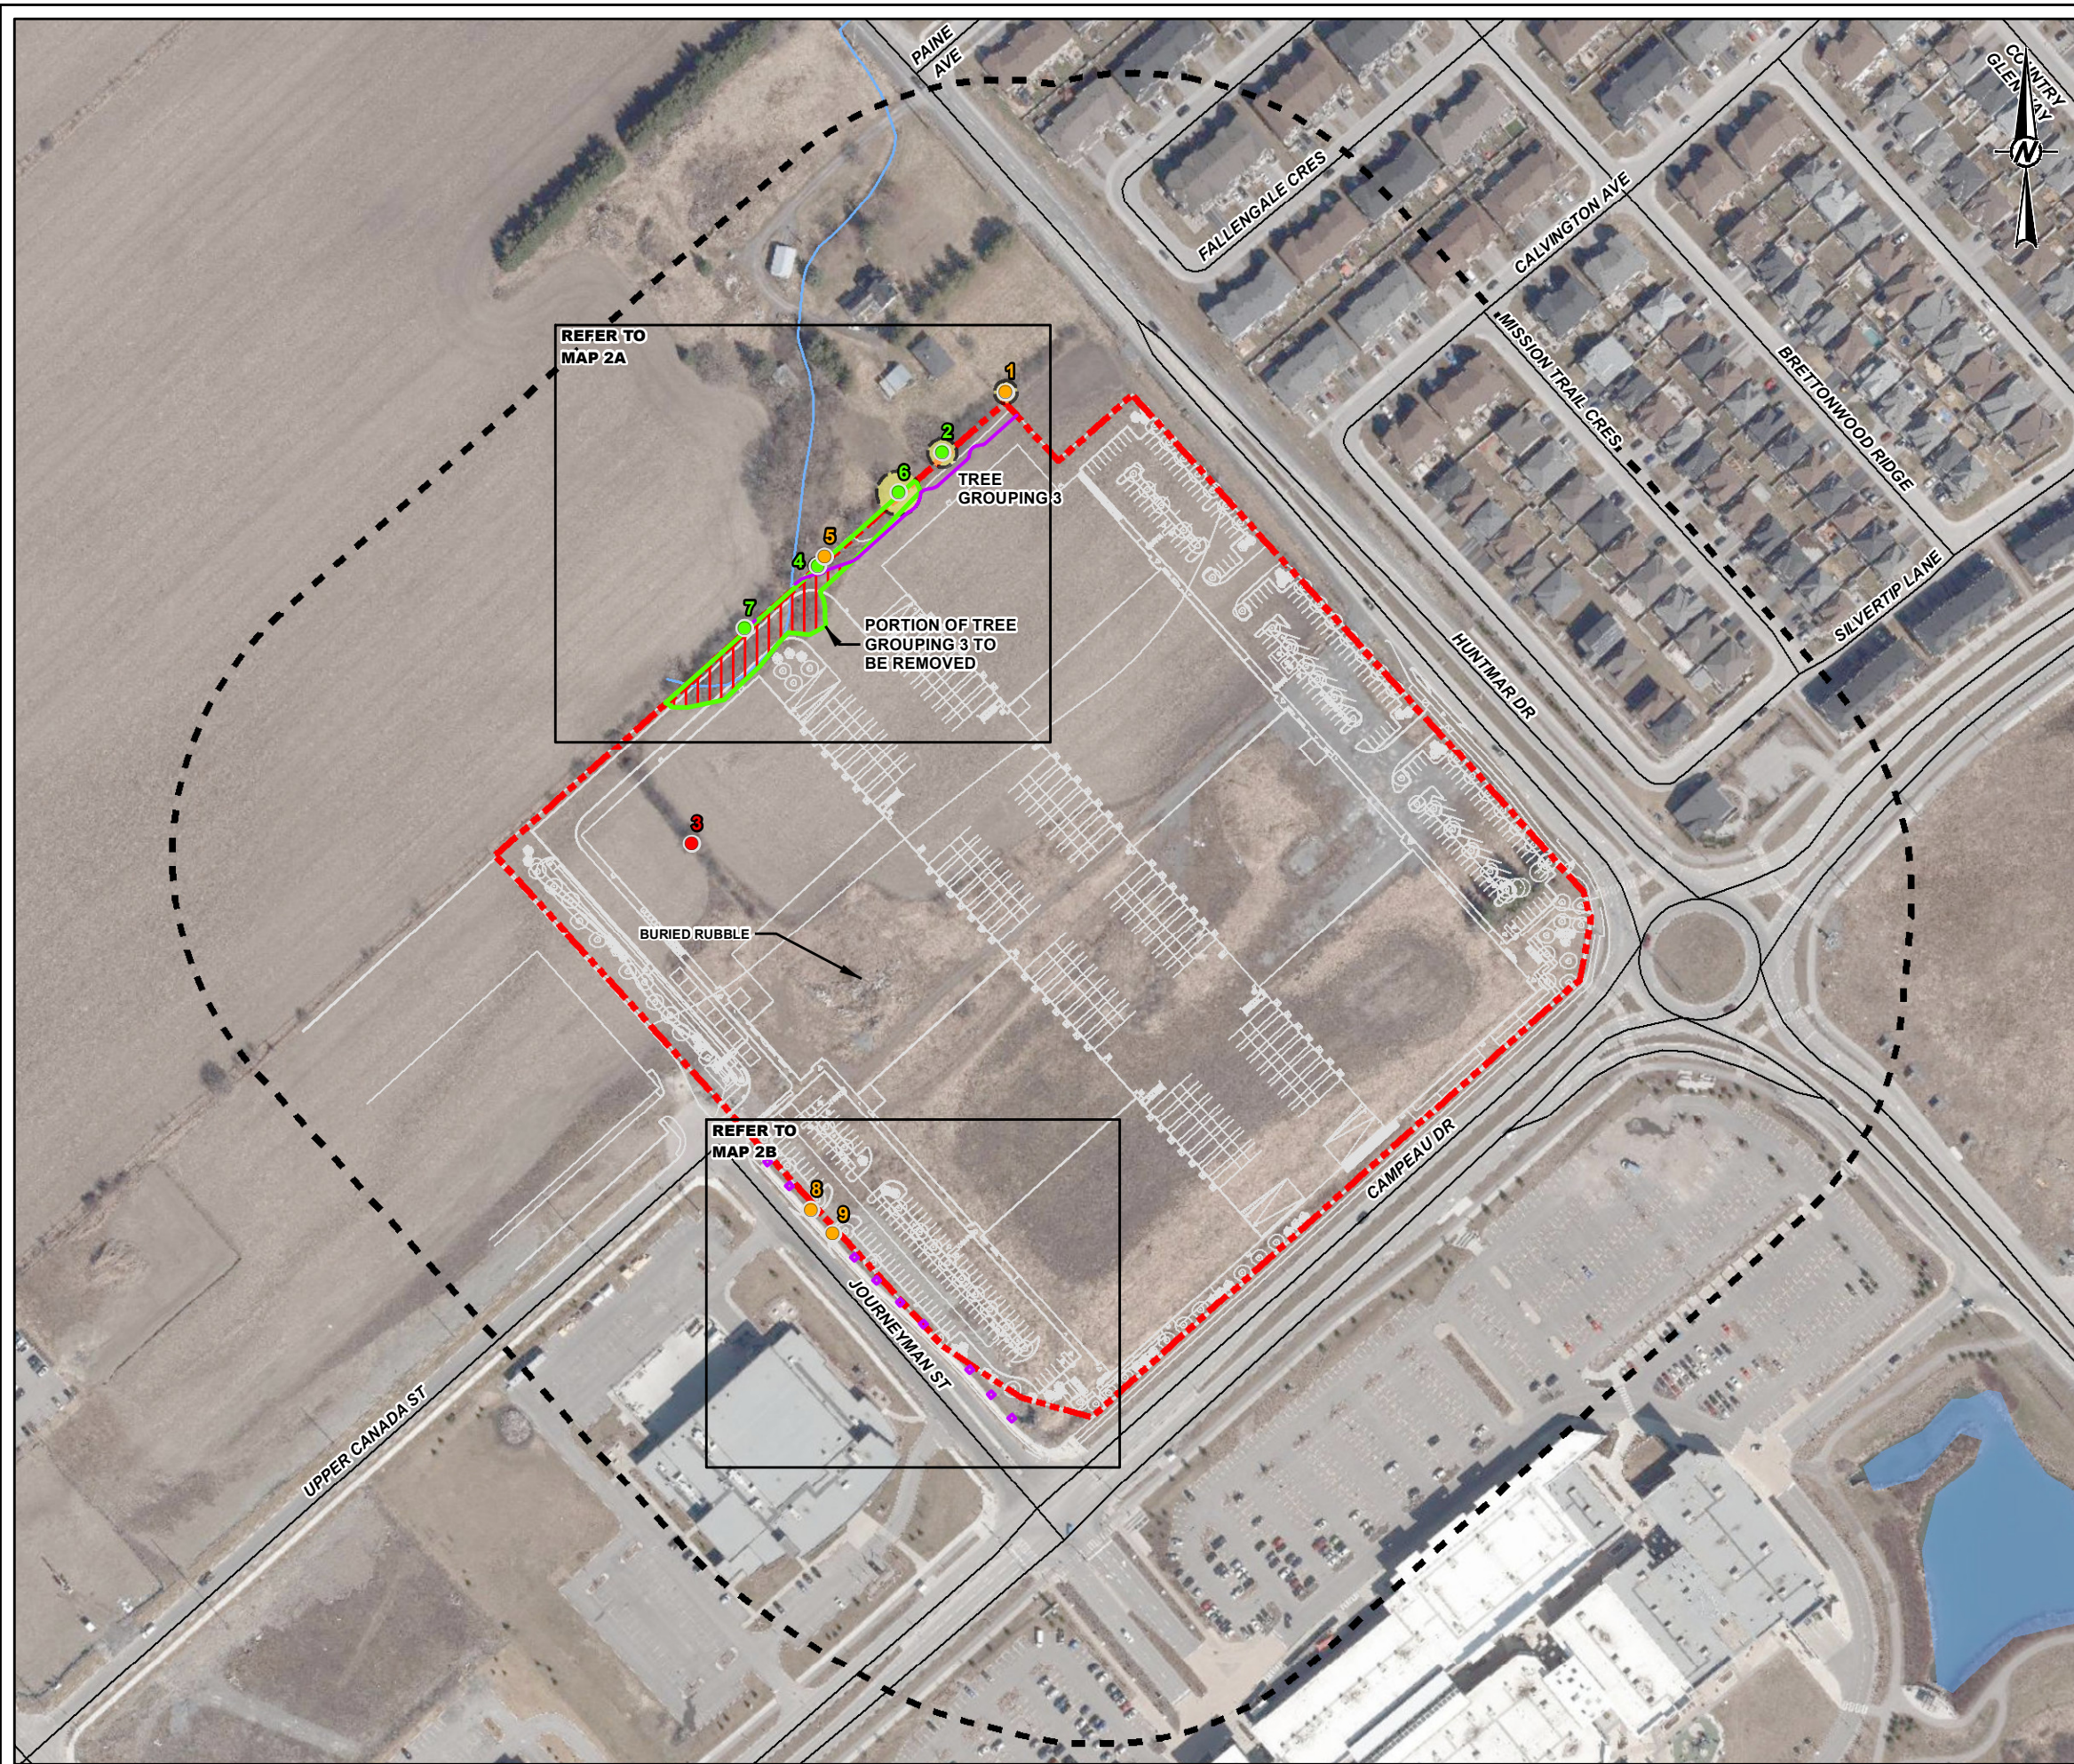
PROJECT No.	CONTROL	REV.	MAP
22572533	0002	0	2

The final design plan is shown on Maps 2, 2a and 2b. This design plan has been slightly revised compared to the design plan that was submitted as part of the preliminary Scoped EIS and TCR. The key changes include:

- An increase in the number of proposed trees planted from 75 to 141.
- The watermain and 6 m easement have been shifted at the back of the drive aisle curb to provide clearance for the CRZ of the Trees 4 and 7.
- The curb on the drive aisle has been curved to provide clearance to grade down to tie-in to existing grades to protect the existing Tree 4.
- The swale, catch basins and grading tie-in along the north property line adjacent Building A has been relocated farther away from the existing northern hedgerow to provide adequate clearance.

The proposed impacts to tree cover and protection of trees to be retained are illustrated on Maps 2, 2a and 2b. The proposed development will remove the majority of the existing tree cover on the Site (approximately 45 trees >10 cm DBH), with the exception of the eastern end of Tree Grouping 3 and individual trees along the northern Site boundary in the northern hedgerow (Maps 2 and 2a). This has been achieved through minor alterations to the proposed design plan to provide further protection of the northern hedgerow as detailed in Section 4.0. Trees within the City-owned ROW along Journeyman Street will be protected, with the exception of two (Trees 8 and 9) that will be removed to allow for construction of the Site entrance off Journeyman Street. Protection measures for trees being retained are shown on Maps 2, 2a and 2b and were detailed in the original Scoped EIS and TCR.

Section 4.8.2 of the Official Plan provides strong direction to maintain the urban forest canopy and its ecosystem services during intensification noting priority should be given to the retention and protection of large, healthy trees over replacement plantings and compensation. Due a City of Ottawa requirement, a watermain was needed to link Upper Canada Street to Huntmar Drive. It was required to have the watermain pass along the northern property line, away from the truck court where there was a concern of the additional loading on the watermain, which is the cause of removal of much of Tree Grouping 3.

The proposed tree removal will be compensated for by the proposed planting of 141 trees on the Site, which exceeds the number of trees >10 cm DBH proposed for removal (approximately 45 trees). This will result in a net gain of tree cover at the Site and will have a positive cumulative impact on the urban forest, over time and space. The impact of the tree removal from a natural heritage functions standpoint were assessed as part of the preliminary Scoped EIS and TCR, as well as within this Addendum. No updates to the original conclusions of the Scoped EIS and TCR are required. Tree planting recommendations and species to be used are described in the landscaping plan (Novatech 2023).

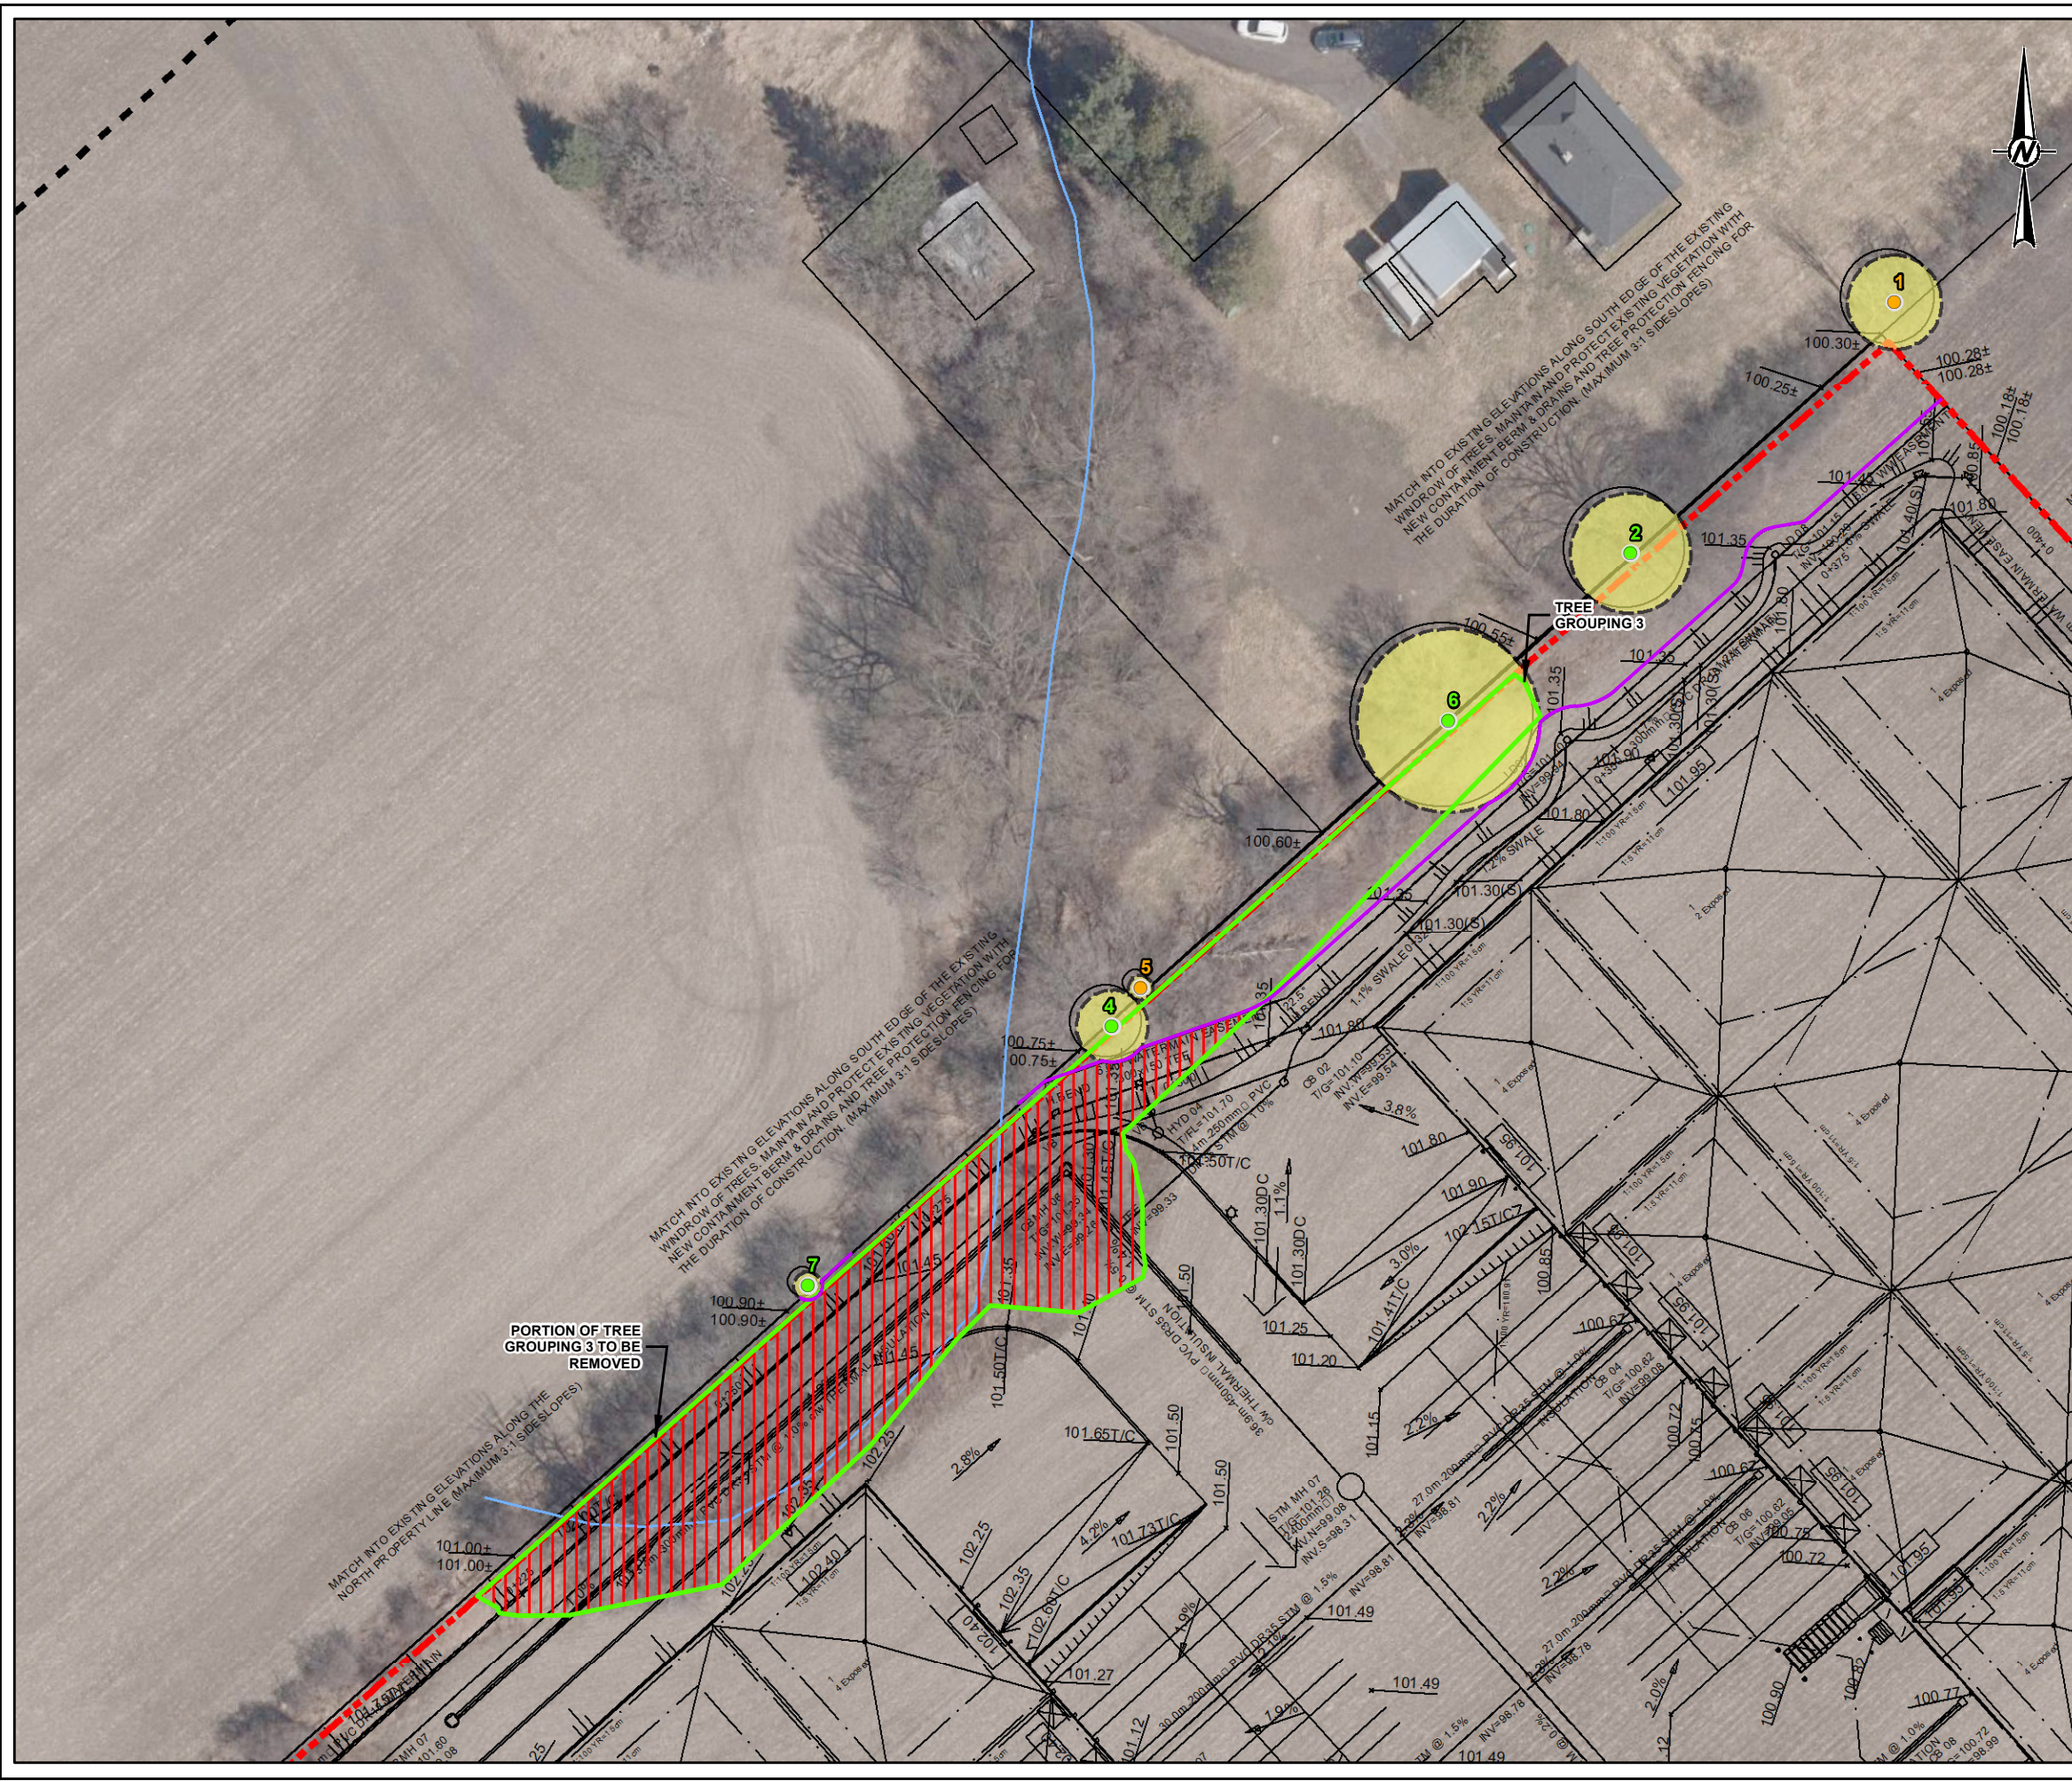
PROJECT No. 22572533 CONTROL 0002 REV. 0 MAP 2A

Tree Grouping #	Species	DBH (cm)	Location	Condition / Notes	Recommendation
1	White spruce (<i>Picea alba</i>) 100%	15-32	On-site	Good, planted	Remove
2	Poplar (<i>Populus</i> sp.) 100%	10-32	On-site	Good, appear to be hybrids	Remove
3*	Manitoba maple (<i>Acer negundo</i>) 60% Black cherry (<i>Prunus serotina</i>) 20% Apple (<i>Malus pumila</i>) 20%	12-58 26-31 18-38	On-site	Poor to fair, mixed with buckthorn thicket and containing dead standing ash	Remove western portion. Retain portions that overlaps with protected CRZs and areas outside the area of disturbance. See Table 2; Map 2; Map 2a

* Note that additional portions of the northern hedgerow on the Site, visible on aerial imagery west of Tree Grouping 3, consists of thicket and standing dead trees only.

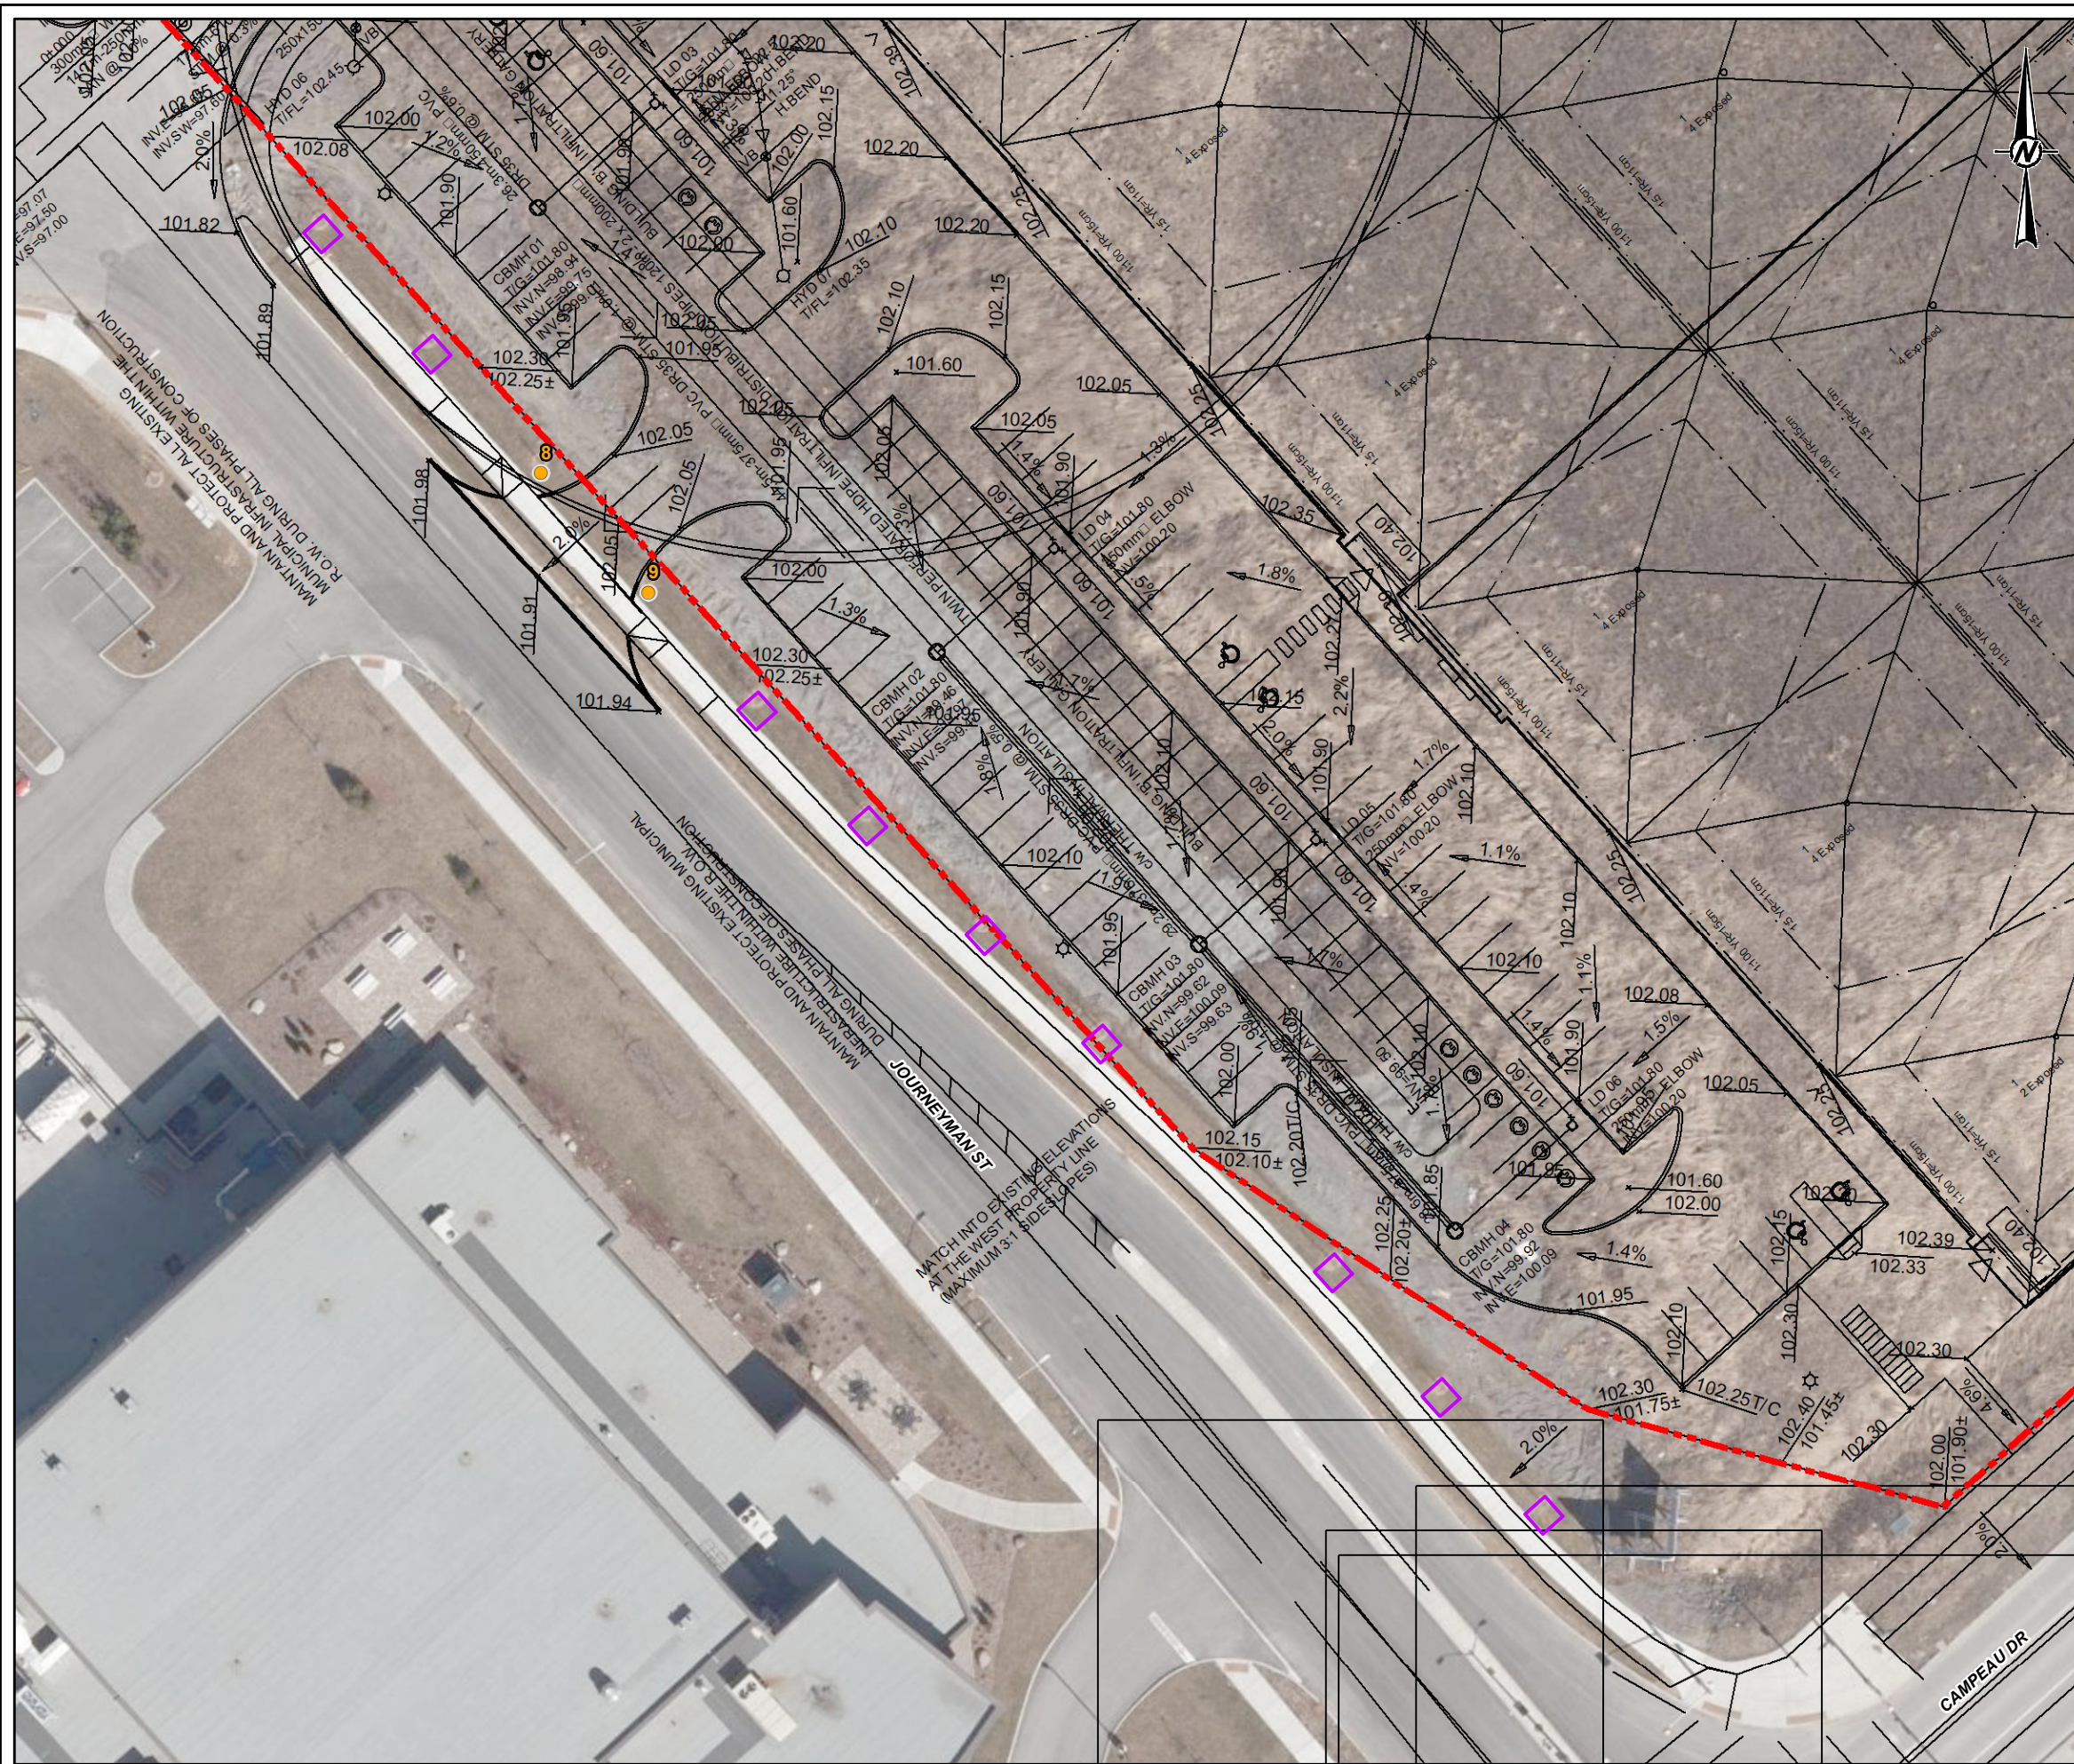
PROJECT No. 22572533 CONTROL 0002 REV. 0 MAP 2B

In addition to the individual trees and tree groupings discussed above, there are several City-owned trees in the City right-of-way (ROW) along Journeyman Street west of the Site (Maps 2 and 2b), all of which are <10 cm DBH. With the exception of Trees 8 and 9 (Map 2, Map 2b, Table 4), all of the trees within the ROW will be retained. The trees to be retained are red oak (*Quercus rubra*), bur oak (*Quercus macrocarpa*), white spruce, hackberry (*Celtis occidentalis*), honey locust (*Gleditsia triacanthos*) and little-leaf linden (*Tilia cordata*). All are small (DBH 2-6 cm), in good condition and have a maximum CRZ of 60 cm (based on the largest of the trees). Although Map 2b appears to show one of these trees within the Site boundary, field verification confirmed that these trees are located a minimum of 1 m from the protective fencing that demarcates the limit of disturbance at the Site, therefore these trees will be protected. On-site works adjacent to these trees will be limited to grading and installation of curbs and sidewalks, as detailed on Map 2b.

Trees 8 and 9 will be impacted / removed by the construction of the Site entrance off Journeyman Street, and they are described below in Table 4 and shown on Maps 2 and 2b.

Tree #	Species	DBH	Location	Condition	Recommendation
8	Little-leaf linden (<i>Tilia cordata</i>)	5.5	City ROW	Good	Remove
9	Red oak (<i>Quercus rubra</i>)	5.5	City ROW	Good	Remove

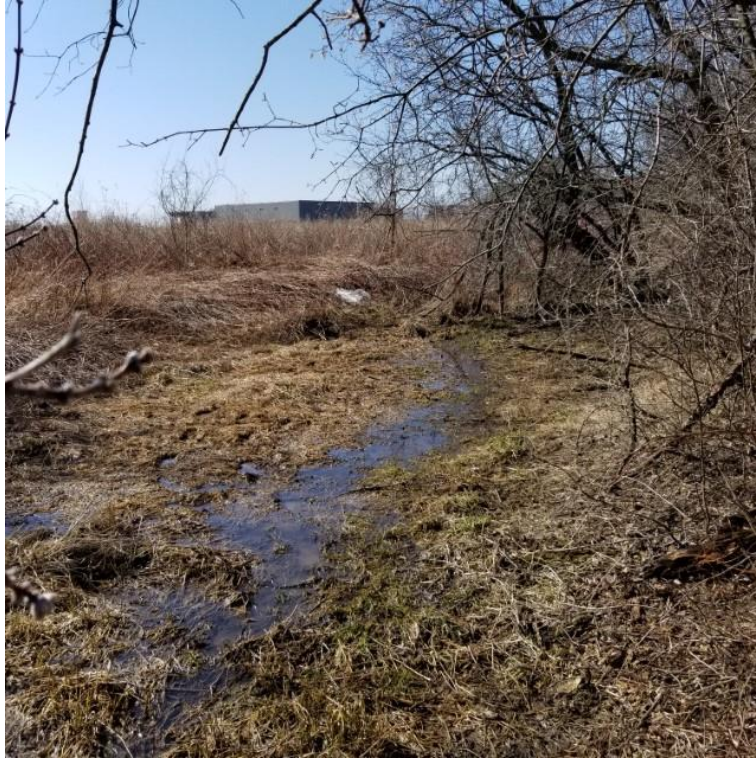
The mapped feature was evident during the April 13 field survey through the presence of standing water, however; the feature was seen to be dry during the May 24 and June 19 field survey, indicating it is ephemeral and likely the result of snow melt accumulating in this area (Attachment A; Photos 1 and 2). The feature was seen to overlap the Site in the form of a small swale running parallel to and within the hedgerow (see Figure 1) then extending north of the Site and eventually connecting to the roadside ditch along Huntmar Drive. An assessment of the feature, where present on the Site, was completed in accordance with the Guidelines (TRCA and CVC 2014), the results of which are presented in Table 1. No fish sampling was completed as the feature was dry during the appropriate window for sampling.

Photo 1: Headwater Drainage Feature April 2023

The management recommendation for this feature, per Table 1, is to maintain or replicate the terrestrial linkage. This management recommendation is intended for feature “with no flow with woody riparian vegetation that connects two other natural features identified for protection”. The feature represents the southern tip of a headwater drainage feature, and so does not perform any linkage function.

Based on the results of the additional field surveys and analysis presented in this letter, the feature is not fish habitat, but it is a headwater drainage feature. As noted in Section 3.1, the management recommendation per the Guidelines is to maintain the terrestrial linkage function of this feature, however; this feature is the southern tip of the headwater drainage feature and so offers no terrestrial connection between two natural areas. The proposed development will remove the on-Site portion of this feature (Map 2), but as noted, it does not perform any linkage function so no impacts to the identified functions of this feature are anticipated. No further consideration of this feature is warranted. No updates to the original conclusions of the Scoped EIS and TCR are required.
