October 12, 2023

Project No. CA-GLD-22572533 Rev.2

UPDATED ADDENDUM TO THE SCOPED ENVIRONMENTAL IMPACT ASSESSMENT AND TREE CONSERVATION REPORT FOR THE PROPOSED DEVELOPMENT OF 405 HUNTMAR DRIVE, OTTAWA, ON

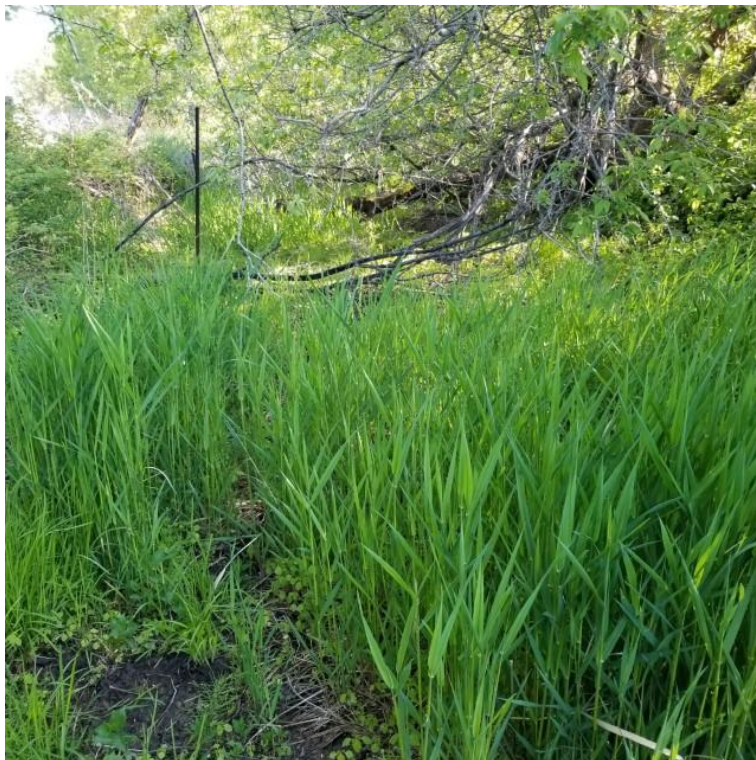
The mapped feature was evident during the April 13 field survey through the presence of standing water, however; the feature was seen to be dry during the May 24 and June 19 field survey, indicating it is ephemeral and likely the result of snow melt accumulating in this area (Attachment A; Photos 1 and 2). The feature was seen to overlap the Site in the form of a small swale running parallel to and within the hedgerow (see Figure 1) then extending north of the Site and eventually connecting to the roadside ditch along Huntmar Drive. An assessment of the feature, where present on the Site, was completed in accordance with the Guidelines (TRCA and CVC 2014), the results of which are presented in Table 1. No fish sampling was completed as the feature was dry during the appropriate window for sampling.

Based on WSP’s analysis, the feature does not provide fish habitat as no flows or direct connection to any surface water features providing fish habitat were observed.

Photo 2: Headwater Drainage Feature May 2023

Based on the results of the additional field surveys and analysis presented in this letter, the feature is not fish habitat, but it is a headwater drainage feature. As noted in Section 3.1, the management recommendation per the Guidelines is to maintain the terrestrial linkage function of this feature, however; this feature is the southern tip of the headwater drainage feature and so offers no terrestrial connection between two natural areas. The proposed development will remove the on-Site portion of this feature (Map 2), but as noted, it does not perform any linkage function so no impacts to the identified functions of this feature are anticipated. No further consideration of this feature is warranted. No updates to the original conclusions of the Scoped EIS and TCR are required.

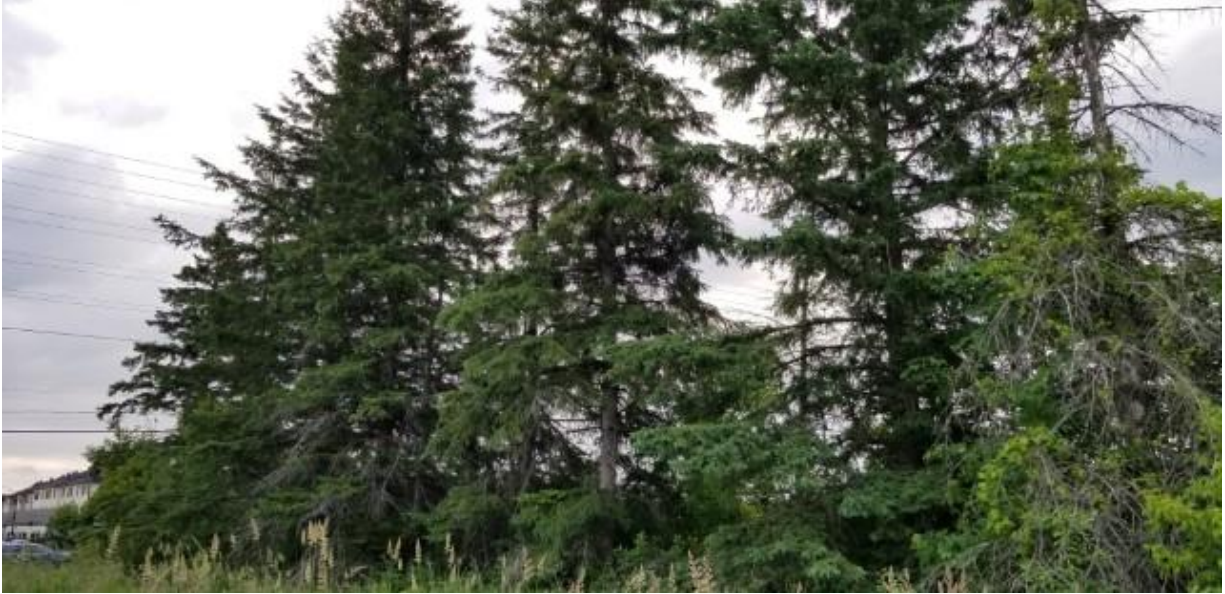
Tree Grouping #	Species	DBH (cm)	Location	Condition / Notes	Recommendation
1	White spruce (<i>Picea alba</i>) 100%	15-32	On-site	Good, planted	Remove
2	Poplar (<i>Populus</i> sp.) 100%	10-32	On-site	Good, appear to be hybrids	Remove
3*	Manitoba maple (<i>Acer negundo</i>) 60% Black cherry (<i>Prunus serotina</i>) 20% Apple (<i>Malus pumila</i>) 20%	12-58 26-31 18-38	On-site	Poor to fair, mixed with buckthorn thicket and containing dead standing ash	Remove western portion. Retain portions that overlaps with protected CRZs and areas outside the area of disturbance. See Table 2; Map 2; Map 2a

Photo 3: Tree Grouping 1

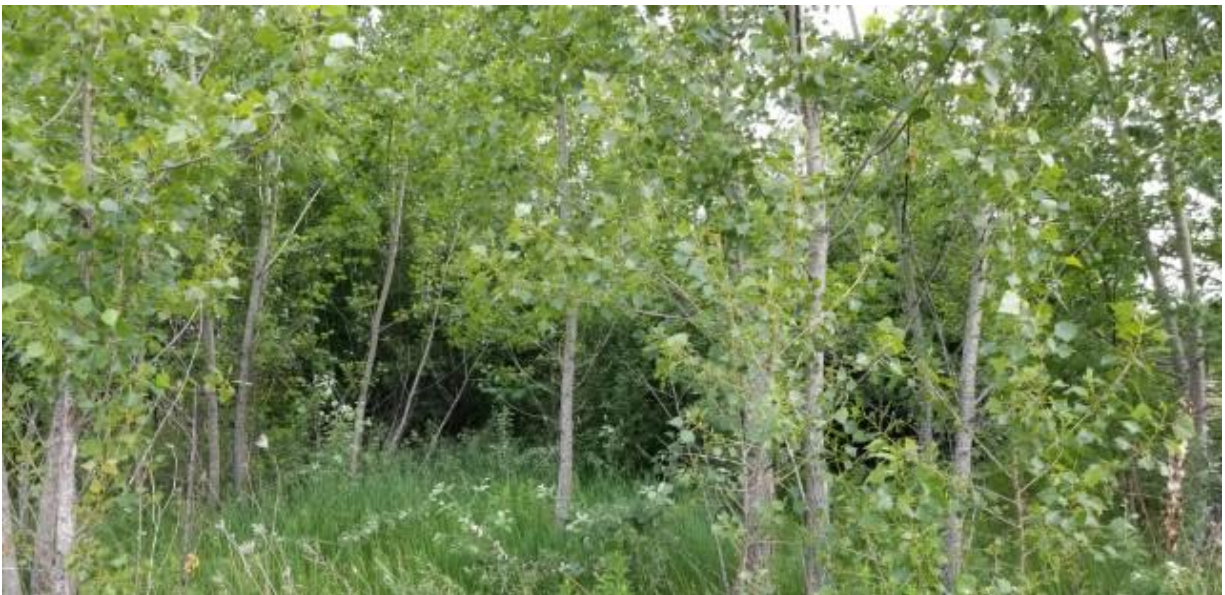
Photo 4: Tree Grouping 2

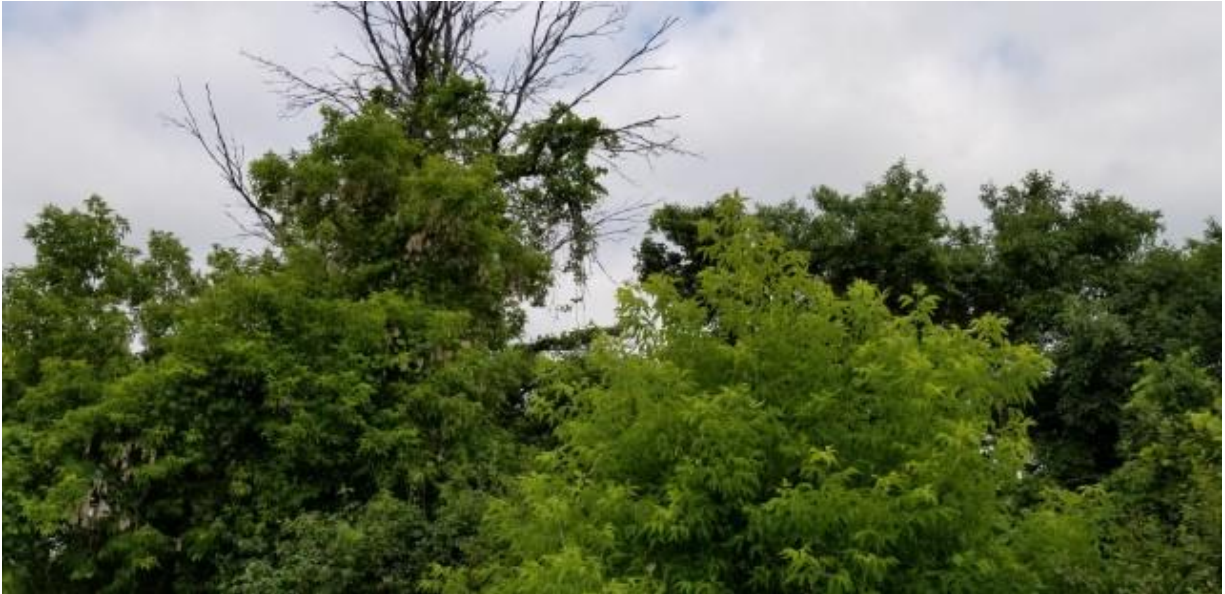
* Note that additional portions of the northern hedgerow on the Site, visible on aerial imagery west of Tree Grouping 3, consists of thicket and standing dead trees only.

Photo 5: Tree Grouping 3

Section 4.8.2 of the Official Plan provides strong direction to maintain the urban forest canopy and its ecosystem services during intensification noting priority should be given to the retention and protection of large, healthy trees over replacement plantings and compensation. Due a City of Ottawa requirement, a watermain was needed to link Upper Canada Street to Huntmar Drive. It was required to have the watermain pass along the northern property line, away from the truck court where there was a concern of the additional loading on the watermain, which is the cause of removal of much of Tree Grouping 3.

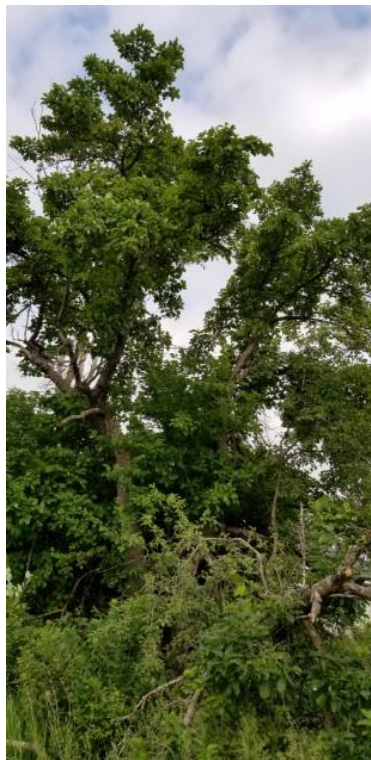
Tree #	Species	DBH (cm)	Location / Ownership	Condition / Notes	Recommendation
1	Apple (<i>Malus pumila</i>)	36, 42	Adjacent (private)	Fair, two-stemmed	Retain; CRZ does not overlap Site
2	White elm (<i>Ulmus americana</i>)	47	Shared (on the property line)	Good, two-stemmed	Retain; Fence entire CRZ
3	Manitoba maple (<i>Acer negundo</i>)	68	On-Site (proponent)	Poor, half dead, covered in dense wild grape (<i>Vitis riparia</i>) vines	Remove
4	Manitoba Maple	18-32	Shared (on the property line)	Fair, multi-stemmed, gnarly	Retain; Fence entire CRZ
5	Hawthorn (<i>Crataegus</i> sp.)	10-11	Adjacent (private)	Good, multi-stemmed	Retain; CRZ does not overlap Site
6	Manitoba Maple	82	Shared (on the property line)	Good	Retain; Fence entire CRZ
7	Hawthorn	12-13	Shared (on the property line)	Good, two-stemmed	Retain; Fence entire CRZ

Photo 6: Tree 1

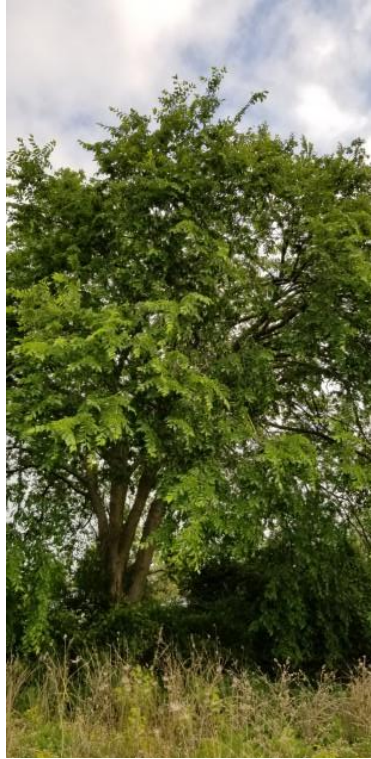
Photo 7: Tree 2

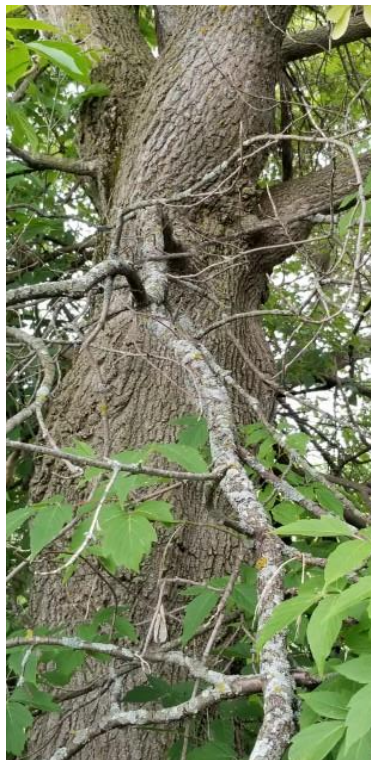
Photo 8: Tree 3
