# Heritage Impact Statement & Stage I Conservation Plan

211-231 Bank Street & 178 Nepean Street

Commonwealth Historic Resource Management  
December 2022

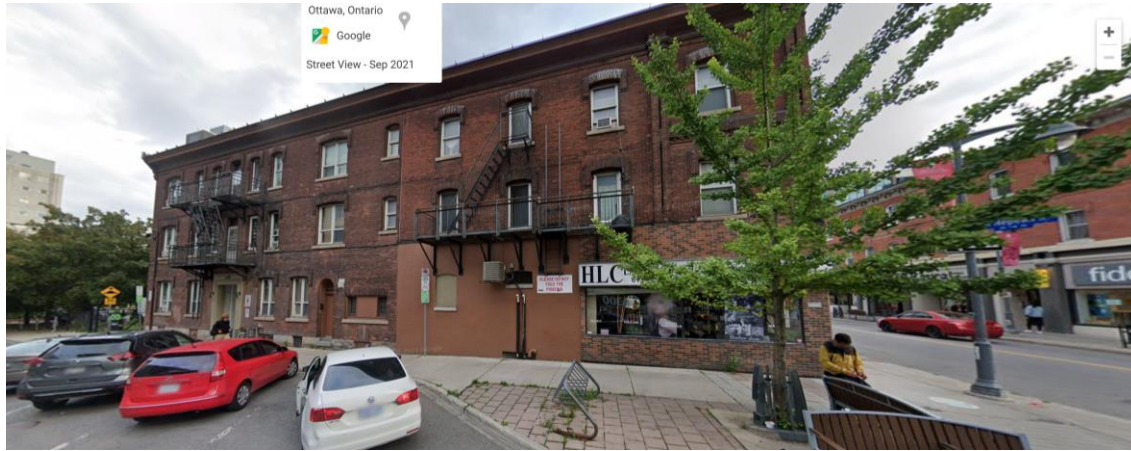
Figure 11: A view of the north elevation of 211 Bank/ 178 Nepean. The slightly different tone of brick delineates the two construction periods.

**178 Nepean 211-113 Bank Street** is a three-storey mixed use building prominently positioned at the corner of Nepean and Bank. Constructed in two stages with the Bank street frontage between 1888- 1901 and a major residential addition to the Nepean address circa 1922. The Edwardian style carries through the three-storey original and addition in a Rideau red-brick with an elaborate metal cornice, decorative

The building's footprint and upper storeys have not changed since the Nepean addition c.1922. The upper floors continue as residential apartments. The building appears to be in fair to good condition with some repointing and renewal of windows. The ground floor commercial storefronts have been completely altered with a variegated brick infill and removal of glazed transoms, ground floor cornice and shop front on both the Nepean and Bank Street frontages.

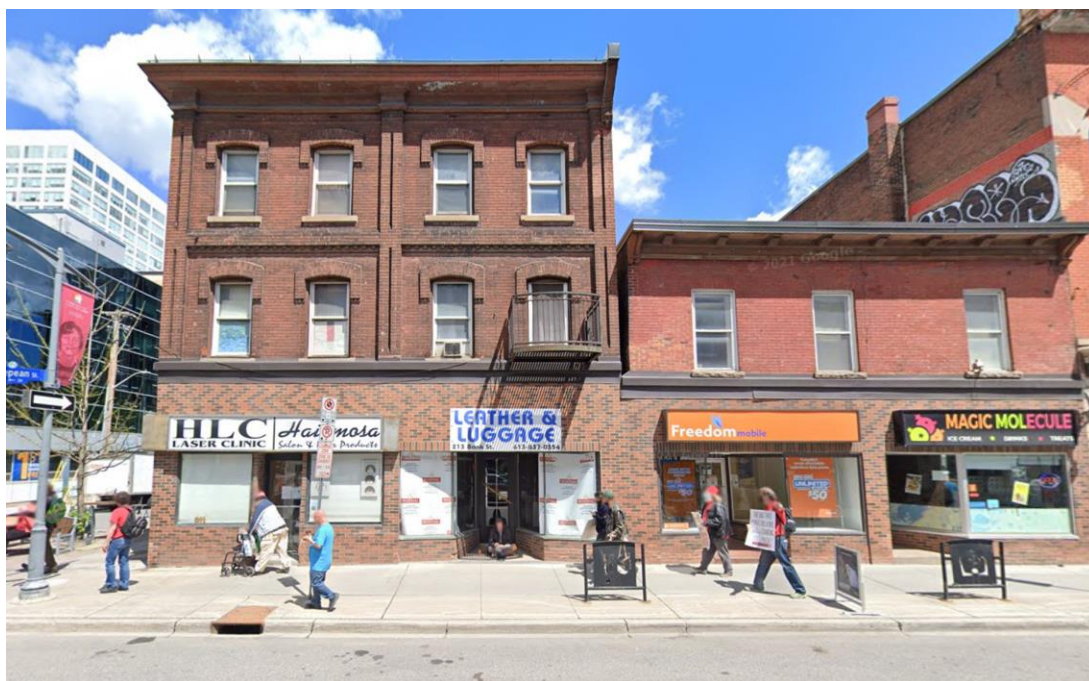
Figure 12: A view of 211 Bank Street with the two-storey unit.

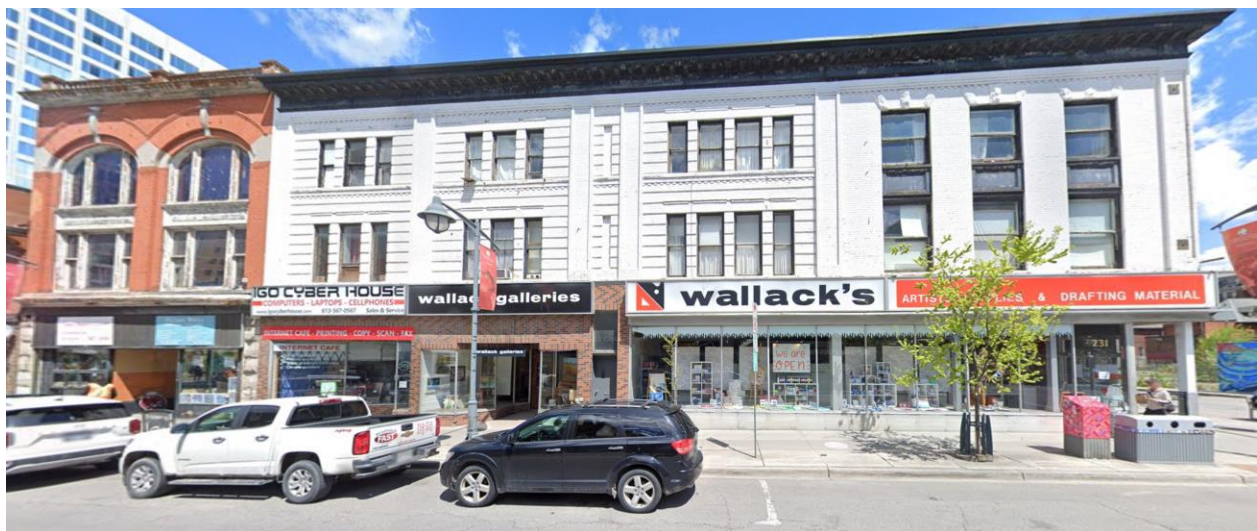
Figure 14: The painted brick commercial range 223-231 occupies the southern half of the block with the Wallacks Art Supply wrapping around the corner and extending along Lisgar Street.

The Wallack Building is a three-storey brick commercial at ground floor and residential on the floors above. The Bank street frontage is divided into three distinct sections suggesting they were built at various times. The upper floors have a rusticated decorative brick in a strong horizontal expression, vertical segmented window pattern. The brick has been painted and architectural features such as the keystones and other decorative features are camouflaged. The ground floor commercial storefront has undergone extensive alterations. Along Lisgar the ground floor windows have been infilled. The upper floors of the building are residential that extends to the rear of the lot with a covered passageway giving access to an interior courtyard.

The building's footprint suggests different construction dates, but since 1912 it has not been altered. The brick has been painted and the three storefronts have been infilled with transoms removed and the recessed entrances relocated. Figure 10 documents the earlier storefronts along the street.

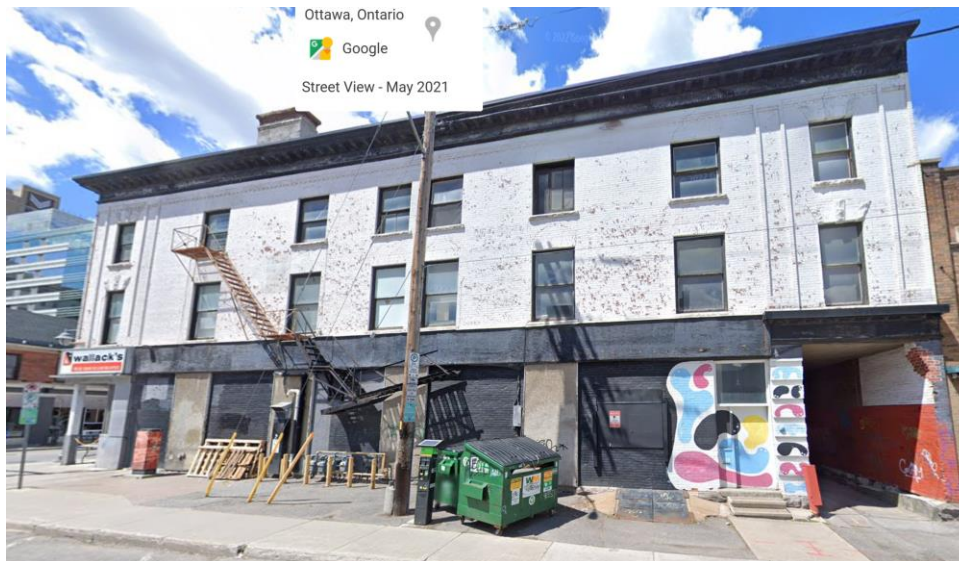
Figure 15: The south elevation of the 231 Bank Street. The ground floor windows have been removed and panels added.

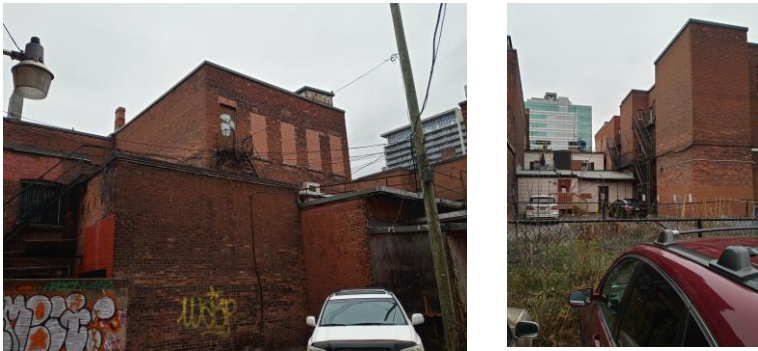
Figure 16: Views of the east facades (rear).

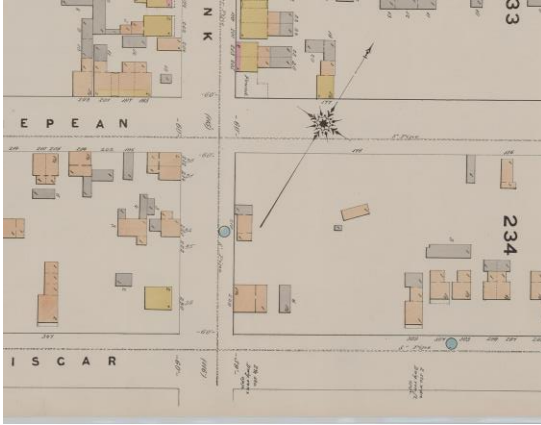
Figure 14: 1878 Fire Insurance Plan with Block 234 on the right. The plan illustrates the early development along Bank Street. In the block 234 bound by Nepean and Lisgar Streets none of the properties had been constructed. Source: Collections Canada

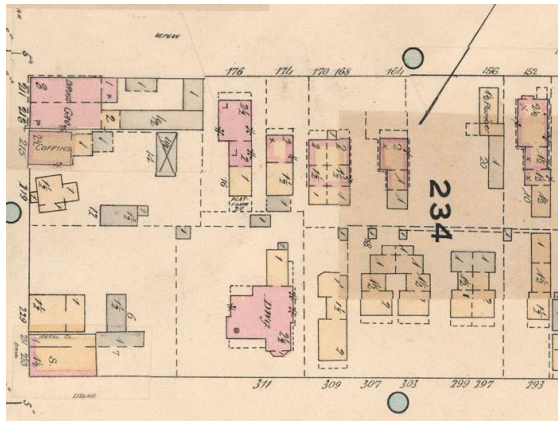
Figure 15: Fire Insurance Plan 1888 revised 1901 illustrates the properties at 211 (druggist) 213 (Grocer) as brick and 3 storeys in height with a collection of 1 and 1.5 storey wood structures occupying the back half of the site. Next to it is a 2.5 storey frame with brick veneer at 215-217 occupied by a coffin maker. The buildings on the southern half of the block appear as 1.5 storey wood and brick veneer with vacant street frontage.

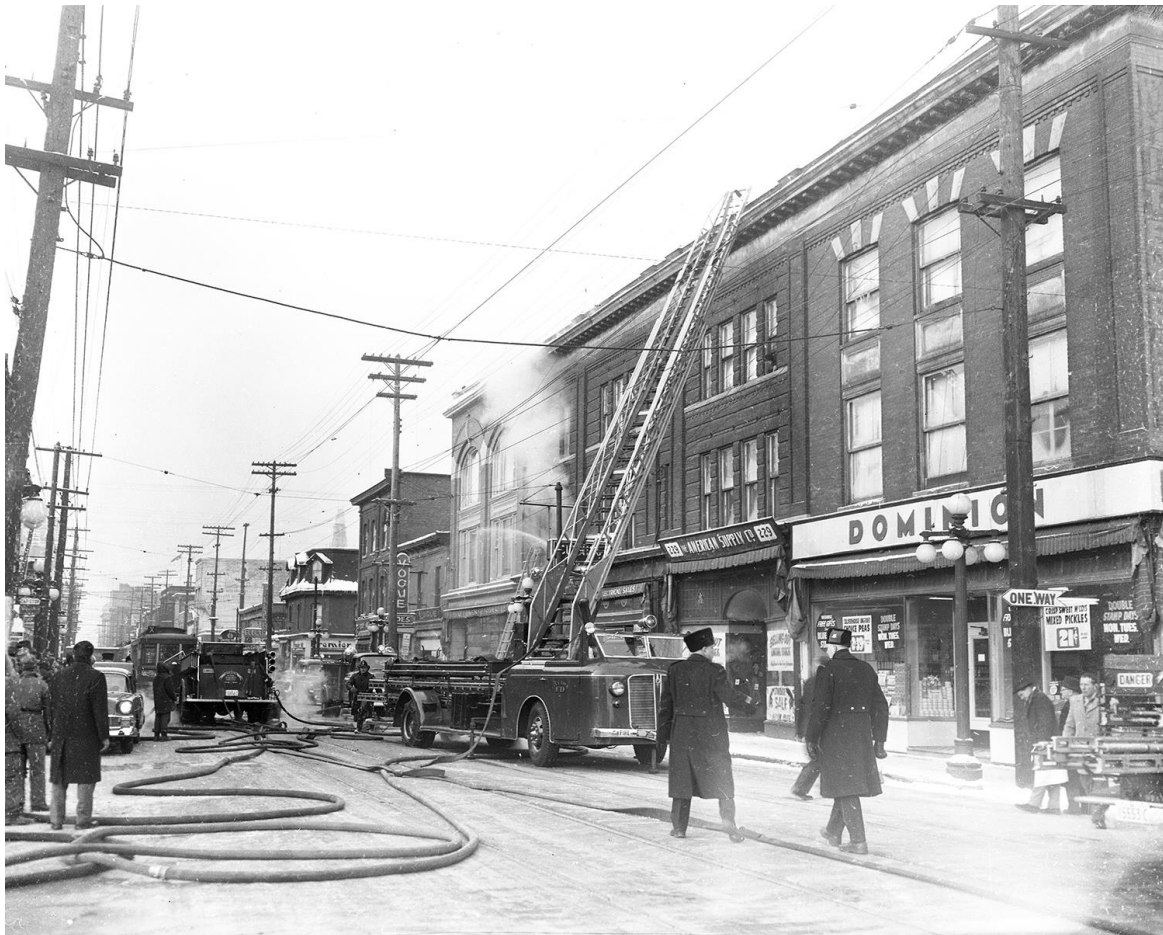
Figure 17: A view of the 211-231 block with fire trucks in the street. Note the unpainted facades with the decorative keystone with spandrels between the 2<sup>nd</sup> and 3<sup>rd</sup> floors. The photo provides a record of the earlier retail storefronts.

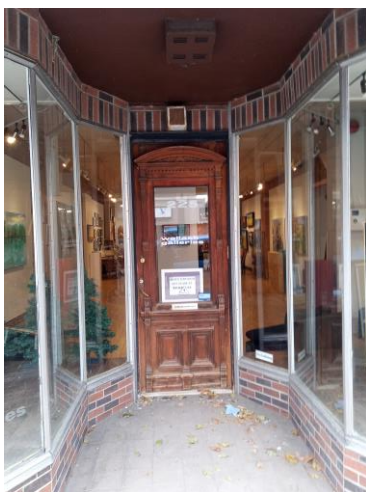
Figure 18: Although the shopfronts have been dramatically altered elements such as the recessed shopfront at 227 Bank Street are still evident. The leaded transom and vaulted arch have been covered over. Based on the 1950 photo it would appear that the three shopfronts at 215, 217 and 219 were similar with recessed entrances and decorative transoms.

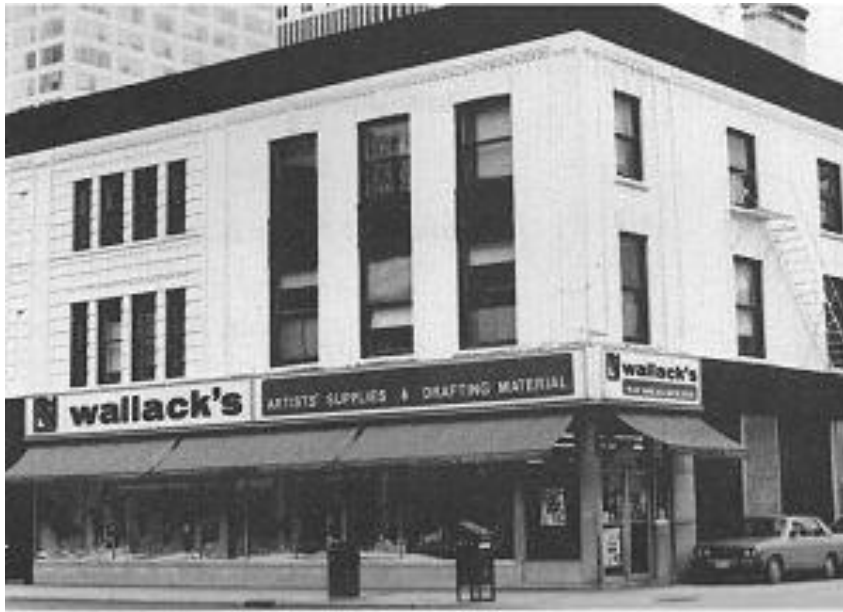
*Figure 19: A view of 231 with the retail entrance shifted from its original central location to the corner and the upper façade painted white.*

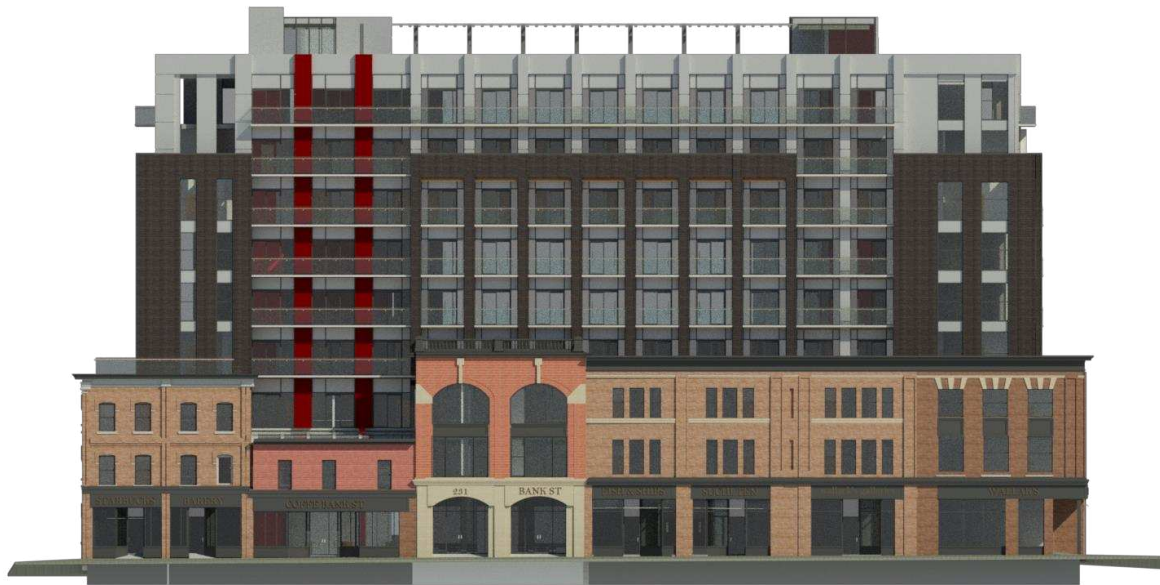
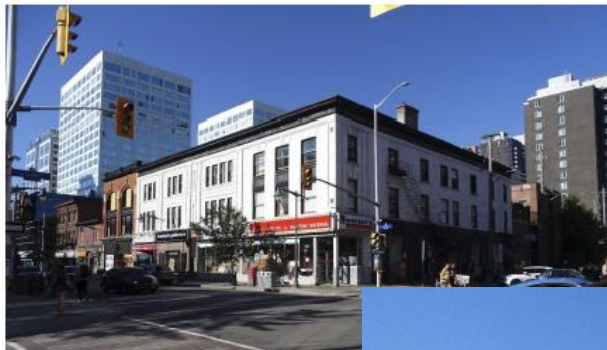
Figure 18 & 19 : Bank Street view looking East and perspective views of the intersection of Bank Street and Lisgar with the proposed 9-storey development. Woodman Architecture December 2022.

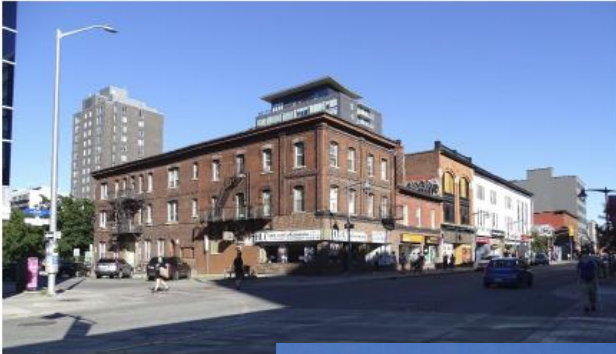
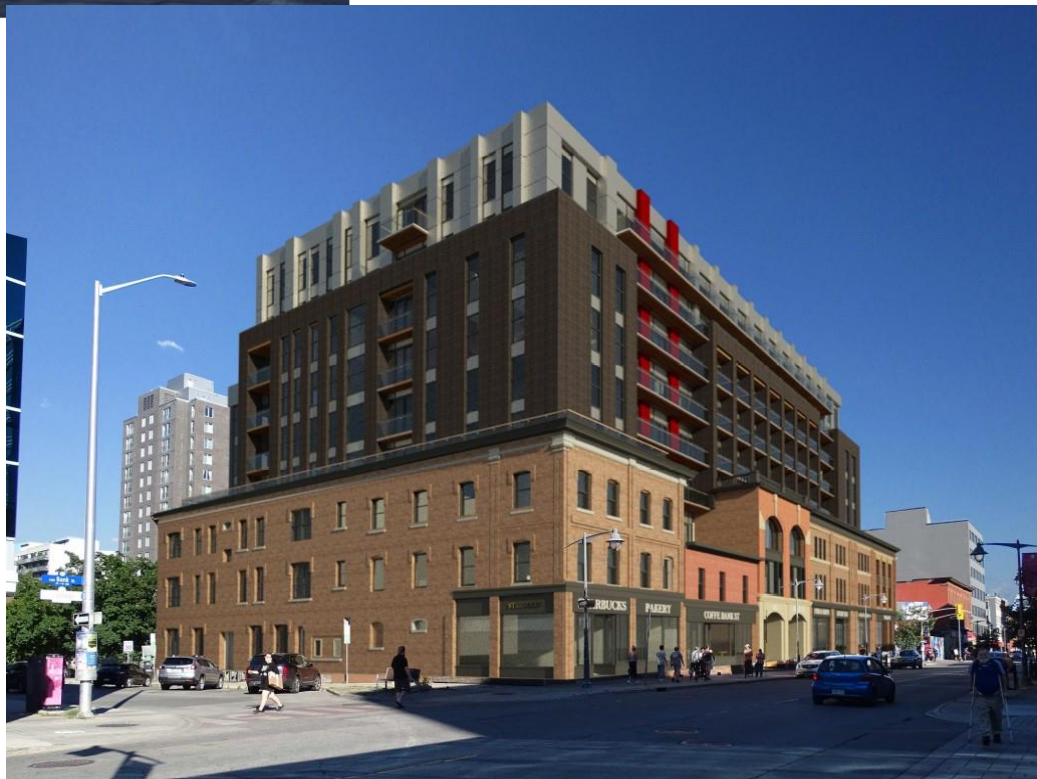
Figure 20: View of the development site looking south showing the existing buildings and the new 9-storey development. Source: Woodman Architecture 2022

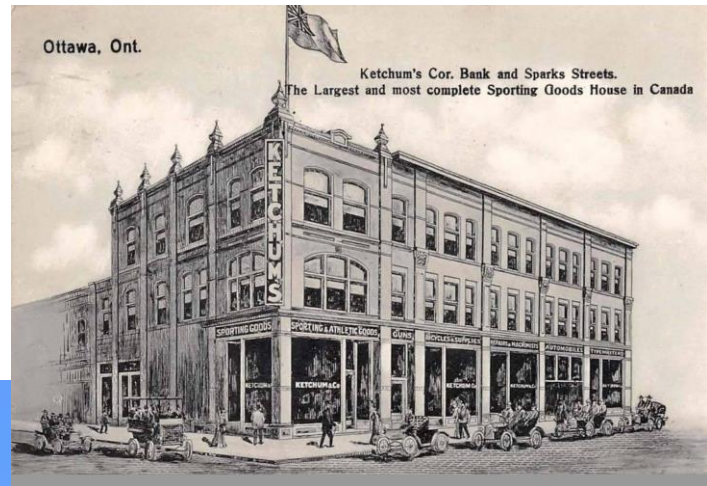
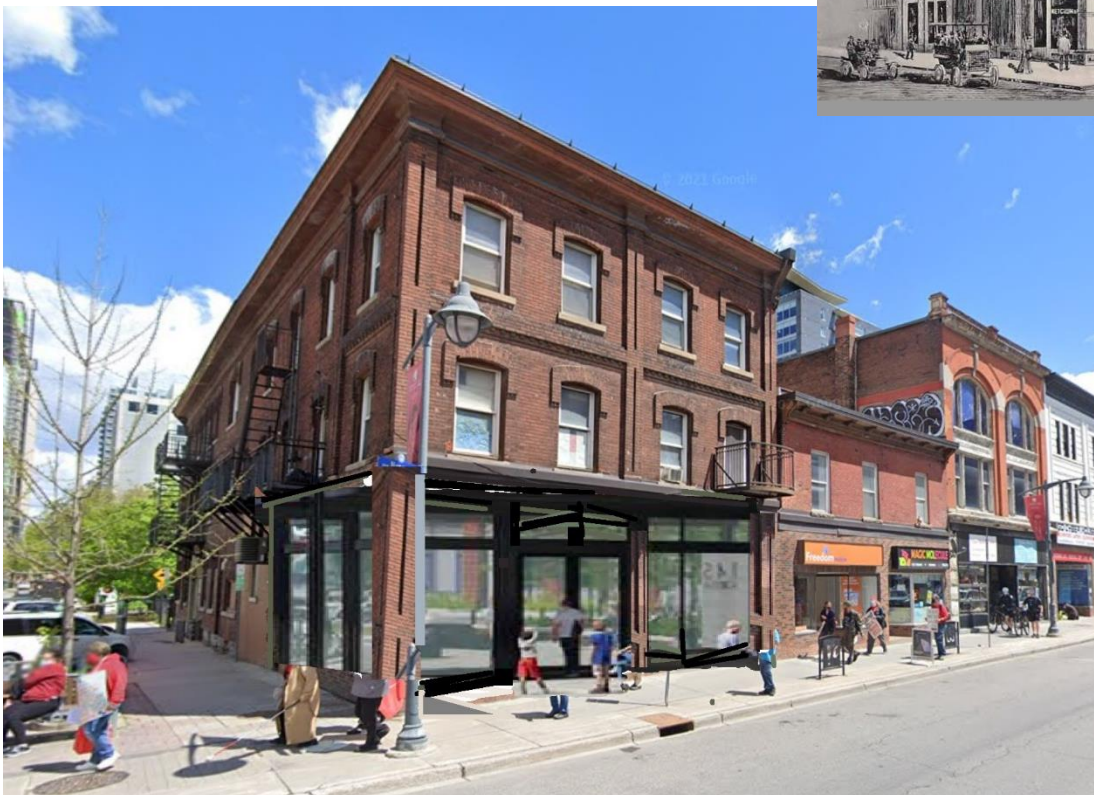
## 211-213 Bank Street

This sketch of Ketchum's Bank at the corner of Bank & Sparks Streets provides an excellent example to model the replacement shop front wrapping around the corner. Commonwealth.

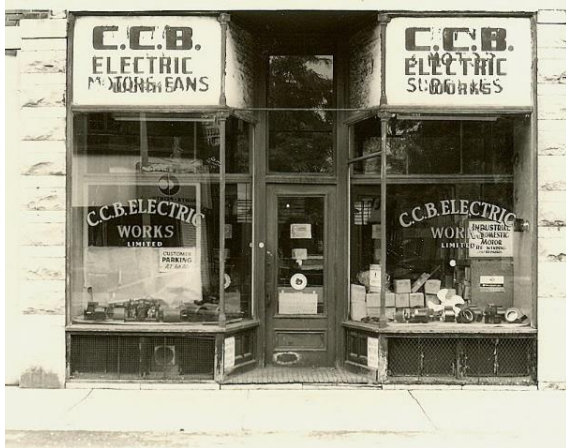
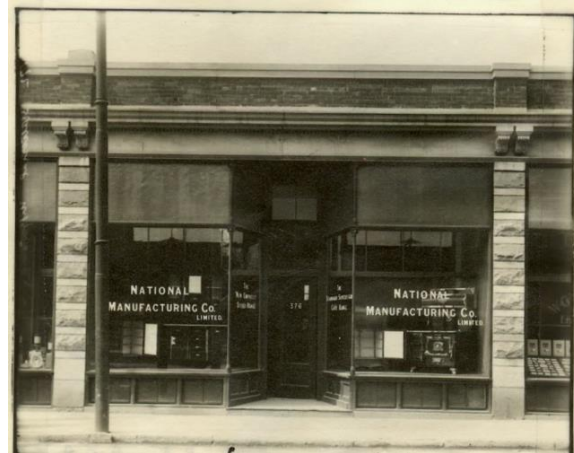
*Figure 23: Storefronts along Bank Street dating from the turn of the century are in keeping with the modest 2-storey building at 213-215 Bank Street.*

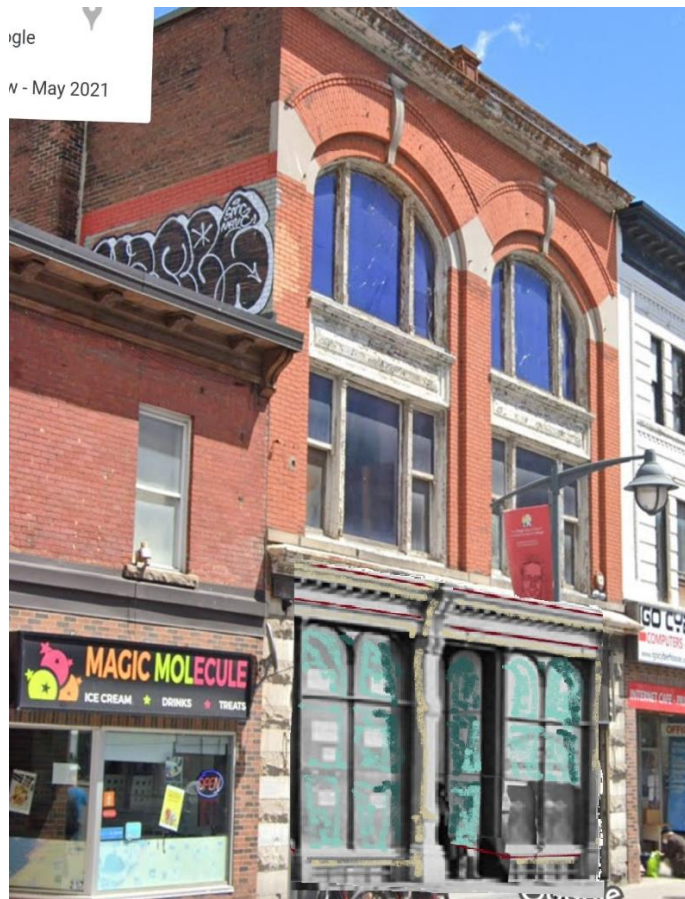
## 219 BANK STREET

Figure 23: Examples of comparable historic Ottawa shopfronts used as models to guide restoration of 119 Bank Street.

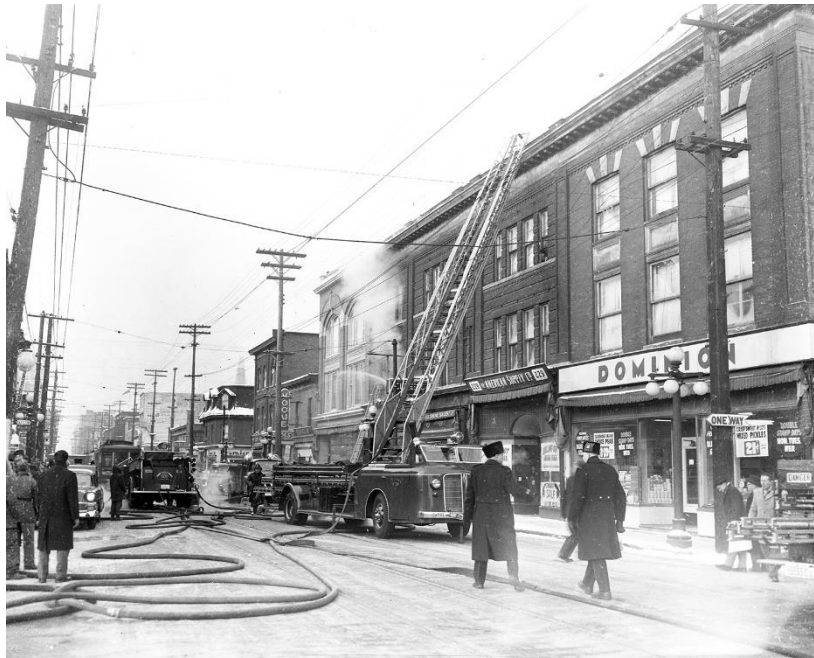
Figure 24: This c1950 street view looking north with the firetrucks in the street provides guidance for the reinterpretation of shopfronts. Source City of Ottawa Archives. The view below has been photoshopped and the shopfronts interpreted.

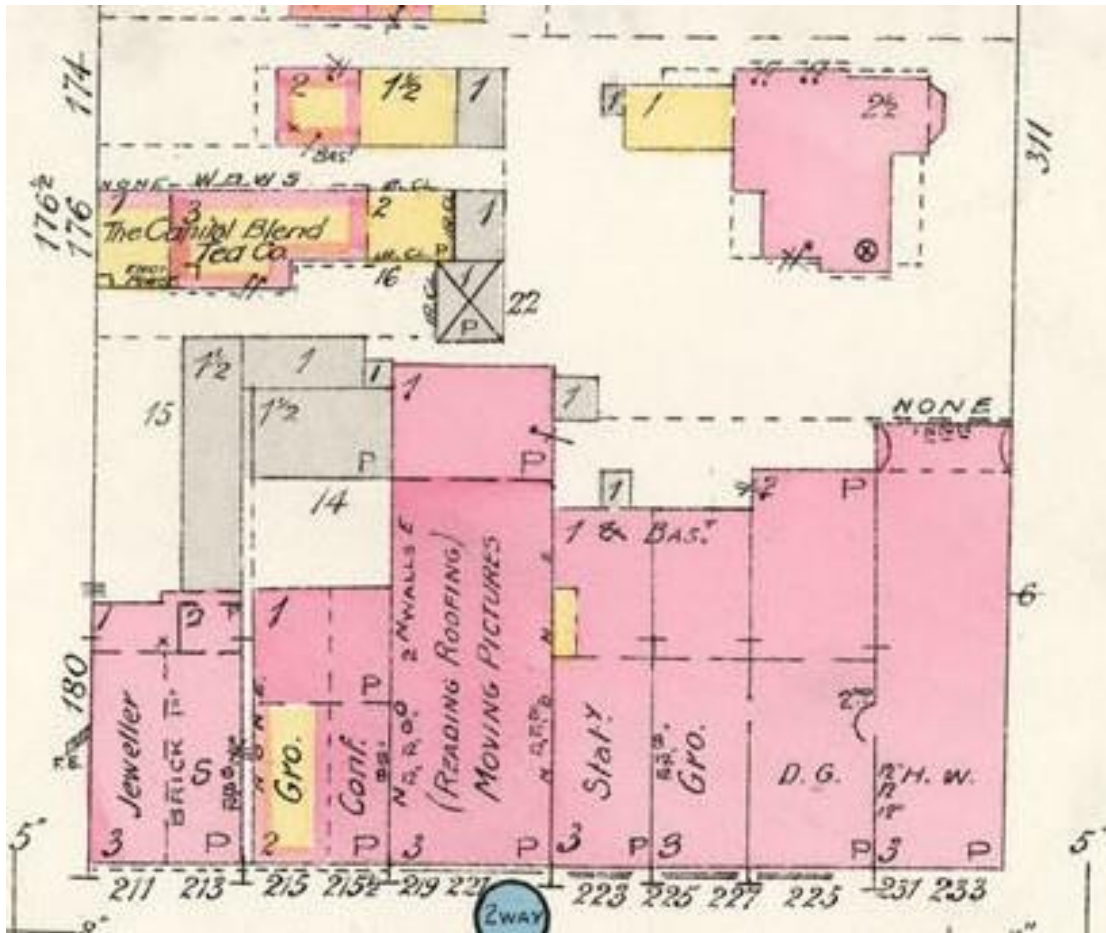
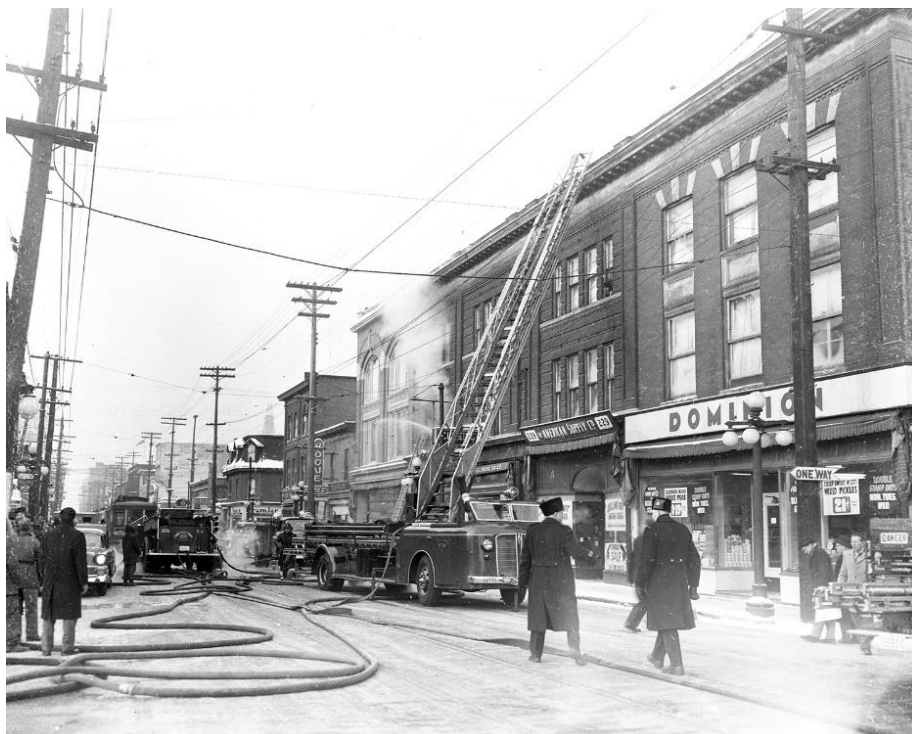
A section of the 1901, revised 1912, Fire Insurance Map along Bank Street between Nepean and Lisgar Streets documents the ground floor occupants and the division of frontages onto Bank Street.

A c.1950 photograph of the street with fire trucks provides a good reference for the shopfronts on the south end of the block.

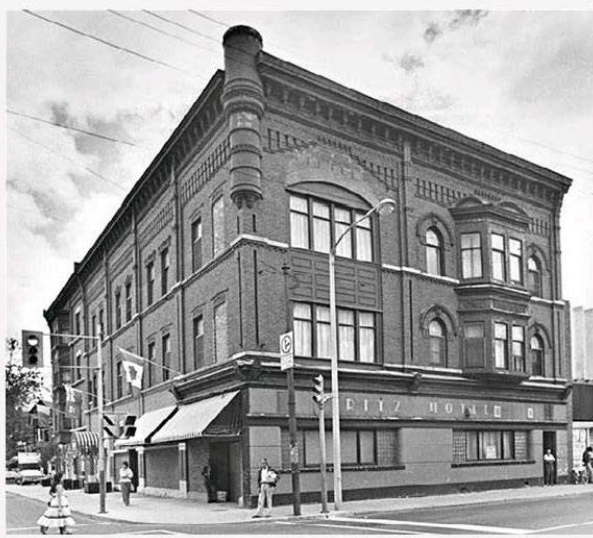
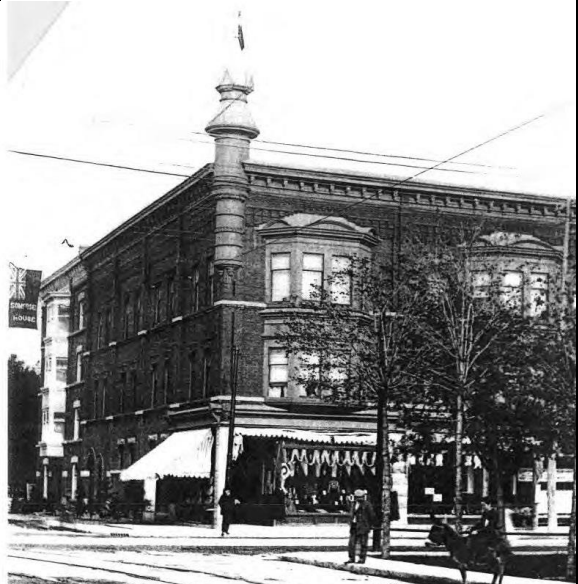
Comparative example of buildings positioned at the intersection with the retail shopfront wrapping around the corner.
