REVISED HERITAGE IMPACT ASSESSMENT & CONSERVATION PLAN FOR 211-231 BANK

Applications D02-02-22-0127 / D07-12-22-0188 and plan number 18910

Revision 2: October 2024

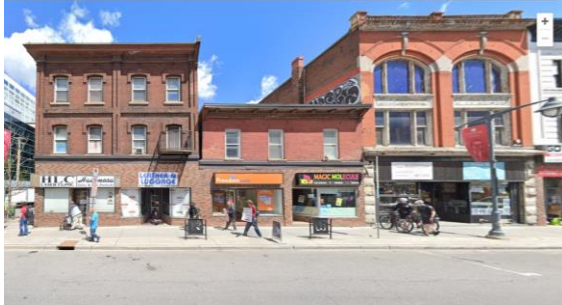
Figure 13: East elevation of buildings 211, 215, 219, 223 and 231 Bank Street.

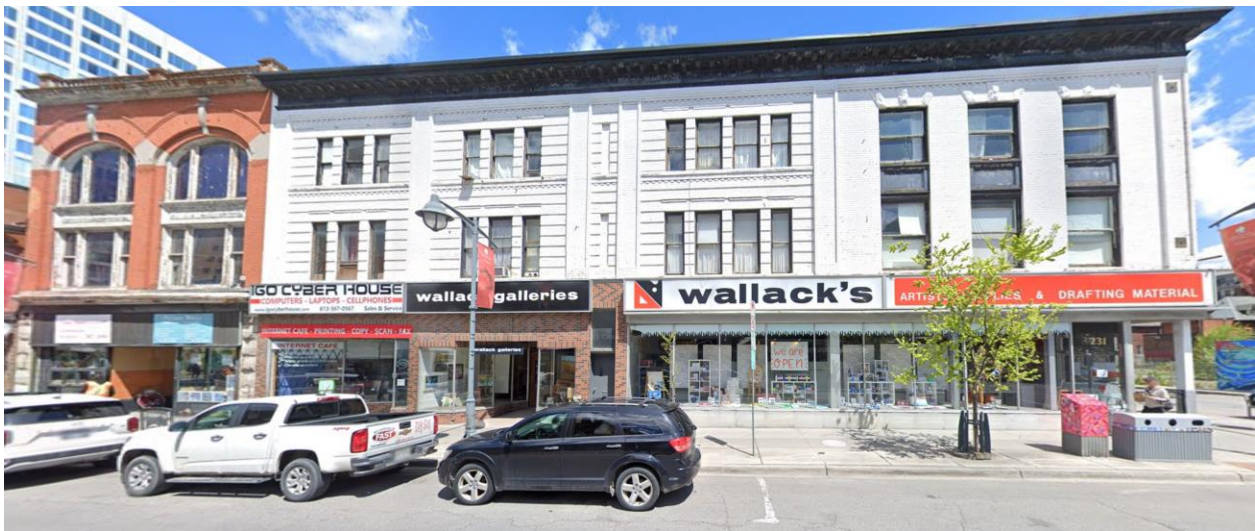
Figure 14: The painted brick commercial range 223-231 occupies the southern half of the block with the Wallacks Art Supply wrapping around the corner and extending along Lisgar Street.

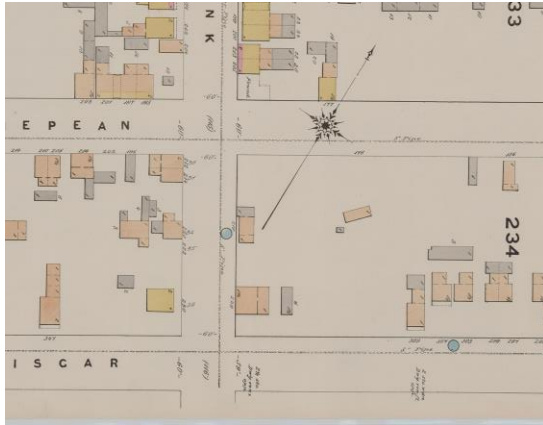
Figure 14: 1878 Fire Insurance Plan with Block 234 on the right. The plan illustrates the early development along Bank Street. In the block 234 bound by Nepean and Lisgar Streets, none of the properties had been constructed. Source: Collections Canada

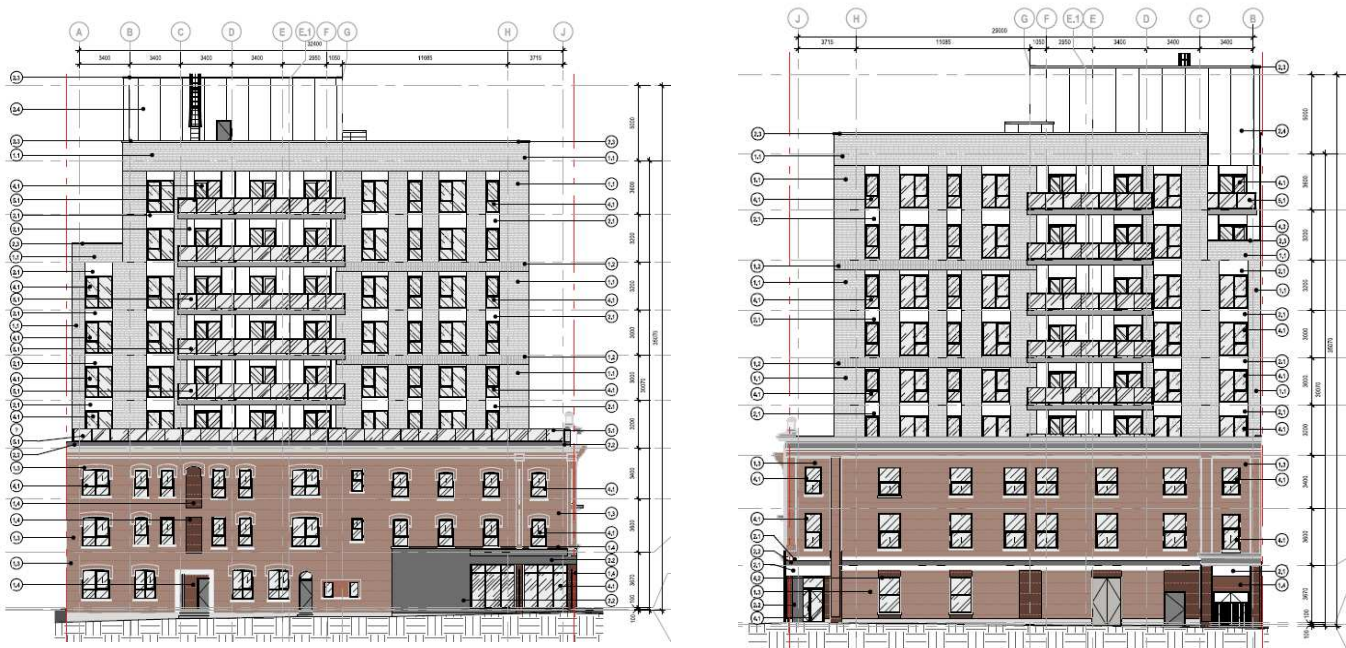
Figures 20, 21, 22, & 23: Nepean Street, Lisgar Street, Bank Street, and east (rear) elevations with the proposed 9-storey development.

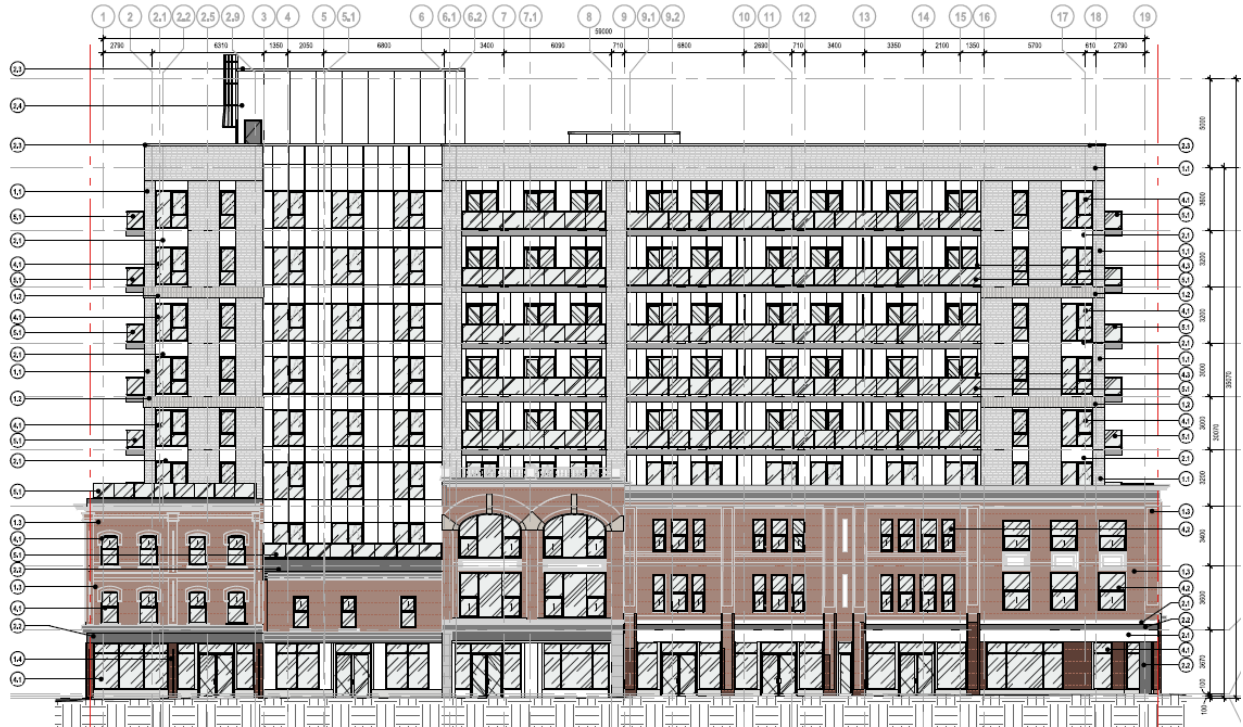
Figure 22: West Elevation and Figure 24 is the east elevation.

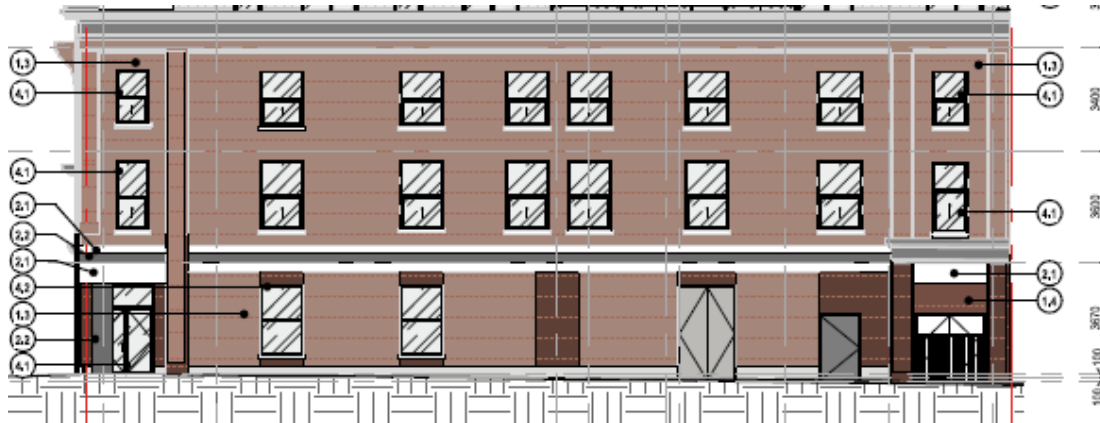
- Is the blue highlighted area on the images below a sign band? If so, consider reducing the height. The Lisgar façade has what appears to be plywood in the location. Please remove and repair any damaged brick below. Additional drawings/updates:

Response: *The horizontal panel along Lisgar façade has been part of the building since it operated as a grocery store (Dominion). The plan is to carry out some removals and determine if it can be removed without extensive brick repairs. It appears to be plywood panels fastened directly onto the brick. If it can be removed and the brick repaired, that is our 1st choice. If there is too much damage, we will consider replacing the panel with a narrower horizontal fascia-board, as shown on the revised drawing.*

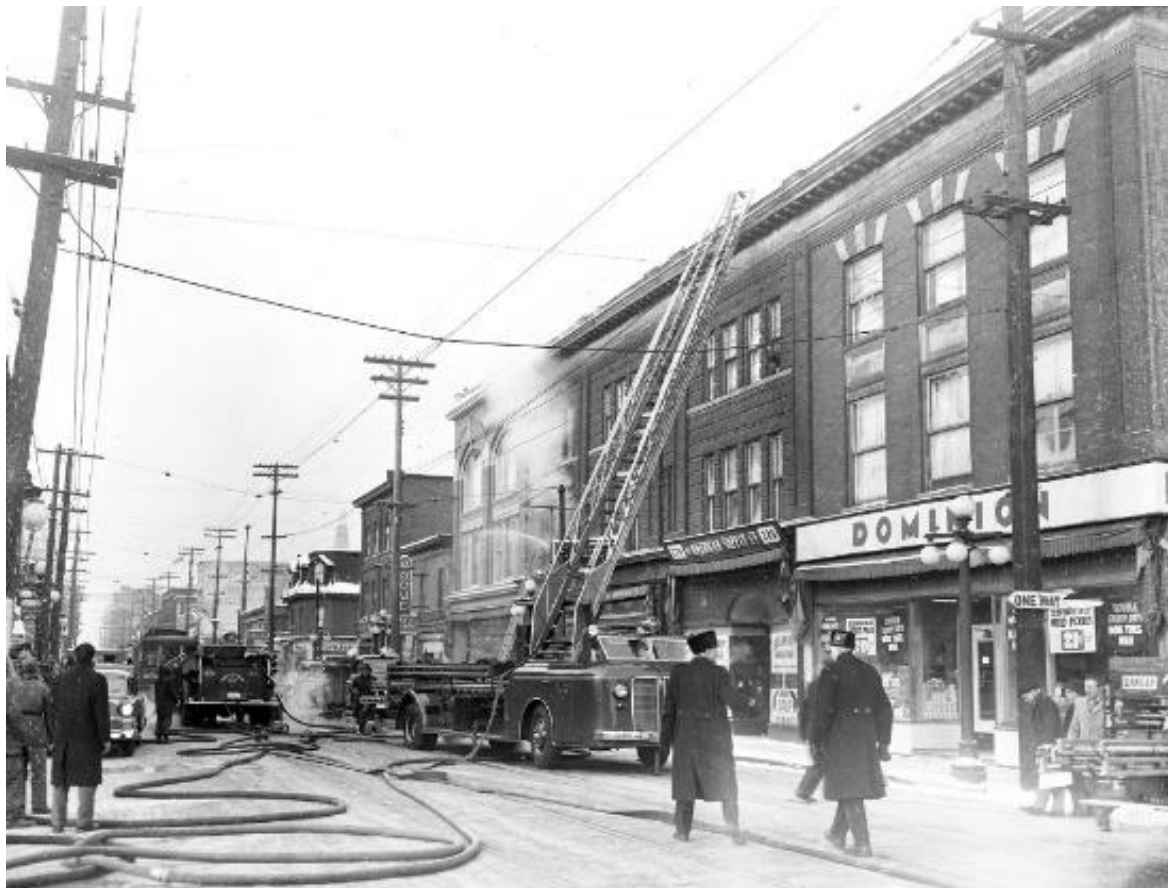
Figure 1: Bank Street view, c.1950. Source: City of Ottawa Archive.

Over time, the storefronts along Bank Street have been altered with only fragments of original features remaining, whereas upper floors have maintained much of their original fabric. There are only a few period photos documenting the appearance of the buildings. The most informative view of the street is taken from the corner of Lisgar looking north. It has been estimated that the photo dates circa 1950 based on the fire truck with smoke billing out from what looks like the 219 Bank Street (figure 1.) In the foreground, the Wallack's Building shopfronts are intact, and the elegant polychromatic upper facade has not yet been painted. Since this photo, the street front has undergone extensive alterations and neglect. The Wallack's entrance has shifted to the corner and the Dominion Grocery Store signboard, which appears to wrap around the corner along Lisgar is still in place.

Features such as the Dominion Grocer signboard that wraps around the corner onto Lisgar are being interpreted. See Figure 1 The flush fascia sign with the awning below is being reinterpreted with flush signage and a fixed awning treatment.

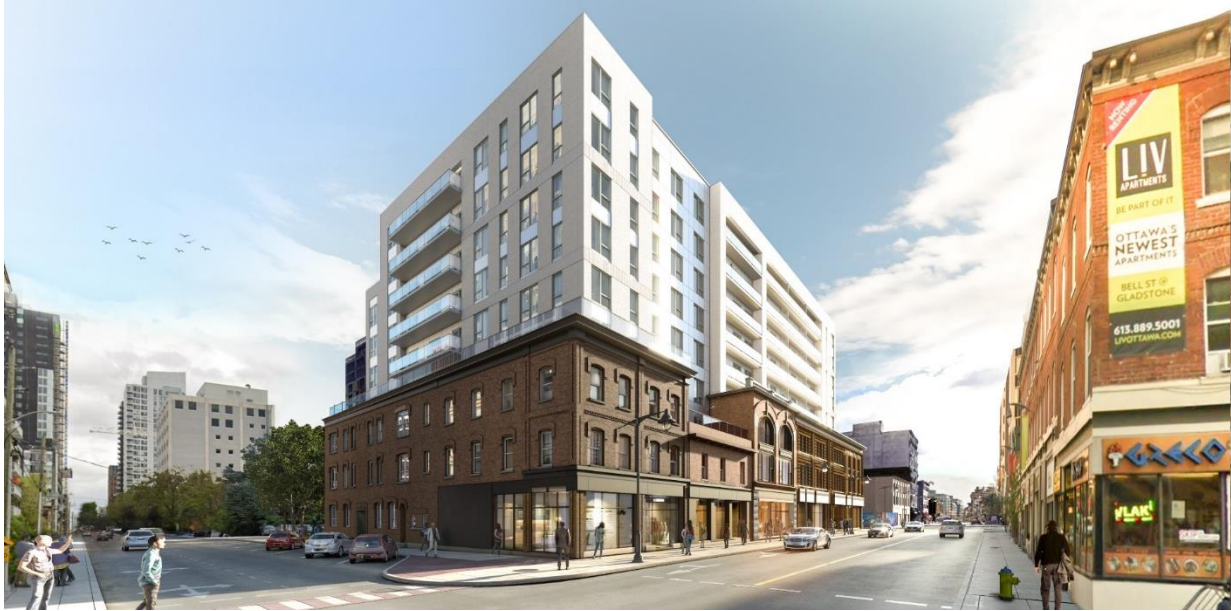
Figure 3: View looking south at the corner of Nepean and Bank Street, with the nine-storey development setback and the existing buildings standing proud. Source: Neuf Architects, August 2024.

The proposed 9-storey superstructure is distinguishable, and of sympathetic contemporary design. The existing buildings serve as a podium, with the new construction setback from the existing buildings by 3m. A palette of materials, and finishes that are neutral, light-coloured help focus on the heritage buildings. Decorative cornices, horizontal and vertical articulations, opening sizes, proportions, and datum lines have taken their cues from the historic buildings. The design respects and reflects the current urban grain and scale, visual relationships, and materials of the neighbouring buildings across the street on the west side of Bank Street. Below is a discussion of each of the existing buildings, identifying their individual character defining features and the work required to rehabilitate each building successfully.

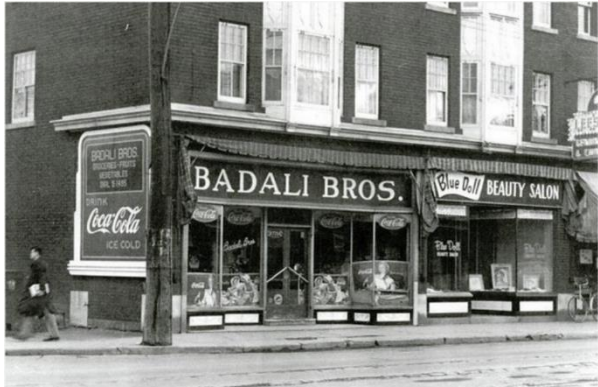
This Bank Street corner building provides a good model comparative example with the large fascia signage and the awning set below the metal cornice, the double door entrances with the recessed flared display windows and brightly accented knee wall. The cornice carries around the corner, with a large signage taking advantage of the corner location.

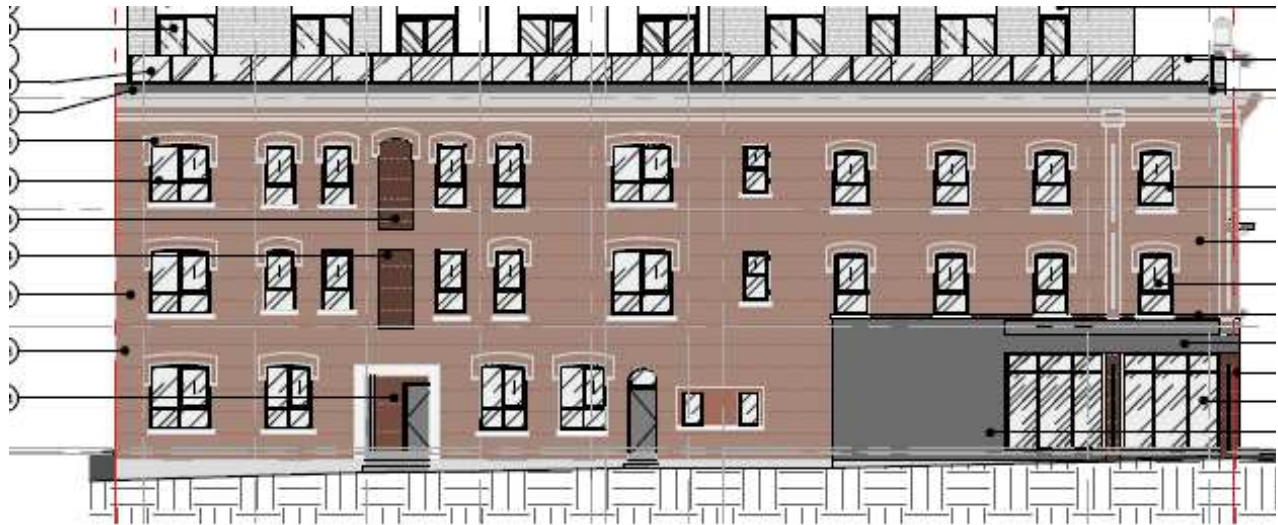
Nepean Street Removals. Source: Art Engineering, August 2024

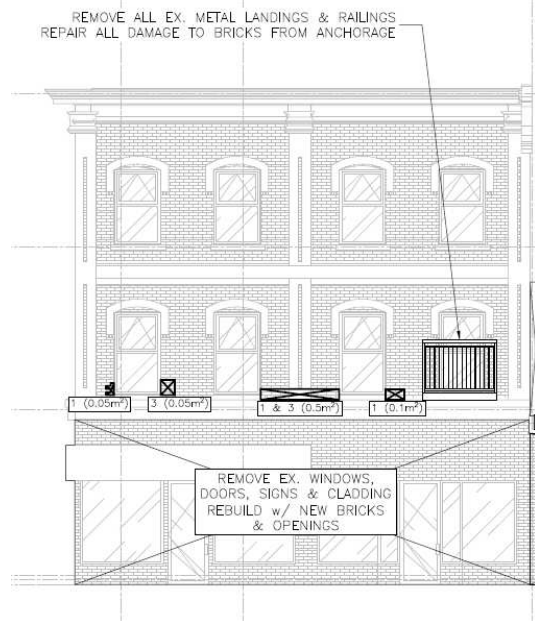
Bank Street removals. Source: Art Engineering,

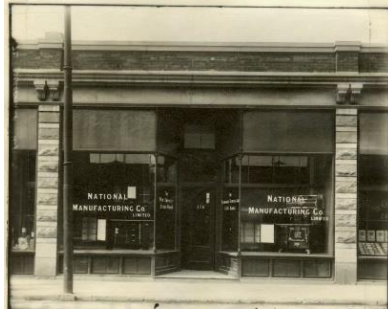
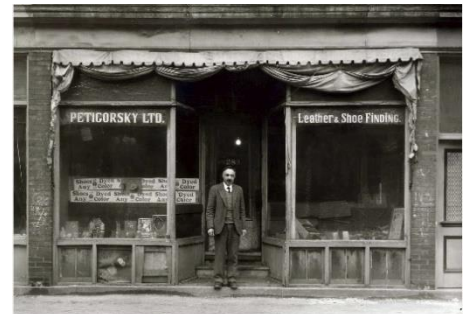
Three Storefronts along Bank Street dating from the turn of the century are models for the modest 2-storey building at 213-215 Bank Street. Note the flared recessed entrances, single entrance door, knee wall, and masonry piers framing the retail units.

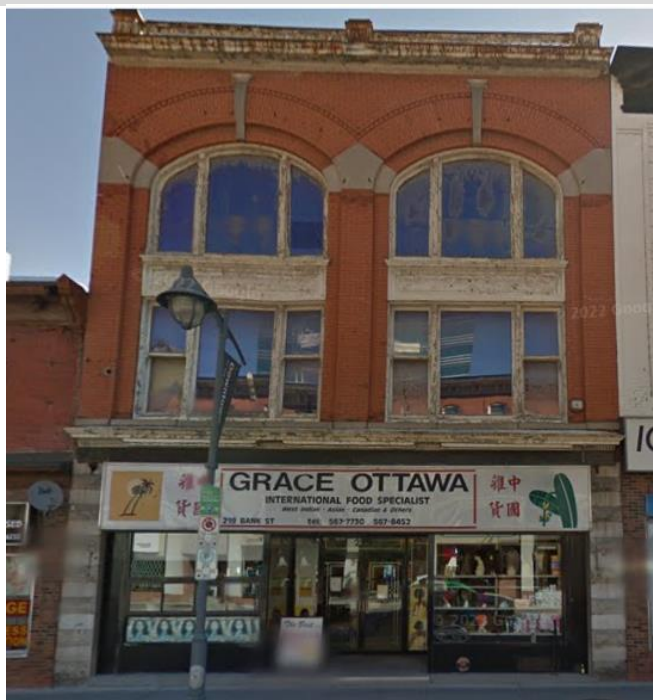
- *Cornice and balustrade.*
- *Large two storey elliptical windows with metal spandrels,*
- *Distinct glazing pattern*
- *Red brick with limestone capitals and decorative quoins.*
- *Upper floor paint scheme that complements the limestone*
- *Shopfront Recessed central entrance framed by two-tone stone pillars concealed columns with a stepped foyer.*
- *Limestone header below second floor windows*
- *Shopfront cornice with dentelles above the fascia board are in deteriorated condition, but salvage remnants will service as model.*
