HERITAGE IMPACT ASSESSMENT & STAGE I CONSERVATION PLAN

211-231 BANK STREET & 178 NEPEAN STREET

Commonwealth Historic Resource Management
Revised August 2023

Applications D02-02-22-0127 / D07-12-22-0188 and plan number 18910

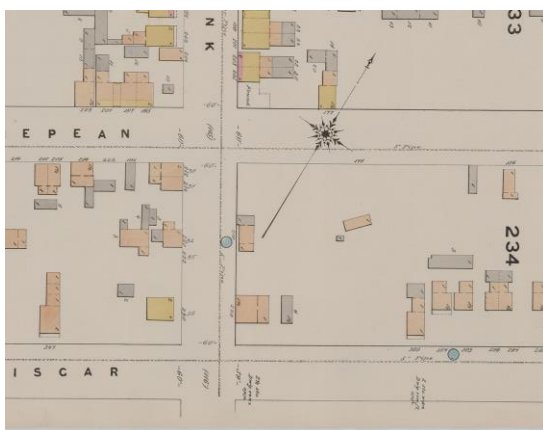
Figure 14: 1878 Fire Insurance Plan with Block 234 on the right. The plan illustrates the early development along Bank Street. In the block 234 bound by Nepean and Lisgar Streets none of the properties had been constructed. Source: Collections Canada

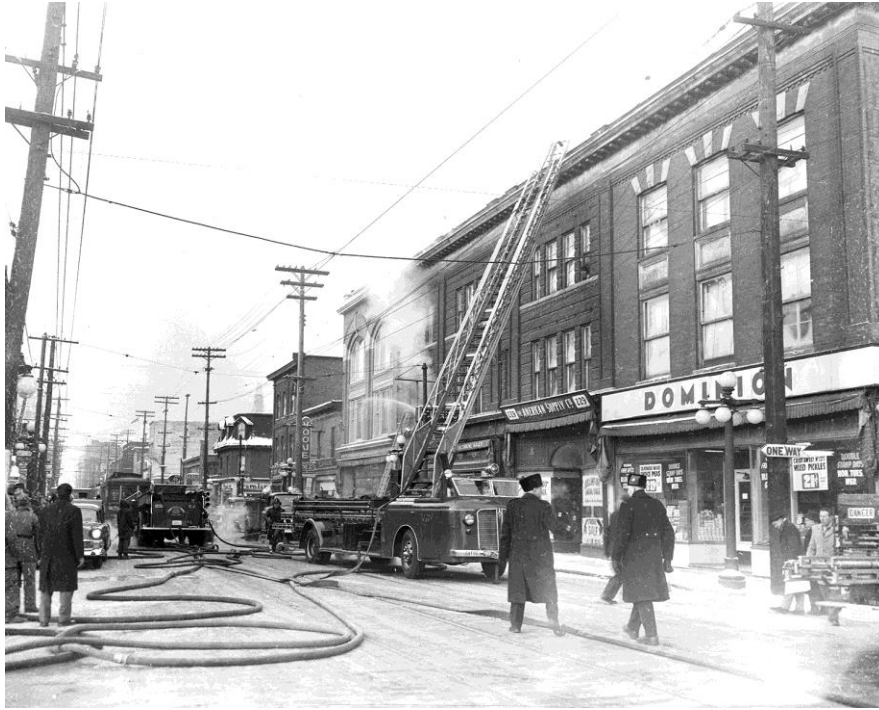
Figure 17: A view of the 211-231 block with fire trucks in the street. Note the unpainted facades with the decorative keystone with spandrels between the 2nd and 3rd floors. The photo provides a record of the earlier retail storefronts. Source: City of Ottawa Archives c. 1950.

A c.1950 photograph of the street with fire trucks provides a good reference for the shopfronts on the south end of the block.

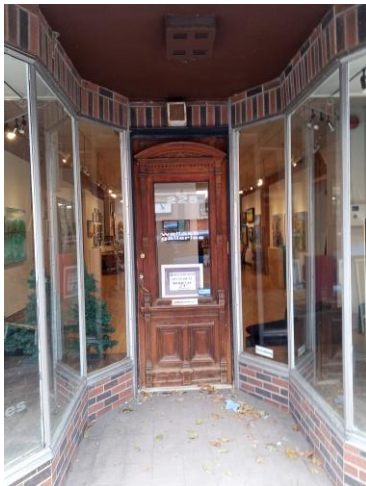
Figure 18: Although the shopfronts have been dramatically altered elements such as the recessed shopfront at 227 Bank Street are still evident. The leaded transom and vaulted arch have been covered over. Based on the 1950 photo it would appear that the three shopfronts at 215, 217 and 219 were similar with recessed entrances and decorative transoms.

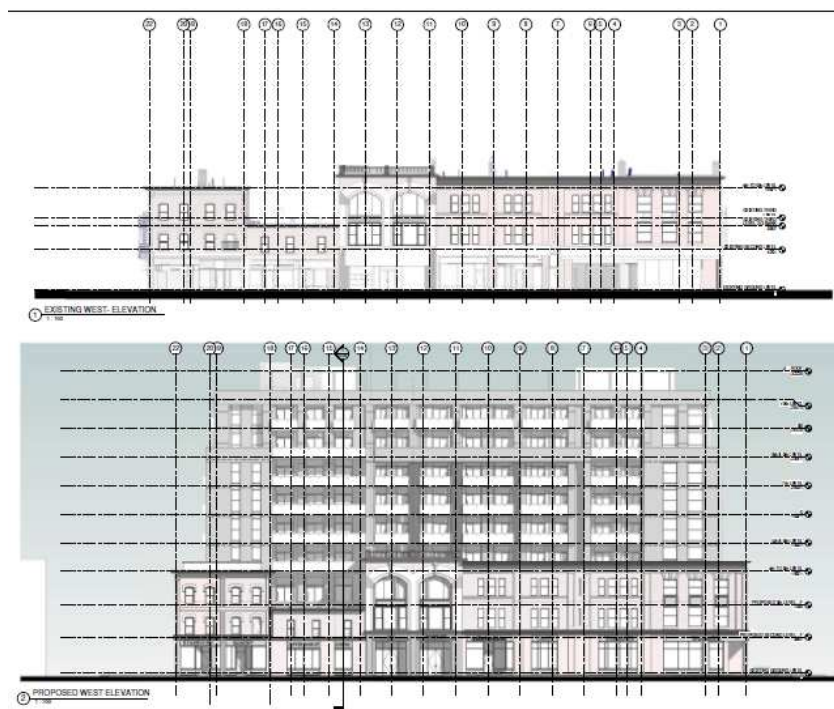
Figure 20 & 21 : Bank Street elevation looking East and perspective views of the intersection of Bank Street and Lisgar with the proposed 9-storey development. Woodman Architecture 2023.

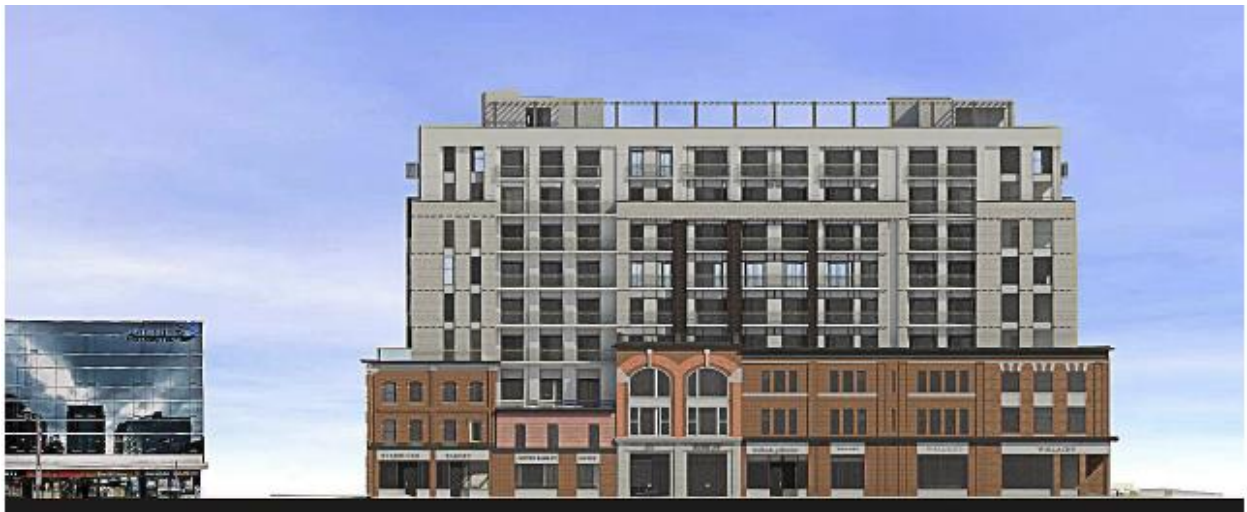
Figure 27: Contextual Elevation along Bank Street. Woodman Architecture. 2023

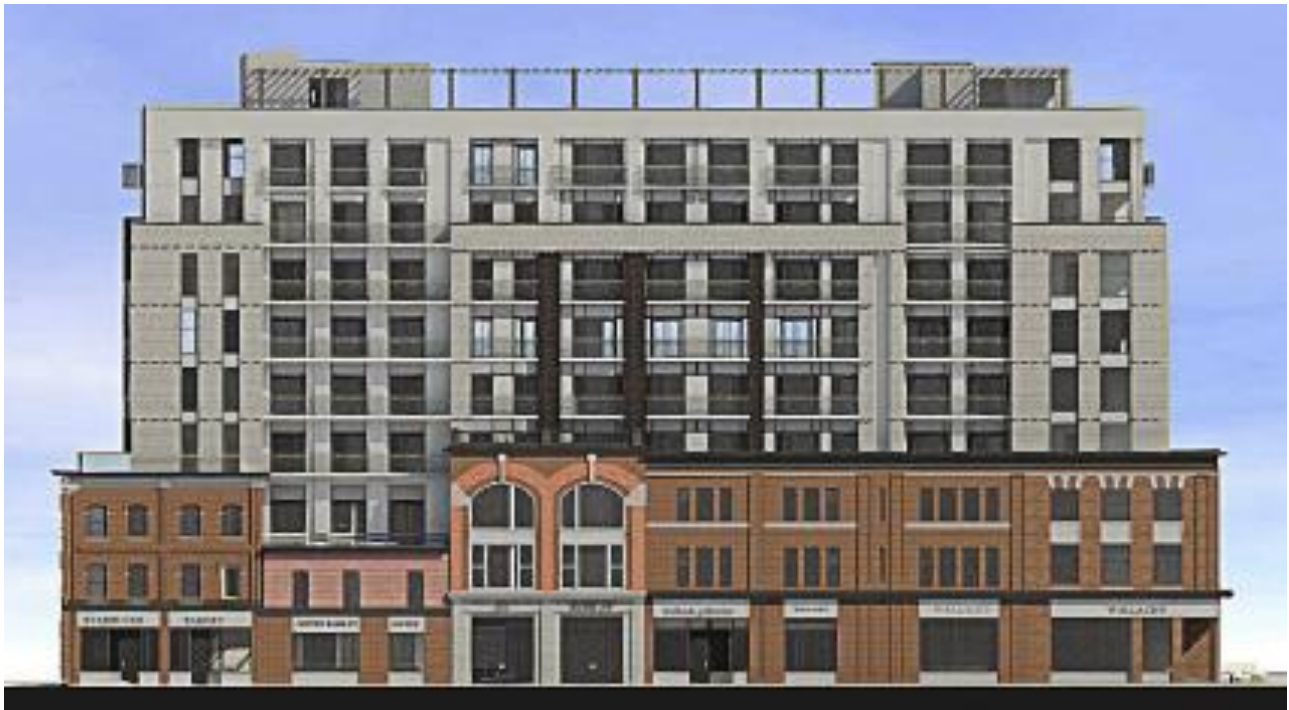
*Figure: Restored Elevations along Bank Street between Nepean and Lisgar illustrating the building's revival.
Source: Woodman Architects Inc 2023.*

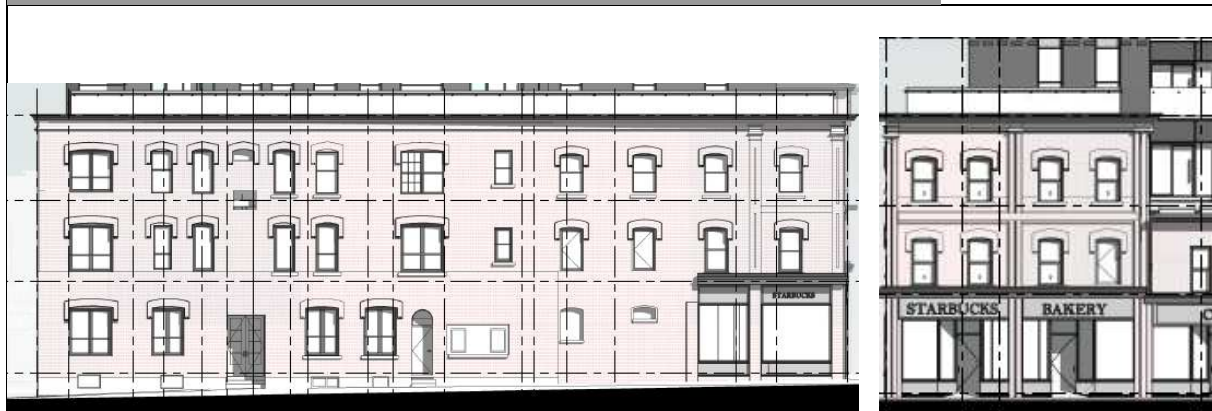
Restored Elevations of the Nepean and Bank Street facades. Woodman Architects

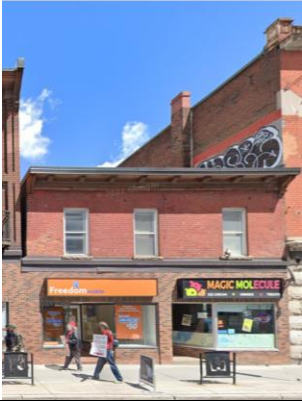
<p>215-217 Bank St.</p>

<p>Character Defining Features</p> <ul style="list-style-type: none"> • Elaborate metal cornice. • Frame construction with 2 storey painted brick façade on Bank Street. • Slightly uneven second floor window configuration. • Lower height of the commercial ground floor compared to adjacent buildings. • Elaborate metal cornice at the roof line.
<p>Removals, Interventions and Conservation Guidelines</p> <ul style="list-style-type: none"> • Chemical wash to remove paint. • Selective repointing of brick, and sills . • The three second floor windows replaced with new double hung units • Remove variegated brick from the ground floor storefront(s) • Restore the ground floor brick pilasters with a capital to frame the two retail spaces • Insert large glazed commercial store fronts into the two bays • Introduce commercial cornice with signboard, knee wall at base, recessed flared entrances. See comparative illustrations • Repair as necessary the elaborate metal cornice.
