Phase One Environmental Site Assessment 178 Nepean Street and 219 Bank Street, Ottawa, Ontario

Smart Living Properties

Phase One Environmental Site Assessment

OTT-22010865-A0

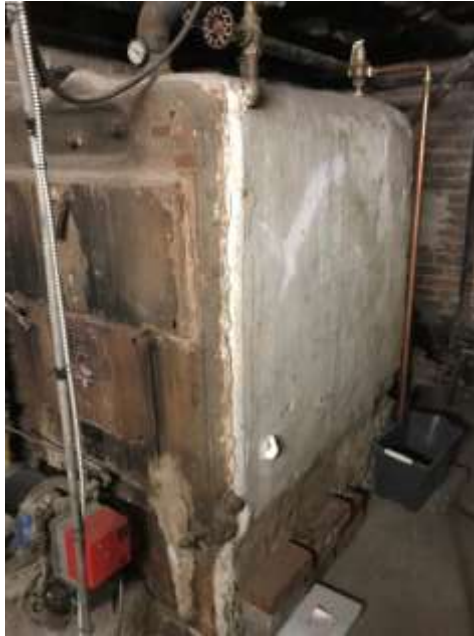
Photograph No. 7

View of the boiler with suspected asbestos insulation in poor condition at 178 Nepean Street.

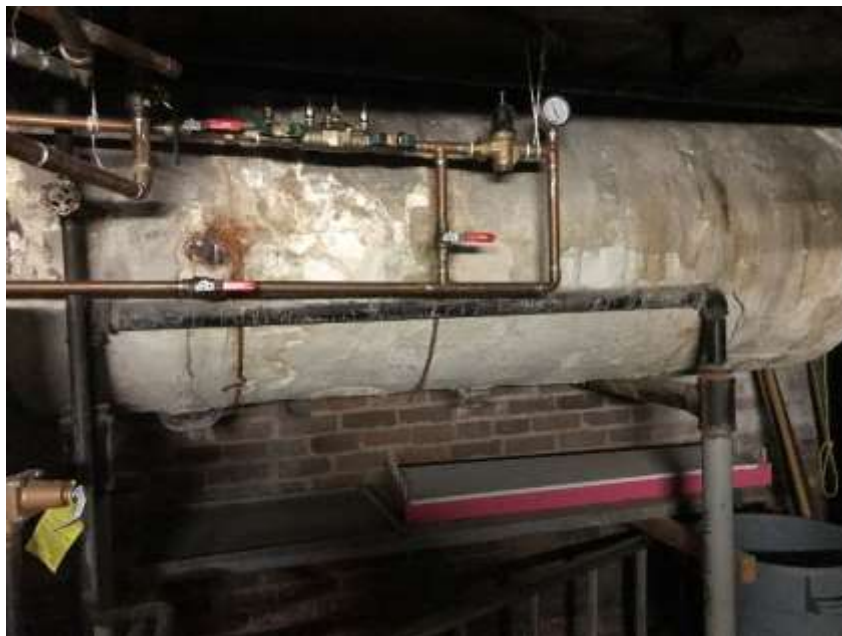
Photograph No. 8

View of the expansion tank with suspected asbestos insulation in poor condition at 178 Nepean Street.

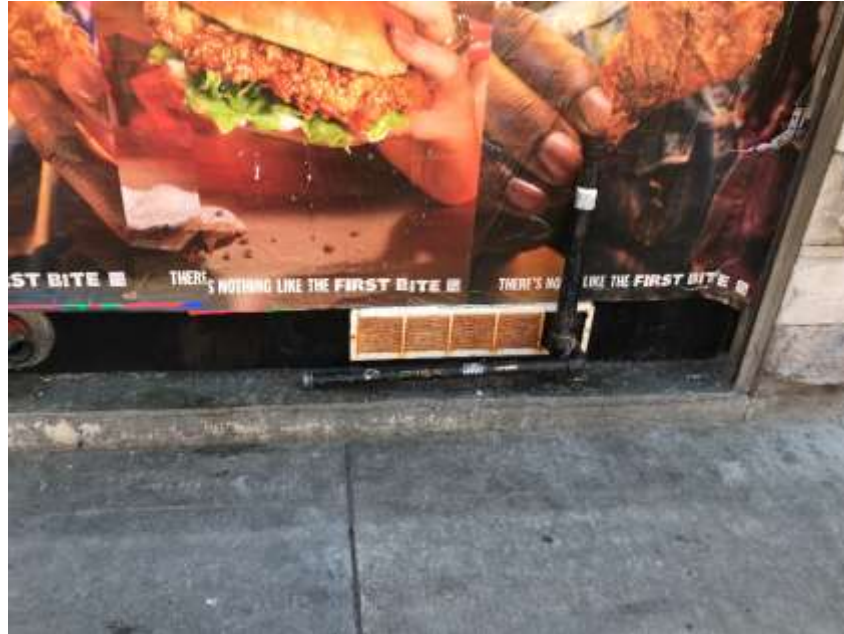
Photograph No. 11

An above ground storage tank (AST) was observed in the basement of 219 Bank Street (**PCA 23**). Vent/fill pipes were present at the southwest corner of the building. The AST was installed in 2005 and appeared to be in good condition. A wood floor was present beneath the AST. No staining was observed on the wood.

View of the vent/fill pipes at 219 Bank Street.

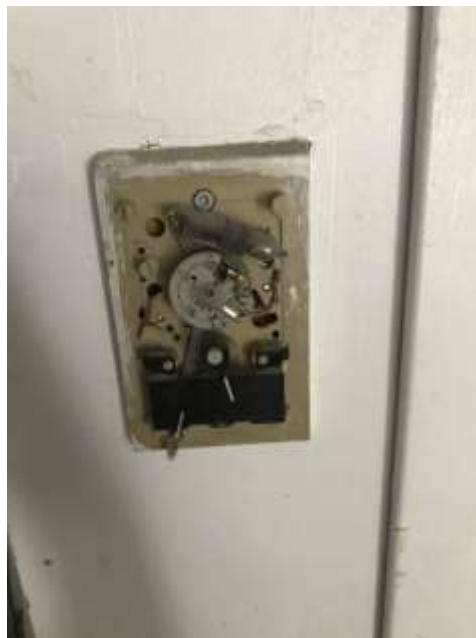
Photograph No. 14

The interior painted surfaces observed during EXP's site visit were in good condition. One mercury-containing thermostat was observed on the second floor of the building at 219 Bank Street.

View of a mercury containing thermostat at 219 Bank Street.
