RE: TREE CONSERVATION REPORT FOR 5120-5210 INNES ROAD, OTTAWA

This Tree Conservation Report (TCR) was prepared by IFS Associates Inc. (IFS) on behalf of Dymon Storage in support of their proposed development of 5120-5210 Innes Road in Ottawa. The need for this report is related to trees protected under the City of Ottawa's Tree Protection By-law (By-law No. 2020-340). The proposed development of this presently open lot will include the construction of a four-storey commercial building.

TREE CONSERVATION PLAN

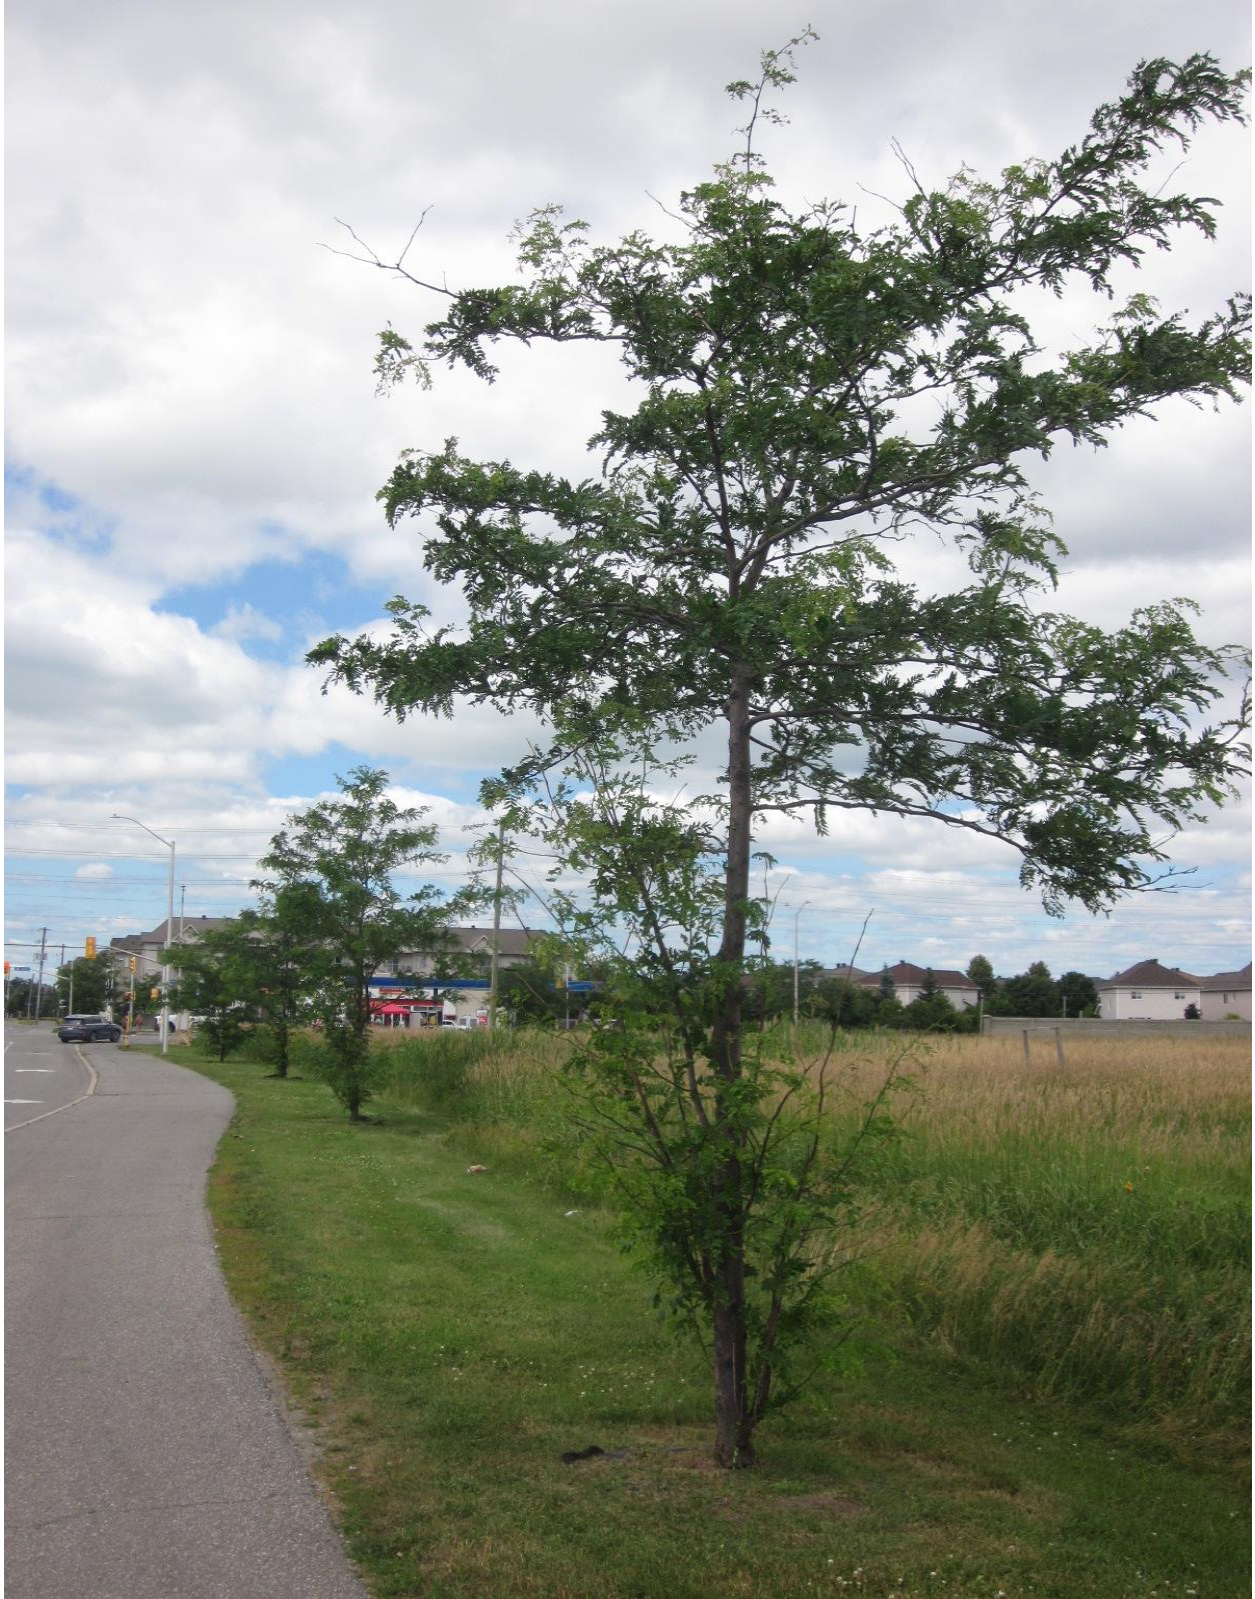
Picture 1. Trees #1-4 (background to foreground), immature honey-locusts at 5120-5220 Innes Road

Tree No.	Tree species /Tolerance to Construction ¹	DBH ² (cm)	Ownership	Condition, age class, tree condition notes & preservation status (to be removed or preserved and protected)
1	Honey-locust (<i>Gleditsia triacanthos</i>) Good	12	Private	Good; immature; typical form for species; broad dense crown; epicormic sprouts on lower bole; introduced species to Eastern Ontario; to be removed (will not survive root loss due to nearby proposed parking lot)
2	Honey-locust (<i>Gleditsia triacanthos</i>) Good	10	Private	Good; immature; typical form for species; broad dense crown; epicormic sprouts on lower bole – some of which are dying back due to salt spray; introduced species to Eastern Ontario; to be removed (will not survive root loss due to nearby proposed parking lot)
3	Honey-locust (<i>Gleditsia triacanthos</i>) Good	9	City	Good; immature; typical form for species; broad dense crown; epicormic sprouts on lower bole – some of which are dying back due to salt spray; introduced species to Eastern Ontario; to be removed (conflicts with proposed entranceway)

4	Honey-locust (<i>Gleditsia triacanthos</i>) Good	9	City	Good; immature; typical form for species; broad dense crown; epicormic sprouts on lower bole; some crown and sprout dieback due to salt spray; introduced species to Eastern Ontario; to be preserved and protected

Picture 1 on page 5 of this report show the trees on and adjacent to the subject property.
