Phase One Environmental Site Assessment

2040 Arrowsmith Drive, Ottawa, Ontario

January 7, 2022

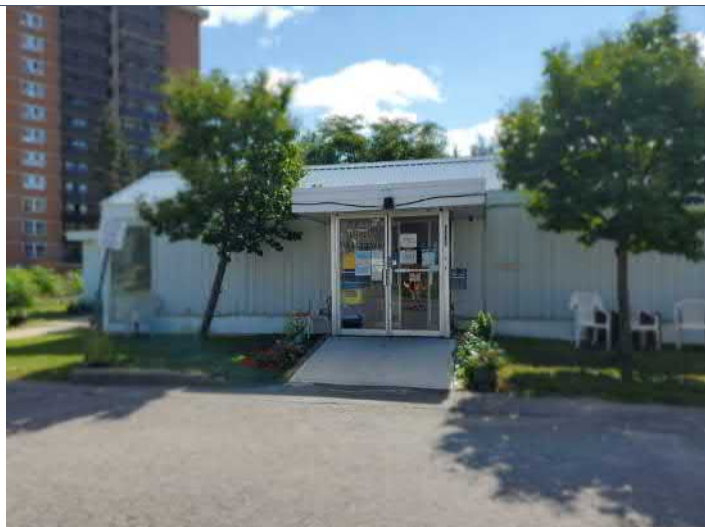
Picture 1 – Site building on RSC Property (facing south)

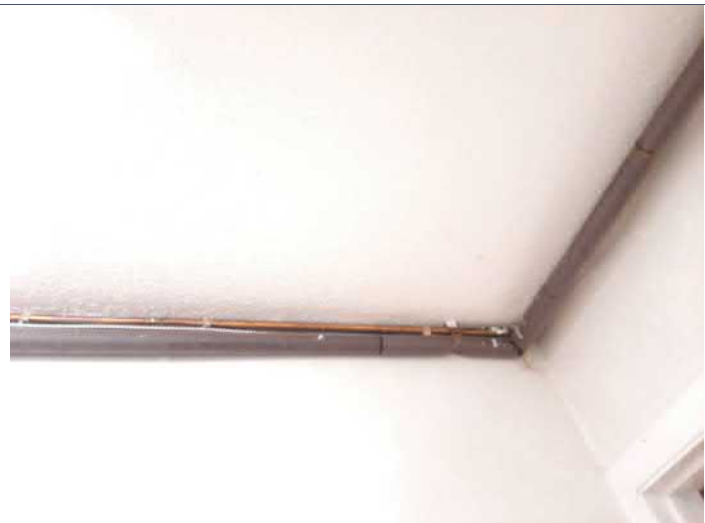
Picture 3 – Piping inside site building

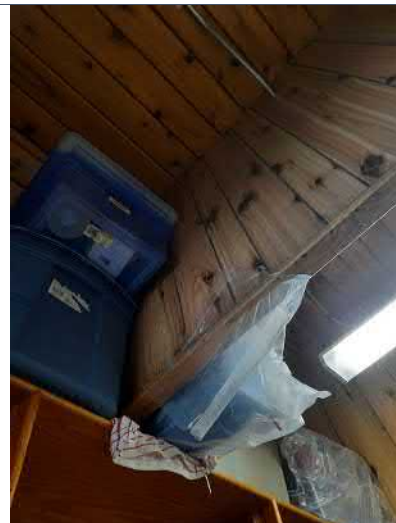
Picture 4 – Patched portion of ceiling in site building that has been reported by staff to have leaks in the past

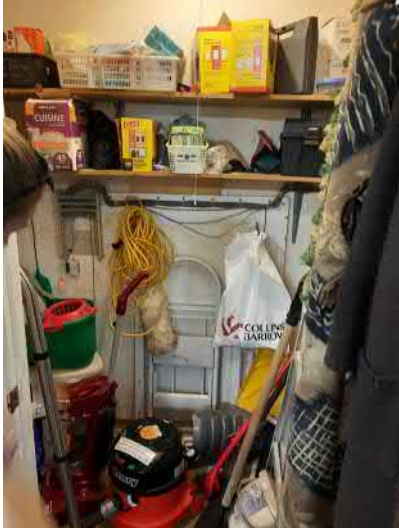
Chemicals stored at the RSC property include household cleaners including bleach. No spills or staining were observed within the vicinity of the chemicals. It is noted that cleaning products were being stored in a small storage closet with carpet flooring and no floor drains.

Picture 5 – Contents of storage closet/closet containing water heater

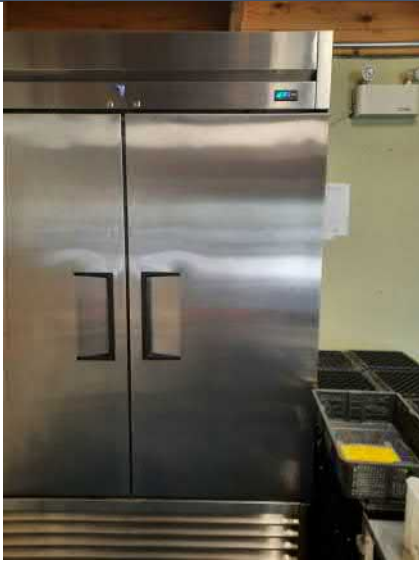
Potential ODS-containing equipment observed at the RSC Property includes residential type refrigerators and freezers. ODS equipment is not expected to result in impacts to soil or groundwater at the RSC Property.

Picture 7 – Industrial sized refrigerator in site building

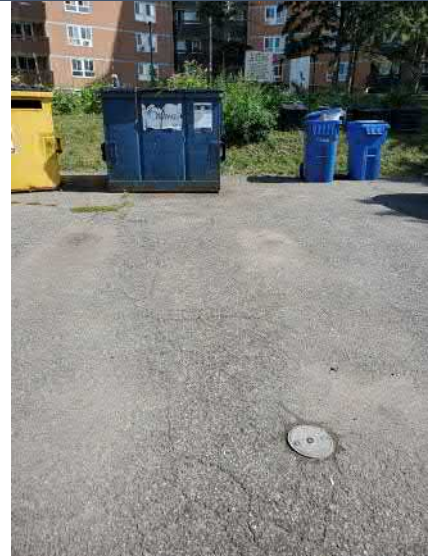
- Asphalt-paved access roadways and parking areas surrounding the building. Catch basins were observed in these areas.
- An asphalt-paved parking lot is located to the southeast of the building. One flushed-mount style monitoring well is located here, which was installed as part of Dillon's 2013 Phase Two ESA (confirmed by referencing the Site Plan from the report). Waste bins are situated at the north east edge of the parking lot.

Picture 10 – Monitoring well (facing east) in parking area, waste bins.

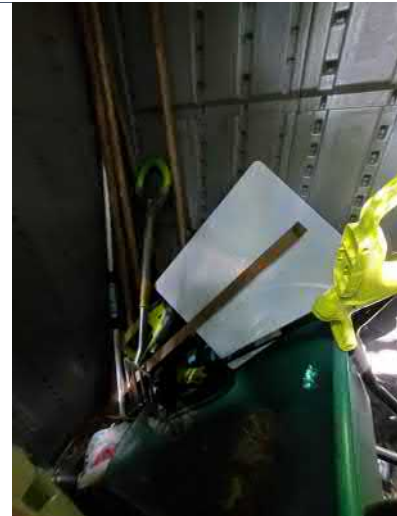
- Additional structures on the RSC Property include a storage shed and several locker stalls (located adjacent to the south wall of the building). The storage shed contains lawn maintenance equipment. It was noted that the City has since taken over the maintenance of the RSC Property and these items are no longer needed or used. Storage lockers are designated for volunteers of the GEFC and typically contain personal items used to tend to community gardens (gloves, small tools, etc.). No chemicals or fertilizers are stored on the property.

Picture 12 – Contents of small storage shed located on south side of site building

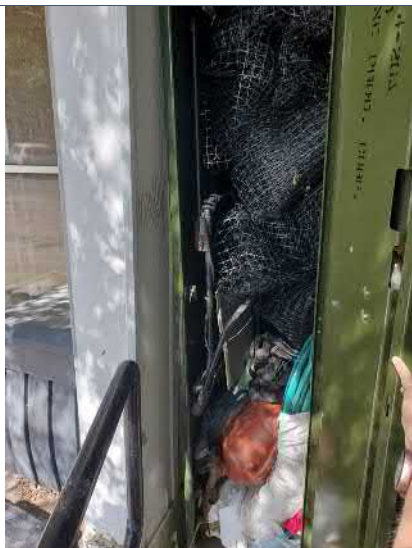
Picture 13 – Contents of storage locker located on south side of site building

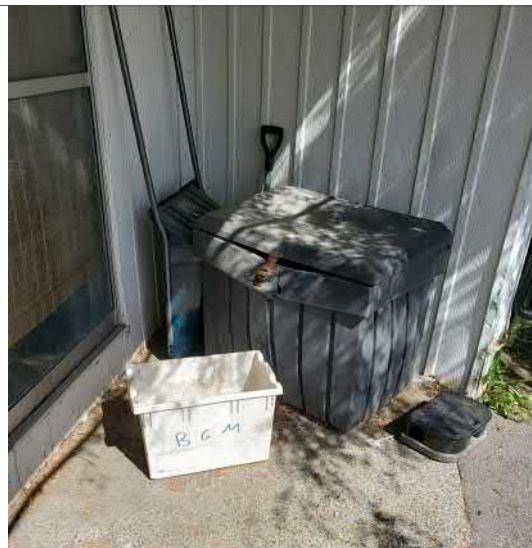
Picture 14 – Salt storage bin located at south entrance of site building

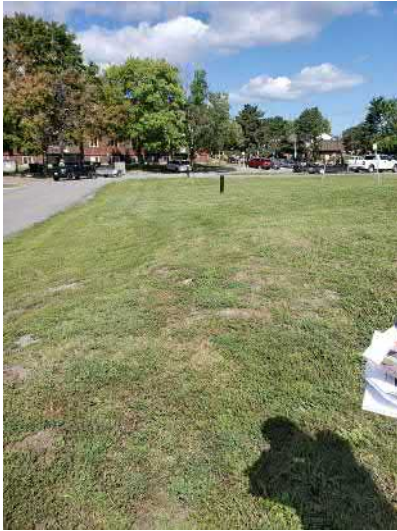
pathway. The southern-most portion of the grassed area slopes upward at a higher elevation than the rest of the grassed area and borders a chained-link fence. Two monument style monitoring wells were observed along the west portion of the grassed area, which were installed as part of Dillon's 2013 Phase Two ESA (confirmed by referencing the Site Plan from the report).

Picture 19 – Site view from landscaped portion of property (facing north) capturing two monitoring wells
