Phase I Environmental Site Assessment

Proposed Residential Development

84 and 100 Gloucester Street

Report PE5571-1 dated February 16, 2022

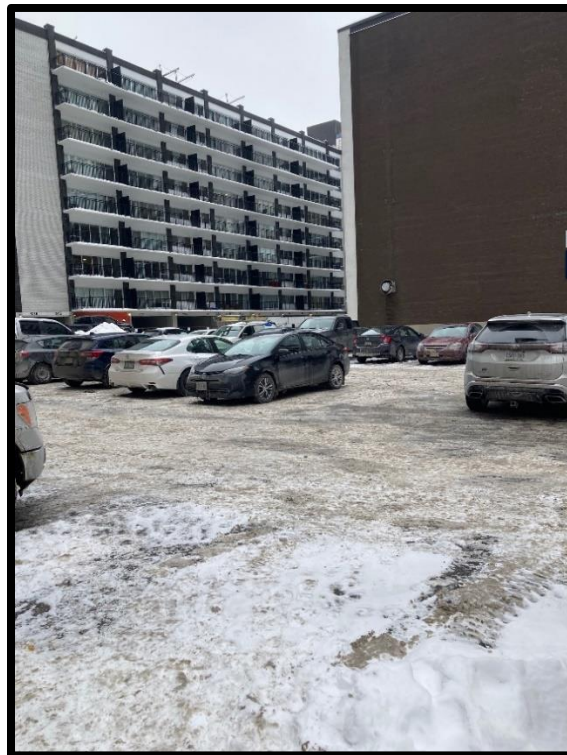
Photograph 2: View of the parking lot, looking southwest.

Based on the findings of the Phase I ESA, it is considered likely that road salt was applied to the surface of the parking lot on the Phase I Property for the safety of vehicular and pedestrian traffic under conditions of ice and/or snow. Although not defined as a specific PCA under Column A of Table 2 of O.Reg. 153/04, the use of salt for safety purposes is considered to result in an APEC on the Phase I Property (APEC 4).
